# Forensic Engineering Analysis of Dynamic Wheel Tire Impact Ejection of Manhole Covers

by Jon O. Jacobson, Ph.D., P.E. (NAFE 401F)

Michael Kravitz, P.E. (NAFE 451F)

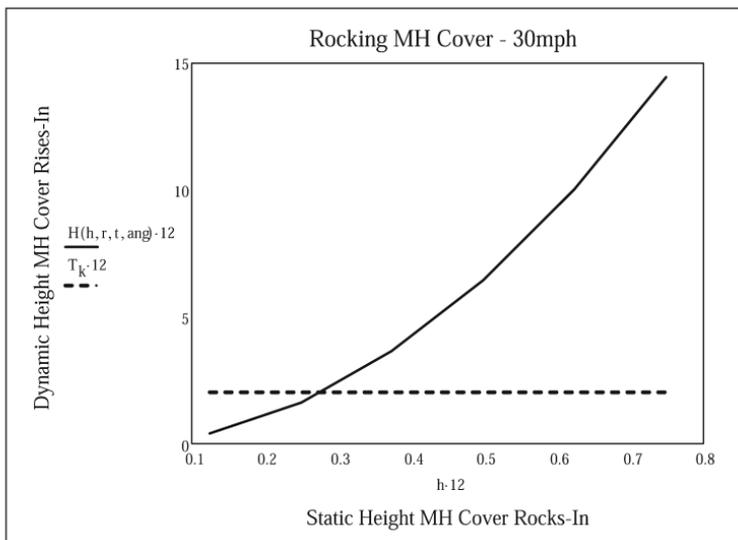
The graph below was created for a rocking manhole cover where a tire rides over the manhole at 30 MPH. It shows that if the manhole cover had the ability to rock a minimum vertical distance of approximately 3/8", then it could clear the casting if the casting thickness and manhole cover thickness in this example were equal to two inches.

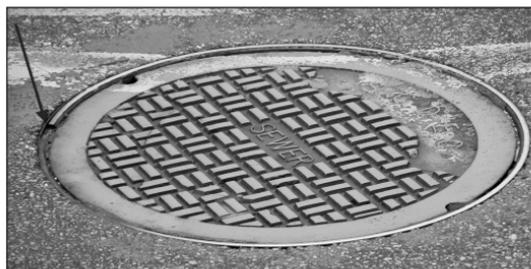
The sketch is an example of the adjustable riser ring. Notice that there is no method of preventing the edges where the turn buckle is located to move relative to each other in the vertical direction thereby creating a helix effect for the seat of the manhole cover if movement occurs.

The arrow in the photograph is pointing to where the turn buckle would be located. Notice the height differential of the adjustment riser where it is split. Also notice the debris between the manhole cover and the sides of the adjustment ring which would prevent manhole cover motion.

The debris would take some period of time to collect which would result in a stable manhole cover and prevent rocking.

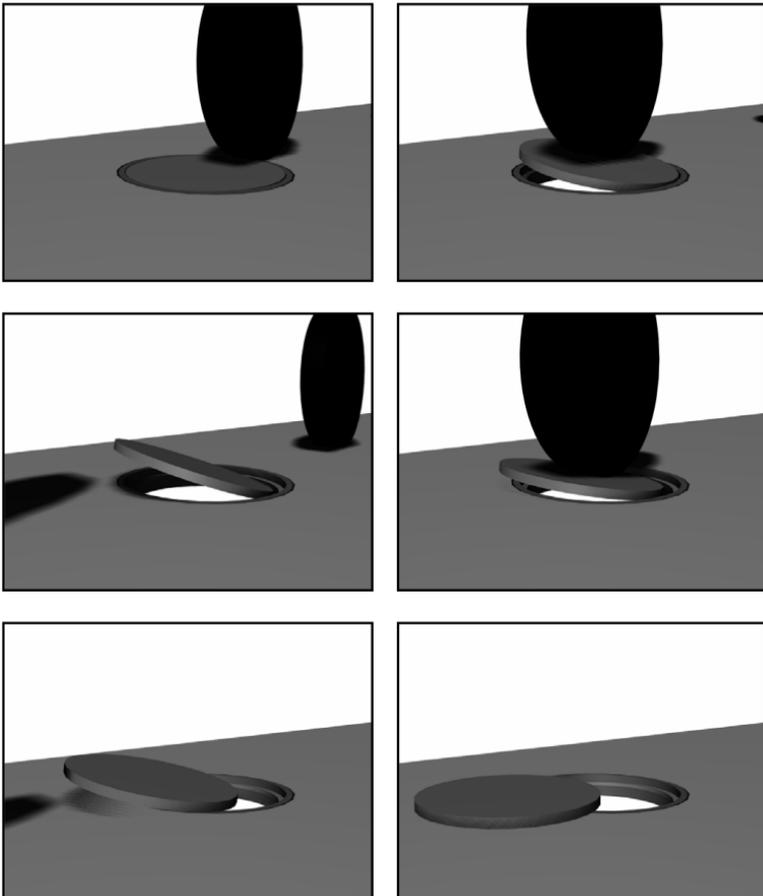
The images below depict an 800 pound tire riding over a 26" diameter, 1" thick manhole cover that weights approximately 150 pounds. The manhole cover sits on a helix that has a pitch difference of 1/2" so that the manhole cover is not flush or even with the manhole casting. The helix emulates an adjustable manhole riser where the diameter of the adjustable riser varies depending on the diameter of the original manhole casting and the turn buckle or adjustment screw creates a pitch difference which causes the manhole cover not to have complete contact on the adjustment riser seat and therefore rocks within the casting. The manhole cover is allowed to rock and as a result when the tire rolls over it causes it to rotate and move out of the casting. The speed of the two tires is 30 mph at a distance of 110 inches which would approximate the wheel base of a vehicle. The orientation of the helix, and the location of the tire rolling over the manhole cover is random which may or may not cause the manhole to move in, as well as not move in the casting.

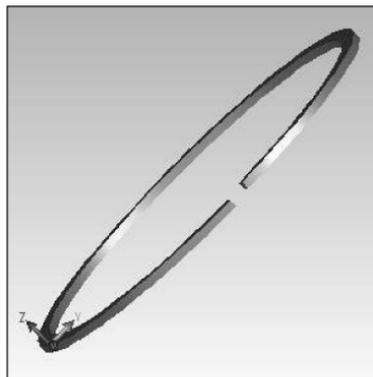
The adjacent helix represents the seat of the adjustable manhole riser on which the manhole cover sits. The diameter is approximately 26" with a difference in pitch of  $\frac{1}{4}$ " with a gap that represents the distance the turn buckle has expanded within the adjustable riser. The result is that the manhole cover does not sit completely on the seat and rocks relative to the pitch difference of the helix.

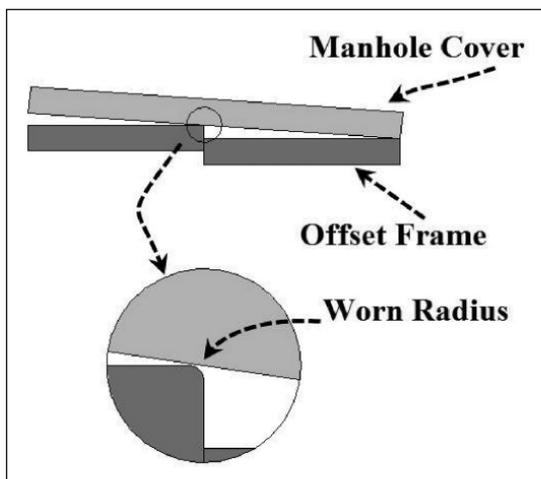
In the second instance where the probability existed that the manhole cover fractured, the strength of the manhole cover has been analyzed from the standpoint of the local contact stress originating at the corner where the manhole cover is lifted up at the end of the helix of the misaligned adjustment riser frame.

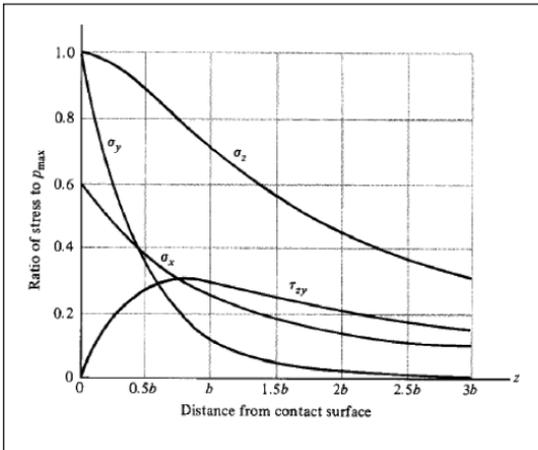
From this we can calculate the maximum pressure on the surface. With the maximum pressure the solution for the maximum shear stress can be determined from the graph from Thomas and Hoersch:

In this instance, the maximum shear stress is the indicator of the origin of failure, this being near the b-value below the surface and being 0.3 of the maximum surface pressure.

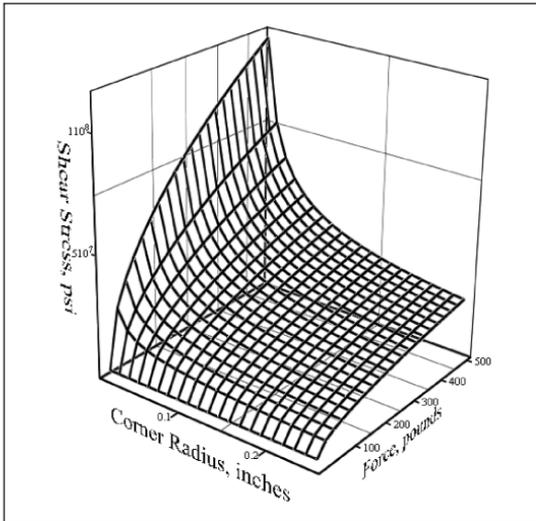
$$p_{\max}(.1\text{-in}, 500\text{-lbf}) = 2.291 \times 10^5 \text{ psi}$$

$$\tau_{\max}(.1\text{-in}, 500\text{-lbf}) = 6.874 \times 10^4 \text{ psi}$$
