Vol. 37 No. 1 December 2020

Forensic Engineering Investigation of a Pipe Joint Tester Explosion

By William Keefe, PE, (NAFE 481M)

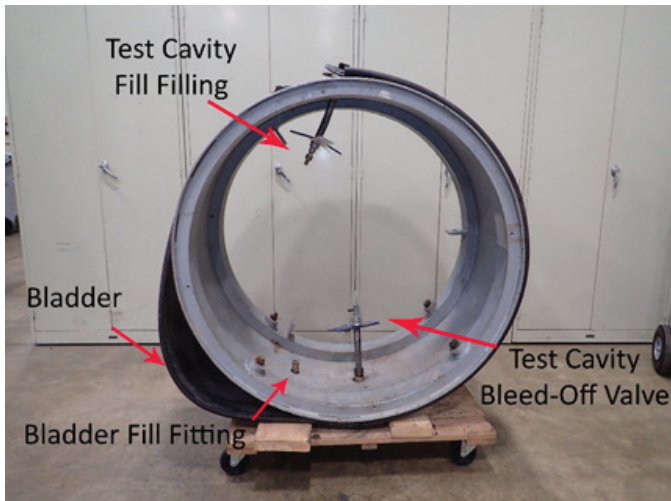
Two telescoping air supply pipes extended from the inner diameter of the joint tester frame to the outer circumference of the bladder. This allowed a separate source of compressed air to be introduced into the annular space at the pipe joint between the outer surface of the pressurized bladder and the inner surface of the pipes. This annular space was referred to as the test cavity. One test cavity air supply connection was located at the upper center of the joint tester; the other was located at the lower center of the joint tester. The upper connection was used to supply compressed air or water to the test cavity and was equipped with a male quick-disconnect fitting. The lower connection was equipped with a ball valve and was used to bleed air out of the test cavity (**Figure 1**).

Figure 1
Damaged pipe joint tester (post-incident).

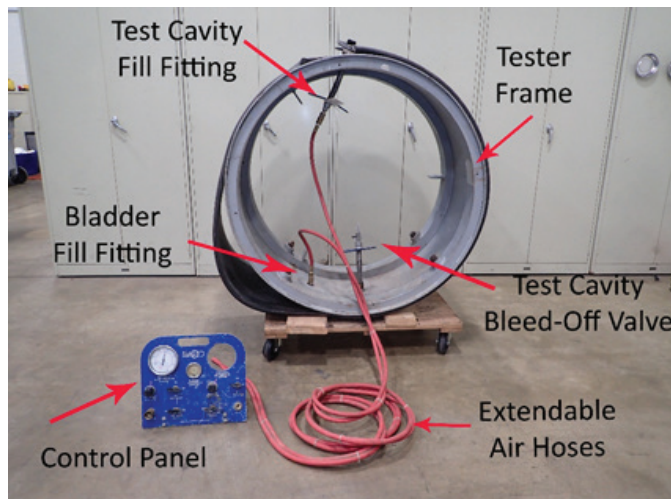
Figure 5
Control panel attached to tester (post-incident damaged condition).

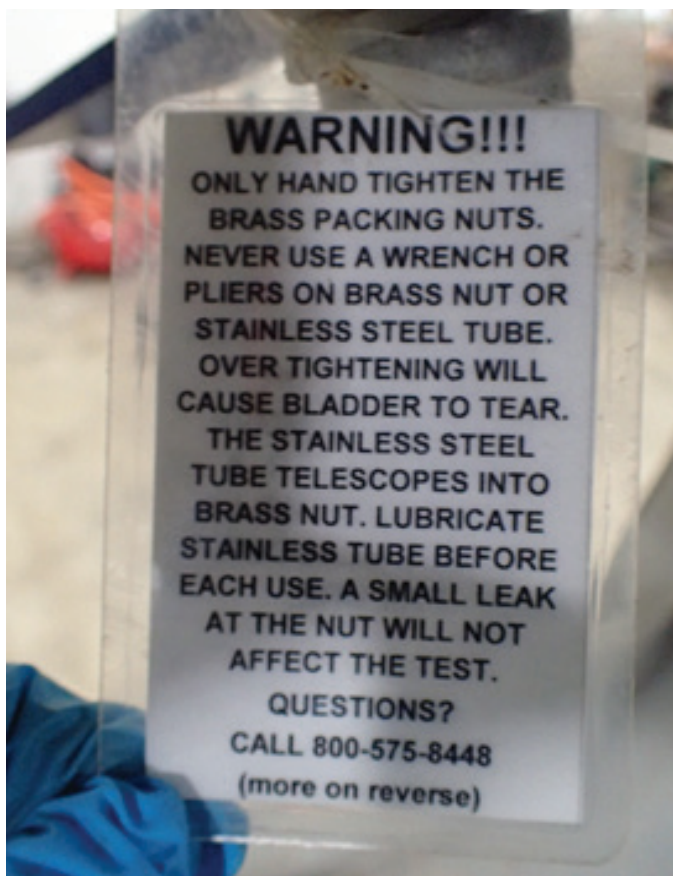
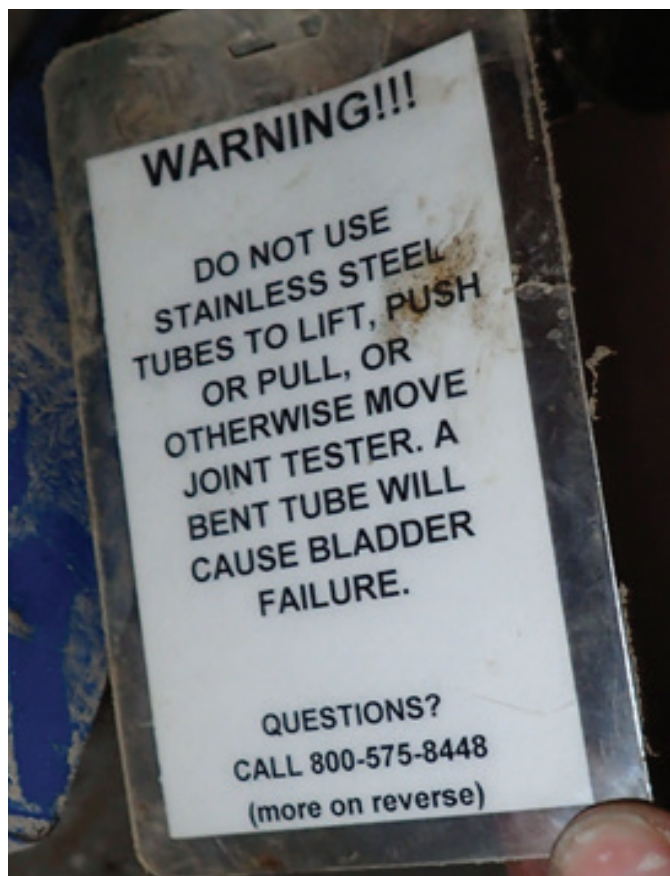
Figure 7
Warning tag (front).

Figure 8
Warning tag (rear).

Two identical laminated warning tags were attached to the telescoping test cavity fill port and the telescoping test cavity bleed-off port. One side of each tag contained a warning regarding overtightening of the packing nut. The other side contained a warning against using the tester

with bent telescoping tubes (**Figures 7 and 8**).

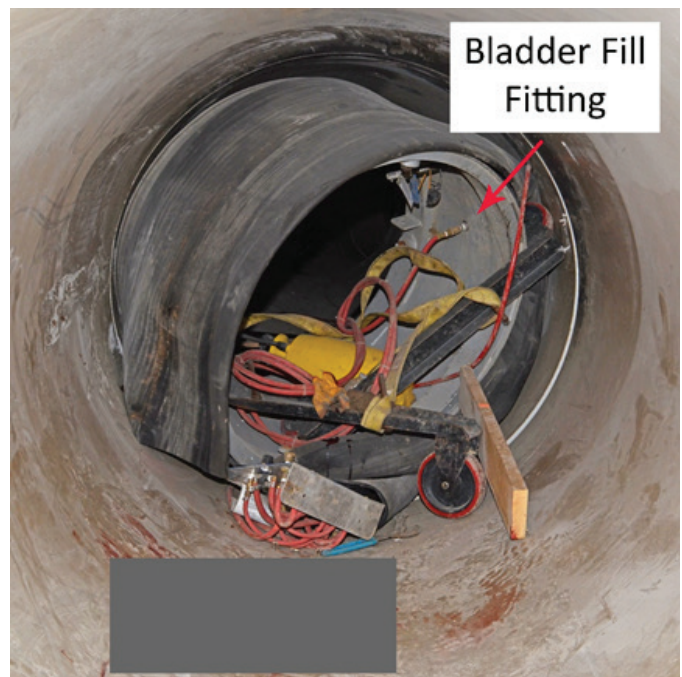
Figure 11

Pipe joint tester in pipe after incident.

- The axis of the tester frame was not parallel with the pipe axis. The frame was rotated slightly counterclockwise about a vertical axis (viewed from above) and slightly clockwise about a horizontal axis (viewed from the left).

- The test chamber fill fitting, which had originally been positioned at the 12:00 position was located at about the 7:30 position. The bladder fill fitting, which had originally been located at about the 7:00 position, was located at about the 2:30 position.

- The bladder contained a rupture parallel with the pipe and pipe tester axis. The rupture appeared to extend the entire width of the bladder. The bladder was partially separated from the frame.

- Both transport wheel frames were completely separated from the tester frame and were resting partially within the inner diameter of the frame. One steel channel wheel frame contained significant deformation. On the other frame, one wheel was wedged between the tester and the pipe wall.

- The control panel was resting on the lower pipe surface directly in front of the tester. The paired bladder and test cavity supply hoses were partially wrapped around the wheel frames. The air supply hose was not connected to the control panel and appeared to be wrapped around the right side of the joint tester.

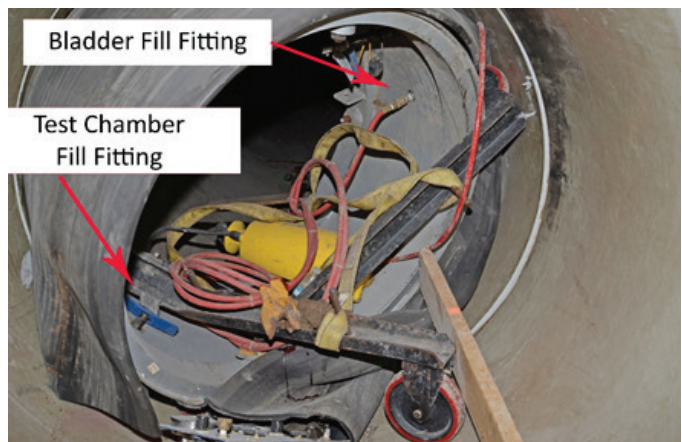
Figure 12

- The photographs were taken from the side of the tester where Laborer 2 and the engineer had been positioned. A large amount of blood was present on the lower portion of the pipe adjacent to the tester frame.
- After the incident, the side of the joint tester frame equipped with lifting lugs was facing away from Laborer 2's position.

Pipe joint tester in pipe after incident.

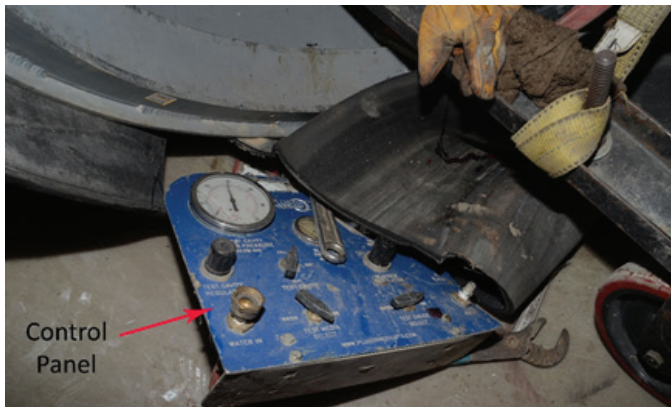
Figure 13
Joint tester control panel.

- Some of the controls on the control panel were visible. The test media selector valve was positioned slightly clockwise from the AIR position.

The test cavity valve was positioned slightly clockwise from the FILL position. The test gauge valve was positioned slightly counterclockwise from the AIR position.

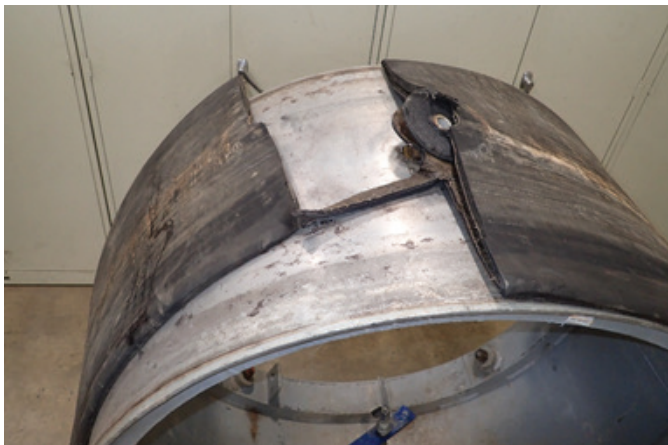
Figure 14

- The damaged bladder was loosely attached to the tester frame. The bladder was held in place by the telescoping tubes of the test cavity fill fitting and the test cavity bleed-off fitting, which extended from the bladder through the frame. The bladder fill fitting was wedged between the bladder and the outer surface of the frame.
- The bladder was ruptured along a line parallel with the axis of the joint tester frame. The rupture was roughly centered on the test cavity fill fitting tube. This would have been located at the 12:00 position when the joint tester was set up for use in the pipe. The rupture extended almost completely through the entire bladder. A 1¼-in.-wide strip of material still connected the two sides of the rupture (**Figure 14** and **Figure 15**).

Top of joint tester showing ruptured bladder.

the tester where the telescoping test cavity tube extended through the bladder. The rupture was parallel to the axis of the joint tester frame and extended along the entire 24-in. width of the bladder. The rupture was also parallel to the reinforcing cords. It is well known that holes, grooves, notches, and other discontinuities in any material alter the stress distribution in the material and create stress risers. The manufacturer had knowledge and previous experience with failures at the location of the test chamber fill and bleed-off fittings. Instruction tags on the pipe joint tester indicated that overtightening of the packing nut at the telescoping tube could create a delamination of the steel fixture inside the bladder and cause the bladder to rupture. However, there was no way for the user to examine that assembly to determine its condition.

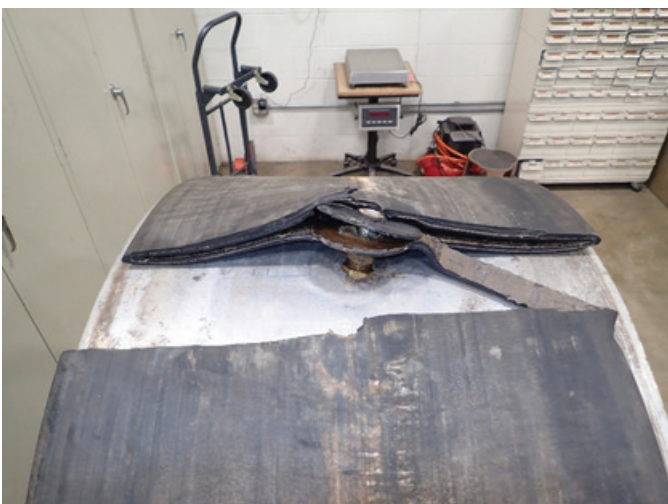
Figure 15

Ruptured bladder showing test cavity supply tube connection.

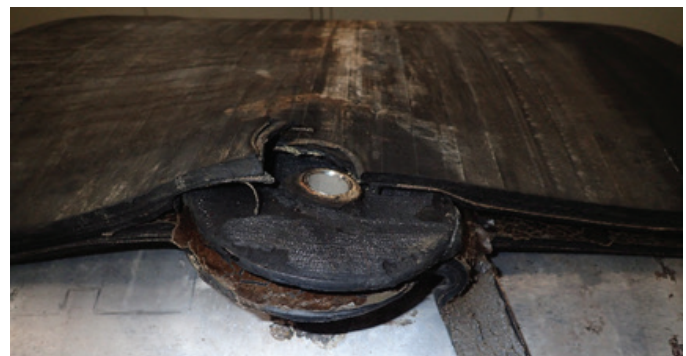
Figure 18

each location where the telescoping tube extended through the bladder. These reinforcing discs were about 5 in. in diameter, and each was sandwiched between the two layers of rubber material of the bladder wall adjacent to the reinforcing cords. At the site of the rupture, the disc in the inner wall was still partially connected to one side of the bladder rupture. At the outer wall, the reinforcing disc had completely separated from the bladder (Figures 18 and 19).

Bladder rupture at test cavity fill tube.

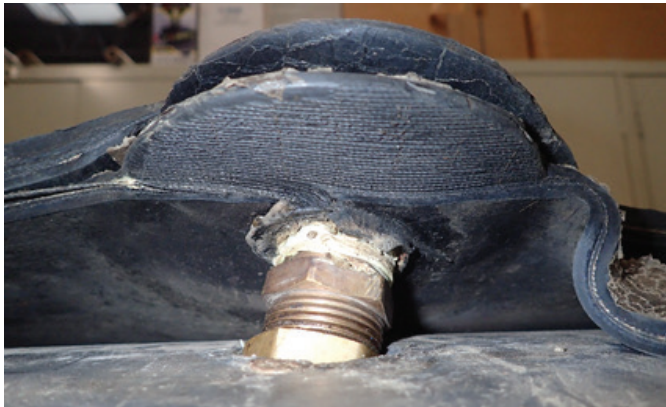
Figure 19
Bladder rupture at test cavity fill tube.

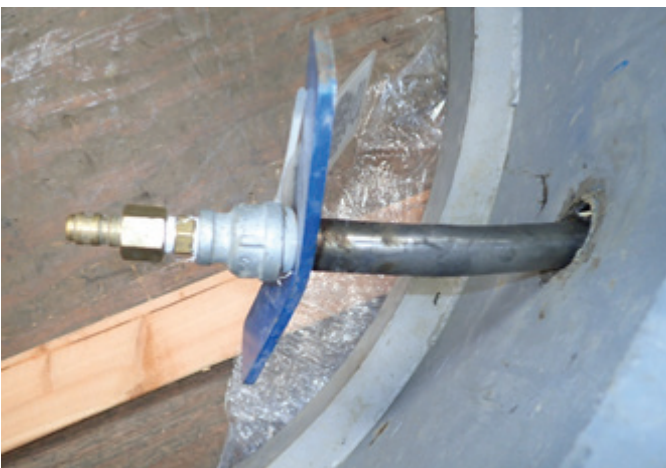
- The test cavity fill tube was bent. A male quick-disconnect fitting was attached to the inlet end of

the tube (Figure 20).

Figure 20
Test cavity fill tube.

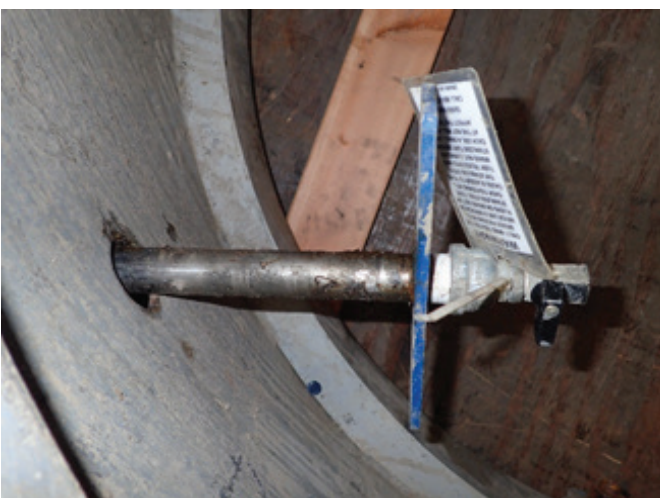
- The test cavity bleed-off tube did not appear to be bent. A ball valve was attached to the inner end

Figure 21
Test cavity bleed-off tube and valve.

of the tube. The valve was in the closed position (Figure 21).

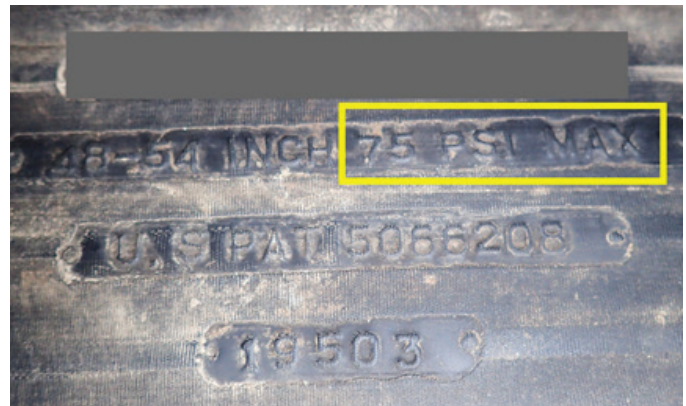
- A label molded into the exterior surface of the bladder indicated a maximum pressure of 75 psi (Figure 22).
- Both transport wheel frames had separated from the joint tester frame. Each wheel support frame consisted of a 4-in.-wide steel channel with an 8-in. diameter wheel mounted on each end. Each wheel frame had been attached to the inner diameter of the joint tester frame with two 3/4 in. nominal diameter acme thread bolts. Each wheel frame was positioned at a 45-degree angle from vertical. One of the wheel frame channels contained a severe bend extending from the end to the connecting bolt. The end of the channel was bent upward about 5 in. from the bolt and was twisted to the side. The other channel was bent upward about 1/2 in. All four of the 3/4-in. connection bolts for both channels had fractured just below the adjusting nuts on the underside of the channel (Figures 23 and 24).

Figure 22
Label embossed on outer bladder surface.

- The label for maximum pressure molded into the bladder was 75 psi. However, the pressure regulator was rated to supply air at a pressure of 125 psi. After the incident, the bladder pressure regulator was found set at 104 psi.
- The bladder pressure relief valve was adjustable

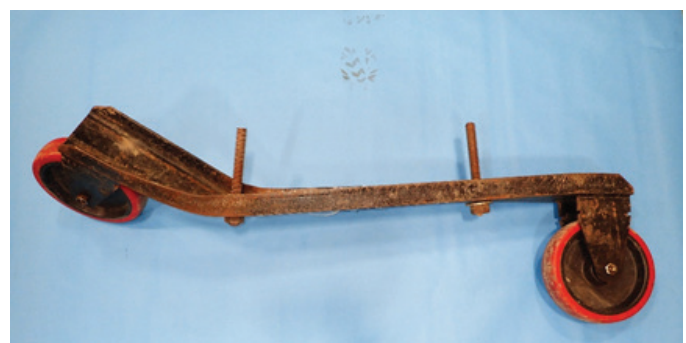
Figure 23
Damaged wheel frame.

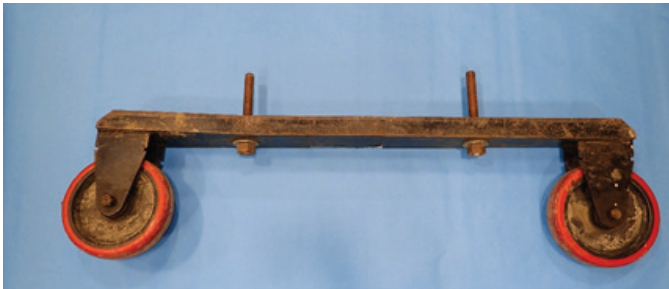
Figure 24
Damaged wheel frame.

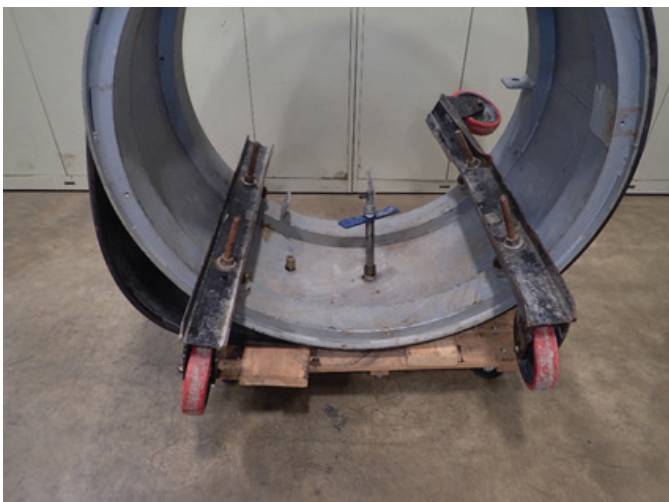
- The wheel frame connection bolts had been threaded into four cylindrical extensions on the inner diameter of the tester frame. The fractured ends of the $\frac{3}{4}$ -in. bolts remained in the tester frame. Comparison of the fracture surfaces indicated that the deformed ends of the wheel frames had extended out the side of the joint tester frame equipped with the lifting lugs (**Figure 25**).

Figure 25
Wheel frames repositioned in tester frame.

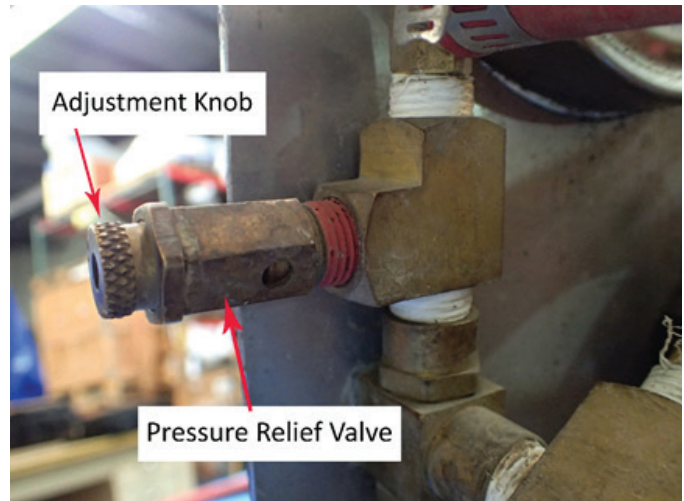
Figure 26
Bladder pressure relief valve.

line extending out of the bladder pressure regulator. This pressure relief valve was adjustable, and the relief valve manufacturer's specifications indicated that the adjustable range was 50 to 100 psi (**Figure 26**).

- When first tested the pressure relief valve leaked at 89 psi and popped full open at 93 psi. On two subsequent trials, the valve leaked at 84 psi and popped full open at 90 psi.

and could be adjusted above 75 psi. After the incident, the pressure relief valve was found set at about 90 psi.

- Replace the adjustable pressure relief valve with an appropriately sized non-adjustable pressure relief valve.
- Supplied air to the test cavity circuit from downstream of the bladder pressure regulator. This would prevent the test cavity pressure from ever exceeding the bladder pressure.
- Use a test cavity pressure regulator with a lower rated outlet pressure.
- Provide an appropriately sized non-adjustable pressure relief valve in the test cavity circuit.
- Provide a third air hose extending from the test cavity bleed-off port back to a valve at the control panel. This would eliminate the need for personnel to reach into the test cavity frame to operate the bleed-off valve.
- Use hoses of the appropriate length to adequately separate operating personnel from the pressurized pipe joint tester.
- **Figure 30** shows a modified air control schematic.
