**Vol. XXV No. 2 December 2008**

# Forensic Engineering Investigation of Pyrite's Expansive Forces and Impact on Long-Term Building Failure

by Paul G. Carr, Ph.D., P.E. (NAFE 664S)

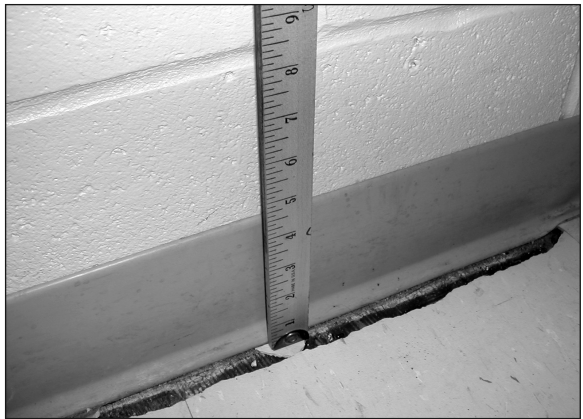
One situation observed in the investigation was the movement in the slab-on-grade floor at the elementary school. It was discovered that there had been differential movement between the interior slab and the exterior foundation wall. As would be expected, the first impression was that the foundation had settled due to the concentrated forces on the exterior walls, transmitted to the foundation, while the floating slab inside the building was lightly loaded. This condition in 2003 is presented in Figure 1.

**Figure 1**  
Differential Floor / Wall Movement

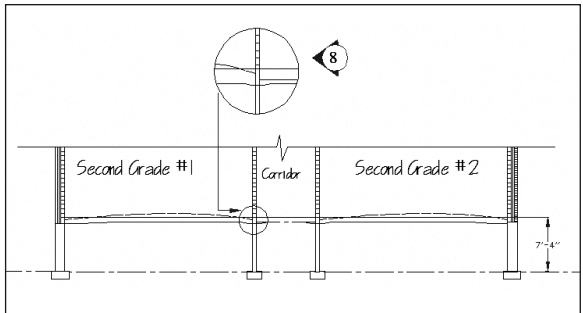
In January of 2003 a survey of the school had been completed to establish a baseline of elevations, since there was no ‘as-built’ survey performed at the time of construction completion. It was discovered that the slab within the building was higher in the center of the classrooms than at the edge, and the survey established that the edge of the slab was higher than the top of the exterior foundation wall. The cross-section in Figure 2 provides a graphical presentation of the survey results.

**Figure 2**  
Cross-Section of Elementary School

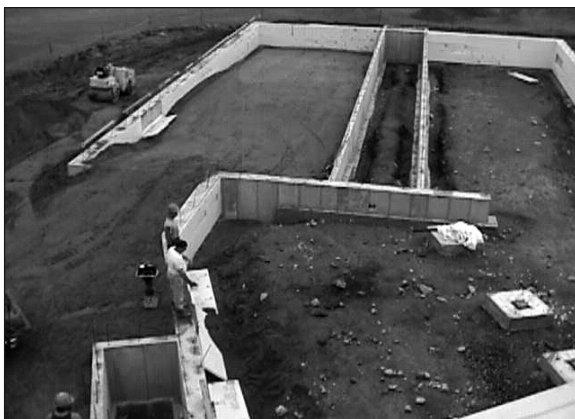
This fill, at the elementary school ranged from approximately 1-foot to over 6-feet in depth. It was specified to be an engineered structural fill, and the contractor requested to use stone dust as a substitute for this material. Figure 4 shows the first lift of the substitute stone dust installation. The granite stone dust when placed was light gray in color as was noted in the color construction photos.

**Figure 4**  
Elementary School Foundation with  
Initial Lift of Substitute Material

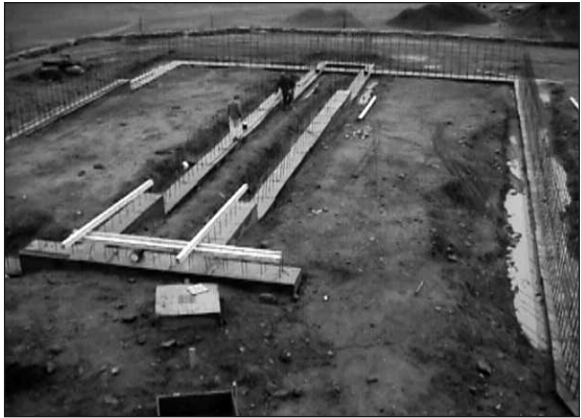
**Figure 6**  
Water Trapped Adjacent to Footing

of the water to penetrate into the native soil is limited; therefore it will be captured at the base of the foundation wall. The footing, once in place, and without a footing drain, has created a moat around the building that allows water to be captured and to stand in place without the opportunity to freely drain away. This is shown in Figure 6.

The school was advised concerning the concept of the installation of footing drains around the perimeter of the building. We reported to the Board on the potential for frost heave, and that while the control of water adjacent to the footing was a reasonable prophylactic measure, we did not believe that frost was the problem; and therefore the drains would likely not be the final solution. The footer drain project moved forward and was completed in the summer of 2005. We continued monitoring the site throughout 2005.

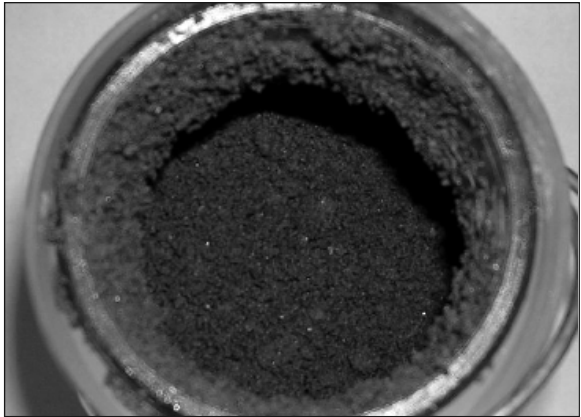
The footing drain installation in the summer of 2005 allowed us to observe and collect additional material for analysis. The footer drain was installed at the bottom of the footing elevation, and the foundation wall was exposed for the drain installation. Core drilling of the concrete foundation wall allowed us to collect additional samples of the structural fill under the slab-on-grade. The material collected had the same “wet sand” appearance as the samples collected by means of core drilling the floor in 2003. Figure 7 depicts the material taken from the cores along the foundation wall. This material appears as wet sand (brown in color) and does not resemble the gray stone dust from the construction photos.

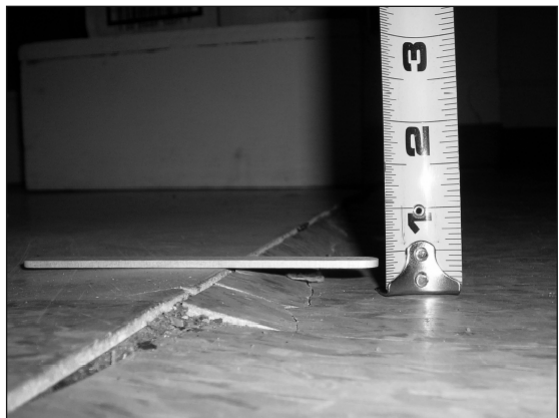
The following Figure 8 is from a reference study where pyrite was the agent that caused expansion. This photo can be compared to the situation at the case study elementary school, Figure 9.

**Figure 9**  
The Effect of Pyrite Expansion

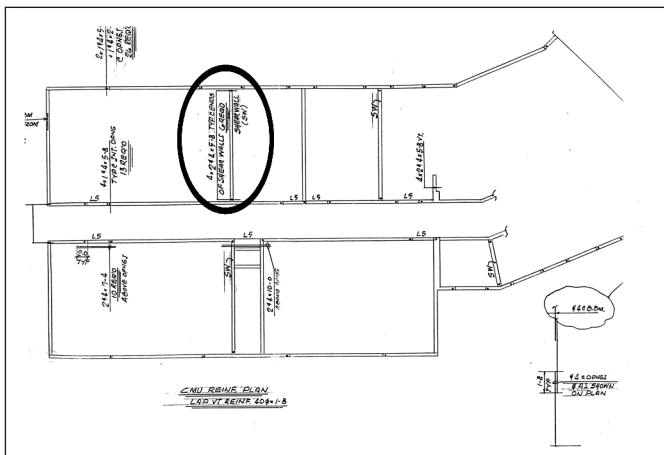
In addition to the conditions above, the lifting of the slab has in 2005 resulted in the structural impact to the building. The interior wall adjacent to the end classroom is a shear wall. This is a wall that transfers the horizontal wind load on the building from the walls to the foundation. The location of shear walls is shown in the Figure 10.

**Figure 10**  
Floor Plan

One such location, where the wind forces are transferred into the shear wall is at the location depicted in the circle. Without this connection the forces imposed by the wind would have to be resisted by the exterior wall alone, and from our earlier work at the school we know these walls alone are incapable of resisting these forces.

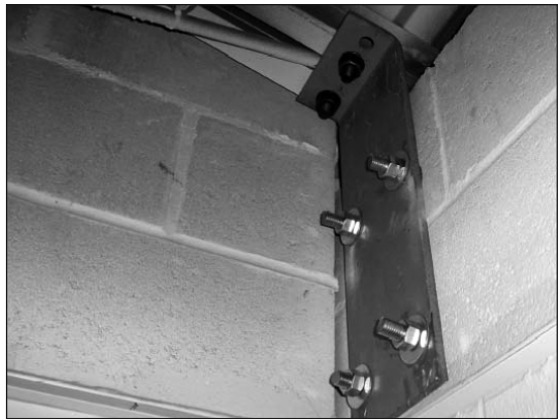
As the interior wall has lifted, the travel available in the slotted connections has diminished. The connecting bolt was discovered to be in the top of the slotted connection in August 2005.

The wall, which rests on the upward moving floor slab, was now lifting the structural joist. In August 2005 it was discovered that the joists adjacent to the two shear walls had been loaded upward to a point where it had broken free of the

exterior wall. It was also noted that the joist located approximately four-feet on either side of the shear wall were also disconnected from the exterior wall. The joist's functioning as a load-transmitting member to resist the forces of wind load on the building was in serious question. Remediation was essential, and the attachment shown in Figure 11 was effected.

**Figure 11**  
Remediation Measure

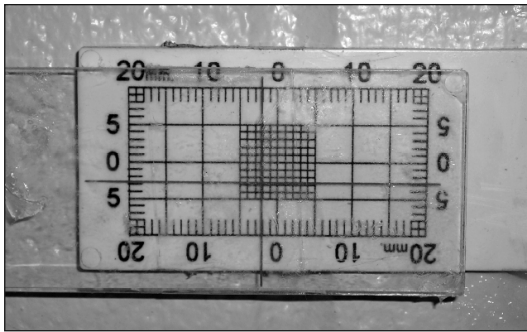
Evidence of the expansive forces now moving the foundation of the structure in the horizontal direction is shown in the movement gage and in the exte-

**Figure 15**  
Movement Gage installed July 2005 –  
Observed November 10, 2005

rior wall being pushed outward from the interior shear wall. The movement is greater in the lower portion of the wall than the upper wall area, where the roof joist restrains it. This creates an untenable situation.

As a result of this, and the evidence of the potential for a dramatic structural failure, the elementary school building was closed in January

It has become clear that over time that these facilities will require extensive remedial work. The pyritic material will be removed and replaced with a non-expansive material, and the structure reconstructed to its original intended condition.
