Vol. XXV No. 2 December 2008

Forensic Engineering Analysis of Excessive Iron Corrosion in a Class of Automobile Engines

by Michael D. Leshner, P.E. (NAFE 559F)

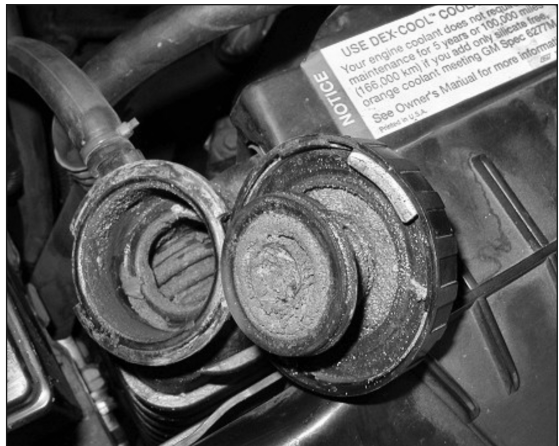
Figure 1

In the affected vehicle models, sludge was observed on the radiator cap and inside the radiator as shown in figures 1 and 2. Problems in this class of vehicles appeared with one or more of the following symptoms:

- Rusty sludge on the radiator cap
- Rusty sludge inside the radiator, particularly inside the filler neck and upper tubes
- Radiator cap vacuum valve fails to close (sludge)
- Low coolant level
- Heater failure
- Engine overheating

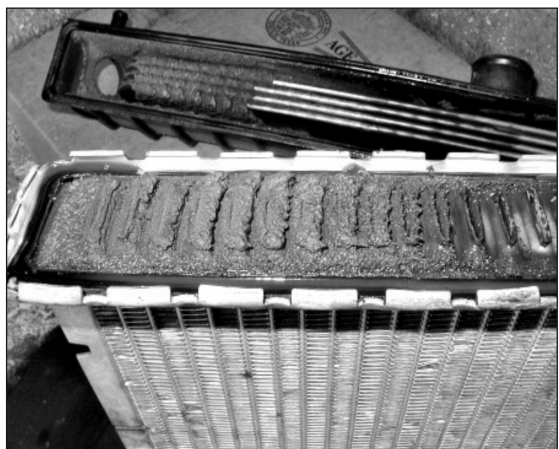
Figure 2

The author owned one of the affected vehicles before becoming involved in the investigation. It was purchased second-hand with approximately 57,000 miles. Shortly after purchasing the truck, it experienced an overheating incident. The engine was shut down before permanent damage occurred. When the radiator cap was removed, it was covered with a dark red/brown sludge. The sludge occupied the entire filler neck of the radiator. The hose connecting the radiator to the recovery bottle was also plugged with sludge.

In an attempt to correct the problem, the cooling system was flushed thoroughly with water and the radiator cap was replaced with a new one. The cooling system was re-filled with the specified (orange) coolant. Subsequently, the cooling system needed to be flushed approximately once per year, with replacement of the coolant.

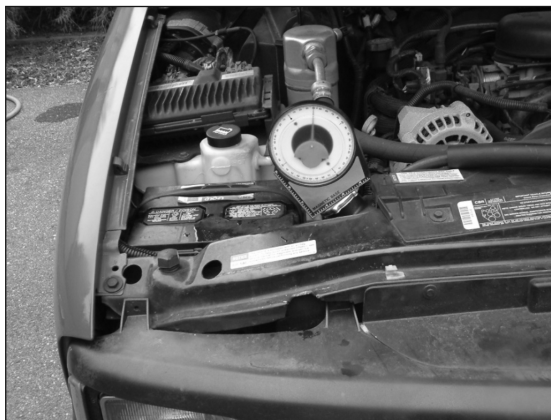
Figure 4

The affected vehicles were made with radiator caps having a weighted caps having a weighted vacuum valve. The same vehicles also have radiator caps mounted at an angle of 36 degrees from the horizontal as shown in Figure 4. This cap orientation was a change from the prior model year, when the cap was horizontal. If the vacuum

valve were not sealing properly, coolant would tend to over-fill the recovery reservoir and be lost from the system.

1. Excessive iron corrosion in this group of vehicles is caused by operating with a low coolant level;
2. Low coolant levels result from vacuum valve leakage;
3. Once sludge begins to form, it accelerates coolant loss;
4. The use of a weighted vacuum valve is to be avoided in a radiator cap mounted at an angle.

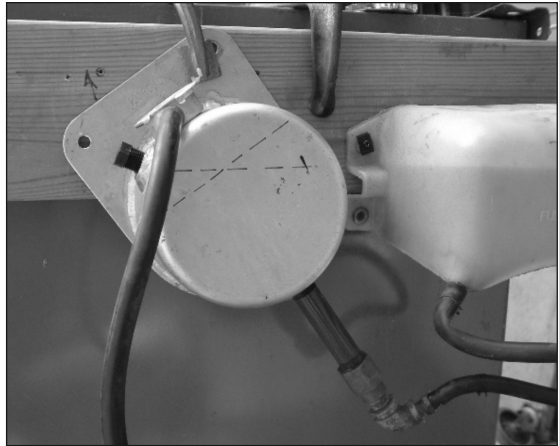
Figure 5

In order to assess whether the radiator cap vacuum valve performed differently when mounted at an angle, two series of tests were performed. The first was a bench test designed to measure leakage past the vacuum valve when mounted in both the horizontal and angled positions, shown in Figure 5. Coolant was transferred under a slight pressure from the plastic tank to the aluminum tank, and any leakage past the vacuum valve was measured. This test setup was intended to simulate the normal transfer of air and coolant from the radiator to the recovery bottle during operation.

When mounted horizontally, the vacuum valve permitted air to escape and sealed promptly when the liquid level rose to the valve. No leakage was observed. When mounted at an angle, the valve leaked before sealing completely.

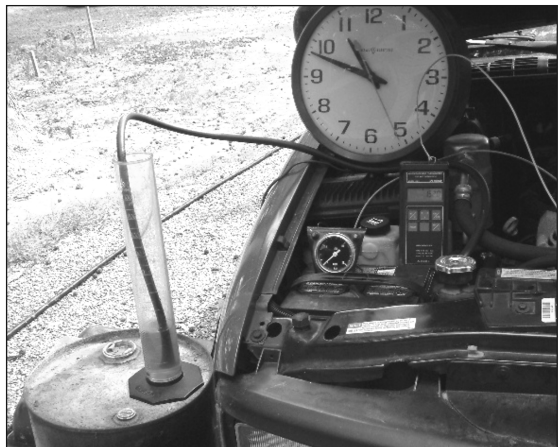
Figure 6

Another series of tests was performed on a vehicle, instrumented to measure cooling system pressure, temperature and leakage from the vacuum valve. The test setup is shown in Figure 6.

Note that the radiator cap is mounted horizontally in Figure 6. This was achieved by using a radiator from a prior model year. Leakage was measured after a cold start, at idle, in Drive.

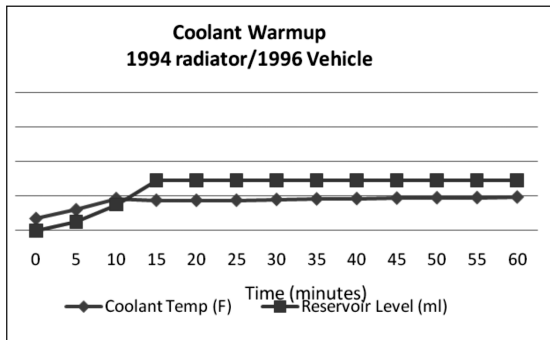
As shown in Figures 7 and 8, the orientation of the radiator cap has a strong influence on the performance of the vacuum valve. In the horizontal position (Figure 7), the vacuum valve properly allows air to escape and then promptly shuts to seal liquid coolant inside the radiator. Figure 8 is an example of runaway leakage past the vacuum valve.

Figure 7
Radiator cap mounted horizontally

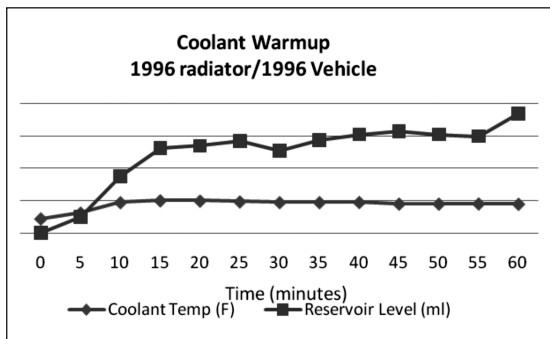
Vacuum valve leakage tends to over-fill the coolant recovery reservoir, resulting in coolant loss.

Figure 8
Radiator cap mounted at 36° angle
