# Forensic Engineering Investigation of Side Glazing Failure in Rollover Collisions

By Stephen A. Batzer, Ph.D., P.E. (NAFE 677M)

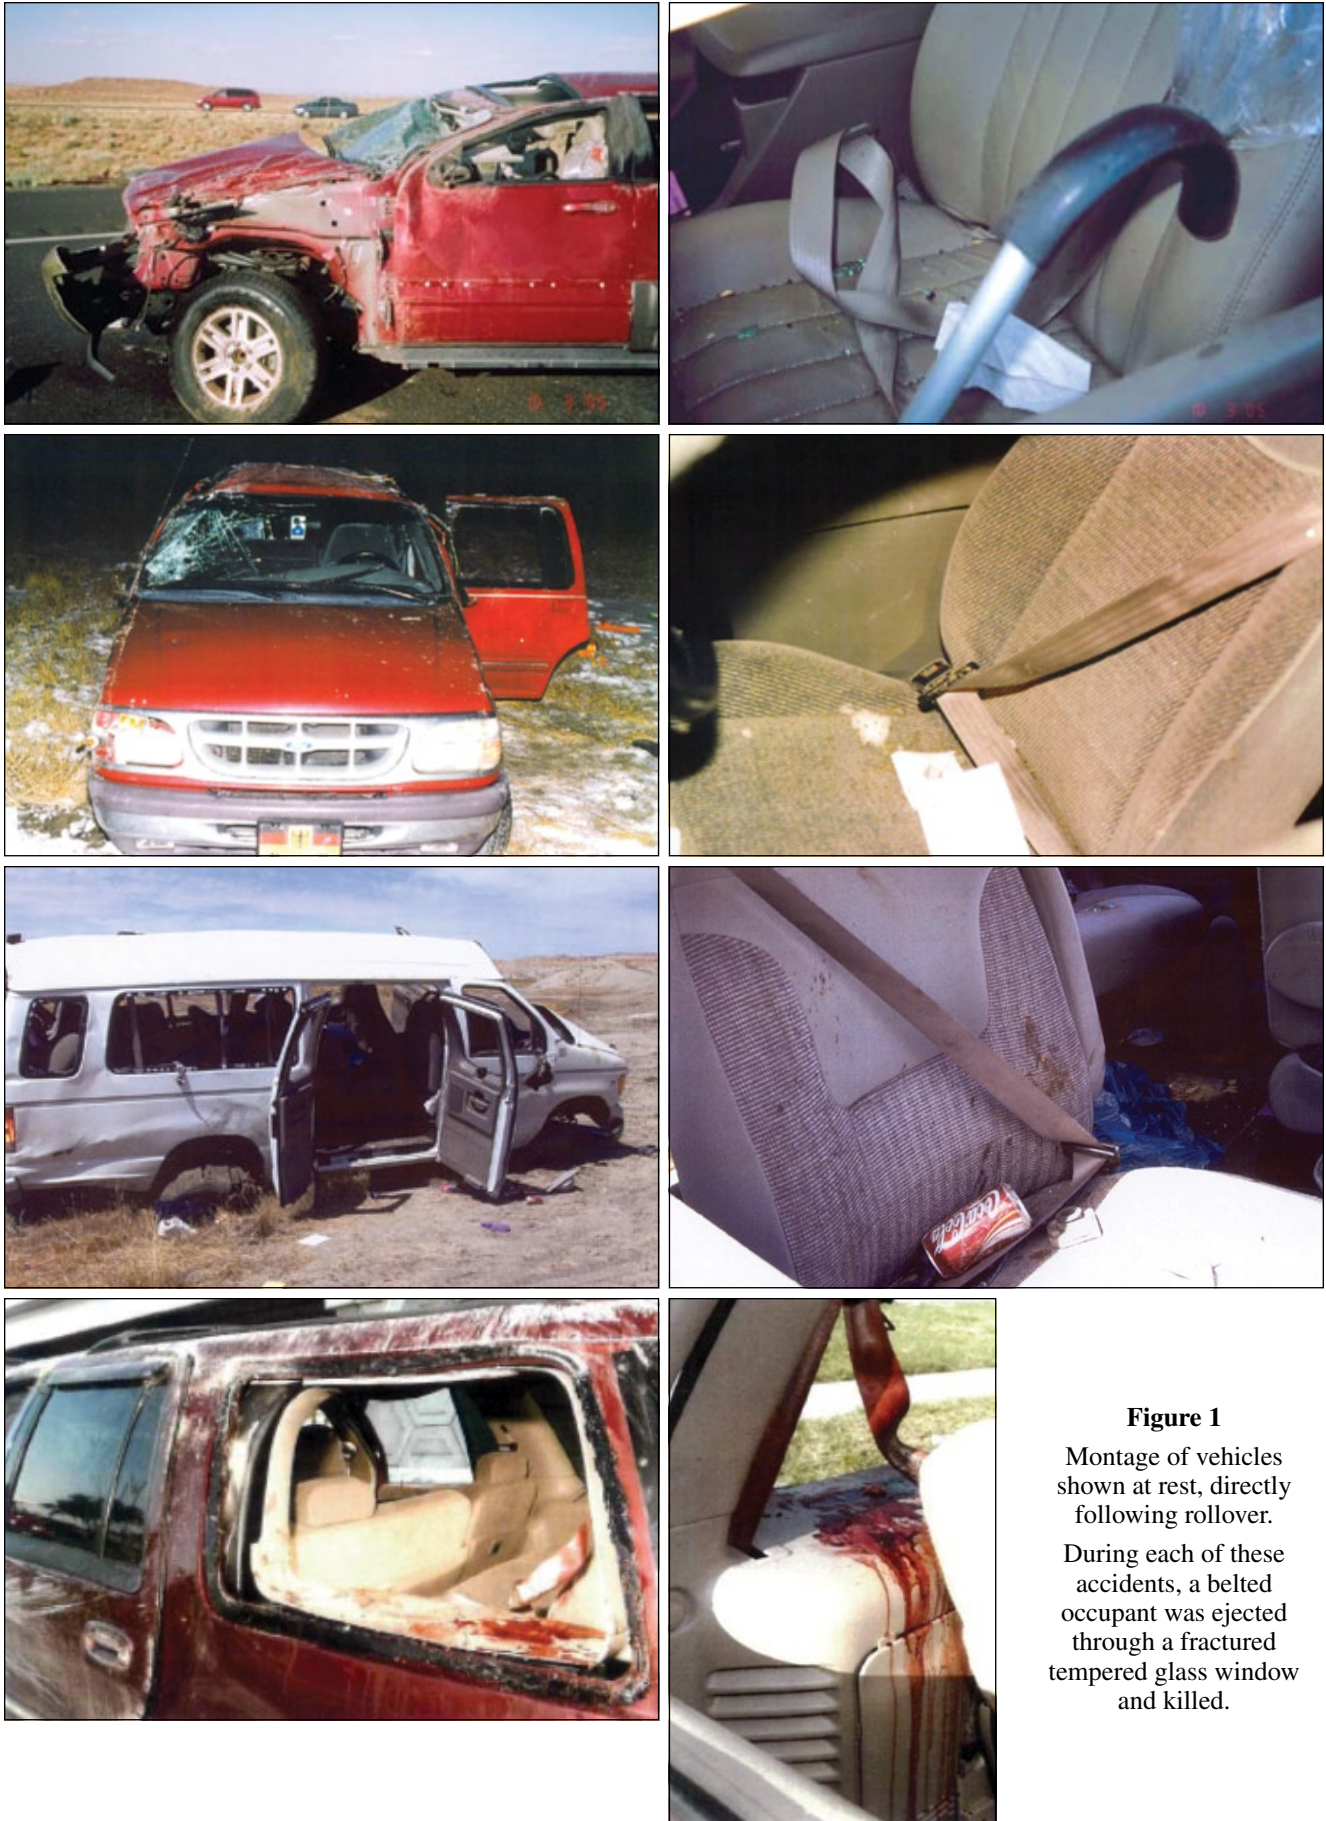
Figure 1 documents that there has been a thirty-plus year contradiction within the federal regulations. Automotive glazing is regulated because of its profound influence on occupant safety, and an explicit goal of regulation is that all glazing minimize partial and full ejection of belted and unbelted occupants during collisions. However, the stated goal of the FMVSS-205 regulation does not distinguish between window type, ejection type, belt status, and collision type. Further, the referenced standard, ANSI/SAE Z26.1, has never required that laminated glass be used in any position other than the windshield. Thus, the federal regulation has not been consistent, and manufacturers have been free to produce vehicles with large, tempered glass side windows that do not have the inherent capability to protect occupants the way that laminated glass can.

**Figure 1**  
Montage of vehicles shown at rest, directly following rollover. During each of these accidents, a belted occupant was ejected through a fractured tempered glass window and killed.

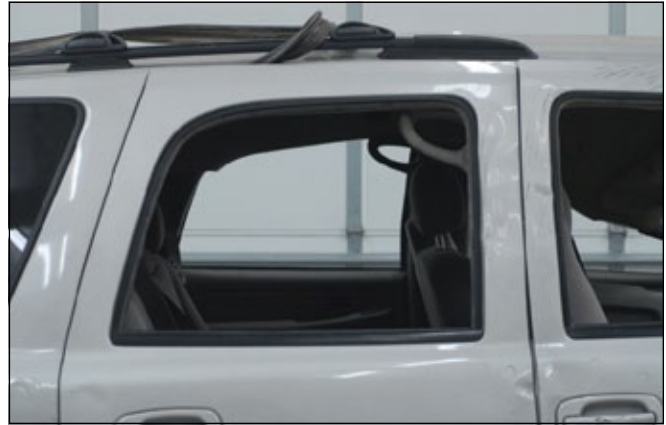
**Figure 5**

The poorest window designs do not even support their tempered side glass, see Figure 5. The use of flexible polymer at the outboard periphery allows the glass to dislodge, making the weatherstripping, not the glass, the weak mechanical link of the glazing system.

2004 GMC Yukon. Second row right window is ejection portal for 140 lb occupant. No glass fragments remain in seal, a forensic indicator that crash forces dislodged the glass followed by cantilever failure. No divider bar present.

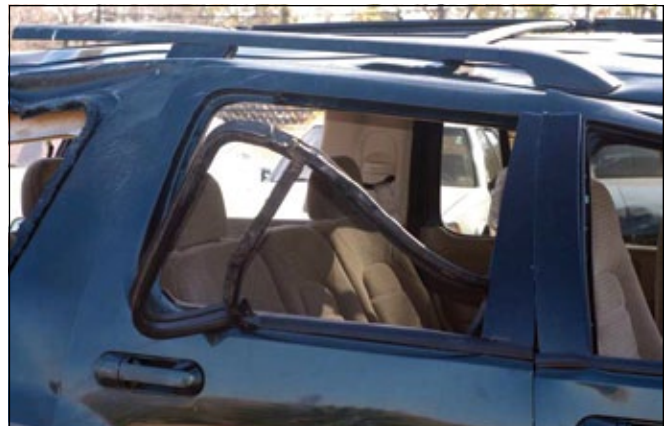
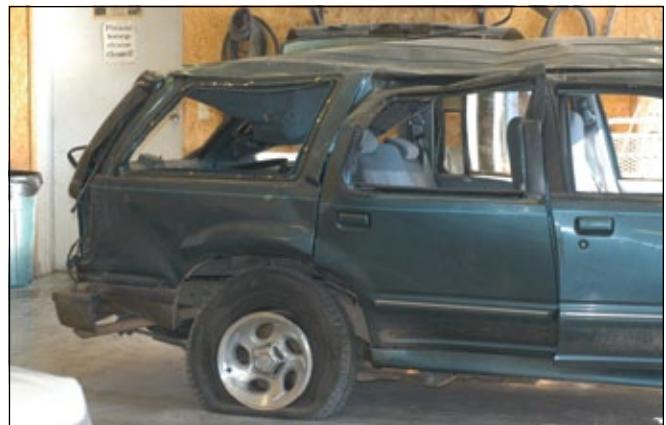
**Figure 6**

The likelihood of ejection is proportional to the window size. Smaller windows present a lower likelihood of ejection<sup>29</sup>. One technique for size reduction is the incorporation of a vertical divider bar at the position of the head/shoulders. This must be a *structural* divider bar that can absorb occupant impact loading. Conventional yellow school buses are a primary example of horizontal structural divider bars. Many vehicles have divider bars to separate fixed windows (sail lights) from the larger moveable windows, see Figure 6.

Two SUVs of different generations with passenger's side second row failed, non-load bearing, divider bars. Each window was the ejection portal during a fatal rollover.

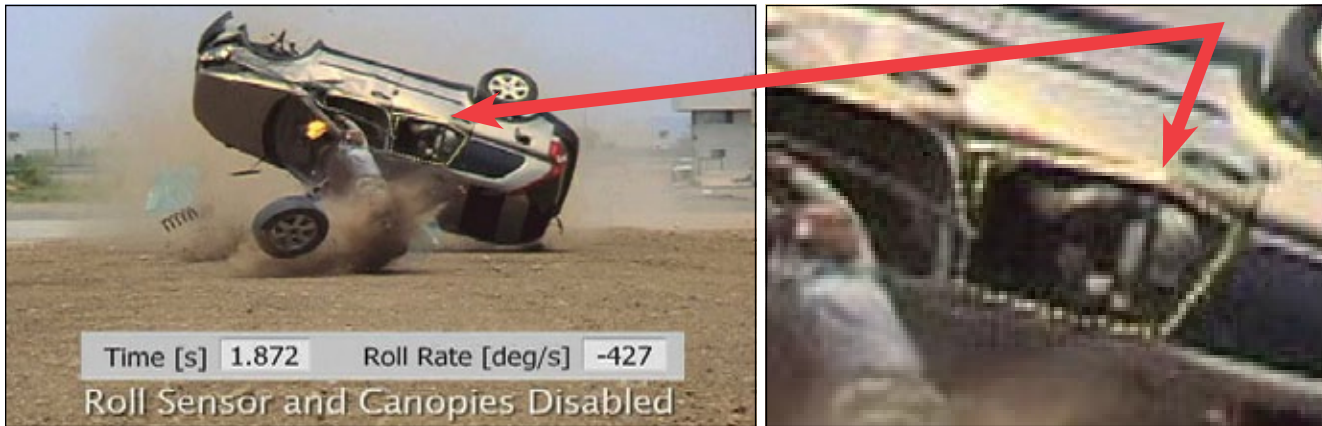
**Figure 7**

Of interest, a rollover demonstration has shown that the low-cost, low-tech solution of a divider bar will contain some occupants. Figure 7 shows a Volvo XC90 equipped with structural divider bars that retained a 50<sup>th</sup> percentile male ATD during a high velocity dolly rollover. Note that the roll rate in this demonstration exceeded 600 degrees per second, and is not representative of the vast majority of real-world rollovers. This vehicle was rolled at 43 mph, rather than the FMVSS-208 standard 30 mph, amongst other protocol differences<sup>24</sup>.

Images from the Exponent rollover of an XC90, showing containment of the second row right side ATD by the structural divider bar that separates the moveable and fixed door glazing.

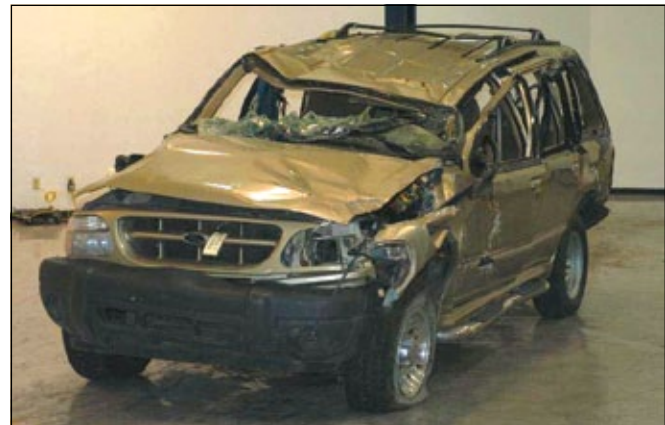
**Figure 8**

On May 31<sup>st</sup>, 2003, a 2000 Ford Explorer was traveling east on FM 582, Zavala County, Texas, with four unbelted occupants. The roadway made a sharp 90° turn at the intersection with CR 2010, which continued straight. The driver of the vehicle failed to negotiate the curve and continued straight onto CR 2010. At this point the driver lost control and the vehicle initiated a driver-side leading roll onto the flat soil roadside. During the rollover sequence, the two second row females were ejected from the second row of the vehicle and suffered fatal injuries, see Figure 8.

Accident vehicle. Notice gross intrusion of roof.

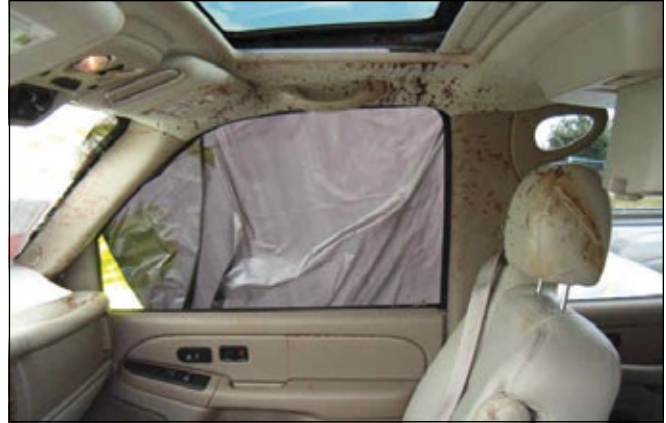
On October 22, 2004, a mother was traveling with her nine year-old daughter in a 2004 Chevrolet Tahoe in Round Rock, TX. According to the Texas Peace Officer's Report, "Unit #1 was yielding to north bound traffic in the 2700 block of S. IH-35 on the East Frontage from the IH-35 south-to-north turn around lane. Driver Unit #1 stated she maintained visual of the North bound traffic behind her vehicle when attempting to enter the roadway. Driver Unit #1 did not see the guardrail dividing the East Frontage between two outer lanes for traffic use and two inner lines for construction. Unit #1's LF struck the guardrail, causing Unit #1 to roll to the right. Unit #1 then came to rest on the vehicle's right side." During this minimally severe overturn, the right front passenger, was partially ejected and received significant injuries to her right hand and arm. See Figure 9.

**Figure 9**  
Accident vehicle. Notice complete lack of deformation to window framing.

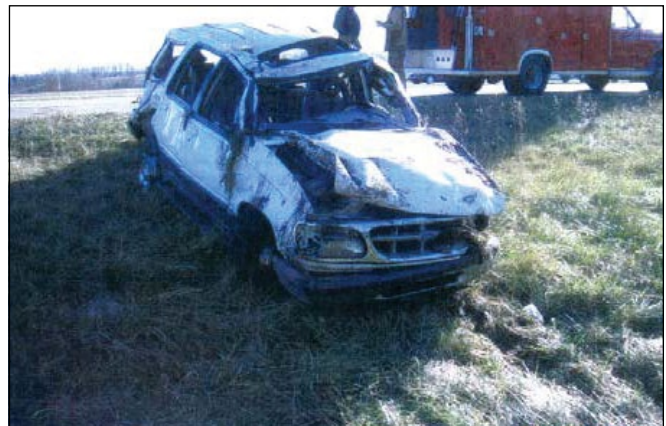
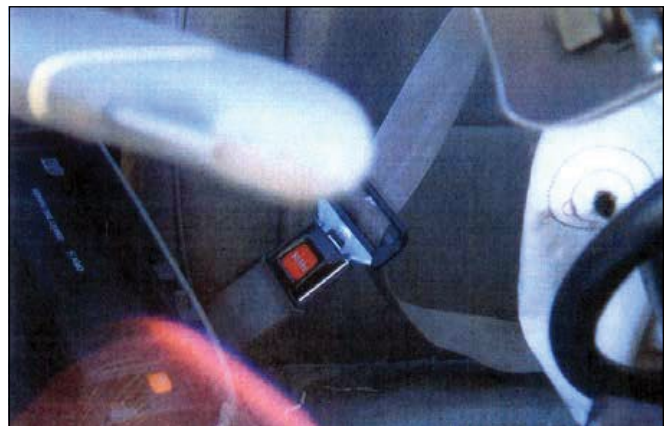
According to the Indiana Officer's Standard Crash Report, "V1 was traveling S/B on I65 when V1 drove off of the west side of I65. V1 continued S/B as it traveled off of the west side of I65. V1 struck an earth embankment on the south side of C.R. 1000 south Bridge as it continued S/B over the bridge embankment striking two cement drainage structures. V1 became air born [sic] as it left the north side of C.R. 1000 south bridge embankment. When V1 landed it started to flip several times, ejecting D1 from the vehicle. V1 came to rest facing west off of the west side of I65. The seat belt for the driver's seat was still fastened. D1 was ejected through the sunroof of V1. D1 still had the window seal gasket from the sunroof wrapped around his feet when medical personal [sic] arrived. D1 was pronounced dead at the scene at 9:59 a.m." See Figure 10.

**Figure 10**  
Accident vehicle scene photographs. Driver's adjacent side glass is unfractured, and seat belt is still latched.

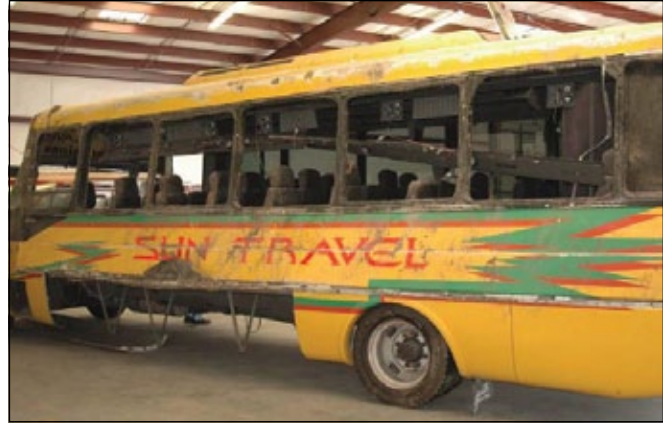
On March 29, 2006, the Beaumont High School Girls Soccer team, comprising 23 students, was on their way to a match, accompanied by 2 school officials and a bus driver. The driver took evasive action to avoid debris to her front, and left the roadway. The vehicle rolled onto its left side, partially ejecting several occupants who interacted with the exterior. Two students were killed, and numerous others suffered life-altering injuries. This bus was not equipped with seatbelts for any occupant other than the driver. See Figure 11.

**Figure 11**  
Accident vehicle. Notice the size of the tempered side windows.
