Journal of the
National

A Forensic Engineering Investigation of a Ladder Failure

By Nicholas A. Petrucci, P.E., C.S.P. (NAFE 650M)

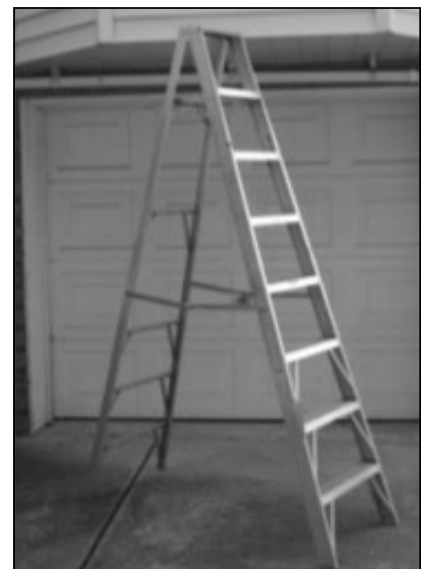
The incident ladder was an eight foot aluminum step-ladder with a duty rating of 225 lbs. The change in elevation between each step was one foot. An overall view of the ladder is shown in Figure 1. A label affixed to the ladder referenced ANSI A14.2-1981.

The overall condition of the ladder was poor. Various scratches, abrasions, deformations, wear marks, etc., indicate that the ladder was used, at times improperly, relatively frequently since it was placed in service. Two rivets secure each of the front rails to the top cap, and one rivet secures each of the rear rails to the top cap. The rear rivet that secures the left-front rail to the top cap was missing (see Figures 2 and 3), and was not recovered. Also shown in Figure 2 are gouge

Figure 1
Overall View of the Ladder

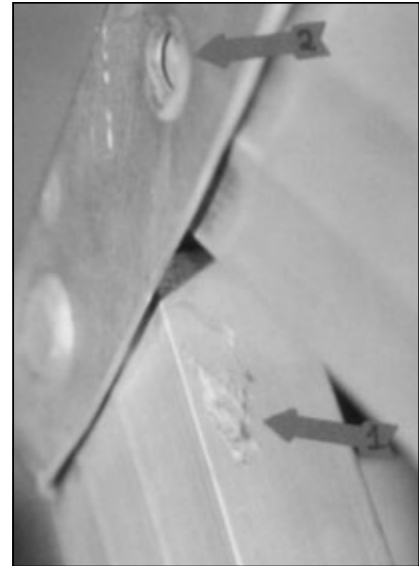
marks on the left-rear rail that appeared to be relatively fresh and consistent with an impact from the top-rear edge of the left-front rail. Several other ladder rivets were loose and/or distressed. The foot of the left-rear rail was missing (see Figure 4). The other ladder feet were significantly worn to the point that the metal foot clamps would contact the ground surface when the ladder was in use. The wear on the feet of the front rails was most severe toward the front of the ladder (see Figures 5 and 6). Additional areas of noteworthy damage to the ladder were the downward deformation of the center portion of its top cap and bent diagonal braces that support the first step of the ladder and the lowest cross brace between the rear rails.

Figure 2
Missing Top Cap Rivet (Arrow 2) and
Rail Gouge Marks (Arrow 1)

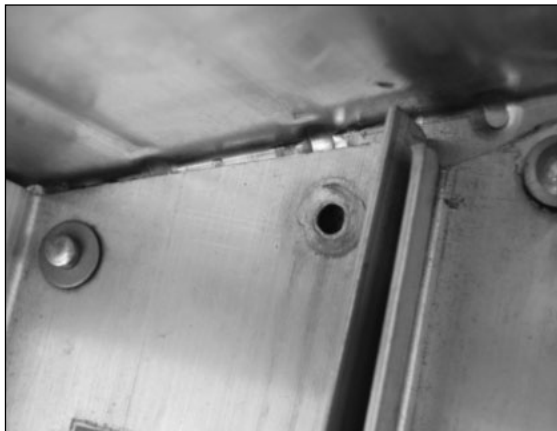
Figure 3
Inboard Side of the Ladder at the
Failed Rivet Location

Figure 3 shows the inboard side of the rear rail where the failed rivet was installed. The other rivet that secured the top cap to the left-front rail was likely set in the same manner as the failed rivet. That is, the tenon of a rivet with a head on one end was inserted through corresponding holes in the top cap and rail from the outboard side of the ladder. A washer was then placed over the tenon. A blunt axial force was applied to the end of the tenon to expand its diameter and secure the washer and thereby the rivet.

Work hardening of a metal occurs when it is cold worked and plastically (i.e., permanently) deformed. While this occurred at the end of the tenon of similar remaining rivets, there was likely minimal plastic deformation in the portion of the rivet tenons that was subject to maximum shear loading.

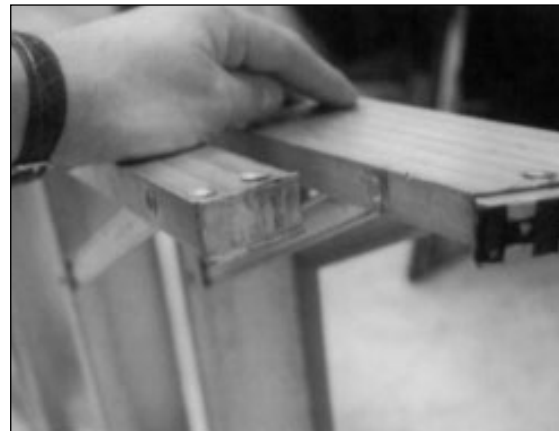
Figure 4
Missing Foot from Left-Rear Rail

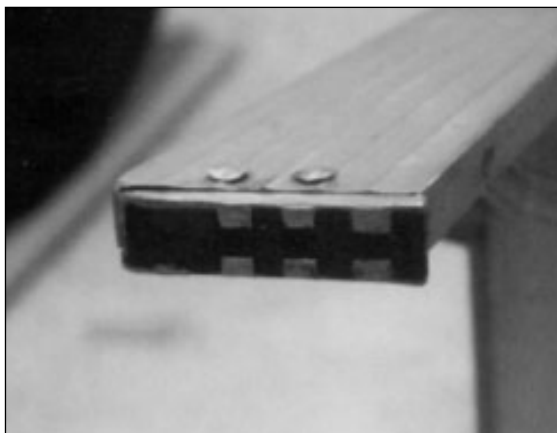
Figure 5
Wear of Right-Front Rail Foot

Of the observed pre-incident damage to the ladder, the wear pattern on the feet of the front rails was one of the more relevant factors with respect to the failure of the missing rivet (see Figures 5 and 6). The wear of these feet is more severe toward the front of the ladder. This indicates that the ladder was moved on numerous occasions by pulling and dragging it by one of its upper steps. The associated vibrations would have resulted in dynamic and cyclical loading of the failed rivet. This loading and that from regular usage likely weakened the rivet prior to its failure.

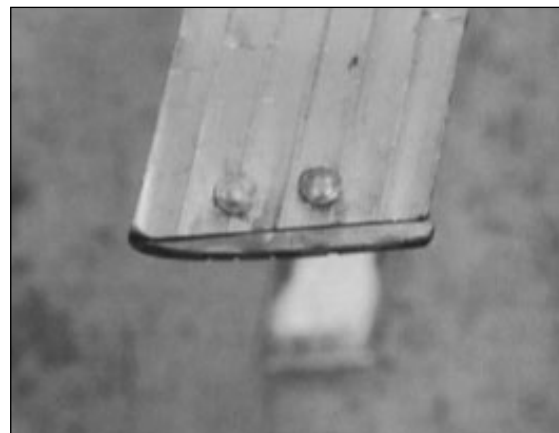
Figure 6
Profile of Right-Front Rail Foot Wear

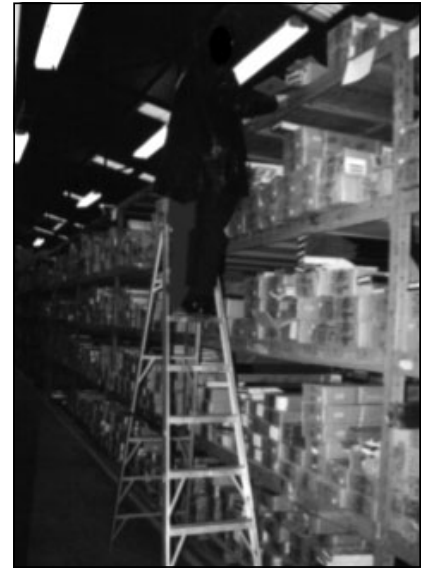
- The Plaintiff was using the ladder to place 3 feet by 2 feet (other dimension not specified) boxes of bed pillows on the top shelf of a set of storage racks (see Figure 7). The top shelf was between 10 and 12 feet above the floor. The incident occurred at 1:30 pm. The Plaintiff first used the ladder at 1:00 pm that day.

Figure 7
Representative Pre-Incident
Position of Plaintiff

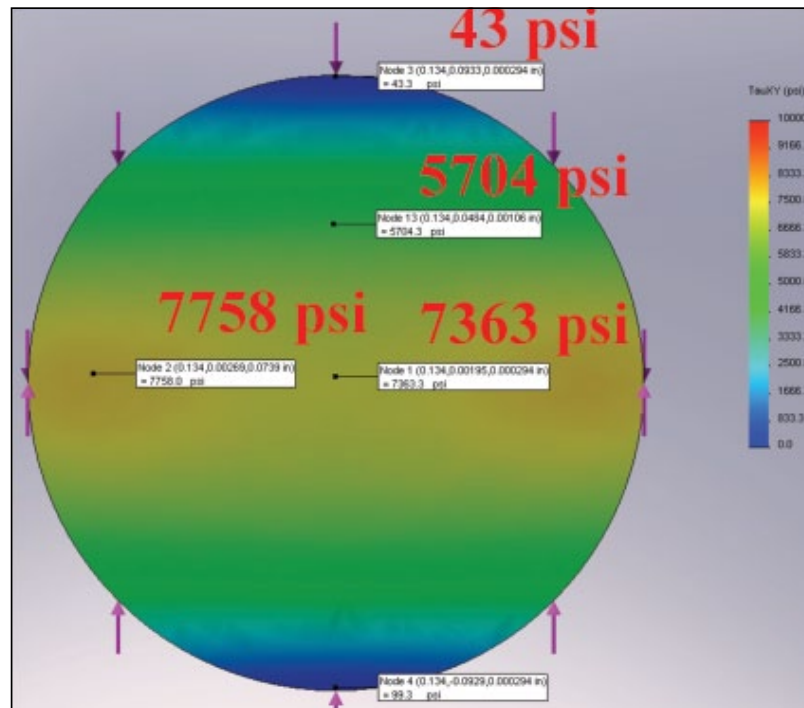
The FEA shear stress plots shown in Figures 8 and 9 are near the axial mid-point of the rivet. Recall that the calculated maximum shear stress in the rivet using the $\tau=1.33V/A$ formula was approximately 7,700 psi., which is reasonably close to the maximum shear stress of 7,758 psi shown in Figure 8 (uniform distributed loading). The maximum shear stress shown in Figure 9 (concentrated loading) of 8,662 psi is approximately equal to $1.5V/A$. It is expected that a more elaborate analysis utilizing a

more realistic non-uniform distributed loading (i.e., greatest loading at the top and bottom of the rivet that diminishes rapidly toward the ends of the neutral axis) would result in a maximum shear stress near 7,900 psi (i.e., $\tau \sim 1.38V/A$) at the mid-point of the neutral axis as noted above. Using the average shear stress equation (i.e., $\tau = V/A$) yields a shear stress value of approximately 5,800 psi. Selected locations of this average shear stress value are shown in Figures 8 and 9.

The FEA shear stress plots show a shear stress distribution that is generally consistent with near zero shear stress at the top and bottom of the rivet and the maximum shear stress at the neutral axis that is reasonably close to the calculated value. Although an approximation by nature, the FEA stress plots tend to confirm that $\tau = 1.33V/A$ would be a more appropriate equation to determine the maximum shear stress in the rivet than $\tau = V/A$.

FEA Shear Stress Approximation – Uniform Distributed Load

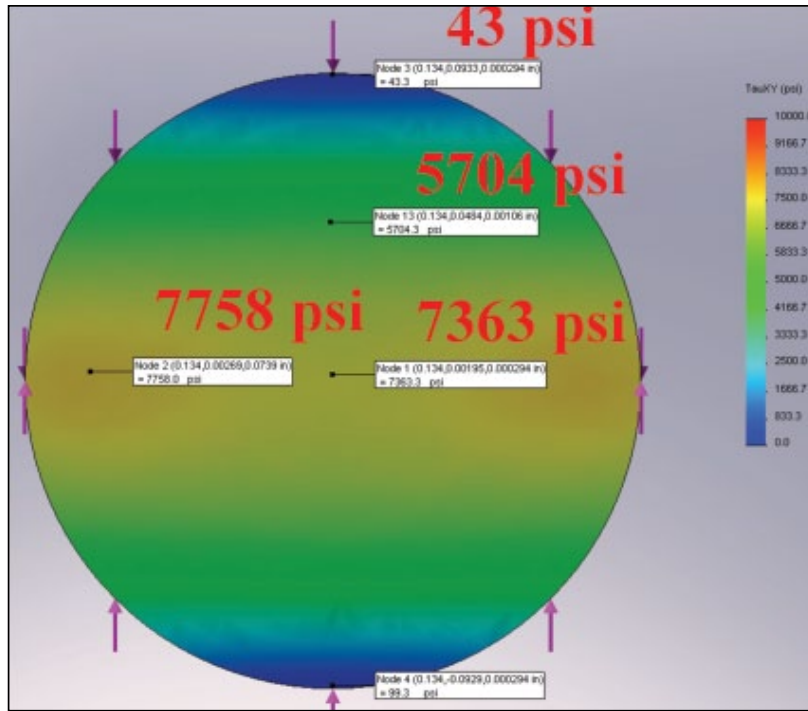
Figure 9
FEA Shear Stress Approximation – Concentrated Load

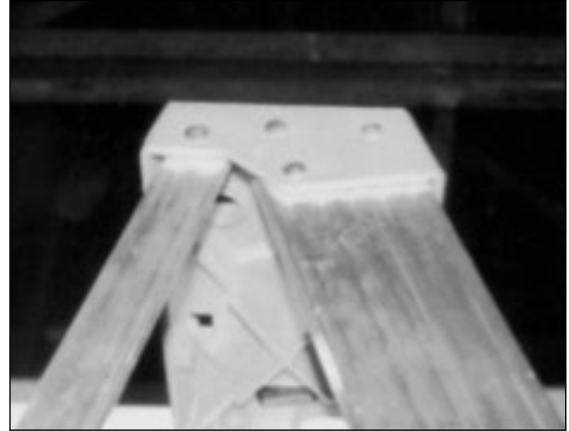
Figure 10
Exemplar Ladder –
Two Rivets at the Failed Rivet Location

These three factors increased the calculated factor of safety from 1.7 to nearly 10.0. Further, many ladders use two rivets at the location of the failed rivet (see Figure 10). This will further reduce the stress in the rivets that secure the top cap to the front ladder rails and add redundancy at a critical location.

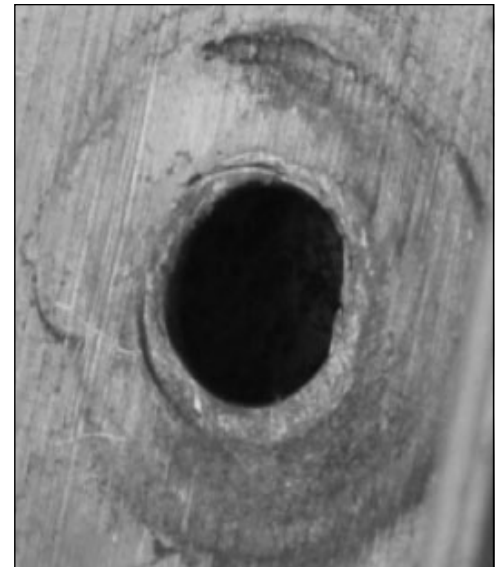
Although the analysis presented above proved to be helpful in resolving the case at hand, it may have been of limited relevance regarding the actual rivet failure. Figure 11 shows a close-up view of the prominent markings on the rail surface from the rivet washer, along with a predominately vertical elongation of the rivet hole in the rail. Therefore, the rivet may have failed as a result of a shear failure or its washer being pulled from its tenon. However, attempting to prove the same and the potential associated defects without the rivet or the washer would not have been a worthwhile endeavor.

Figure 11
Close-up view of the inboard surface of
the rail where the rivet was located.
Refer to Figure 3
