Forensic Engineering Experience with Purported Electric Shocks

By Roger L. Boyell, P.E. (NAFE 696F)

Abstract

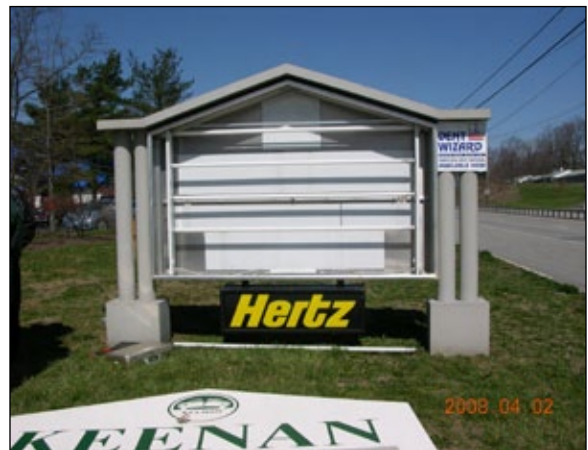
As illustrated by Figure 1 the electrician removed the translucent letter board and diagnosed the failure as due to a defective fluorescent lamp ballast, shown in Figure 2. Being familiar with the facility from previous visits, he turned off the circuit breaker for the building's "Outside Lights" and began to change out the ballast.

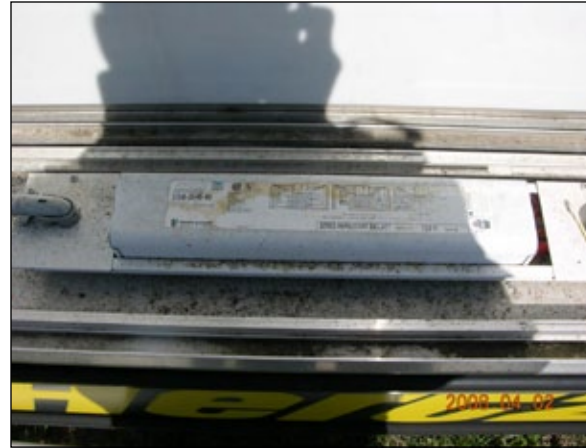
Figure 3

The detailed wiring diagram printed on the ballast can be seen in Figure 3. The primary winding accepts 120 V ac (volts, alternating current). Multiple taps on the secondary are used to feed individual fluorescent lamps with high voltage to strike, then limited current to remain illuminated. With no load the secondary winding develops 1,500 V center-tapped to ground.

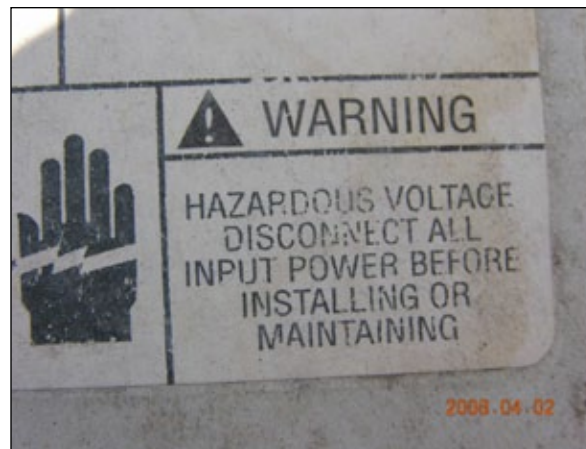
Figure 4

We do not know whether the electrician read the warning of Figure 4, also printed on the ballast. If he had used a meter or voltage probe he would have recognized that he was working, unintentionally, on a hot circuit. Later it was found that the circuit breaker he should have turned off was the one labeled "Outside Sign".

In addition, his procedure of connecting the primary wires before connecting the high-voltage secondary was logically flawed. The flaw was fatal in every sense of the word.

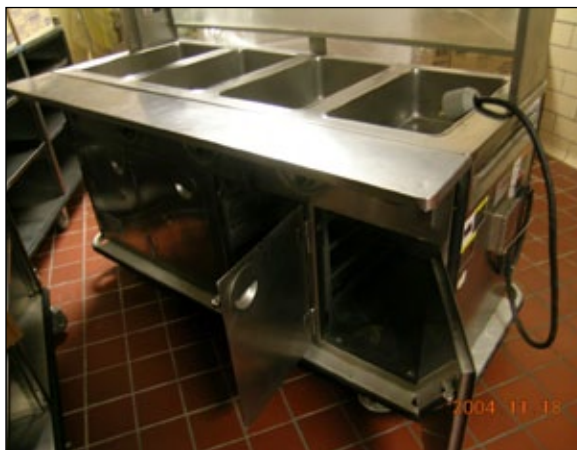
A restaurant worker complained of receiving a disabling electric shock from wires he said were exposed under a steam table. As shown in Figure 5 the steam table had a heavy cord and plug, and it drew 20 A (amperes) from a 240 V circuit, making it a good candidate for an accusation of shock.

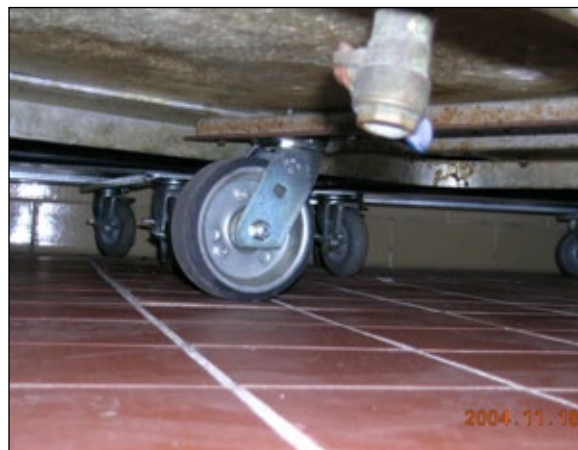
And so it was that a legal claim was filed. The steam table was placed in storage until an engineer could investigate the complaint. Then the underside of the steam table shown in Figure 6 was found to be all metal with nothing exposed except a drain cock which itself was metal. No wires were present.

All surfaces were electrically connected and solidly grounded through the cord and plug. No leakage current flowed from steam table frame to earth ground. The receptacle in use at the time of the incident exhibited a solid ground.

Shock to the client from the steam table as described was thus impossible. When the lawyers were confronted with these findings, the claim was abandoned.

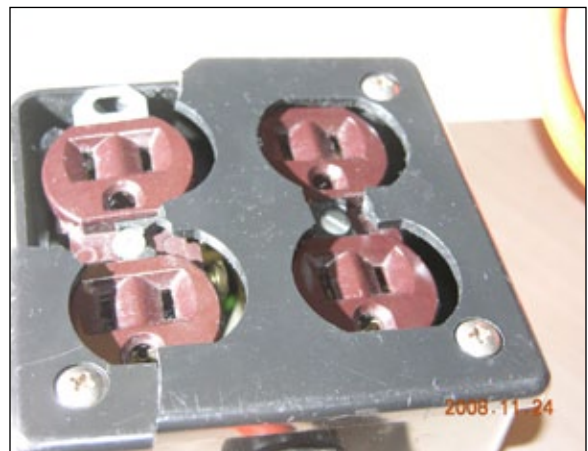
After lengthy legal process another party was compelled to produce the extension cord into which, it was learned, the machine was being plugged at the time of the incident. Figure 7 shows the portable outlet box whose plastic cover plate was fractured and whose receptacle yokes were unsecured. Its condition explains why the party was unwilling to provide it for examination.

Reconstruction of the incident (but not under power) showed that plugging in any appliance cord set would dislocate the loose receptacles. When finally opened for examination the box showed electrical scars seen in Figure 8, where the hot side of one receptacle had contacted the neutral side of the other receptacle.

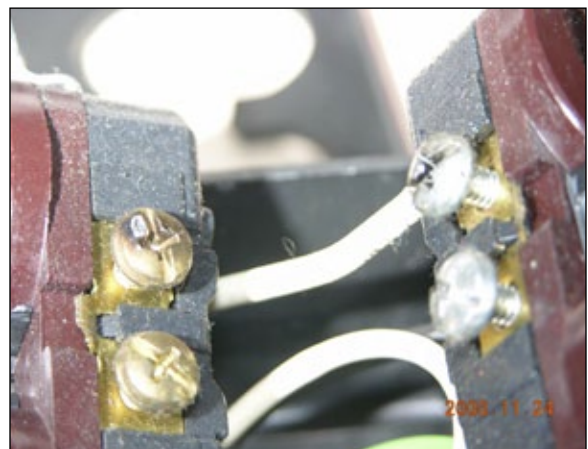
Figure 8

The electric arc which occurred in the damaged box could certainly have given rise to the claimed shock/flash/burn injury. The case against the manufacturer of the baggage-scanning X-ray machine was dismissed, and the party supplying the extension cord became the defendant. A confidential settlement was rapidly reached.

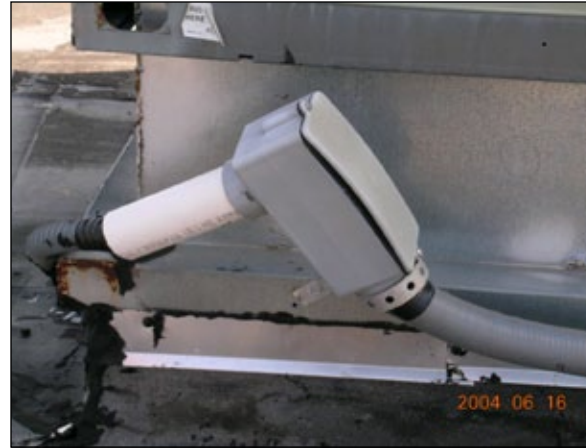
The electrical junction box shown in Figure 9 illustrates many National Electrical Code violations: stressed and overstuffed connector body, L-body should have been straight type, unapproved retaining clamp, PVC pipe instead of a listed fitting for the armored cable.

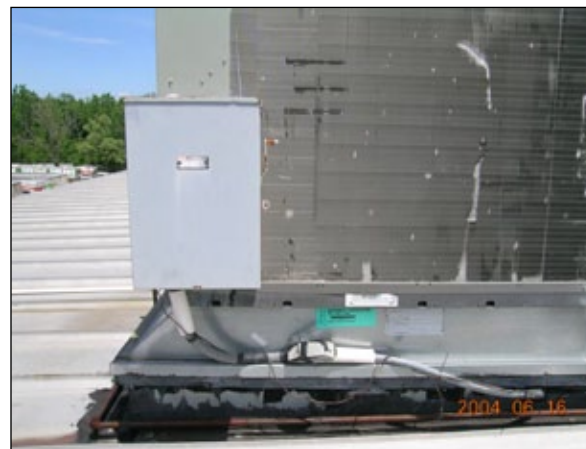
Figure 10

An air conditioning technician observed these violations while checking the rooftop air conditioning unit shown in Figure 10. He claimed that the shock and burn he received from an electrically energized surface of the unit disabled him such that he couldn't do any more air conditioning work.

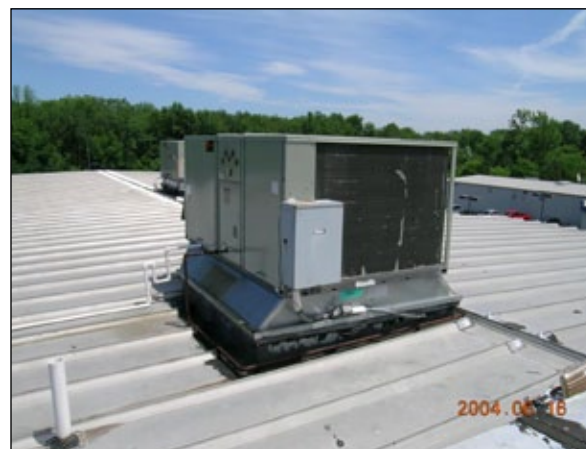
Careful engineering examination of the entire unit shown in Figure 11 revealed no electrical hazard. Despite its appearance no conductors were accidentally exposed or shorted, and the junction box afforded no opportunity for insertion of even a child's finger.

However, the metal roof itself was indeed hot. The examination was conducted at around noon and on a date close to the Summer Solstice. The shadow of the pipe in the foreground of Figure 11 shows that the Sun was essentially overhead. The real danger to workers on that corrugated metal deck was found to be the baking temperature of the roofing material, which was hot enough to burn foot soles even through leather shoes.

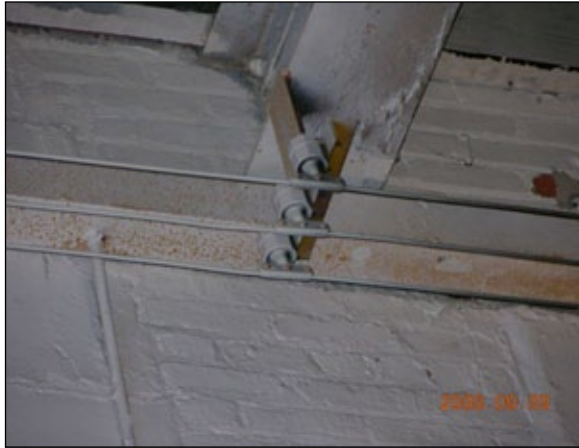
The wires shown in Figure 12 ran across the 5-meter-high ceiling of a dingy warehouse, serving an overhead crane which had not been operational for many years. The old crane was simply abandoned, off in a corner of the bay, because its scrap value would not have covered the cost of removal.

A worker installing security cameras used a 3-meter-high forklift platform to boost himself up toward the ceiling. Losing his balance he grabbed the wires for support. His hand made contact with two of the wires, and an arc flash vaporized much of his hand before he fell to the floor.

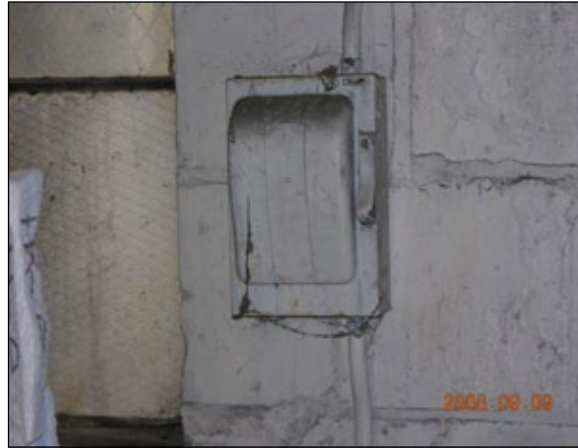
Figure 13

The investigators, crawling through a crumbling and dusty section of the warehouse, found the cobweb-draped disconnect switch shown in Figure 13. Sure enough, it served the abandoned crane wires with 460-volt 3-phase power, and its rocker switch was still in the ON position. Liability of the warehouse owner to an employee of an outside contractor was the subject of the subsequent litigation.

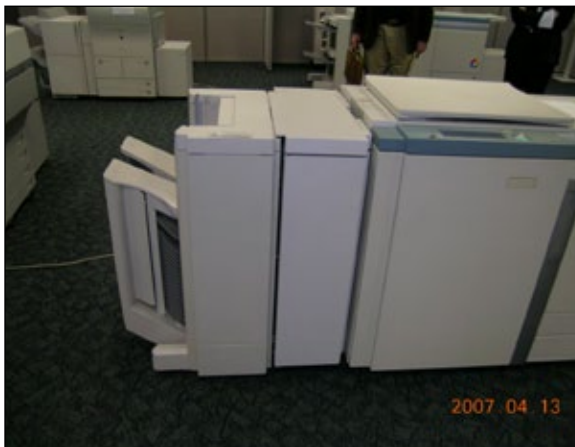
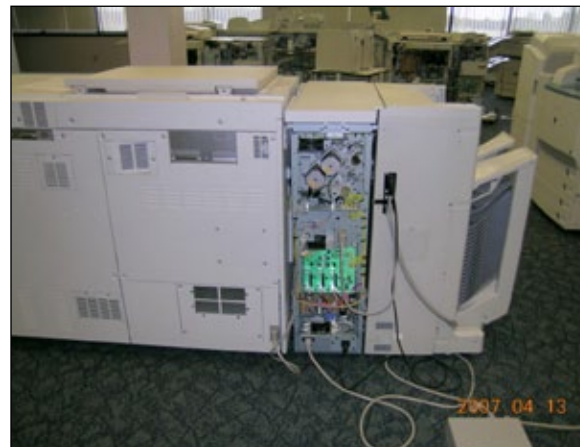
As shown in Figures 14 and 15 the basic machine was coupled with a ‘buffer’ and a ‘sorter’ as separate chasses. One theory of the incident was that the just-ejected paper carried a sufficient static electric voltage to spark across the operator’s hand to the grounded machine, although the injuriousness of the minute current from a static discharge was questioned.

Another theory was that the separate chasses, being simply pushed in to position, were not electrically bonded. Somehow the potential of one chassis was raised 120 V ac with respect to another, across which the operator’s hand was moved. Of course a third theory was that the incident didn’t occur.

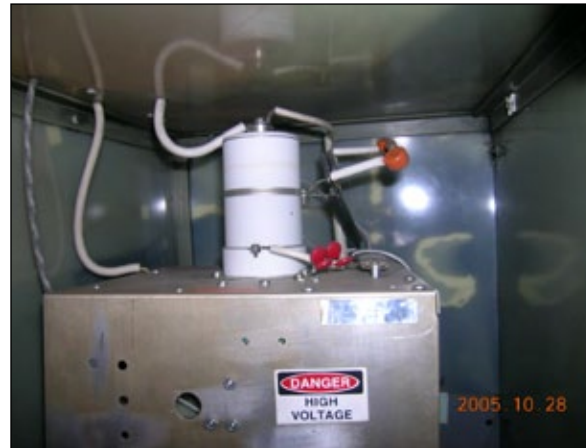
Figure 16

A well-known manufacturer of high-voltage power supplies had a subsidiary whose specialty was serving the high-power laser industry. They produced a unit which held 15,000 V dc to tight tolerances for regulation and ripple even when subjected to loads up to 300 mA (milliamperes). To test such a laser-driving power supply they built fixtures of the type shown in Figure 16.

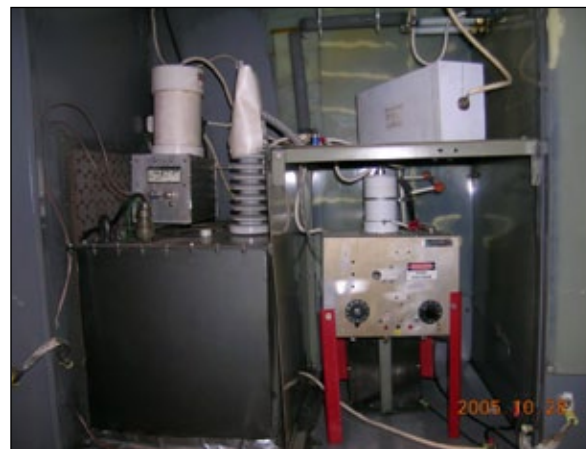
The fixture includes a switch which slams a 50,000-ohm, 5,000-watt heating element across the otherwise unloaded 15 kV supply, while instruments track its performance. Figure 17 shows some of the other components associated with the test fixture – obviously not a commercially sold device.

No one in the company had informed the worker that the component at the upper right of Figure 17 was a capacitor. Its markings are in the close-up of Figure 18. (It is ironic that the capacitor is labeled to contain no harmful chemicals. It bears no warning about harmful electricity.) Although the worker had attended safety briefings, he had never been given a shorting bar. He didn't know the capacitor would retain any of the 15 kV charge.

Based on the time constant of a leaky circuit whose capacitance is 0.1 microfarad into the bleeder resistor of 1,000 megohms we estimate the worker contacted 5,000 volts. The company received a citation from the Occupational Health and Safety Administration and revised its practices accordingly. The estate of the worker was unsuccessful in their lawsuit against the company for gross negligence.

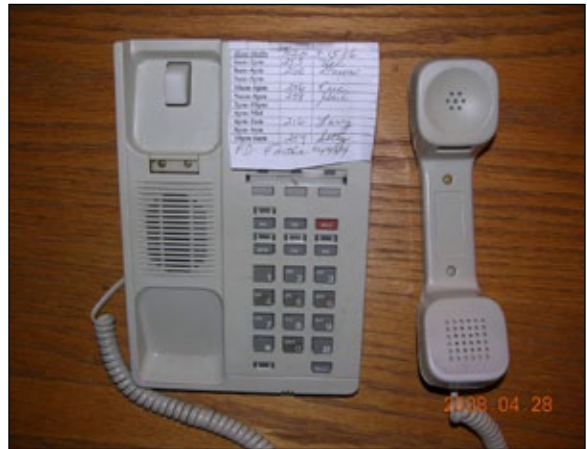
Claims of electric shock to a subject may be difficult to verify. The user of the telephone set illustrated in Figure 19 suffered damage to her ear and head, allegedly an electric shock from the handset. Investigation of crossed power lines, lightning strikes, and dielectric withstand of the plastic all refuted the claim of electric shock.

Perseverance by the claimant's lawyer raised the possibility of acoustic shock. An intermittent connection was found to initiate the boot-up sequence of a microprocessor in the base of the telephone while the earpiece remained unmuted. The unexpected static may have been a blast in the ear of the unalerted user.

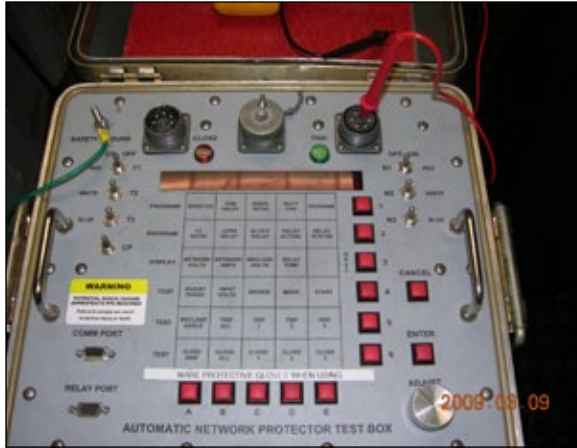
Figure 20

Electric power networks incorporate network protectors to disconnect the power under fault conditions such as line-to-ground short circuits. Simulating faults in electric networks requires test equipment. One such device is an Automatic Network Protector Test Box shown in Figure 20.

Under questioning the worker admitted that he had not secured the clamp to a known earth ground but simply let it pinch a convenient nearby surface to hold the wire out of the way. Having disregarded formal instructions, his shocking claim was dismissed.

The user is instructed to apply the safety ground clamp a to a reliable earth ground, before connecting any test cables to the multipin connectors. Do not assume a ‘neutral’ conductor is at ground potential. Maintain the “Safety Ground” wire, shown at the upper left of Figure 20, connected to a securely grounded conductor such as the unpainted frame of an electric switchboard. Use the clamp shown in Figure 21, all through any test procedure.

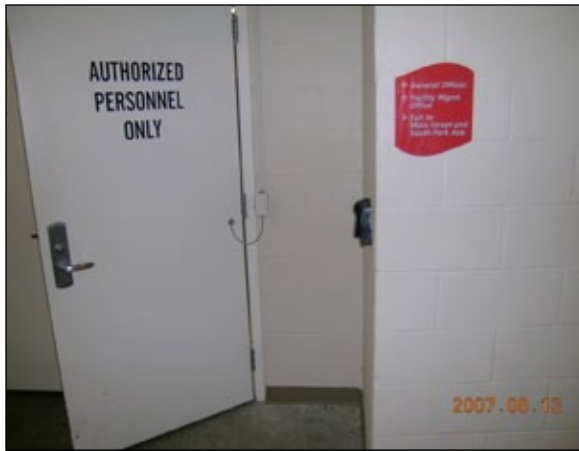
Figure 22

A completely disabling electric shock was reported by a victim who held the handle of the door shown in Figure 22, and a witness testified that the victim exclaimed he was hurt when he pulled on the handle.

It was a metal door with metal hinges hung on a metal frame inside a concrete building. Everything was solidly interconnected and grounded. Wires for the card reader, exit pushbar (The pushbar was on the opposite side of the door.), and door strike are all low voltage (12 V dc, 24 V ac), and all were in metal conduit as shown in Figure 23. Apparently the victim had been hauling something with his other hand at the time of the alleged shock from the door. Further, other people used the same door on the same occasion, and no else reported an injury from it.

No means of electrifying the door itself could be supported. Examinations were made by a host of experts for the victim, the facility, the builder, the security card reader supplier, the pushbar supplier,

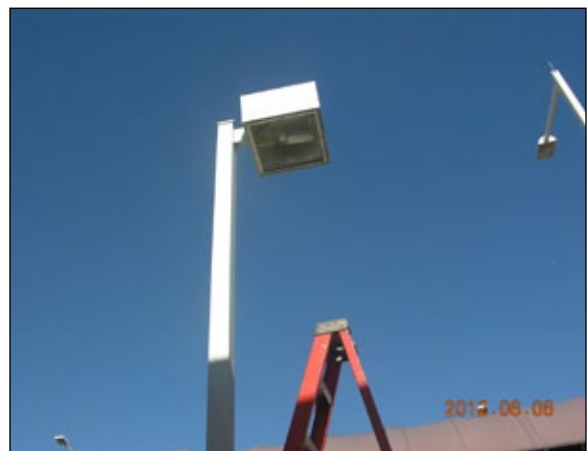
A worker for a condominium had erected a 4-meter A-frame ladder in order to service a 5-meter pole light fixture in the parking lot. Figure 24 shows the fixture, and Figure 25 is the view from beneath the fixture when two lens-holding fasteners are removed and the lens has swung out of the way. The 250-watt metal-halide lamp has been unscrewed from the mogul-size socket.

Examination and testing of the fixture, the pole, and the wiring thereto showed that everything touchable was at neutral/ground potential and thus could not cause a shock. The electrically energized center pin was deep inside the lamp socket and could not be touched by a worker while he was holding the lamp.

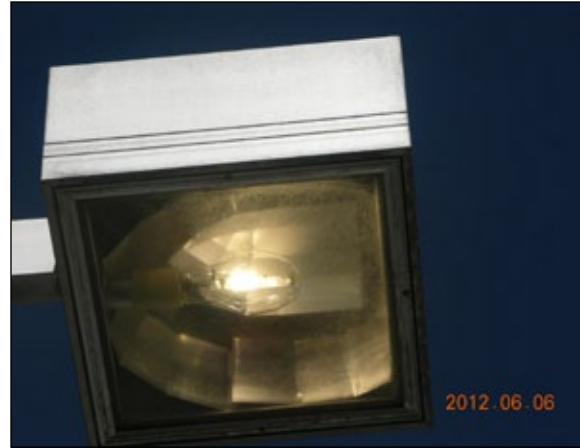
Figure 26

Further, simply screwing the new lamp into the socket effected normal operation of the fixture, as shown in Figure 26. The examining engineer thus concluded that no physical evidence existed to support the shock part of the worker's claim.

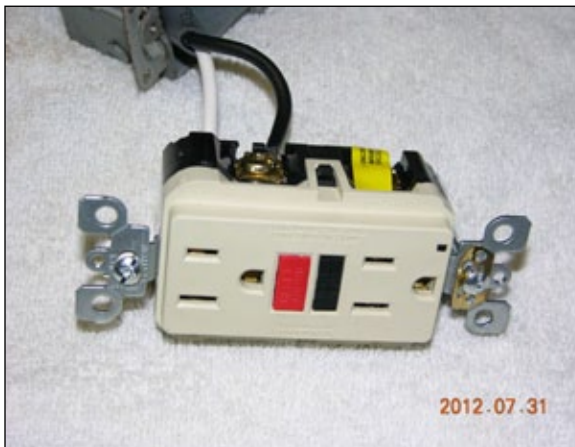
Figure 27

Expert examination determined that the drain machine was properly wired, and its frame was properly grounded through the third pin of its attachment plug. An inspector's outlet tester had revealed no issue with the GFCI receptacle, which was of the type shown in Figure 27. The electrically hot (black) and neutral (white) conductors were found to be attached to their proper terminals.

There was no ground conductor. The house wiring was old and did not carry a ground to the location of this receptacle. In this event the proper installation would be to label the receptacle “No Equipment Ground” and let the GFCI capability protect the appliance user as it is designed to do.

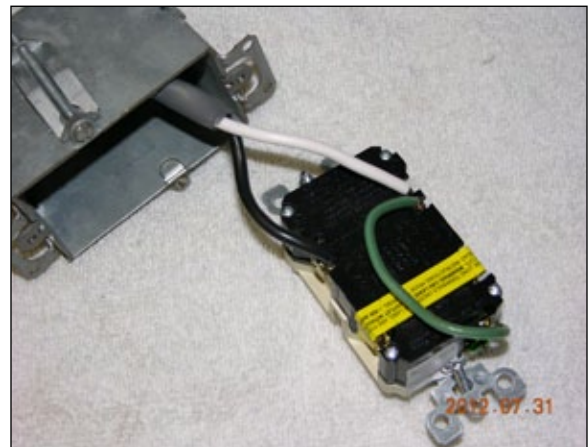
Unfortunately the receptacle installer (obviously an amateur) was unhappy with leaving the ground terminal unconnected, so he ran a jumper from it to the neutral terminal, shown as the green wire in Figure 28 – wrong but still not hazardous to the plumber.

The presence of the jumper, however, exposed another defect in the house wiring. Somewhere upstream of the receptacle at issue the polarity had been reversed. The black wire was actually the neutral, and the white wire was the hot conductor. The unwarranted jumper therefore caused the third pin of the GFCI receptacle, intended as a safety ground, to carry full line voltage.

In turn any appliance whose third pin on its attachment plug was wired as a safety ground for its frame, would exhibit a potential of 120 V ac on any exposed surface when merely plugged in to that defectively wired receptacle. Accordingly the drain machine was cleared, as was the clogged drain itself. Legal action against the homeowner is contemplated.
