Forensic Engineering Examination of 11 Foot Diameter Sanitary Sewer

By W. T. 'Dusty' Yaxley, P.E., CSP (270F)

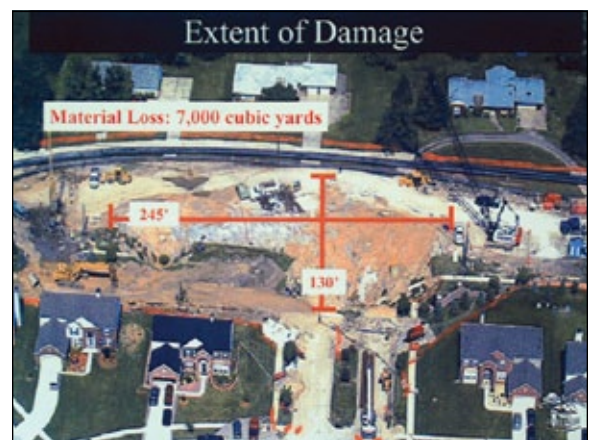
Over 150 homes in Fontana Villas, were built starting in 1999. The collapse occurred in late 2004. The collapse occurred under 15 Mile Road, which ran East to West along the Northerly border of Fontana Villas, the location of the 7 homes investigated were along the bottom of this photograph. The aerial view, see figure 1, of the sinkhole created by the collapsed 11 foot diameter sewer failure identifies close proximity to the 7 homes that were investigated. An earlier failure in this same pipeline occurred in 1978, approximately 900 feet to the East of the 2004 failure. Many conclusions and recommendations from the 1978 failure were ignored and were thereby, contributory to this 2004 failure.

The infiltration into the sewer was slow and took several years to move the fill into the sewer from under and around the sewer line. The 60 foot depth of the sewer allowed the fill around the sewer to ‘bridge’ over until the cavity around the sewer was large enough, and no longer able to bridge over the cavity, the surface collapsed into the hole visible in Figure 1 and caused the cross section damage seen in Figure 2.

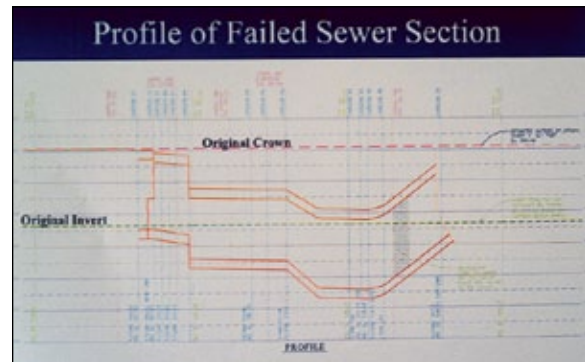
The substandard thickness of the sewer concrete occurred at station 69+29 and was very near the failure, shown in Figure 2 as the cross hatched area toward the right. This area had been previously repaired by reinforcing rather than re-mining. Station 69+29 was identified to be a control joint. This was likely the first area which began to fail in the 2004 collapse.

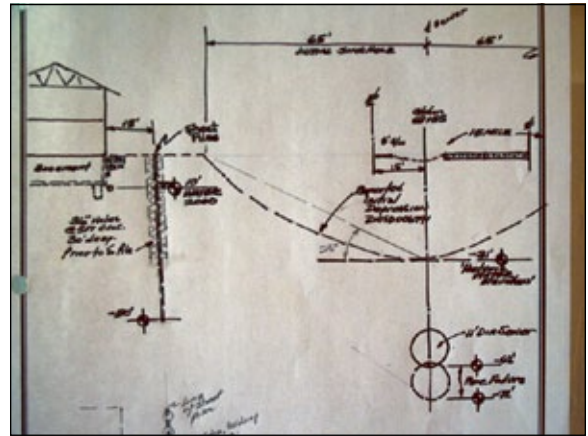
Figure 3

The documentation noted and was assumed to have been 31 feet below the surface (See Figure 3). Since this was noted as “historic” I looked for the supporting documentation for that determination. No supporting documentation was included in the material furnished. The DWSD was contacted by

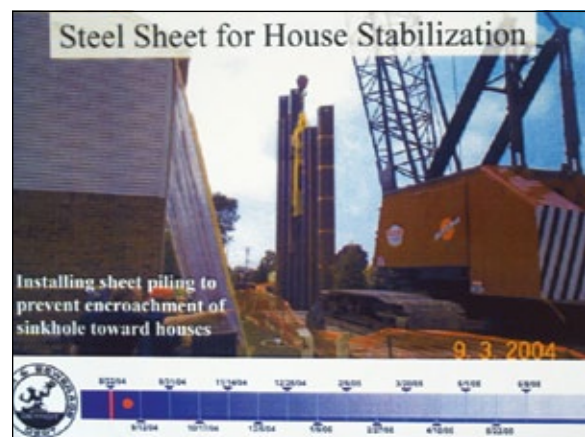
The daily trauma to the residents was intermittent and caused major distress to their living in the home. Hazards of having a 100 ton crane within 20 feet of their home (See Figure 4), making a very loud noise and steel piling being swung near their homes was a major cause of stress for the residents. Vibration was intermittent, depending on the specific construction items that were being performed. In addition to the vibration, the smell of construction especially the raw sewerage was overpowering at times. The constant equipment in their neighborhood and changing access detours were an additional irritant for the residents.

Upon returning home, the neighborhood was drastically changed, construction equipment, noise, vibration and lights were a overwhelming influence on their quiet lifestyle. Several residents had to endure a 100 ton crane handling and driving steel piling within 15 feet of their home. See Figure 4 and note the home on the left, with a splash curtain to help keep the equipment grease from splashing onto their homes and windows. Nothing was provided to prevent the loud noise, vibration, lights and concern for the residents safety. No indication was provided to assure the residents of their safety or when their disrupted lives would be restored to their pre-collapse condition.
