Forensic Engineering Investigation of a Long Span Wooden Truss Failure During Erection

By E. Ross Curtis, P.E. (NAFE 571S)

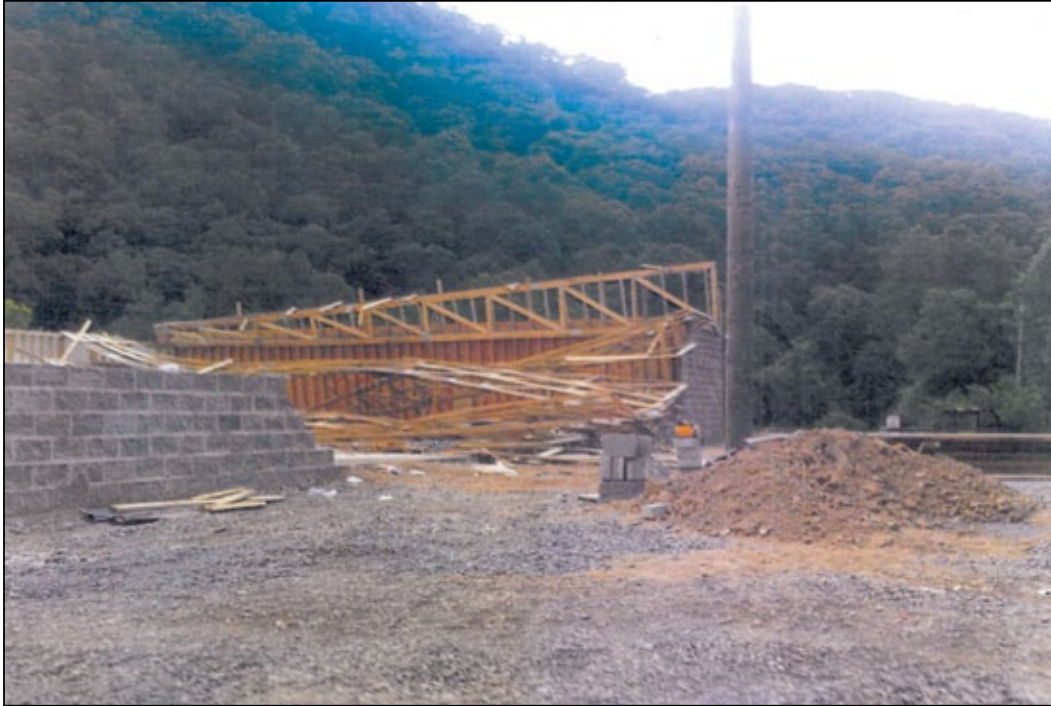
The prime contractor himself was supervising this operation and directing activities during the roof erection using local laborers he had hired two days before the incident. When about two thirds of the trusses were in place, the trusses fell over like dominos, injuring three workers who had been spotting, fastening, and disconnecting them from the crane or supporting the operation from the floor of the building. Photos 1 and 2 show the structure after the collapse. Note the lack of bracing of exterior walls.

Photo 1
Front of Building After Collapse of Trusses

Based on analysis of the photographs taken shortly after the incident, it is apparent that the wood stud exterior walls were only partially sheathed and insufficiently braced. The concrete masonry unit (block) walls also appeared to be insufficiently braced, and there is no evidence of reinforcing steel being present in the block wall, a fact substantiated by observation of the masonry block rubble during the site visit. These factors contributed to the instability of the perimeter walls of the building and are consistent with the findings of the OSHA report.

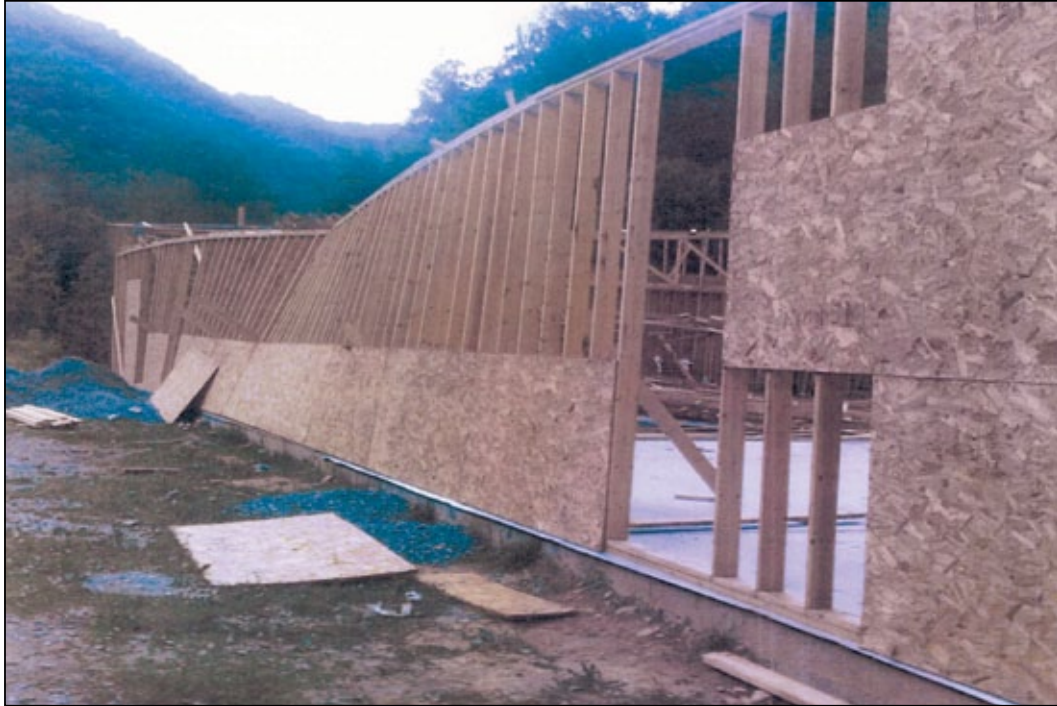
Photo 2
Back of Building After Collapse of Trusses

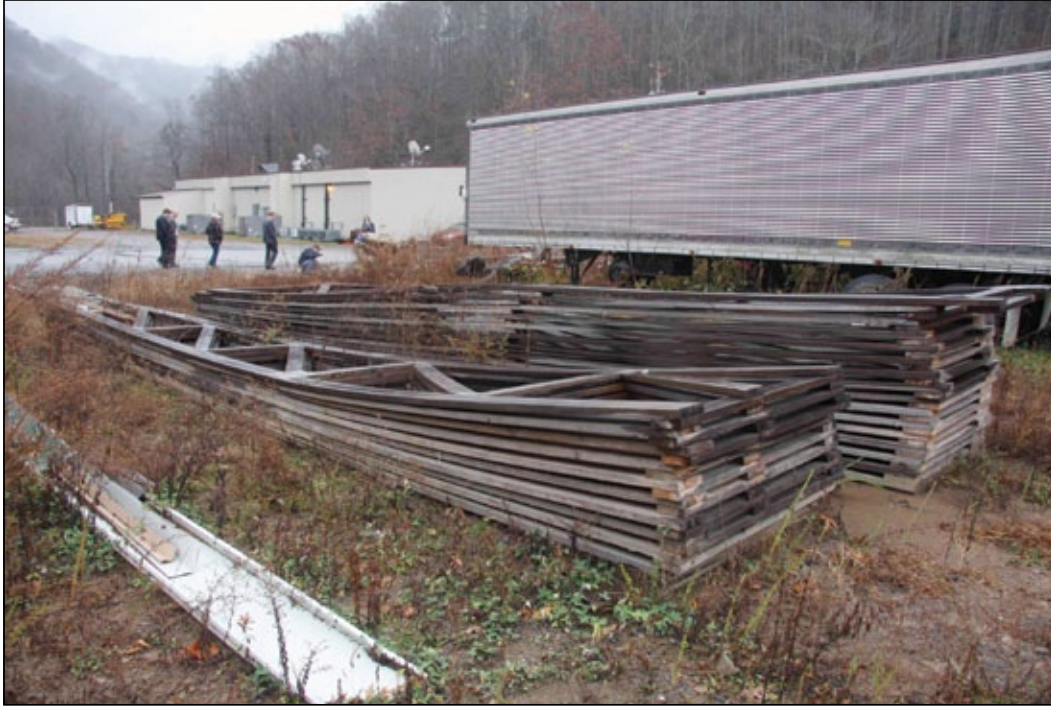
The wood trusses were intact and showed no signs of damage, except that they had been cut in half,

presumably to make them easier to handle, and had been left in a pile where they had weathered for the year and a half since the incident. See photo 3 below. The CMU rubble contained no evidence of any reinforcing, an opinion shared by the plaintiff's expert, a structural engineer. See photo 4 below.

Photo 3
Wood Trusses

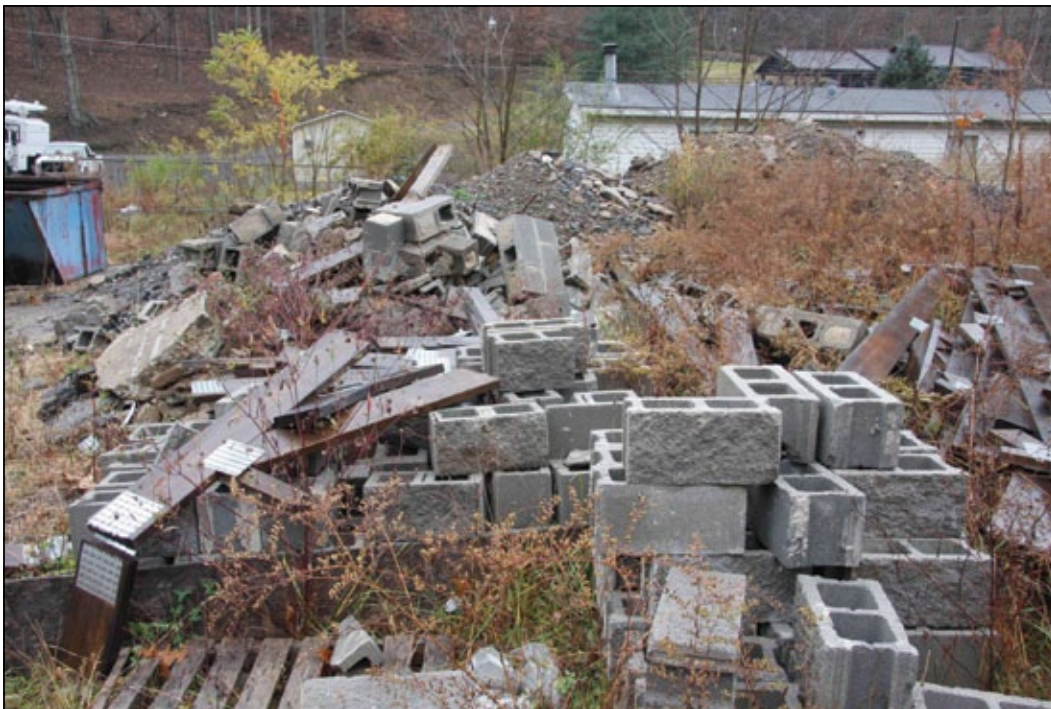
Photo 4
CMU Rubble Pile
