Journal of the
National
Academy OF
Forensic
Engineers[®]

Forensic Engineering Investigation of Lumber Temporary Guardrails

By John P. Leffler, P.E. (NAFE 709S) and

James H. Robinson, Jr., P.E., S.E. (NAFE 741S)

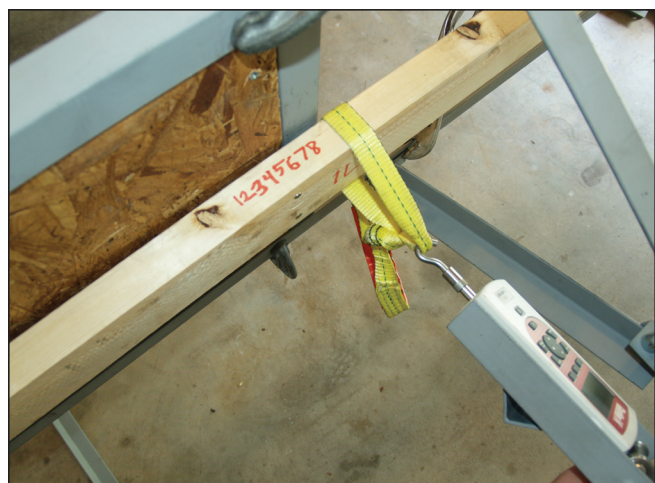
This served to pull the nails axially from their holes. The nails were then re-inserted into the existing holes and the guardrail was re-installed using a hammer and wood block. The cycle of loading / removal / re-installation was repeated until the applied 260 pounds loading could not be achieved due to the nails pulling out of the wall panel holes. The number of cycles was recorded for 2 instances representing both ends of a sample guardrail – see Figure 9. The results showed that one installation was successfully re-installed 20 times, and the other installation was successfully re-installed 8 times.

Figure 9
left end of guardrail during pullout
