Journal of the  
**National**  
**Academy** OF  
**Forensic**  
**Engineers**<sup>®</sup>

# Forensic Engineering Analysis of Golf Course, Cart, Club and Ball Accidents

By Laura Liptai, Ph.D. (NAFE 338C) and  
Michael Johnstone A.I.A. (NAFE 361C)

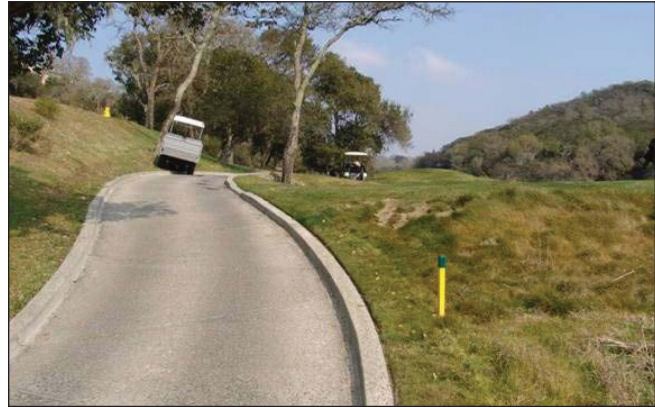
**Figure 1**

In San Diego, a golf cart, modified for concessions, was driven along a designated paved pathway when the 18 year old female driver lost control resulting in the cart mounting the left side curb and colliding with an adjacent tree (Figure 1 and Figure 2). The cart was found at rest with both left side tires

Path traveled by golf cart, shown at point of rest

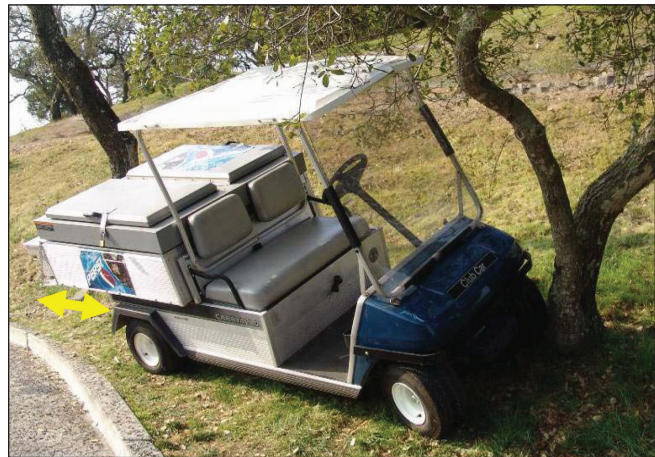
**Figure 2**

The available forensic evidence indicated that the crash was most likely caused by driver error rather than mechanical defect. Inexperience may have been a contributing factor as this was her second day on the job and the first time driving the entire route with limited education or training. Dynamically, the additional rear weight of the loaded cooler may have contributed to steering ineffectiveness.

Golf Cart shown at point of rest. Arrows illustrate concession container weight beyond the rear axle

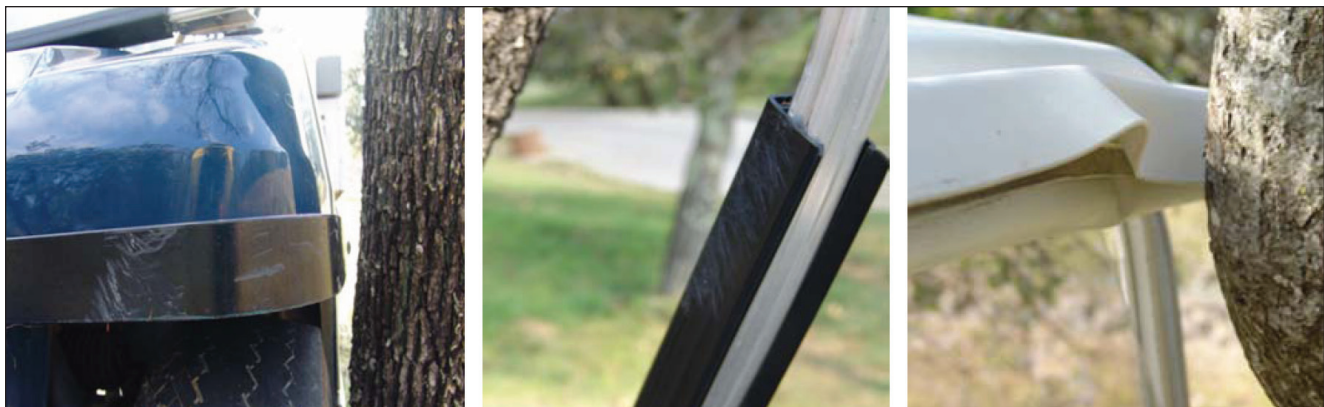
**Figure 3**

mounting the curb and both right side tires on the pathway. Forensic evidence observed on the golf cart suggested that there was contact of the golf cart with the tree at the bumper, A-pillar and canopy areas (Figure 3). The cart was not equipped with a seat belt or other restraint device. The golf cart was examined and found to have been modified with the addition of a welded steel ice chest to the rear of the cart.

Forensic Evidence showing contact locations on bumper, A-pillar and canopy

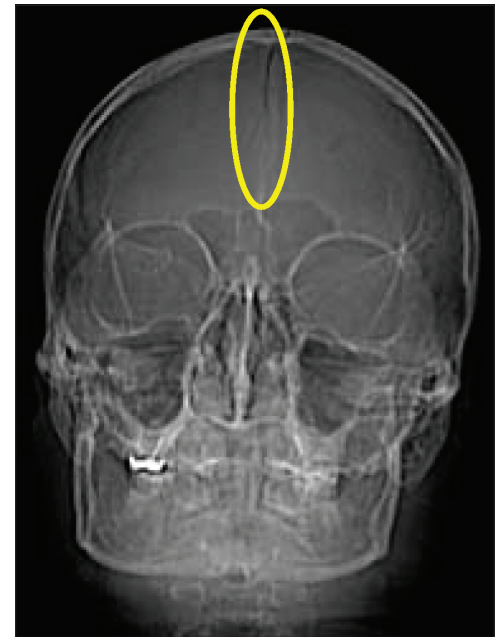
As a result of the head impact with either the asphalt ground surface or the rear platform assembly of the golf cart itself, the following injuries were sustained (Figure 4):

1. Fracture of the frontal calvarium (midline, linear and sagittally oriented)
  - a. Fracture runs along the course of the sagittal suture, extending from above the frontal sinus to the vertex.
2. Right hemisphere subdural hematoma 8 mm thickness
3. Subarachnoid bleeding in right frontal and temporal regions
4. “Significant” swelling over forehead

**Figure 4**  
Radiological Image Illustrating Fracture Trauma Sustained

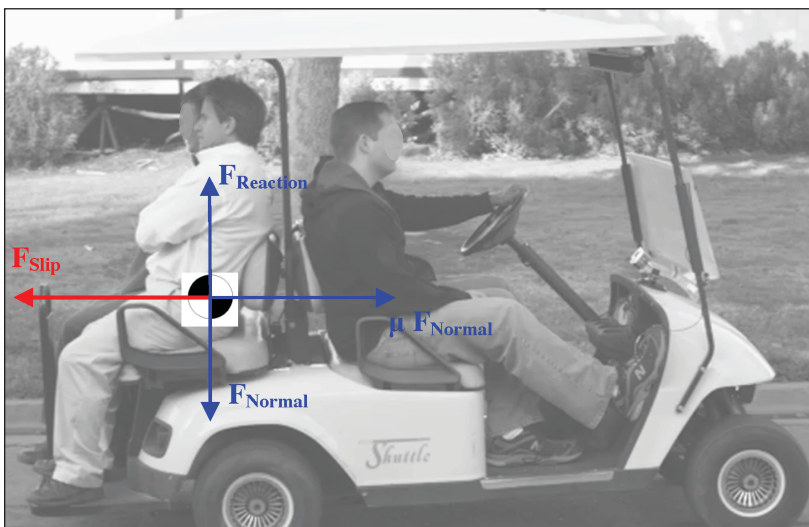
A forensic engineering analysis of the incident kinematics was conducted in order to determine the likelihood of ejection due to roadway topography versus a self-induced step out of the cart. Coefficient of friction tests conducted on the rear facing seat occupied by the plaintiff (Figure 5) quantified the kinetics required to eject

**Figure 5**  
Illustration of exemplar seating configuration with coefficient of friction diagram overlay

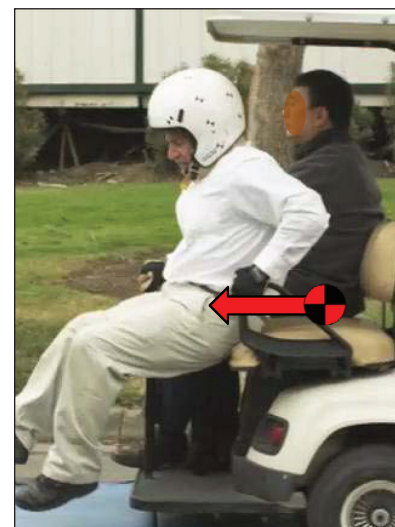
**Figure 6**  
Stuntman testing

the man out of his seat against friction. Figure 6 illustrates stuntman kinematic analysis. Acceleration data associated with the trip across campus indicated that the maximum fore-aft and resultant accelerations produced by the roadway topography were insufficient for inadvertent ejection. Therefore, based upon the testimonial, physical and experimental forensic evidence, the fall from the cart was most likely voluntary (consistent with retrieving his laptop suitcase that had fallen) as opposed to an ejection caused by the alligator cracked roadway topography.

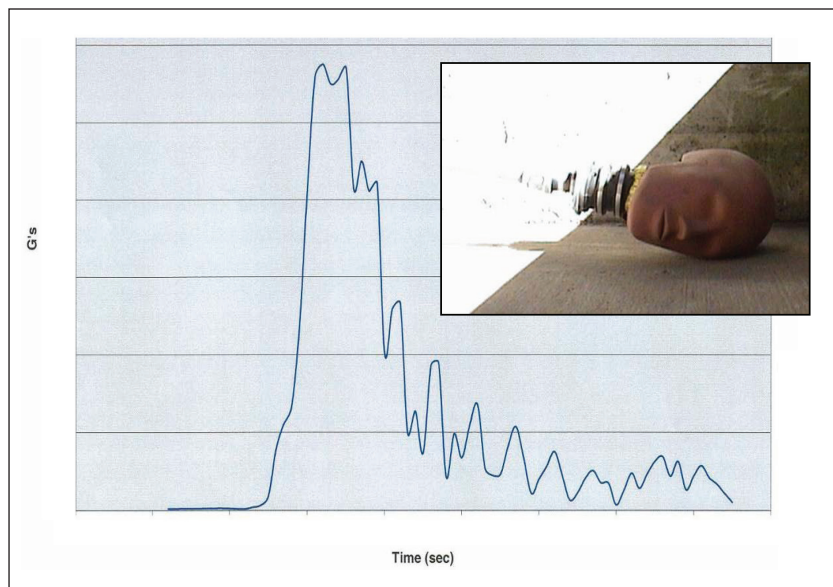
The fracture mechanism was consistent with a fall from the cart as reported. Inverted pendulum testing with the Hybrid III anthropometric test dummy (ATD) was conducted in order to determine if the accelerations resulting from a head-to-concrete impact (Figure 7) would have been sufficient if the plaintiff had been seated. Due to the extremely short time duration involved with a head-to-concrete impact, the Head Injury Criterion (HIC) threshold was exceeded in all experimental trials.

**Figure 7**  
Head to Concrete Testing Exemplar Result

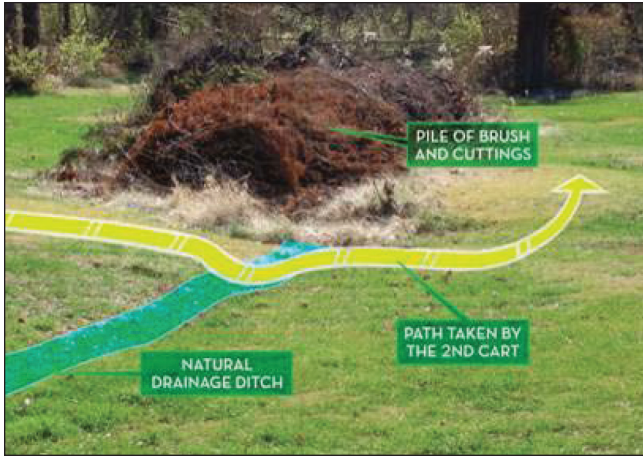
**Figure 8**

An incident occurred in Illinois involving a player who was allegedly ejected from a golf cart on a poorly maintained alternate cart path. Inspection of the incident scene revealed that there were topographic anomalies present in the area of the ejection including a large pile of brush cuttings and a drainage ditch (Figure 8). Forensic engineering analysis of the scene topography indicated that while the accident was likely caused by irresponsible driving (Figure 9); poor path maintenance, specifically, exposure of the ditch without guarding or warning was also a likely factor.

View of golf cart and alternate cart path

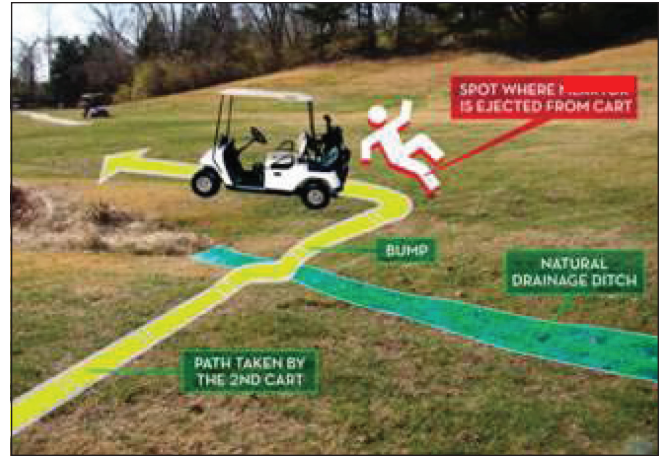
**Figure 9**

Image showing path taken by golf cart

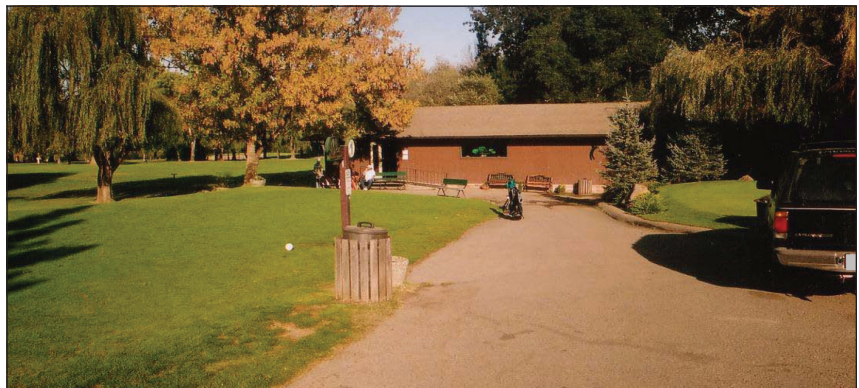
**Figure 10**

In South Carolina, a 39 year old female instructor was marking a scorecard near the 9th hole green and clubhouse when she was struck in the head by a golf ball (Figure 10). A witness stated that she saw the ball bounce prior to striking the woman. The instructor did not fall, but was found with a golf-ball sized lump on top of her head; there was no reported loss of consciousness.

Photograph showing approximate location where 39 year old female was struck by golf ball adjacent to 9th green and clubhouse

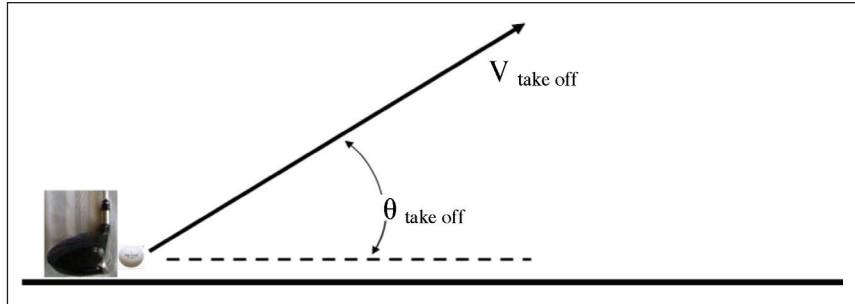
**Figure 11**

An engineering analysis of the golf ball trajectory was conducted based on the woman's position in the nearby vicinity of the clubhouse when she was struck by the ball. The angle of departure and departure speed of the ball was calculated based on the distances and known characteristics of the club used (Figure 11). It was found that in order for the ball to clear the clubhouse and bounce prior to striking the 5-foot 9-inch tall woman, the ball would have been traveling at a speed of approximately 27.5 mph upon impact.

Analysis of golf ball trajectory,

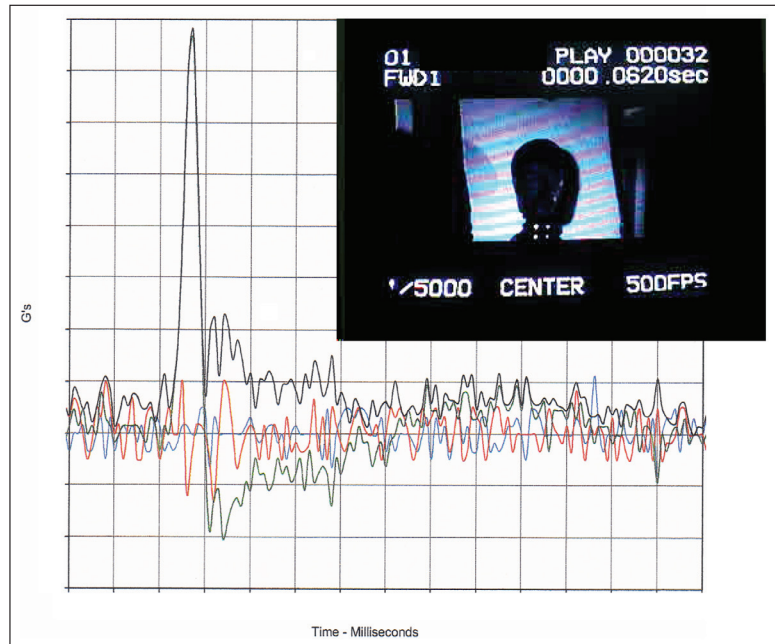
**Figure 12**

Testing with the Hybrid III anthropometric test dummy (ATD) was conducted in order to determine the forces and accelerations resulting from a golf-ball-to-head impact from a similar height (Figure 12). The probability of brain injury to the average person was determined to be unlikely in experimental trials.

Sample golf ball-to-head impact test plot with Hybrid III ATD as well as high speed video snapshot

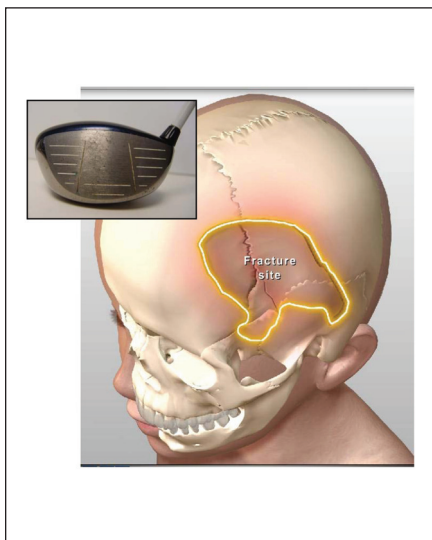
**Figure 13**

In Chicago, a 12 year old male was struck with the head of the golf club (Big Bertha driver) while he was seated adjacent to the tee. While his partner was taking practice swings, the seated child was struck with the partner's club as it was in the stroke of a full swing. The club reportedly struck the child in the temporal bone (at the area of the left ear) (Figure 13). After impact, the child fell to the ground impacting his head a second time.

Golf club and resulting impact injury

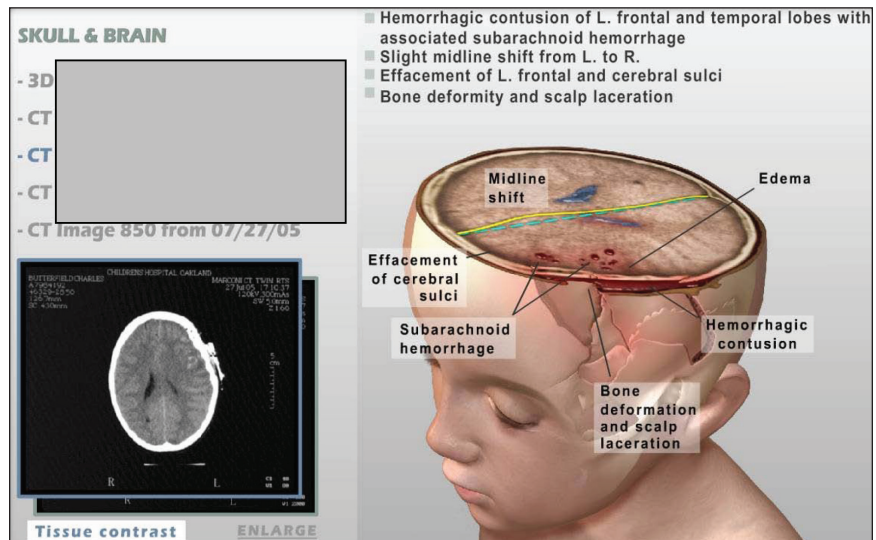
**Figure 14**

Imagery of resulting injuries

As a result of the incident, the child sustained severe head injuries (Figure 14) including the following:

1. Significant hemorrhagic contusion, generalized brain swelling, subarachnoid hemorrhage and depressed skull fracture.
2. Depressed left parietal skull fracture, craniotomy for removal of depressed skull fragment.
3. Left temporal scalp laceration.
4. Traumatic Brain Injury with right hemiparesis and Broca's aphasia.

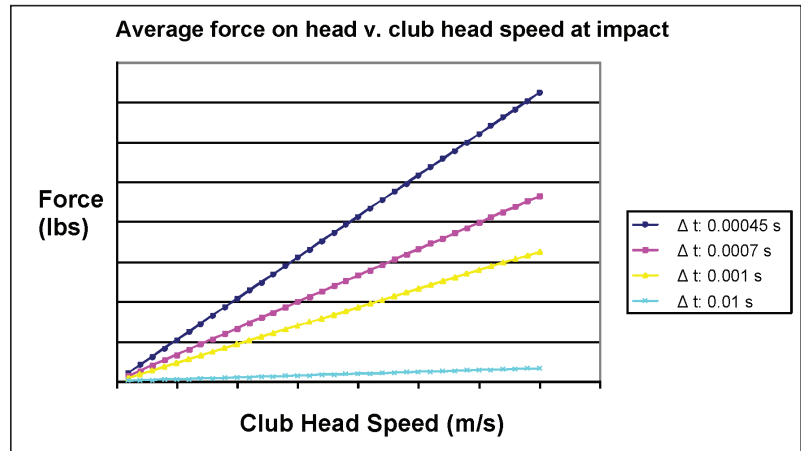
**Figure 15**

An example of calculated force applied based on club head speed and contact duration

Based on this information, bio-medical engineering analysis was conducted in order to quantify impact forces based upon an estimated club-to-head impact speed. An inspection of the club revealed specific size and weight characteristics (Figure 15). The golf club dimensions along with specific child stature information were then used to determine the speed of the club head at the point where it struck the head of the male child. Testing with the “Iron Byron” mechanical driving device suggest that a golf ball remains in contact with the club face for about

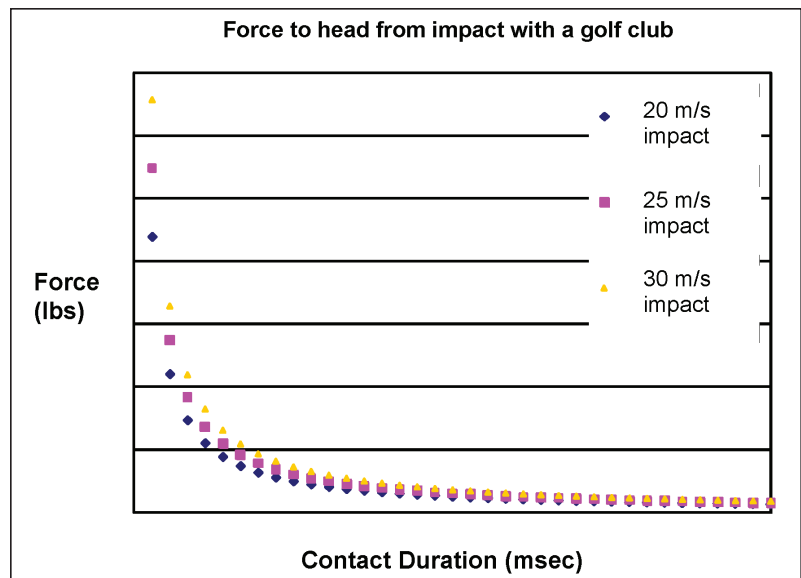
**Figure 16**

An example of calculated force applied based on club-to-head contact duration

450 milliseconds. During the impact phase, the ball is flattened to nearly 2/3 of its original diameter. The ball then leaves the club face at a velocity of about 160 mph, requiring a contact force of over 1700 lb. Based on the calculated club head speed and contact duration, the average force for the club-to-head impact was determined (Figure 16).

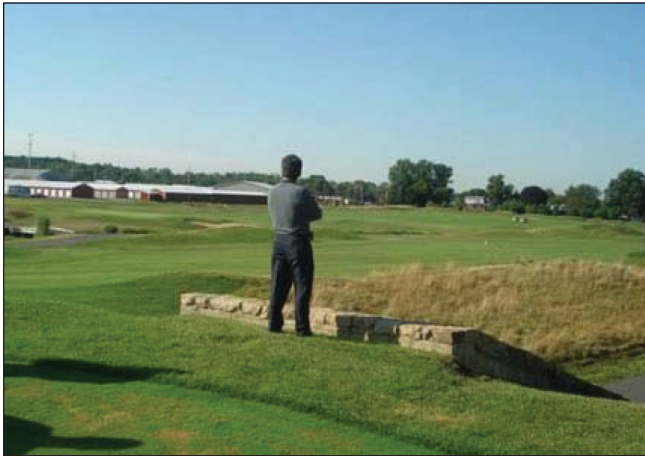
**Figure 17**

In Northern Georgia, a man was severely injured on a golf course when he reportedly walked backward and tripped on a tunnel abutment (Figure 17) and fell to the cart path below (Figure 18). Forensic engineering analysis of the incident location indicated that the man had passed by and through the visible tunnel on previous holes and that the tunnel was obviously marked. To improve, the abutment could have been marked, guarded and/or golfers warned.

View of tunnel abutment from path above

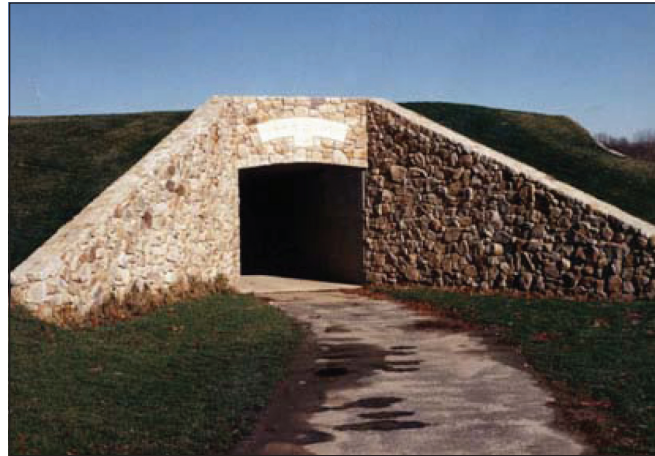
**Figure 18**

View of tunnel from cart path below where fall occurred

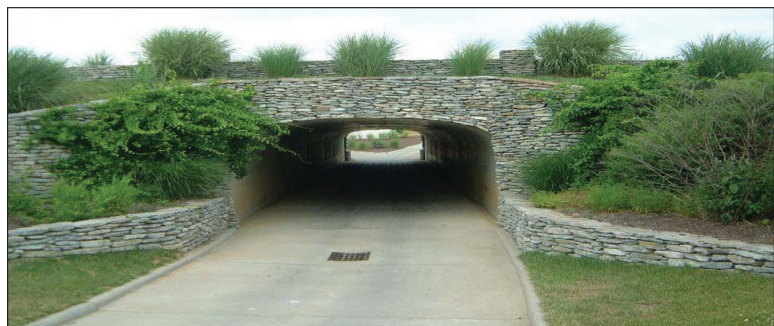
**Figure 19**

A man was fatally injured after a collision occurred between his golf cart and a truck at a bisection between the golf course and an Indiana State Highway. The golf cart path passed through a tunnel passing below the Highway designed and constructed by the State's Department of Transportation (Figure 19). The players are directed to use the tunnel to traverse the Highway. The carts in use at the time of the accident were approximately three years old.

Photograph showing golf course at bisection with State Highway

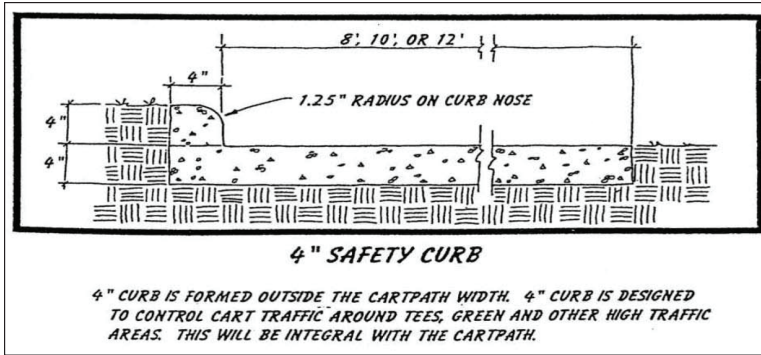
**Figure 20**  
Curb schematic

The cart path was found to be a six foot wide, one-way, continuous concrete path with 4" non-mountable vertical curbs (Figure 20) specifically designed to keep carts on the path. The slopes and grades were gentle and provided a clear path for golf cart navigation on the course. The path for crossing the highway was clear, safe and easily found. The tunnel provided for two-way traffic and was 14 feet wide. Further, tall fescue grass, berms, bushes, trees and other landscaping treatments visually define the borders of the course and were an obvious barrier to carts (Figure 21). Warning signs in the cart state, "Operate from driver side only and not on public roads" (Figure 22). Signs were visible throughout the course regarding non-access areas for golf carts (Figure 23).

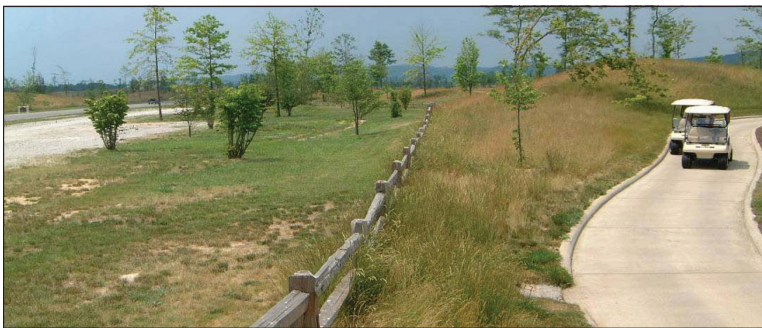
**Figure 21**  
View of the cart path, curbs and tall fescue grass

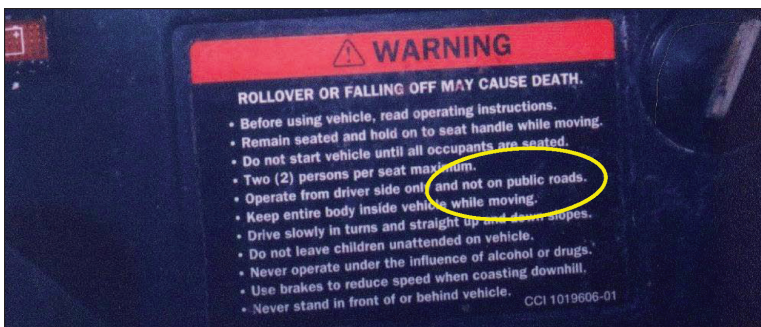
**Figure 22**  
Warning label stating cart should not be operated on public roads

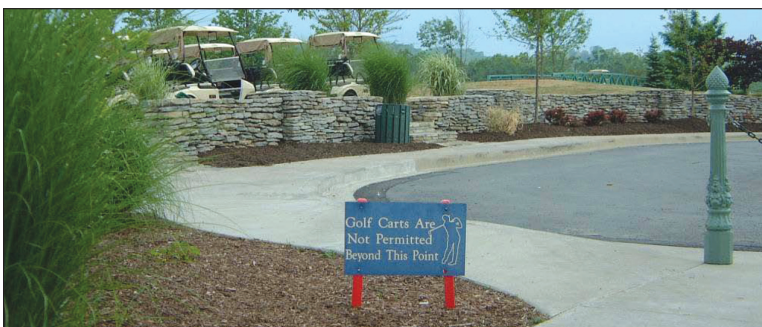
**Figure 23**  
View showing warning sign at the entry to the parking lot

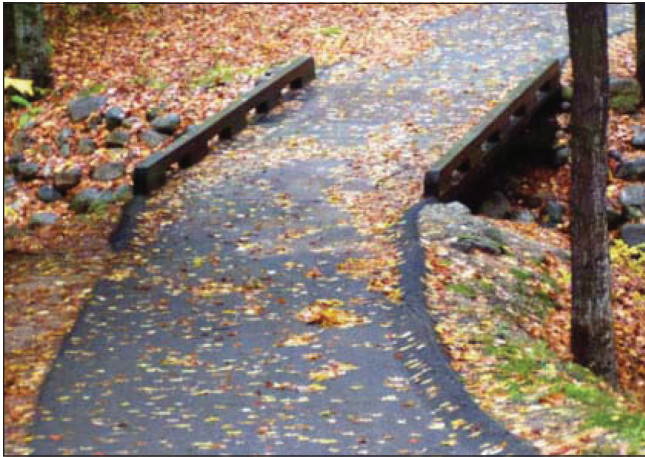
**Figure 24**

While on a resort golf course in Oregon, a player and passenger were riding in a golf cart on a wet, leaf-ridden path when the cart skidded and overturned on a steeply sloped bridged area (Figure 24). Forensic engineering analysis established that the cart path exceeded the accepted maximum slope and acted as a drainage swale distributing sand and debris onto the bridge. There were no warning signs alerting of dangerous conditions. It was determined that the likely tripping mechanism for the rollover was the curb which initiated at the bridge where the path curved at the bottom of the slope (Figure 25).

View of the wet, leaf-ridden steeply sloped bridged area

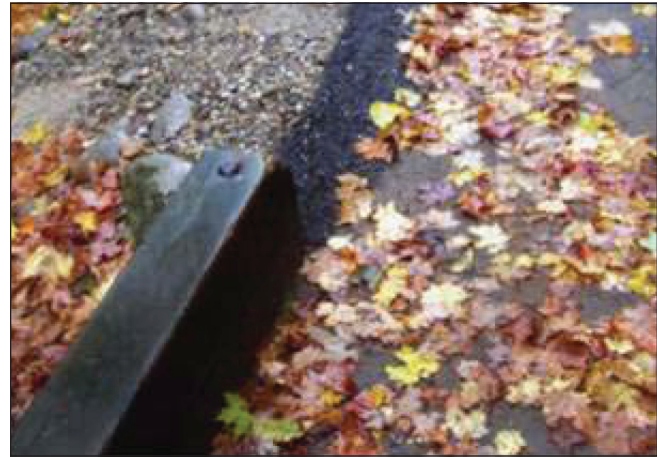
**Figure 25**

View of the curb  
(likely tripping mechanism initiating rollover)

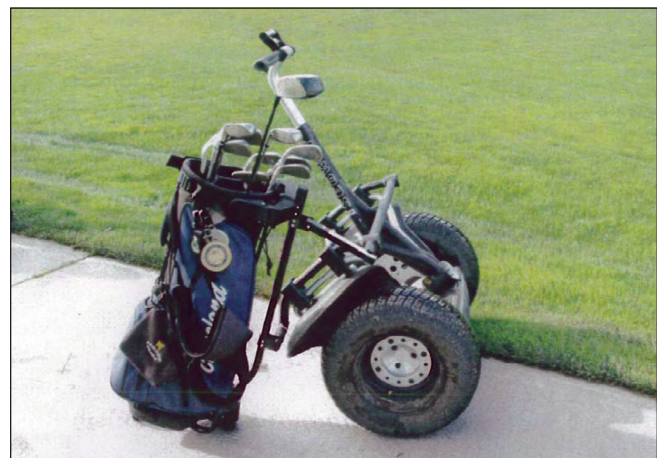
**Figure 26**

In Virginia, a man was transporting himself and his golf clubs up a hill on a Segway machine when the machine fell backwards, causing a fracture of the mid left fibula and distal tibia. The Segway machine, as seen in Figure 26, was provided by the golf course as a means for transportation. It was discovered that the man was not riding on the provided pathways, but was riding on a steep un-traveled grass hill. Through analysis, it was determined that the load of the man and the golf clubs was near maximum weight capacity contributing to the inability of the Segway machine to successfully maneuver the hill leading to a fall.

Exemplar Segway machine

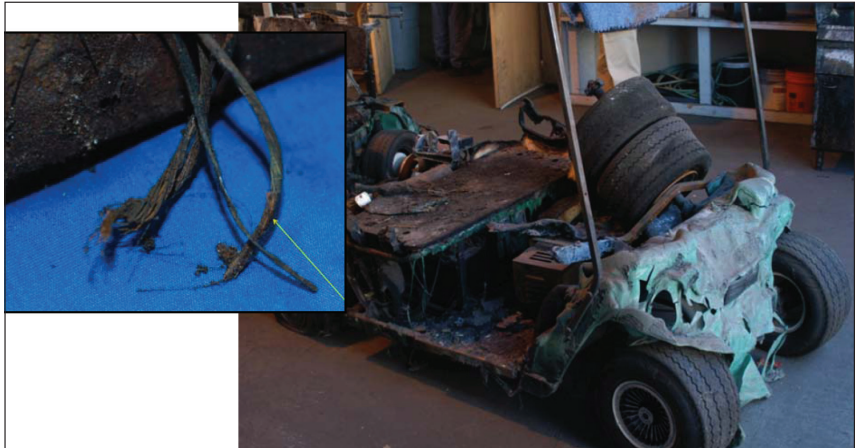
A fire occurred in a golf cart storage facility in upstate New Jersey (see Figure 27). A foreign copper wire was found in the battery compartment. It was reported that the golf cart was charging when the charger failed resulting in overheating of the batteries and cables. It was hypothesized that a battery cable failed due to high temperatures, arced and ignited the excess hydrogen. This is significant as golf carts are commonly stored within the clubhouse or the home garage.

**Figure 27**  
Golf cart fire and wiring evidence
