Journal of the
National

Forensic Engineering Investigation of Vehicle Hub Separations

by John Leffler, P.E. (NAFE 709S)

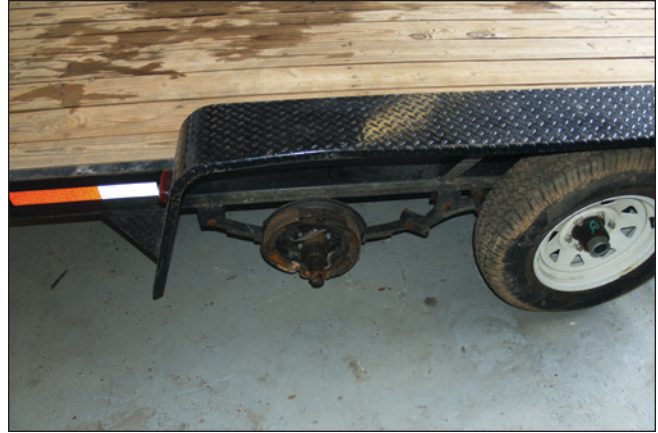
Figure 9
Axle end remaining from hub separation

traveling the opposite direction on the Interstate, causing him permanent injury. The separated assembly was retrieved by the first responders. The right rear axle stub and brake assembly were damaged as the hub separated. Following the incident, the trailer was transported to the owner's residence. See Figure 9.

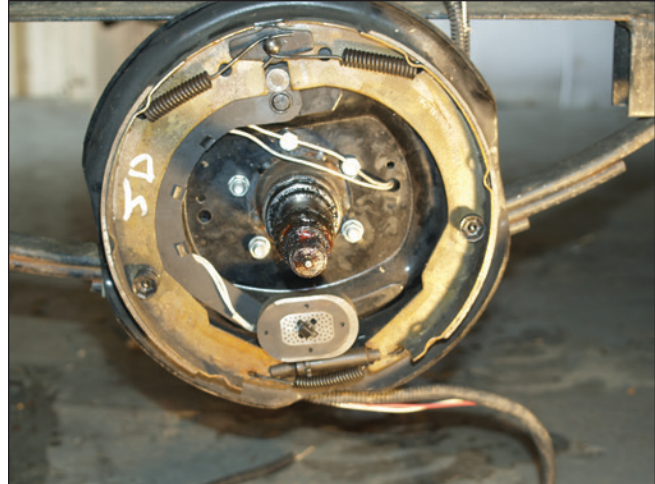
Figure 10

Left rear brake assembly on side opposite from separation

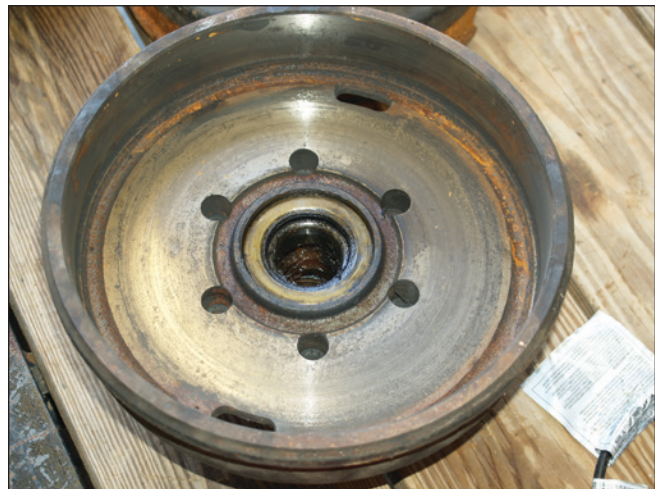
Figure 11

Left rear brake drum with little wear

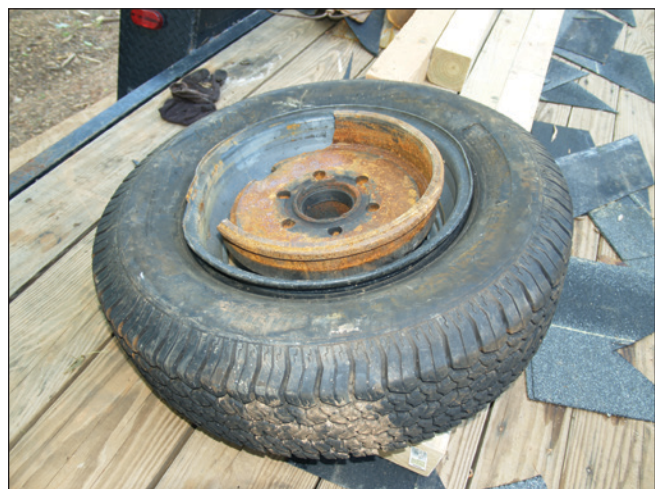
Figure 12

had a large chunk broken away, as shown in Figure 12. The wheel was bent and deformed in several areas, and the tire was deflated, though otherwise in apparently good condition.

Separated hub, wheel and tire assembly

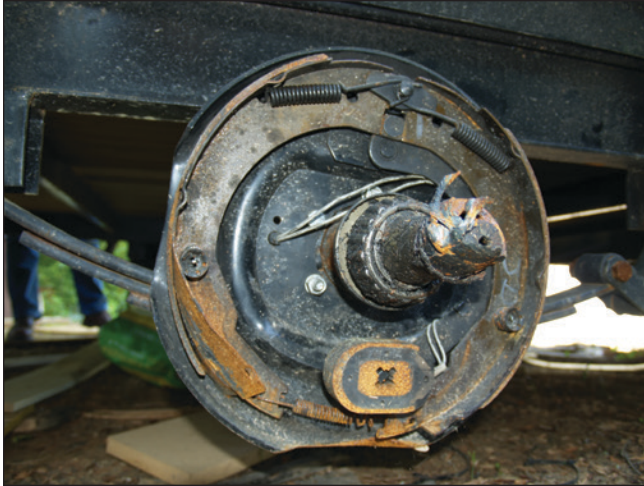
The axle stub showed evidence of friction superheating, melting, and bending. The axle nut was missing, though damaged portions of the outboard bearing inner race, outboard bearing cage, and axle nut washer were present. The inboard bearing cone and ring-type seal were intact in place on the axle stub. See Figures 13 & 14. The brake shoes were present but were bent on the lower portions, and abnormal wear patterns were observed on the friction surfaces. See Figure 15. The condition of the brake shoes and axle stub end are consistent with the hub/drum partially separating and rolling askew on the axle stub, still somewhat retained, for some distance before complete separation.

Figure 13
Axle end from separated hub

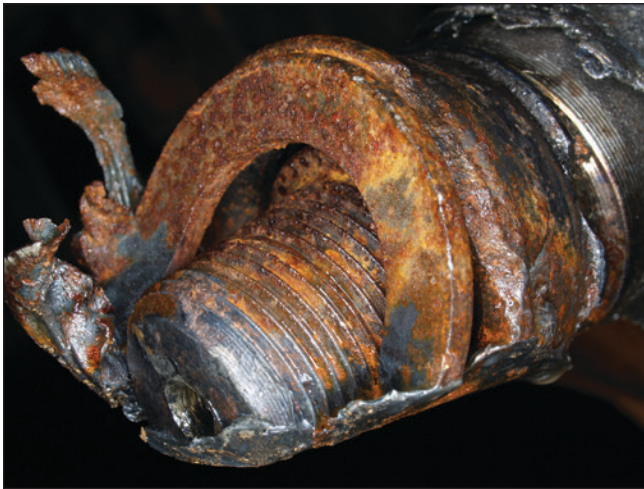
Figure 14
Melted and deformed axle end

The lack of an axle nut on the right rear is consistent with a process documented in Searle¹, wherein the failed superheated bearing causes thermal softening (annealing) of the axle nut threads and/or axle stub end threads. The softened threads yield and the nut comes off, and eventually the hub comes off.

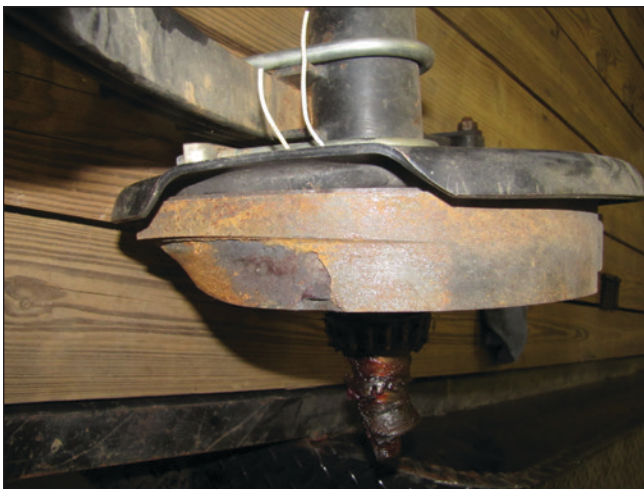
Figure 15
Deformed and abnormally worn rear brake shoe

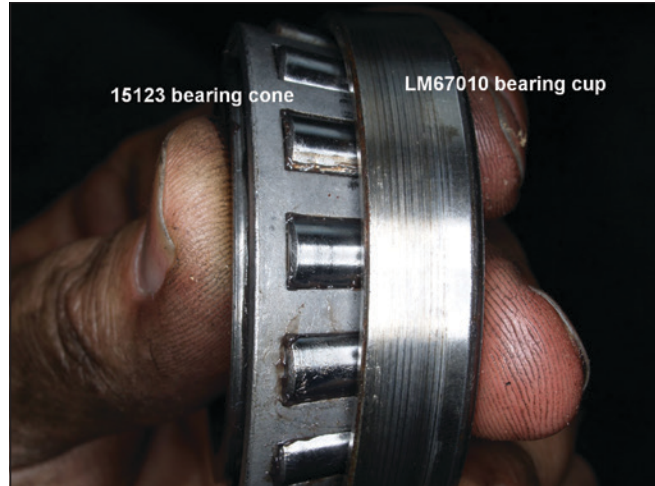
It should be evident that a 15123 cone cannot be expected to function properly in a LM67010 cup. Referring to Figure 17, only about half of the bearing roller width actually contacts the cup, which will lead to uneven load distribution, high localized compressive stresses, and cocking of the rollers. Additionally, the cone angles are different

Figure 17
Mismatched bearing cup and cone

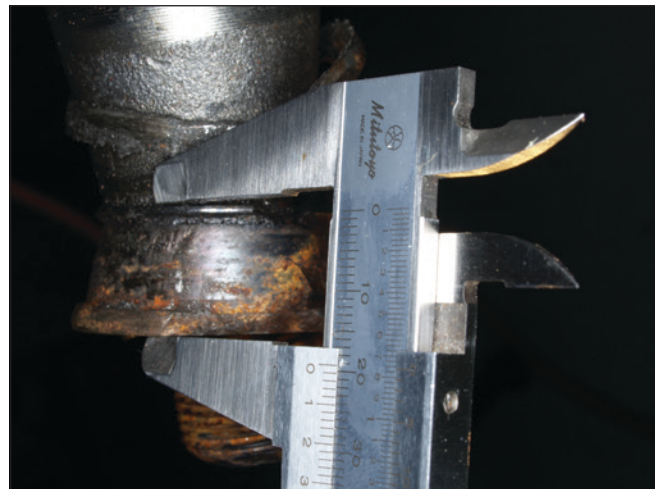
an LM67010. The partial remains of the separated hub's outboard bearing cone inner race were measured (see Figure 18), and the dimensions matched that of a 15123 bearing cone inner race. As such, it was apparent that 15123 bearing cones had been used with LM67010 cups on the rear axle.

Figure 18
Measuring remains of outboard 15123 bearing inner race

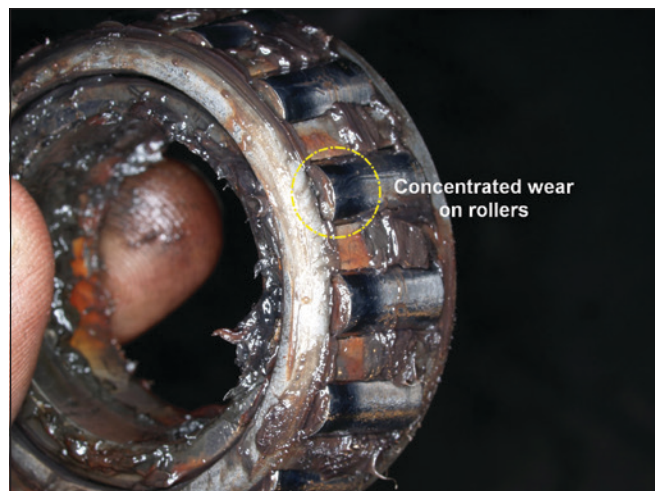
Figure 19
Left rear outboard 15123 bearing damage due to outer race mismatch

for the two designs. As an aside, subsequent closer inspection of the surviving left rear 15123 cone revealed compressive damage to the small-end edges of the bearing roller contact surfaces – failure of this bearing was impending. See Figure 19. It is a tribute to modern bearing design and manufacturing that these bearings lasted as long as they did. It is of note that any of the Alpha, Bravo, or Delta hub/drums, properly installed with the correct bearings, will result in approximately 1/8" of axle threads protruding from the axle nut (see Figure 20). If the subject mismatch is created, however, the inability of the 15123 bearing cone to insert fully into the smaller LM67010 cup will result in about 1/4" fewer axle threads engaged in the axle nut – the nut will “overlap” the axle end (see Figure 21). This may or may not be noticeable, depending upon the presence of grease and depending upon the expectations and skills of the observer.

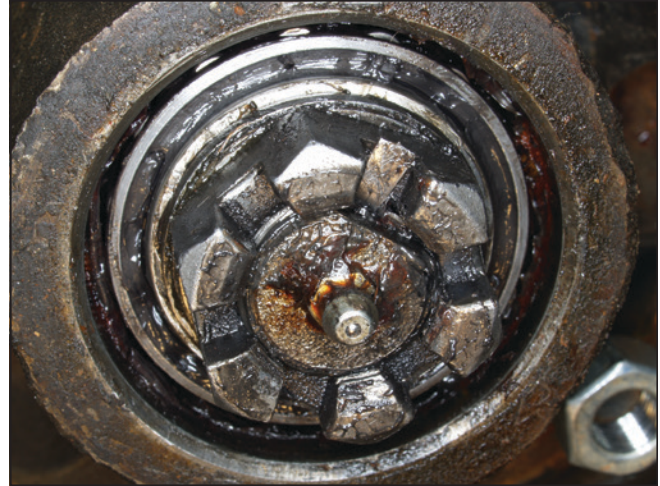
Figure 21

Assembled mismatched hub (left rear) showing nut overlapping axle stub end

- The technician stated that he used a “thumb wrench” to tighten the axle nut and set the bearing tightness – again reflecting deficient technical skills. His “thumb wrench”, though undefined, was likely an adjustable wrench (which has thumb-wheel adjustment), yet manufacturer installation instructions specify a bearing preload setting process requiring a torque wrench.
- Based on the manufacturer’s poor inventory control, mixing of stock brands, reuse of used parts, and deficient technician skills, it was deemed more likely that the manufacturer installed the subject mismatch, versus the dealer or owner. The poor technical skills were considered as well in questioning whether the technician would have noticed that the grease-covered axle threads would not have protruded through the axle nut in the normal manner – due to the bearing mismatch.

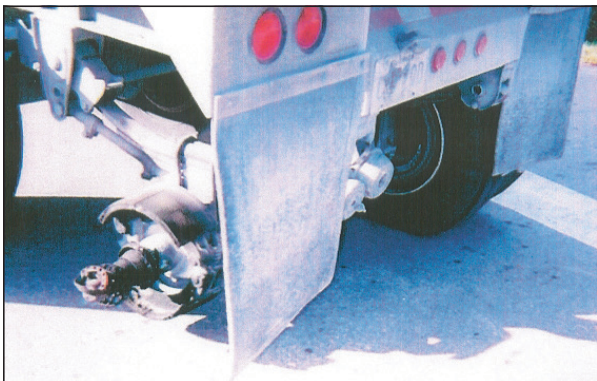
Figure 24
Separated hub, wheel, and tire assembly

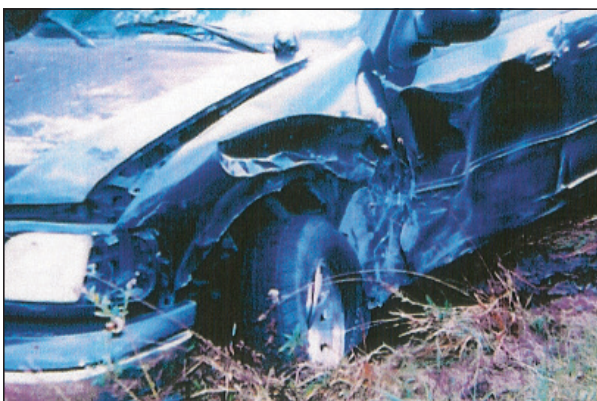
Figure 25
Damaged vehicle struck by separated wheel-end

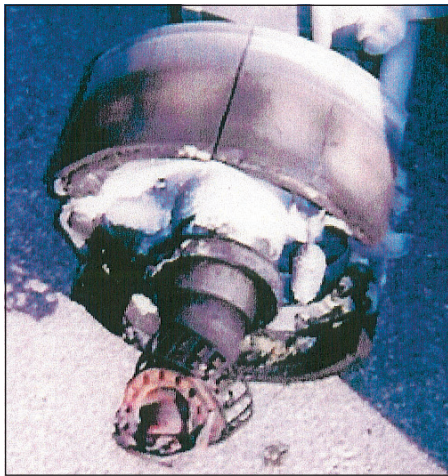
- The axle stub is missing the outer axle nut and tabbed lockwasher, though the perforated locking ring is present. The outer axle nut could have deformed sufficiently (with heating) to loosen and fall off, or the axle stub threads could have been damaged.

- The outboard bearing cage and rollers are gone; the inboard bearing cage is present. Due to the difference in bearing diameters (outboard being smaller), the outboard bearing in an oil-filled hub will fail sooner in a low-lubricant situation – see Figure 30.
- The brake shoes appear to have staining and localized bands of wear consistent with a hub oil leak. The staining could also be merely products of combustion caused by the hub oil fire – the evidence was not directly inspected by the author.

Figure 29
Subject axle end post-incident

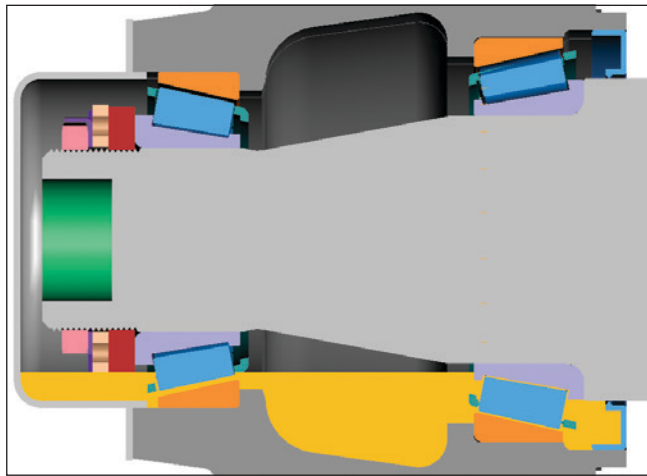
Figure 30
Oil-filled hub showing smaller outboard bearing will starve first in a low-oil condition.
