# Forensic Engineering Analysis In The Collision of Two Tractor-Trailer Trucks

by William J. Arnoult III, Ph.D., P.E. (NAFE 209F)

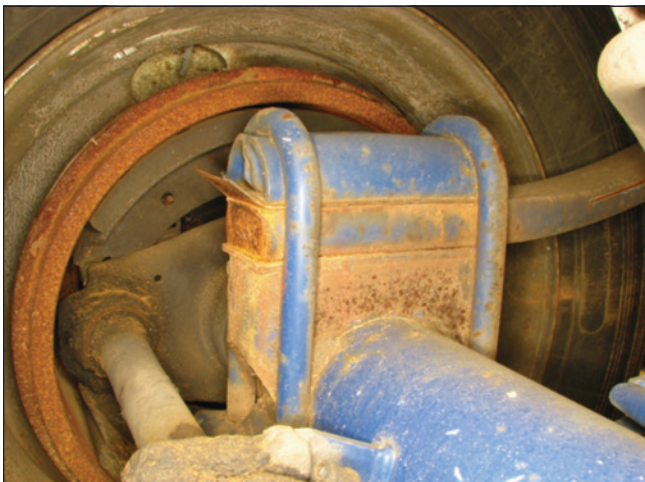
**Figure 1a**

- The Vehicle #1 flat bed trailer had single-leaf suspension springs on both the fourth and fifth axles. (Tractor-trailer axles are numbered sequentially from the front of the tractor to the rear of the trailer.) The trailer's fifth axle left leaf spring was fractured and parted at the aft edge of its top plate. The mating piece of the spring was found by the investigating officers approximately 10 to 20 feet from the final resting place of the #1 rig, approximately 300 feet east of the overturn point. See **Figure 1a and 1b**.

Vehicle #1 Fifth Axle Left. Shown is the spring fracture location. Forward is to the right.

The continuous propagation of the tearing texture at the top of the two springs, and specifically in the #5 Left spring, showed the Forensic Engineer that either the #5 Left spring was fractured prior to the incident, or, more likely, fractured during the course of the incident as the trailer was sliding on its side or up-righting itself. The Forensic Engineer determined that it did not fail first, thus causing the trailer to overturn. Additionally, with no shackle to keep the broken piece of spring in place, if it had broken first, it would have been found close to the overturn location rather than approximately 300 feet from the overturn location. And, there were no abrasion marks on the loose piece of #5 Left spring to indicate it had slid on the pavement.

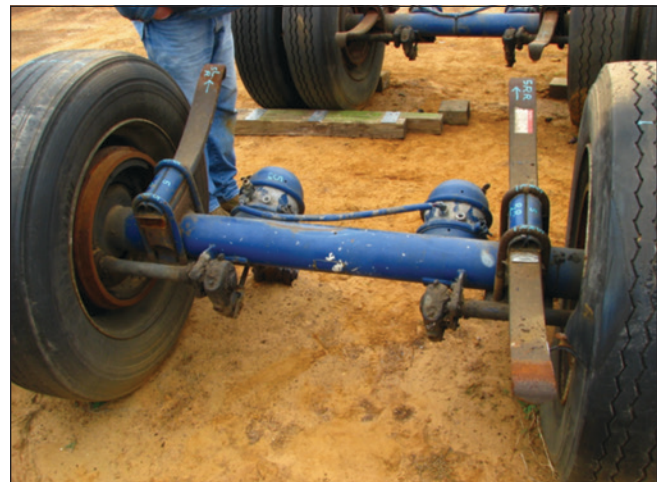
**Figure 1b**

Vehicle #1 Fifth axle.  
Fourth axle is at the top of the figure.

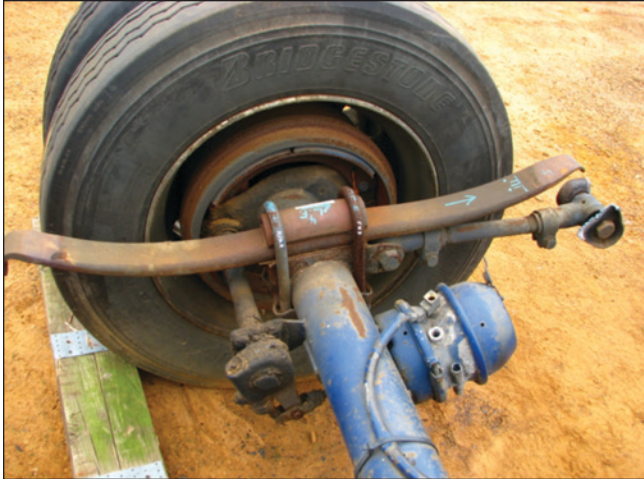
**Figure 2**

Vehicle #1 Fourth Axle Left Leaf Spring.  
Deformed downward and touching the radius rod.

- Vehicle #1 fourth axle left leaf spring was permanently deformed downward. See **Figure 2**.
- Vehicle #1 fourth axle right leaf spring was fractured underneath its top plate and was separated. Abrasive polishing was found on the top plate, which showed that the spring had been fractured and separated prior to the incident. See **Figures 3 and 7**.

The Forensic Engineer performed hardness testing of all four springs and found that spring #4 Left (the one that was deformed downward) was much softer than the other three, and in fact was not even spring hardness ( $\geq 40$  on the Rockwell C scale). This explained why it was deformed downward.

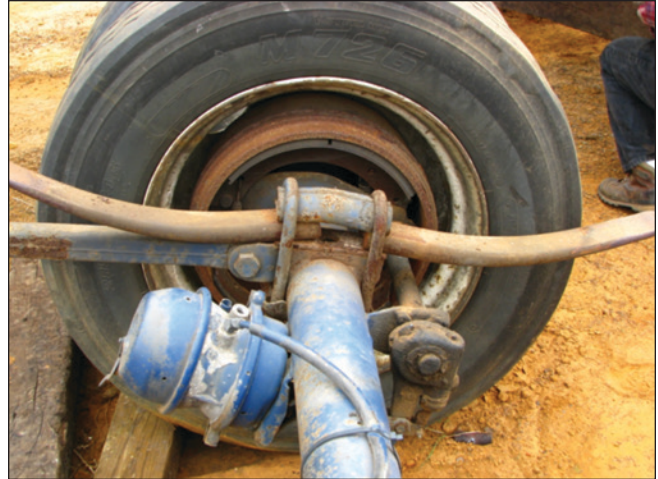
**Figure 3**

Vehicle #1 Fourth Axle Right Leaf Spring.  
Fractured and separated.

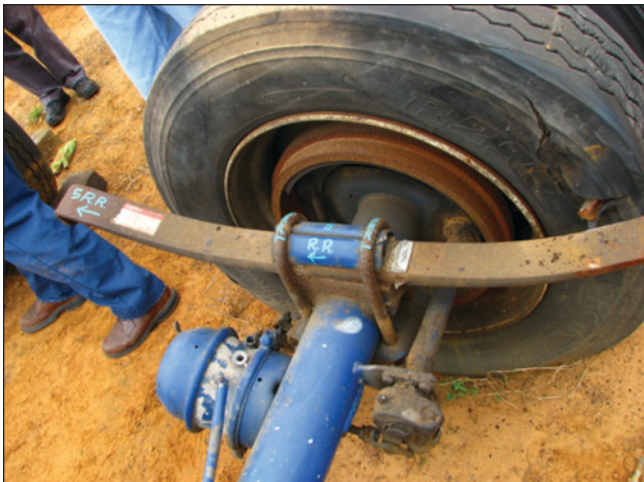
**Figure 4**

Vehicle #1 Fifth Axle Right Leaf Spring.  
Intact and not deformed.

- Vehicle #1 fifth axle right leaf spring was intact and not deformed. See **Figure 4**.
- The adjustable radius rods of both the fourth and fifth axles of the vehicle #1 trailer were deformed laterally in a direction that showed that the axles were laterally loaded toward the left (driver side of the trailer). See **Figure 5**.

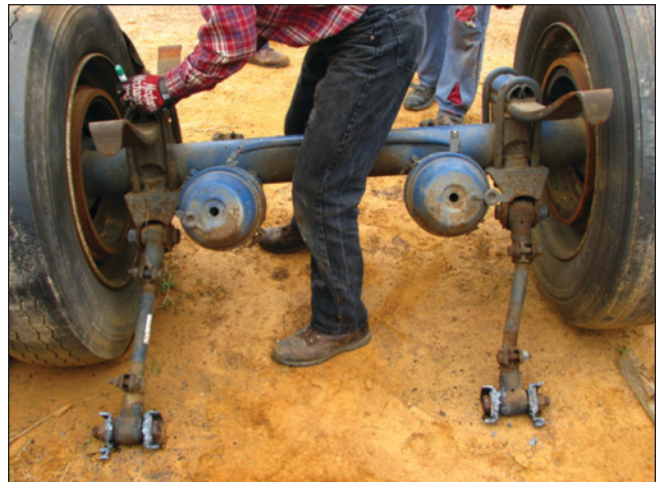
**Figure 5**

Vehicle #1 Fifth Axle Radius Rods.

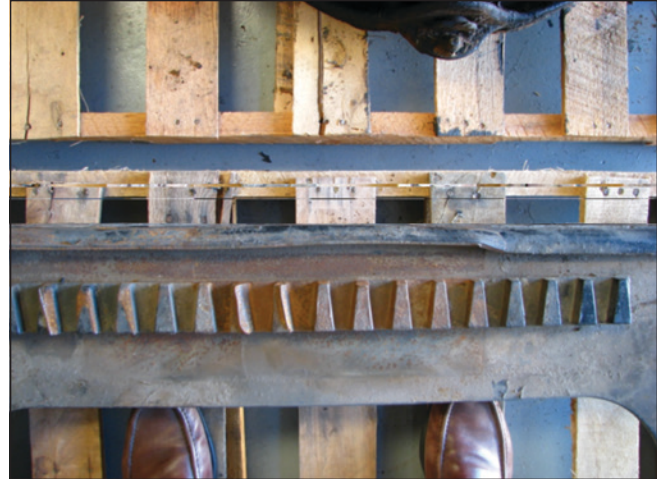
- Vehicle #2 fifth wheel assembly showed that both the right-side and left-side channel retaining lips on the pad had deformed, thus allowing the fifth wheel to disengage from and channel and override the adjusting teeth. In addition, the right-side channel lip had fractured. See **Figure 6**

Vehicle #2 Fifth Wheel Toothed Adjustment Pad.  
Note the forward deformation of the teeth (to the left) and the deformation of the channel lip.

At the time that the case settled, laboratory examination by the Forensic Engineer had not yet begun on the fifth wheel assembly from Vehicle #2. However, visual examination results were sufficient to show that the assembly was grossly overloaded, and was a victim of the collision.

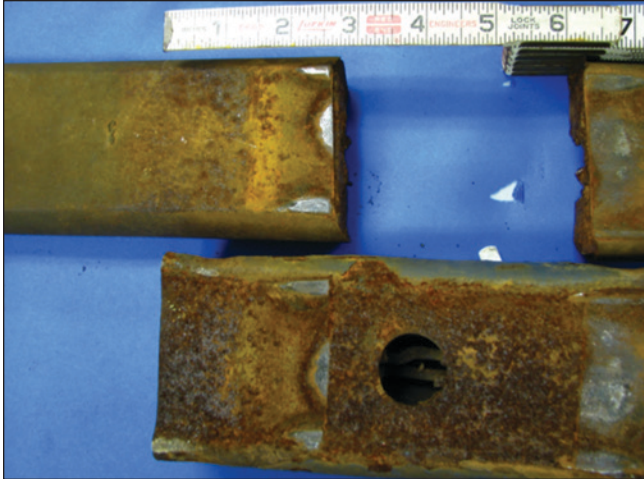
**Figure 7**  
Vehicle #1 Fourth Axle  
Right Leaf Spring (top) and  
Top Plate (bottom).

On spring #4 Right (the one that was broken under the top plate), wear markings and areas of abrasive polishing (fretting) were found at the interface between the spring top surface and the top plate bottom surface. These markings were separated the same distance as the spring. Additionally, there were wear markings on the radius rod that

was under the forward portion of the spring. These witness markings showed the Forensic Engineer that this spring had been fractured for some time prior to this incident. See **Figure 7**.

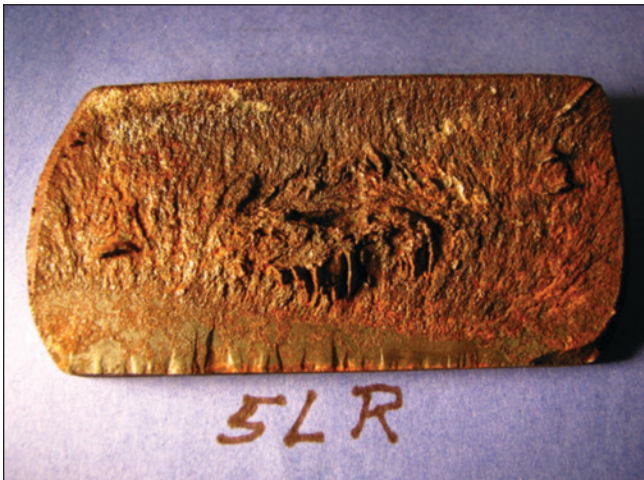
Microscopic examination of the fracture surfaces of springs #4 Right and #5 Left showed the Forensic Engineer that both fractures had occurred from the *bottom* of the spring, and had progressed to the top of the spring! Both fractures were *tearing fracture* propagating from fatigue pre-cracks at the *bottom* of the spring. The tearing fracture propagated *continuously* to the top surface of the spring - there was no area at the top surface that changed from tearing to axial tensile overload. See **Figures 8 and 9**.

**Figure 8**  
Vehicle #1 Fifth Axle Left Leaf Spring Fracture Surface.  
Fatigue fracture at the bottom progressing continuously in  
tearing fracture to the top of the spring.

stresses were on the bottom of the two springs. Fatigue fracture in metals is a cyclic *tensile* phenomenon. The fatigue at the bottom of the spring and the tearing toward the top of the spring showed that the two fractures were the result of the axles being pulled vertically *away from* the trailer bed. An example of such loading would be from the trailer bouncing off the road, over time, and lifting the wheels with it.

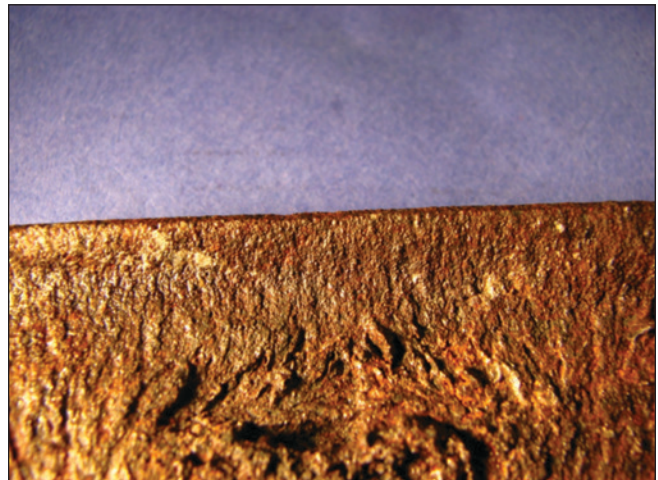
**Figure 9**  
Same as Figure 8 showing continuous tearing fracture  
texture to the top of the spring.
