Vol. XXVIII No. 2 December 2011

Forensic Engineering Determination of Who Was Driving

by Jeffrey D. Armstrong, P.E. (NAFE 644F)

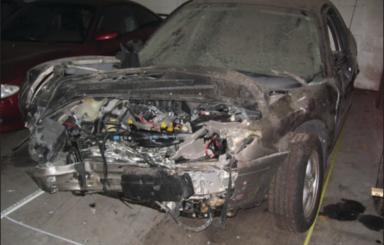
Figure 2 Front view of Ford Taurus.

The Ford Taurus had severe contact damage to the front of the vehicle as seen in Figure 2. A damage diagram for the Ford Taurus was prepared as shown in Figure 3. The average crush depth across the front of the Taurus was 12 inches. The driver and passenger airbags were deployed, and the driver's seat belt was latched with the lap belt resting on the seat and the shoulder harness was resting against the seat back. Rescue personnel indicated that they had to retrieve the young woman through the passenger's door because the driver's door would not open. During our inspection we confirmed that the driver's door would not open from the outside. However, during our interior inspection it was discovered that the door could be easily opened from the inside.

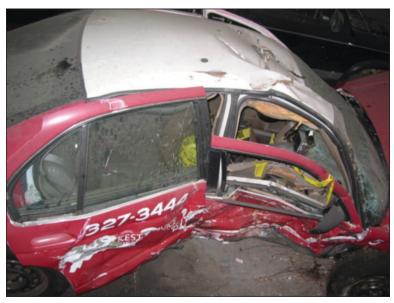
Figure 4 Passenger-side view of Chevrolet Lumina.

The Chevrolet Lumina received severe contact damage on the passengerside of the vehicle as shown in Figure 4. A damage diagram for the Chevrolet

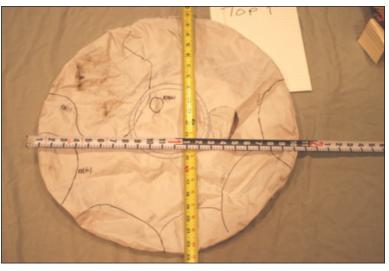
Figure 6 Driver's Airbag from the Ford Taurus.

Figure 8 is an occupant movement diagram that illustrates the direction that the driver and passenger would move during the initial stages of the crash. Figure 9 is an occupant-airbag contact diagram showing where the heads of a driver and occupant would contact the airbags. The location of the DNA sample matching the boyfriend fell within the expected contact area. The diagram clearly indicates that

the driver's face would come in contact with that area of the airbag where the boyfriend's DNA was found. The analysis also showed that during the post-collision phase of the accident as the Ford Taurus traveled from the point of separation to the point of final rest, rotational forces were insufficient to have carried a person from the passenger seat to the point where they would come in direct contact with the deflating driver's airbag.

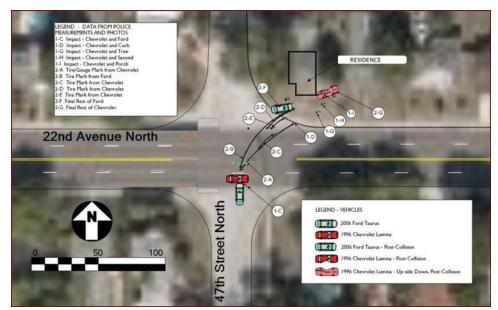
A reconstruction of the collision was performed which indicated that the Ford Taurus was traveling at a speed of 54 to 63 miles per hour (mph) at the time of impact, and the Lumina was traveling at a speed of 30 to 38 mph at impact. The speed of the Taurus indicates that it did not stop at the stop sign prior to entering the intersection. A reconstruction diagram was prepared and is shown in Figure 7.

Following the collision the Chevrolet Lumina rotated clockwise approximately 360 degrees. It continued to rotate as it traveled across the curb, sidewalk, and the front yard of the residence. The Chevrolet Lumina rolled over, coming to rest on its roof. The driver of the Lumina was partially ejected through the driver's window of his vehicle, with the vehicle coming to rest on top of the driver's upper body. The Ford Taurus rotated clockwise approximately 90 degrees (¼ turn), coming to rest at the corner of the intersection.

Figure 7 Accident Reconstruction Diagram.

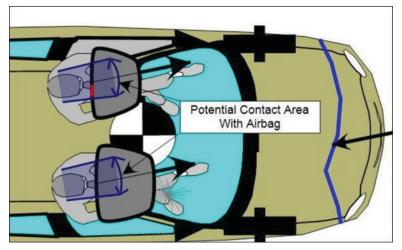
Figure 9 Passenger-Airbag contact diagram.

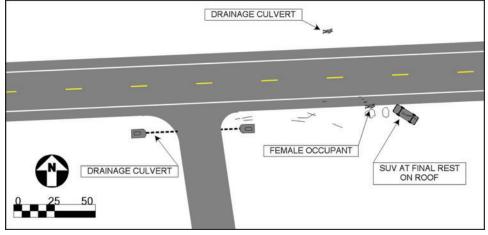
Based on the mapping of the accident location and on a careful review and analysis of the photographs taken by the investigating police officers, a scale diagram of the accident scene was prepared which showed the roadway configuration, roadway grade, cross slopes on the roadside, the location of the drainage culvert, the location of marks on the roadway that were left by the SUV as it was rolling over, the location of final rest of the SUV, and the final rest locations of the male and female occupants. The accident scene diagram is shown in Figure 14.

Figure 14 Accident Scene Diagram.

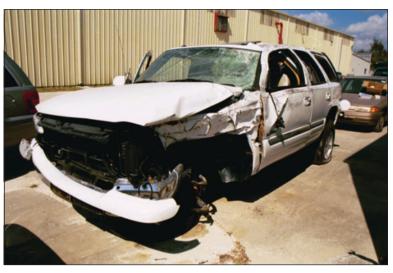
The SUV was inspected, photographed, and measured. Significant contact damage was observed in the area of the front-left (driver's) side tire, which had been separated from the vehicle during the crash as seen in Figure 15. There was severe contact damage to the left-front corner of the SUV. It was

Figure 15 Vehicle inspection photo.

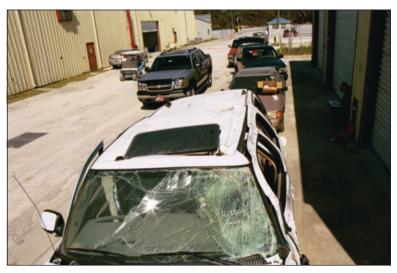
also observed that the left (driver's) side of the roof had partially collapsed during the rollover phase of the crash as seen in Figure 16. A careful inspection of the interior of the vehicle and the exit point revealed no hair or clothing fibers that might have assisted in determining who was driving. The interior of the vehicle was

Figure 16 Vehicle inspection photo.

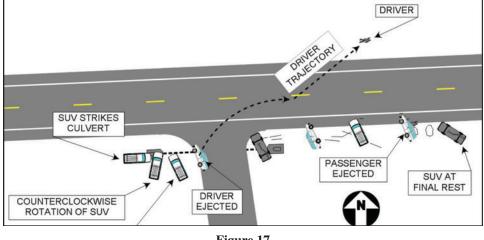
The SUV continued to roll parallel to the roadway, coming to rest on its roof. Just prior to rolling onto its roof, the right (passenger) side of the vehicle rolled over the grass, now at a much lower speed and roll rate, where the occupant of the passenger seat essentially fell out the window of the passenger's (right side) door. The body of the female occupant was found at the location where the passenger-side window would have rolled over the ground. Therefore it was determined that the female occupant had been seated in the passenger seat. The rollover sequence and the ejection events are illustrated in Figure 17.
