Journal of the  
**National**  
**Academy** OF  
**Forensic**  
**Engineers**<sup>®</sup>

# Forensic Engineering Investigation of Failure of an Oil Pipeline

by William R. Broz, P.E. (NAFE 352C)

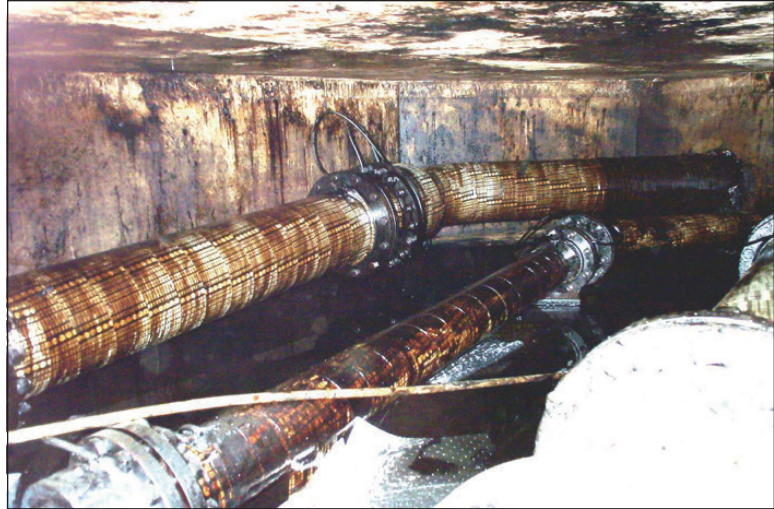
Upon arrival at the site, POS staff met with the author and provided background on the spill. The source of the leak had been identified: a flanged joint in a nominal pipe size (NPS) 12 subgrade fuel oil line, located in a concrete vault on the Pier 90 site (Fig. 1). The gasket had been recovered from the failed joint and exhibited clear evidence of flow erosion through its radius, suggesting that gasket decompression had occurred. No distress was noted in the flange faces, bolts or nuts.

**Figure 1**  
Concrete vault following incident, depicting fuel oil lines and flanged-end ball expansion joints

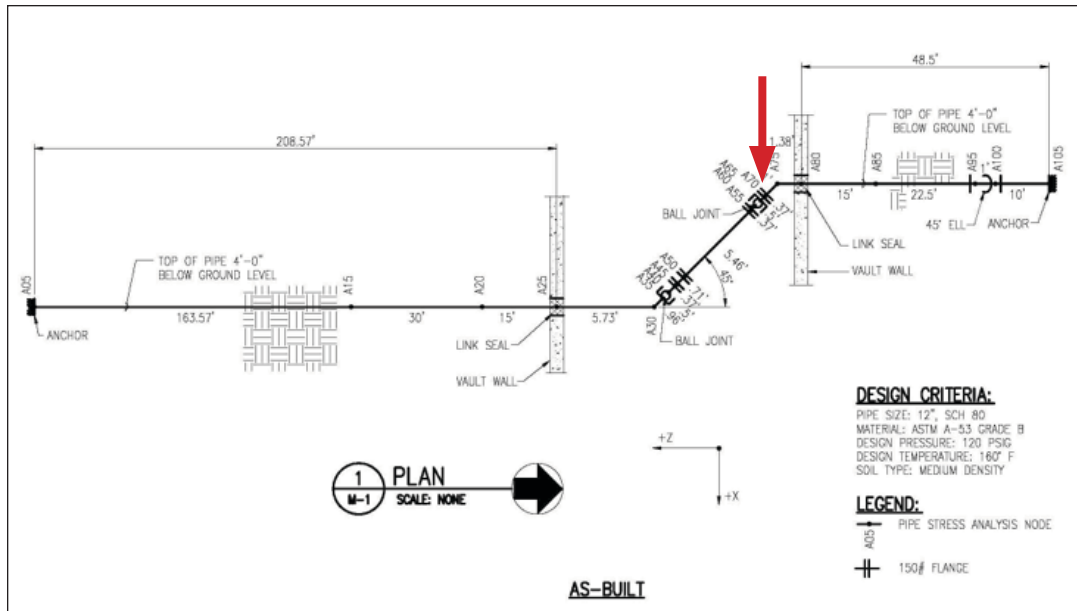
Figure 5

- Piping was ASTM A53 Grade B Schedule 80 carbon steel pipe, direct buried and protected from corrosion by a zinc-rich primer and single overlapping layer of polymer pipe tape
- All three fuel oil lines included a 30-degree offset (dogleg) on Pier 90 (Fig. 5). On the offsets, pairs of ball-type, flanged-end expansion joints absorbed thermal expansion from temperature variation in the product. The offset piping and expansion joints were located in a buried concrete vault with manhole access.
- The leak location was a flanged joint connecting an expansion joint to an adjacent segment of NPS 12 piping on the 30-degree offset.

As-built configuration of NPS 12 piping system surrounding the incident site, showing piping offset and expansion joints in the concrete vault. The arrow indicates the failure location.

Much of the original system remained in satisfactory condition and the author recommended that it remain in place. This included the concrete vault (following extensive cleanup), and much of the piping. To replace the undersized, Class 150 flanges in the system, Class 300 and 400 flanges were specified as indicated by the pipe stress analysis. New expansion joints with higher-rated flanges were also specified.

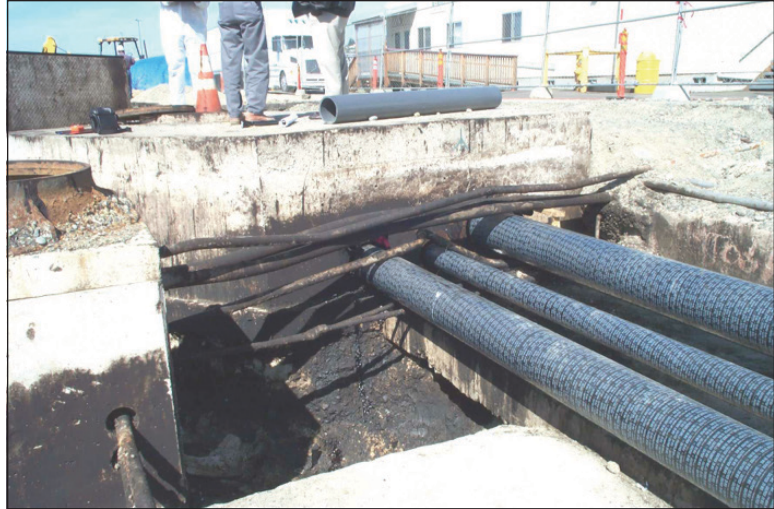
POS initiated its oil spill protocol immediately upon discovery of the leak, including isolation and depressurization of the affected and adjacent fuel lines. Standing oil was recovered from the concrete vault, and excavation then commenced to determine the extent of soil contamination. Inundated soil (Fig. 6) was excavated and hauled to an approved offsite disposal facility. In the process, approximately 260 lineal feet of each of the three subgrade lines were exposed.

Typical example of contaminated soil. The concrete vault, where the oil leak originated, is in the background.

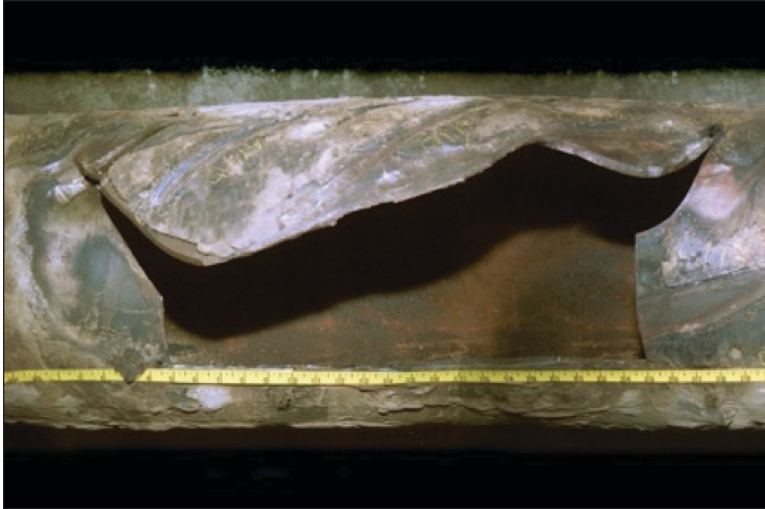
Our initial visual inspection revealed damage from excavation, but apparently no significant diminution of pipe wall thickness. Nonetheless, the observed discontinuities were a source of concern. Approximately one month prior to the incident an NPS 16, high pressure natural gas transmission pipeline near Bellingham, WA failed and exploded, resulting in three fatalities (Ref. 6). Although the investigation into that incident was just beginning, the author's discussion with officials from the Washington State Office of Pipeline Safety revealed that one failure mechanism under strong consideration related to damage to the pipeline's outer wall during a previous excavation operation. The state hypothesized that a backhoe strike had gouged the outer wall of the pipe, resulting in a discontinuity and corresponding stress intensification factor (Ref. 7). This would have been an instance of secondary stress: the pressure cycling in the line could ultimately have caused a microscopic crack at the damage site to grow and propagate through work-hardening, ultimately migrating through the pipe wall and leading to a classic "fishmouth" rupture (Fig. 7). The phenomenon of cyclical fatigue stress in pressure piping is well-known and documented in the literature (Ref. 2), and thus we felt that the mechanism described by the state was plausible. Our inspection and repair protocol was developed with this in mind.

Rupture in Olympic Pipeline Co. high-pressure natural gas transmission pipeline

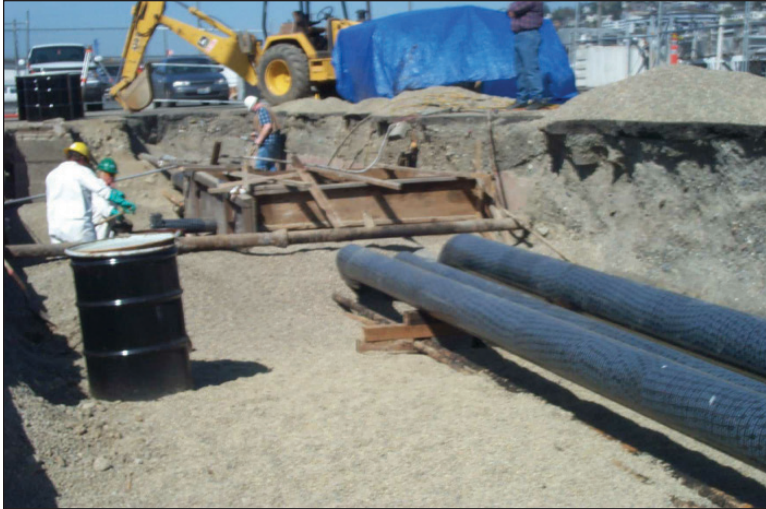
**Figure 8**  
Typical repaired and re-wrapped piping

eliminating sharp radii and transitioning smoothly into the surrounding pipe wall. Dye penetrant testing was then to be performed; indications were to be sanded out and the area retested, with the process repeated until indications were eliminated. Next, irregularities in the pipe surface greater than 1/32 inch were to be weld repaired and ground flush with the surrounding pipe surface. Post-weld inspection would be random visual in accordance with ASME B31.3.

However, the specific geometry of the discontinuities observed in the field and their potential effect on fatigue stress were not well-addressed in the literature. Time being of the essence, a conservative repair approach was adopted. ASME B31.3 provided guidance for allowable discontinuity in a pipe's outer wall due to weld undercut (1/32"; approximately 1 mm) before weld repair is required. This was the criterion we ultimately adopted for the excavated lines at Pier 90. First, all gouges regardless of depth were required to be ground smooth by hand sanding,

- Re-wrapping of all exposed pipe with 20-mil polymer pipe tape (Fig. 8). Holiday test for continuity.
- Installing contractor to submit detailed field procedures to the author for review and approval.

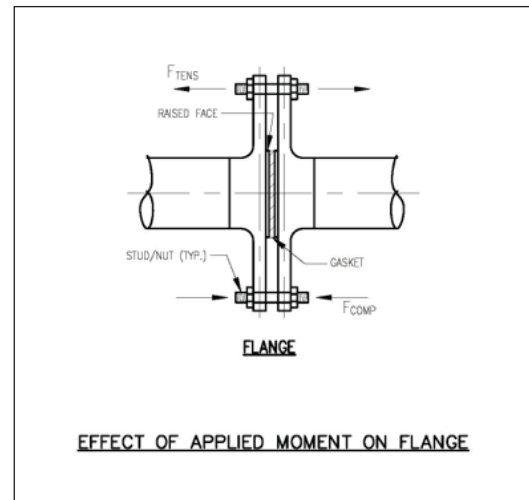
**Figure 9**  
Effect of applied moment on flange bolt elongation

- The through-erosion previously observed in the failed flange gasket was consistent with loss of compression due bolt elongation under external moment.

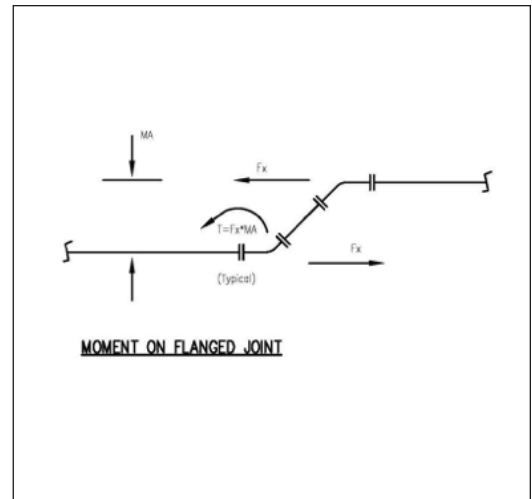
Fig. 10 illustrates the effect of bending moment on the flanged joints in the offset section of piping at Pier 90. The moment originates from thermal expansion of the pipe situated between the two anchors.

**Figure 10**  
Schematic of moment on flanged joint due to thermal expansion
