Journal of the
National
Academy OF
Forensic
Engineers[®]

Forensic Engineering Minimally Invasive Testing For Water Intrusion Using Infrared Technology

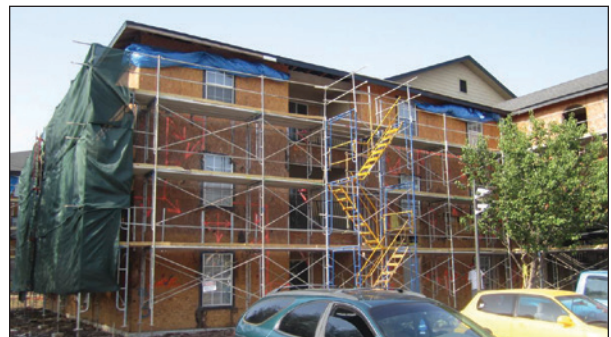
Wholesale Skinning of a Structure's Exterior

while 100% accurate in identifying all areas of damage, is prohibitively expensive and in many cases unacceptably intrusive. The second approach relies entirely on the abilities of a thermographer to correctly interpret the thermal images and identify water intrusion damage without verification or correlation that all damage has been correctly identified. Photo 1 depicts a structure in the process of having its entire exterior skin removed for the purpose of identifying and repairing underlying water intrusion damage.

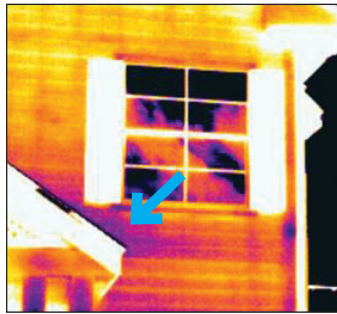
Once thermal patterns attributable to sources other than water intrusion damage are eliminated, the remaining thermal patterns are classified as thermal anomalies potentially attributable to either saturation or water intrusion damage. Photo 2 is an Infrared image demonstrating an anomalous thermal pattern at the bottom left corner of the window opening where reflection from adjacent metal roofing has affected the apparent surface temperature of the lap siding. This potential “false positive” was confirmed by the destructive testing performed at the interior face of this wall (Photo 3) where no water intrusion damage was found.

Photo 2
IR Image of Anomaly

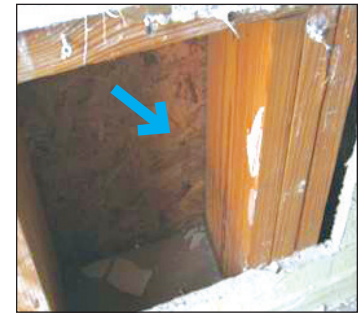
Photo 3
View From Within Wall Cavity

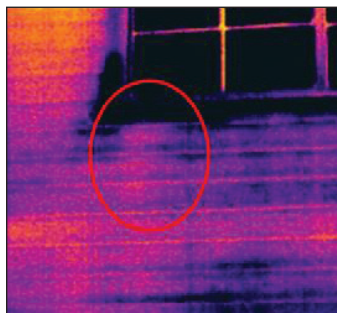
Photo 4 shows a view of the Infrared image of a thermal anomaly detected at the bottom left corner of the window opening where water intrusion damage (deteriorated sheathing) was confirmed during limited destructive testing as viewed in photo 5.

Photo 4
IR Image of Anomaly

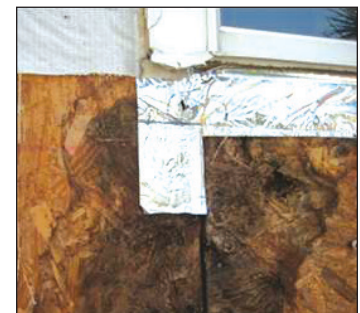
Photo 5
View of Damaged Sheathing

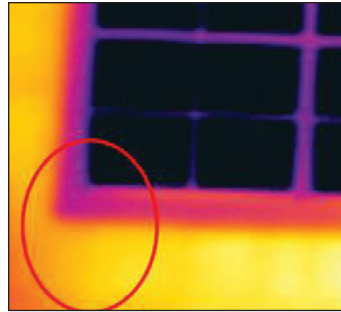
Photo 6 shows a view of an Infrared image demonstrating no significant thermal anomaly at the bottom left corner of the window opening whereas minor staining and surficial damage of the underlying wall sheathing was discovered during limited destructive testing as viewed in photo 7.

IR Image showing no Anomaly

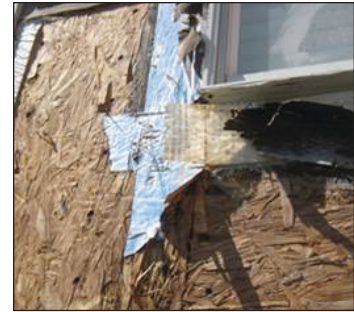
Photo 7

However, while the infrared camera is able to detect conditions consistent with elevated moisture levels within wood frame walls or deterioration of the wood members within wood frame walls, it is not able to detect staining on the wood members within the walls which no longer contain elevated moisture levels and which have not experienced significant section loss. This is not considered to be problematic as given the lack of structural damage, simple remedial measures to prevent further water intrusion are all that is warranted.

View of Sheathing

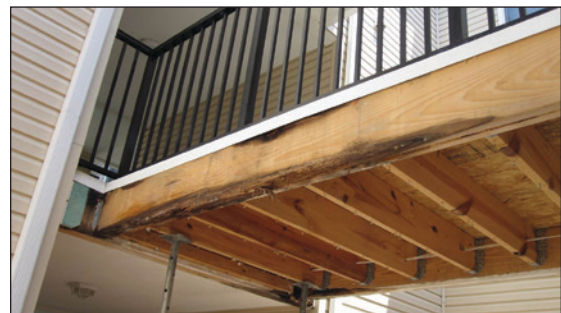
Photo 8 provides an example of water intrusion damage repair where wholesale removal of the exterior cladding was avoided by utilizing a system of Infrared imaging combined with limited destructive testing.

Selective Skinning of a Structures Exterior
