Forensic Investigation of Vehicle Fires in Structures

by Michael Leshner, P.E. (NAFE 559F)

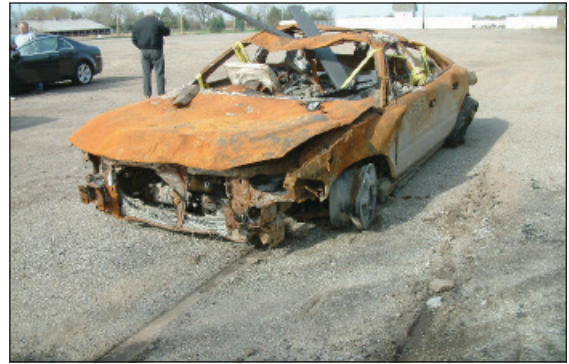
A Buick Regal with 3.8 Liter engine burned in a garage, involving another vehicle and the entire house. The owner reported seeing flames coming from the engine compartment about 10 minutes after being parked in the garage. Shortly after the fire, the owner received a recall notice on the Buick, for a problem resulting in engine fires. The Fire Origin & Cause Investigator identified the origin as the same area identified in the recall.

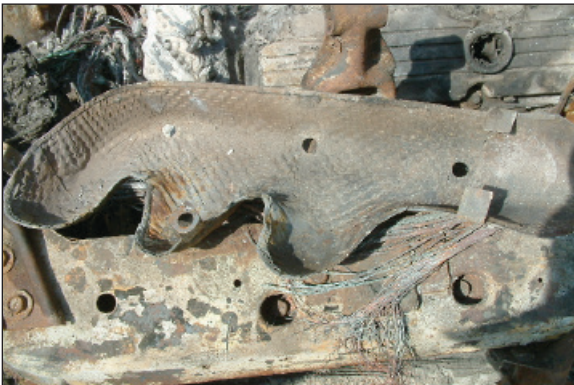
When the burned vehicle was inspected, no evidence of an oil leak or fire appeared inside the heat shield or the exhaust manifold runners beneath the heat shield. At the time of the inspection, this investigator did not recognize evidence of the cause.

Inside of heat shield

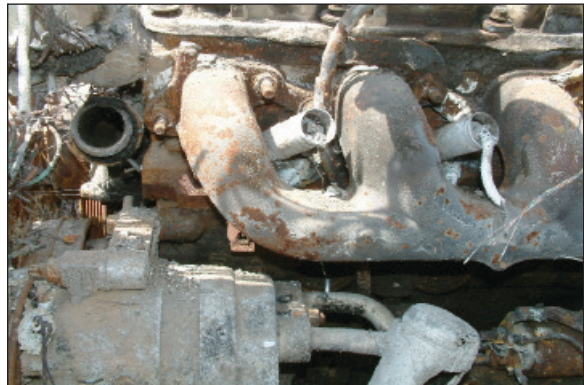
Exhaust runners

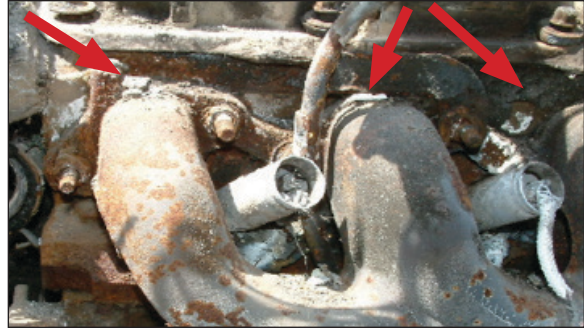
Following inspection of the vehicle, the author received the deposition transcript of a General Motors engineer. He was leader of the team that investigated reports of engine compartment fires in 3.8 Liter engines. His description of the specific evidence pointing to the recall problem included a build-up of “caramelized oil” where it leaks past the front edge of the valve cover gasket, and dark stains under the leaking gasket as evidence of the leak path. A more robust replacement gasket design was implemented in the recall. The evidence of an oil fire was not located “below the heat shield” as mis-directed by the recall language. The evidence was below and adjacent to the leaking gasket.

Going back through our photos, we found the “caramelized oil” right where the GM engineer said it would be. This evidence was strong enough to identify the cause as being the recall problem – a leaking gasket.

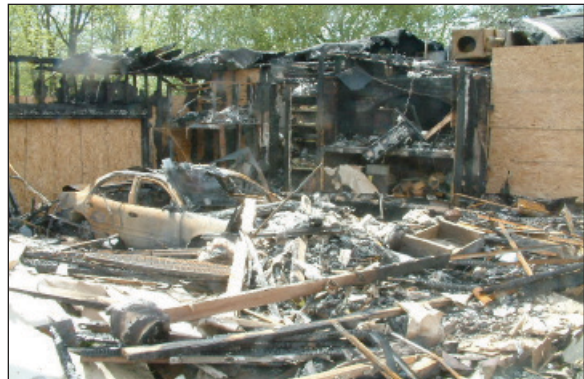
Shortly after reading the GM engineer’s deposition, the author was asked to investigate another fire in a Buick 3.8 Liter vehicle, that burned down the house. All the facts were consistent with the recall problem, but this model had not been recalled. The owner witnessed fire in the engine compartment about 15 minutes after pulling into the garage. The Fire Investigator placed the origin at the front of the engine.

Evidence of caramelized oil on the cylinder head and exhaust manifold was consistent with the specific evidence described by the GM engineer. Another bit of evidence was the dark stain on the gasket sealing surface where the leak occurred. Although this model was not part of the recall, its valve cover

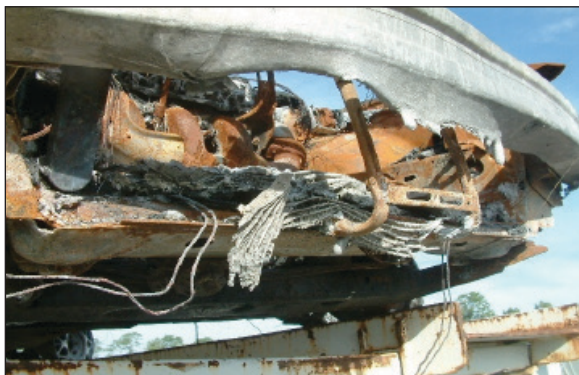
The burn pattern indicates origin at the front of the engine

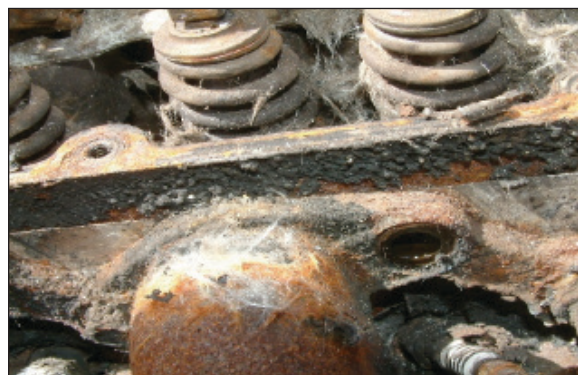
Dark deposits and stains are evidence of an oil leak

and gasket were the same parts used in the recalled models. The more robust gasket design was the replacement part for all models.
