Journal of the  
**National**

# Forensic Engineering Investigation into Decay of Cinder Aggregate Masonry Units

by John J. Hare, R.A., P.E., P.P. (NAFE 785S)

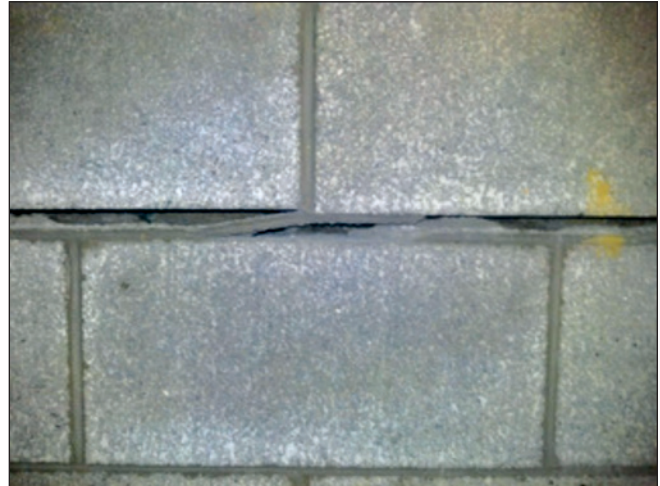
**Photograph 1**

The author has seen this in numerous cases where an inward bowing of the masonry foundation wall occurs and the mortar can be plucked out with just two fingers from between the units – no tools necessary. The mortar has completely lost all tensile bond (See Photograph 1). The mortar tensile bond to cinder aggregate masonry units is, at best, 25 p.s.i., with a maximum of approximately 16 +/- square inches of area on the interior face shell of the unit, stressed in tension for a total of 400 pounds tensile strength to resist bending. Adding a 3/8" diameter reinforcing rod whose area is equal to 0.113 square inches, of either 60 or 80 k.s.i. steel yield strength, provides an increase in the capability of the wall to resist bending well above the original designed unreinforced strength. Adding these rods increases the tensile bond resistance to 0.6 times the yield strength of the steel used, i.e. 6.6 kips for 60 k.s.i. steel per 16 inches per wall. The majority of foundation wall failures repaired are those where long horizontal cracks in the masonry joints develop, usually one, two or three units below the exterior grade. (See Photograph 2). Typically, it has been a single longitudinal crack that becomes diagonal step crack up and down as it nears intersecting or end walls, although it is not unusual to have two or even three horizontal cracks in some cases. Usually, it is possible to repair walls with this problem if the cracks are open 3/8 inch or less. It is also possible to move the wall back to vertical by excavating the exterior backfill, then pushing or jacking the wall back into position. Once this is done, installing reinforcing in the cores and grouting as described later in this paper, restores the wall to well above its original strength.

The mortar has completely lost all tensile bond strength.

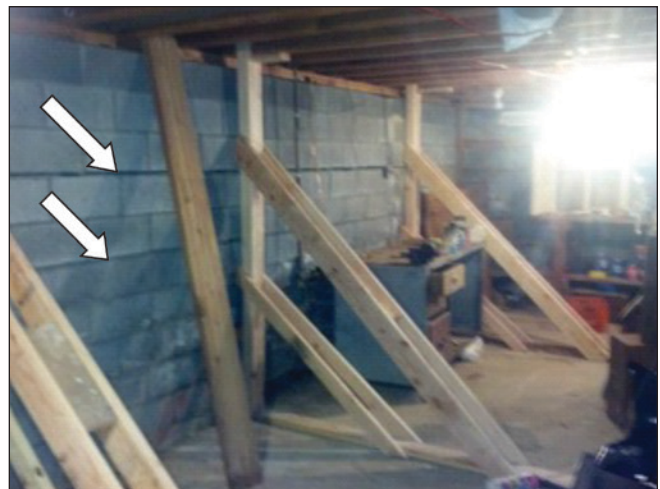
**Photograph 2**

On this wall, two horizontal cracks developed on the wall at 3 and 5 courses below the top of the wall, i.e. the approximate center of the wall height.

Installing reinforcing in the wall in this manner does not make the wall in any way qualify as a “reinforced masonry” wall as defined by the A.C.I. or N.C.M.A. since no horizontal reinforcing is provided. Essentially, it could be considered a series of spaced concrete studs with infill panels to hold back the earth. The pea gravel grout bonds with the existing cinder aggregate concrete of the masonry units helping to re-solidify the fractured units.

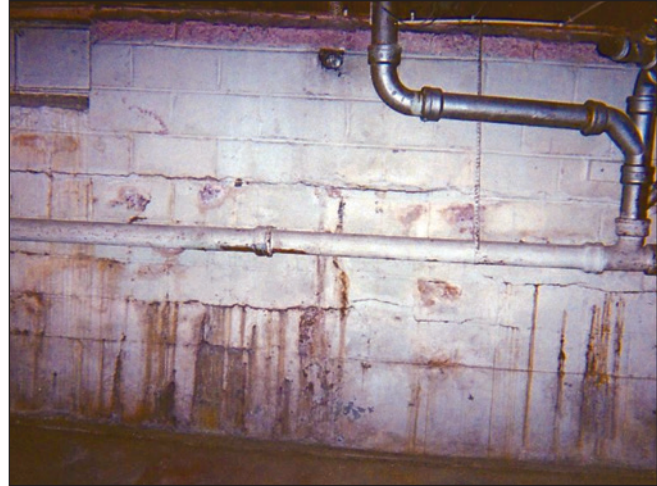
**Photograph 3**

As to the procedures for determining the conditions of cinder aggregate masonry walls, the first is visual inspection of the masonry units, looking for pop-outs and rust stains on the surface, an indication of iron inclusions under the surface (See Photograph 3). Looking closely at the surface, it is also possible to detect hairline cracks on the interior face shell of the cinder aggregate masonry wall indicating the possibility of internal fracturing of the webs and exterior face shells. Sounding, by lightly tapping on the face shell with a hammer, also provides an indication of internal fracturing. Typically, if the unit is not severely fractured internally, the sound produced will be a ping or ringing sound. If the sound is more like a dull thud, it is a sure indication of internal fracturing and deterioration. The amount of wall area that is determined to be damaged by sounding is an indication of the extent of the problem. Deciding whether to either repair or replace the wall is a matter of engineering judgment based on knowledge and experience.

Pop-outs and rust stains on the surface of a masonry wall are indications of iron inclusions under the surface.
