Vol. XXX No. 2 December 2013

Forensic Engineering Investigation of a Police Shooting

by John C. Laughlin, P.E. (NAFE 760S)

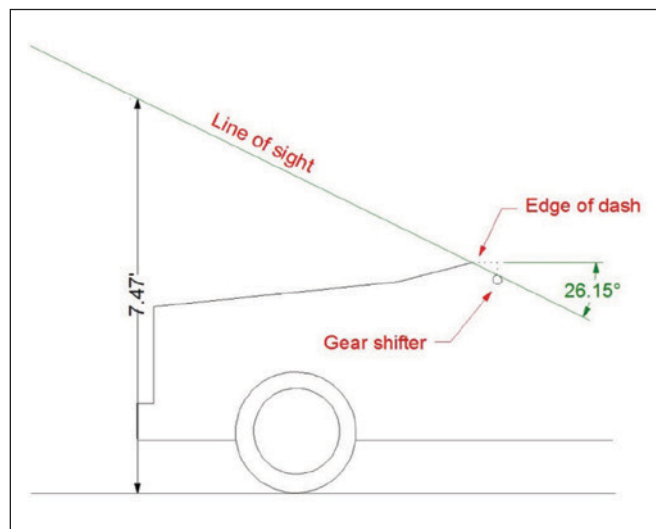
The gear shifter’s highest position was park, followed in descending order with reverse, neutral and drive. Since the SUV had just completed a maneuver in reverse gear, the height of that gear shift position was the most conservative and realistic and was used for analysis. Considering all of the measurements taken, the most conservative measurement revealed that a person standing at the front bumper of the SUV must have an eye height of 7.5 feet in order for that person to see a one inch diameter finger wrapped around the gearshift handle (figure 4). This does not preclude someone

Figure 4
Results of the line of sight analysis.

From the line of sight analysis, it was apparent that the gear shifter could not be seen by a person of normal height from in front of the SUV. This, however, would not preclude someone outside the vehicle from seeing the driver's shoulder moving while shifting gears.

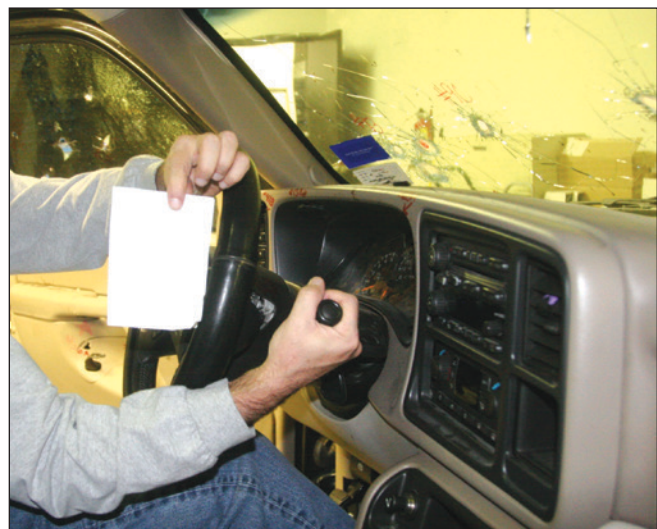
Photograph 1
The gear shifter in “Reverse” position.

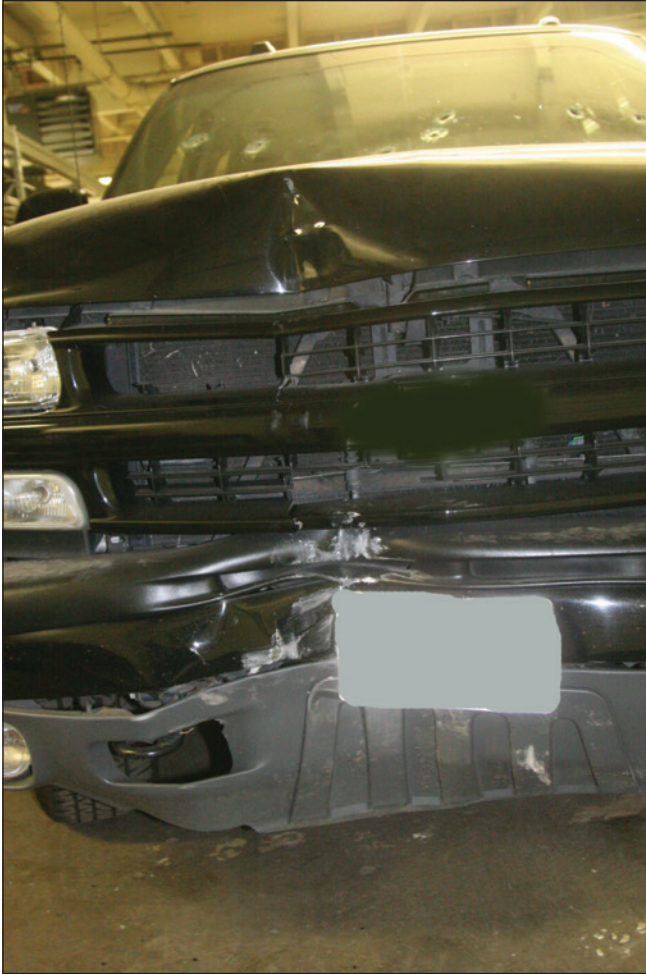
It is logical to question why a speed change of -4.65 mph is recorded as the crash pulse, yet at 1 second prior to AE, the vehicle is recorded as moving 11 mph. This is because the speed change which occurred over the prior (maximum) 0.85 seconds was due to crushing of soft components. It was not until the rigid structures became engaged that the negative acceleration was significant enough to cause AE. The portion of the building which the front end of the SUV struck was a square column, which it struck on a corner. This corner impact occurred between the front bumper mounts and so the softer

Damage to the front end of the SUV. Notice the damage profile is vertical and slender, consistent with an impact with a corner.

structures did not cause as rapid of a negative acceleration as when the bumper and frame became engaged. Photograph 2 shows the front end of the SUV. Notice that the impact is basically vertical and slender, consistent with a corner impact.
