FE Analysis of Modular Woodburning Fireplace Fire with Gas Log Lighter in Determining Fire's Cause

By Jerry R. Tindal, PE (NAFE 642S)

Abstract

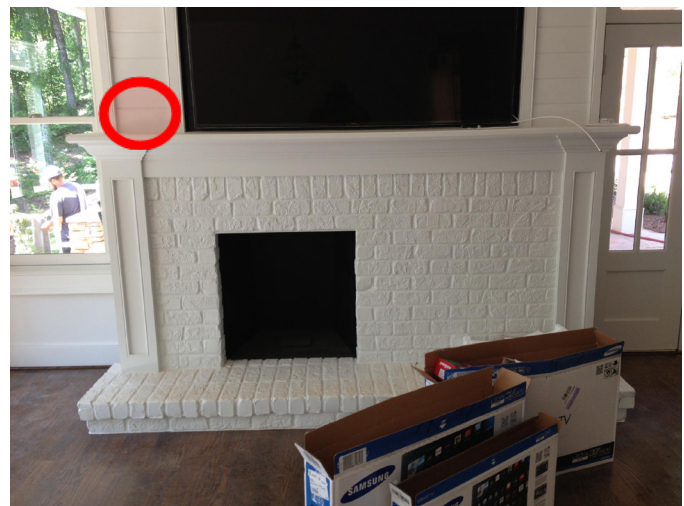
Figure 7

Pre-fire photograph of incident fireplace unit. The circle indicates the area where the witness first observed fire burning through the wall.

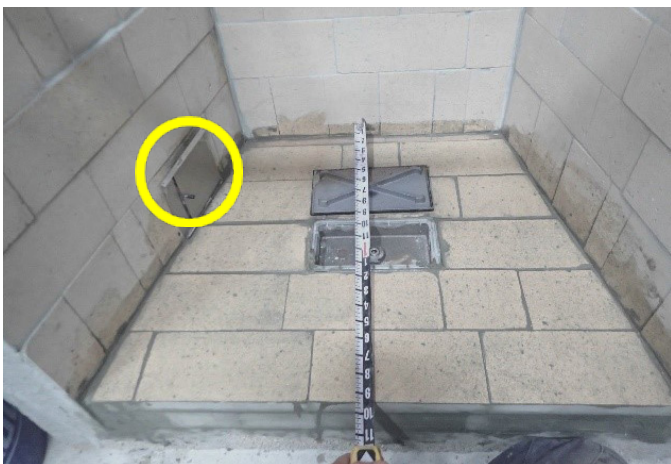
Figure 8f
Constructed to match incident installation.
Combustion air kit discharge register door (circled)
near rear of the firebox and flush with the hearth.

log lighter are flush with the hearth and approximately 8 inches apart (see **Figure 8(f)** again); therefore, the potential for propane gas migration into the discharge register is substantial. While the position of the register door at the time of the incident is not clear, the loose-fitting door is not hermetically sealed, and gas will migrate through the door into the ducting (as verified by laboratory testing) when it is either fully closed or fully open or at any position between. Obviously, the more open the door is, the higher the propensity for gas or flames to enter.

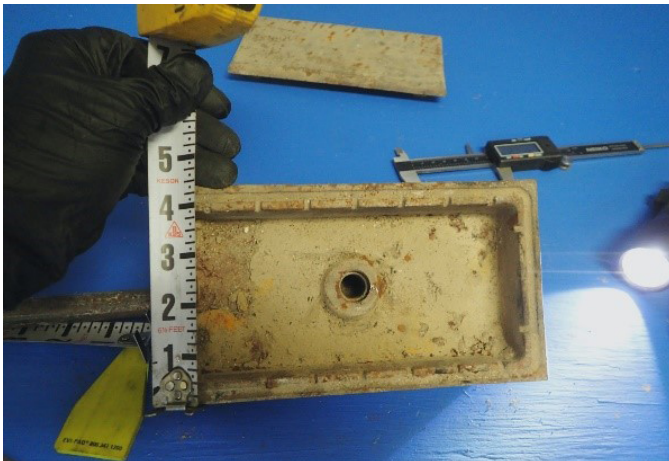
Figure 11a

The plug orifice had been removed from the incident log lighter, likely for leak testing the gas system piping during original construction. The plug orifice, however, was not reinstalled in the incident log lighter (leaving a

0.6670-inch diameter opening). As such, there was no gas flow limiting orifice in the log lighter, creating conditions favorable for large amounts of gas to be released in a short period of time (dependent upon the exact position of the log lighter key valve). See **Figures 11(a)** and **11(b)**, which depict the incident log lighter and the orifice installed in an exemplar log lighter.

Incident log lighter with no orifice (0.6670-inch opening).

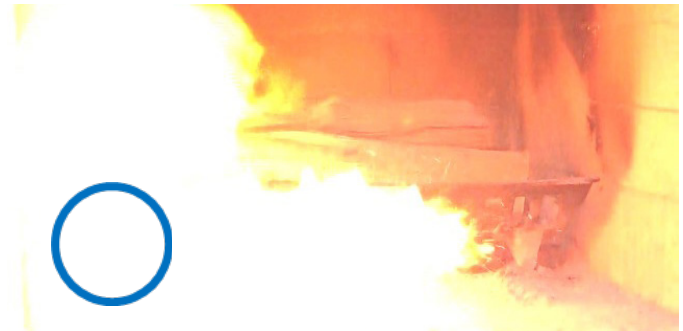
Figure 12f

Flash fire impingement on the left-hand side of the firebox and door when accumulated gas is ignited.

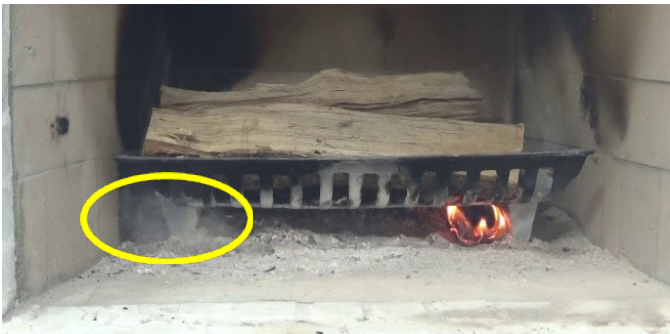
Figure 12c

Ash cloud forms on the left-hand side when the gas valve is opened. Note proximity to the register door.

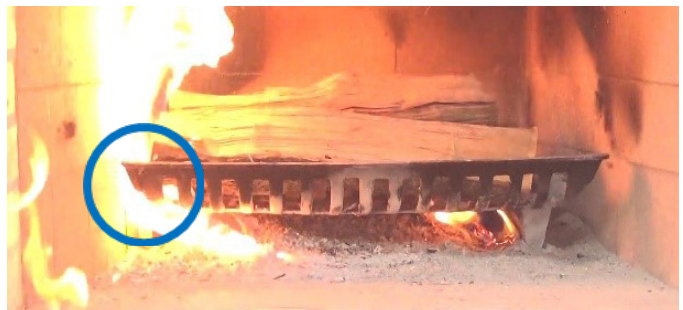
Figure 12h

Asymmetric flames from the log lighter and horizontal deflection to the left side of the firebox and onto the register door. Near flash fire end.

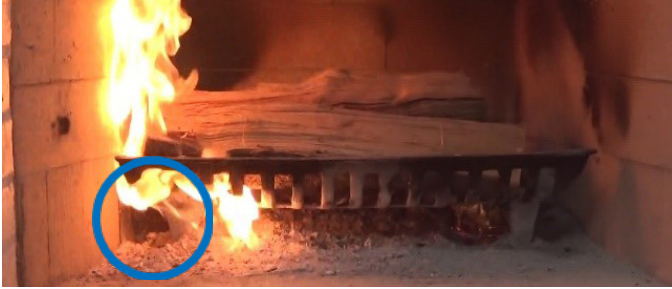
Figure 12i

After the flash fire, flames from the discharging gas impinge on the logs above and toward the left-hand side of the firebox and onto/into the combustion air discharge register door and doorway.

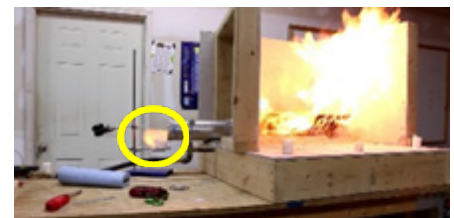
Figure 14i
Flash fire propagation through and out rigid duct work.

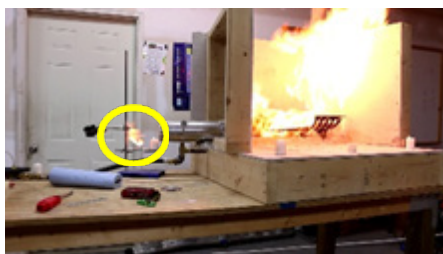
Figure 14j

Flash fire continuing out rigid duct work where flexible ducting would be connected.

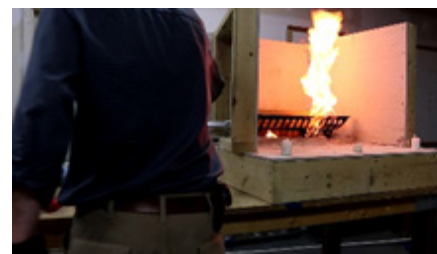
Figure 14l

Asymmetric burning on the right-hand side continues due to blocked log lighter ports.

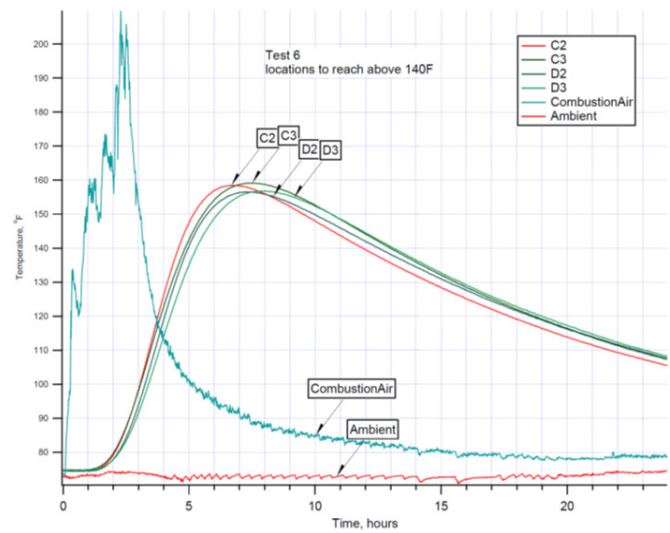
Figure 19

Time-temperature curves for test 6, baseline test most approximating use conditions of the fireplace. The combustion air duct door was partially open during testing. Maximum temperatures of the firebox wall remained below 160°F.

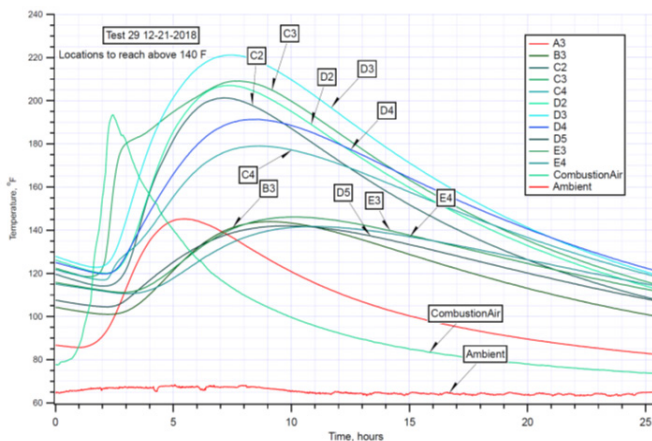
Figure 20

Results of back-to-back testing over three consecutive days. Note that the incident fireplace was only used once or twice each week (the home had five other fireplaces).
