Vol. 39 No. 2 December 2022

Forensic Investigations of Propane-Related Food Truck Incidents

By John L. Schumacher, PE (NAFE 1052S), Charles R. Brown III, Zachary J. Jason, PE (NAFE 1053S), and Dennis E. Shelp, PE (NAFE 1058S)

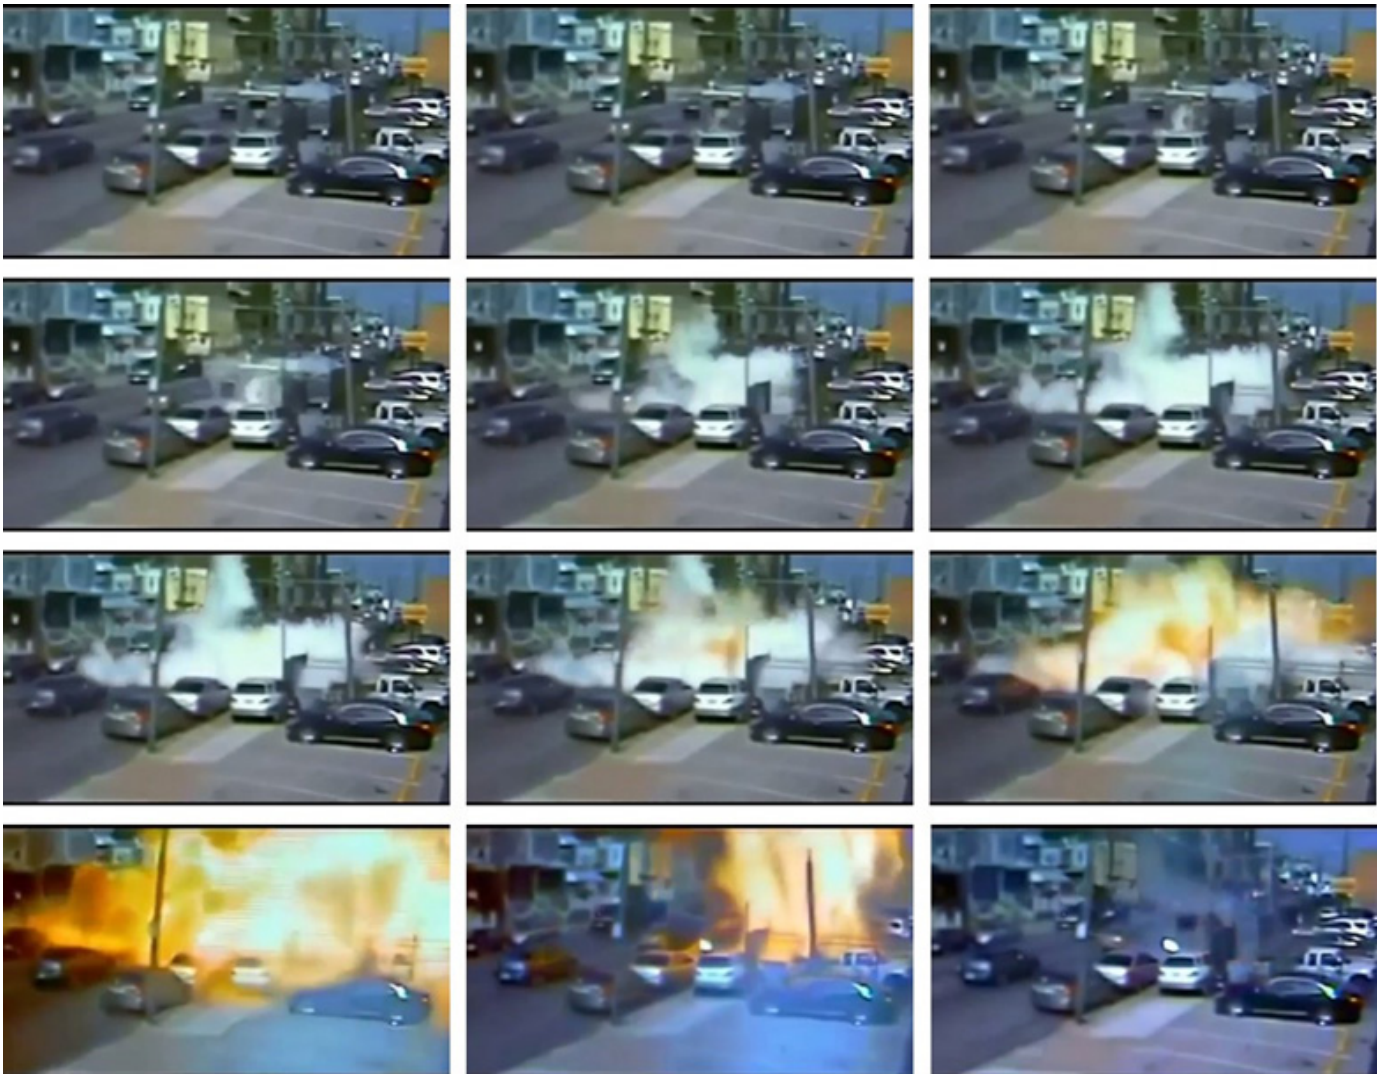
Figure 9

Images of the explosion taken from the video captured by a nearby security camera.

images taken from the video (approximately 25 frames per second) at different times. The first sign of the white cloud associated with propane is visible in Frame 1. The white cloud increases in size in Frames 2 through 7. Ignition is first observed in Frame 8, and the fireball expands in Frames 9 through 11. Smoke without fire is seen in Frame 12.

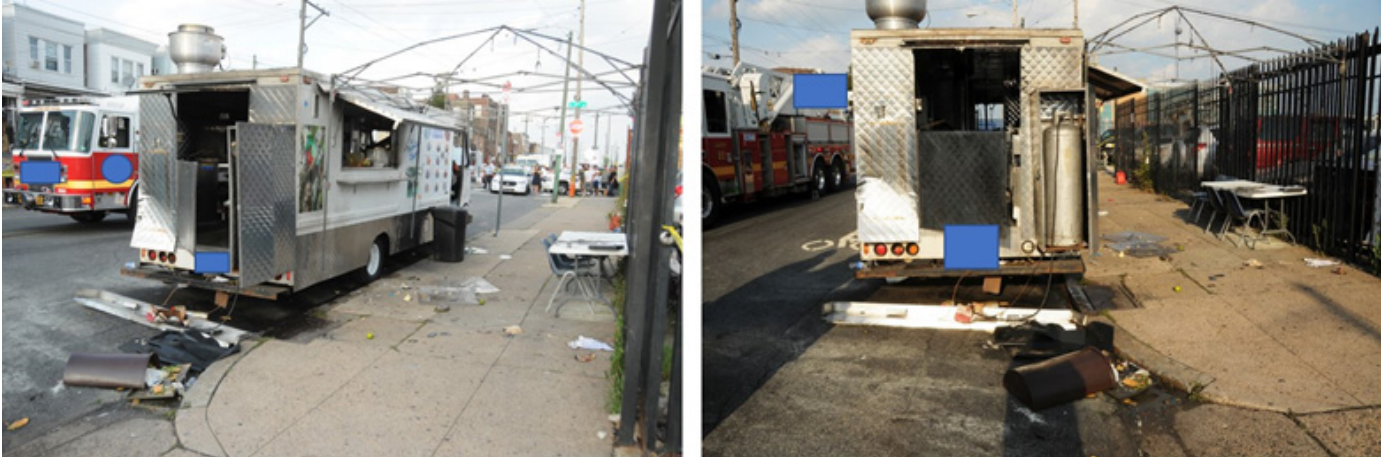
Images of the rear of the food truck post-incident. The left cabinet and cylinder were missing.

Figure 10 shows the back of the food truck post-incident; the left cabinet and cylinder were both missing, but the right cylinder was still intact (and in place) inside the right cabinet. The right cylinder valve was closed after the incident by the fire department. As a comparison, pre-incident images of the food truck are illustrated in **Figure 11**.

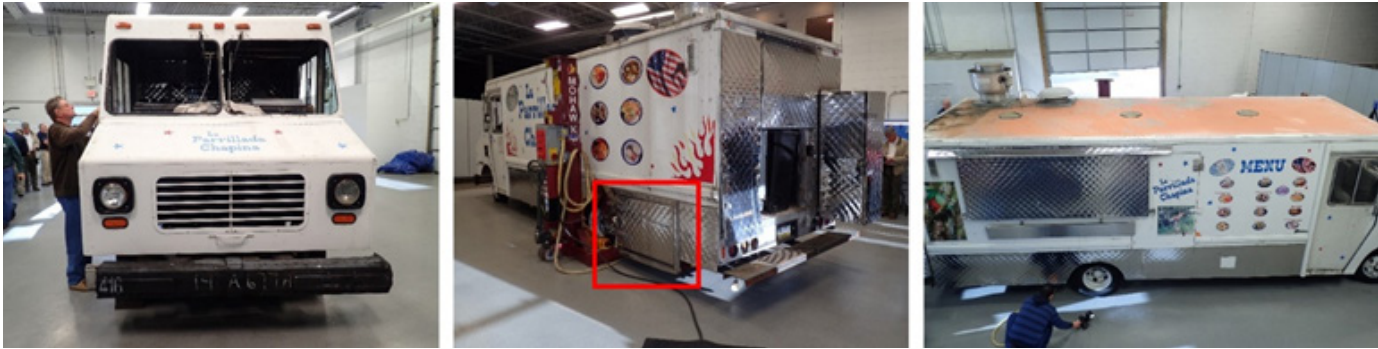
Figure 13

The front (left), driver (middle), and passenger (right) sides of the food truck.

The post-incident appearance of the food truck is illustrated in **Figure 13**. The windshield was missing from its frame. The truck was equipped with a generator located inside a cabinet near the back on the driver's side. Metal on the front and rear sides of the generator cabinet were pushed to the front. The exterior diamond plate on the rear of the truck, which formed the back wall of the left cabinet, had a dent or impact mark about 2 feet 10 inches above the bumper. Reconstruction of the left cabinet, which was framed using square metal tubing covered with diamond plate, is shown in **Figure 14**. The exterior diamond plate on the rear wall of the truck enclosed the back of the cylinder cabinet. The cabinet exhibited signs of forces from the inside acting in an outward direction.

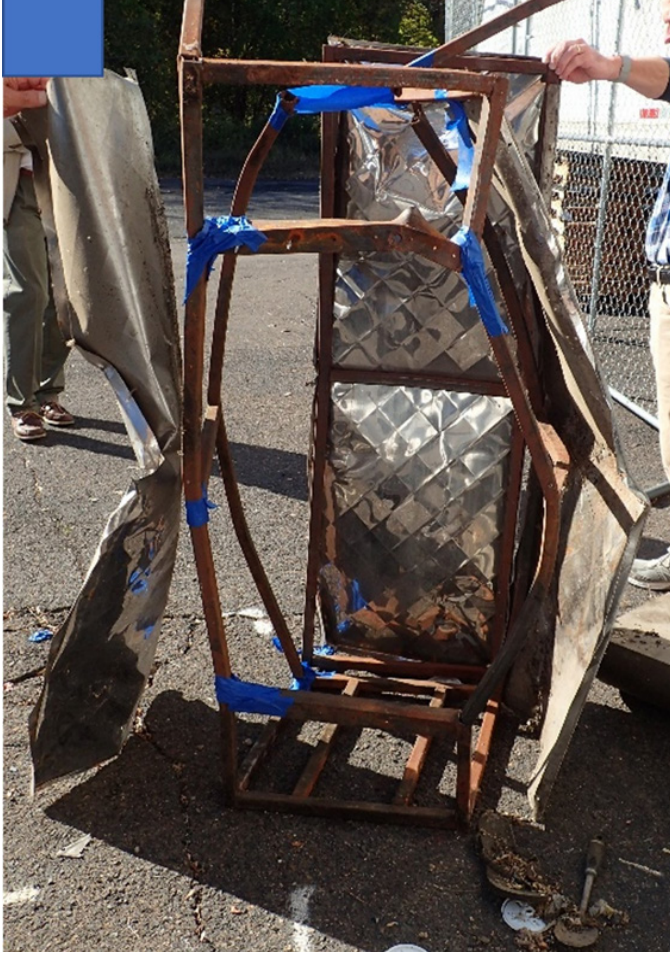
Figure 14
Reconstruction of the left cabinet.

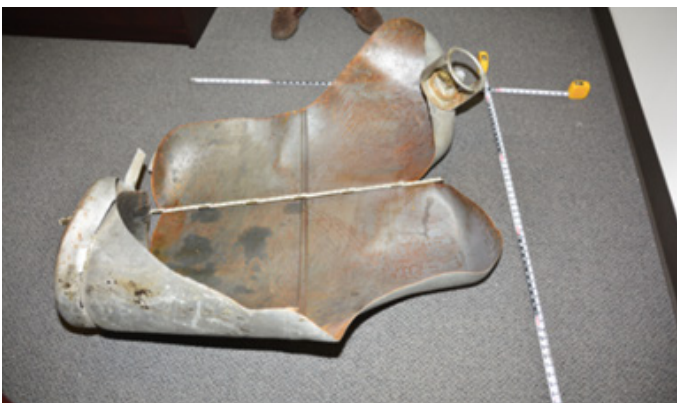
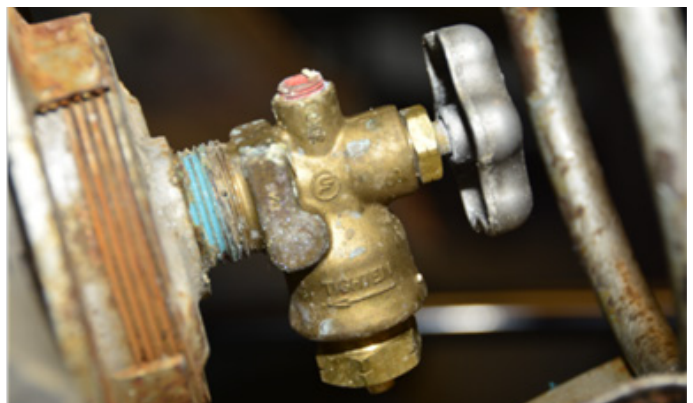
Figure 15
Left cylinder. The cylinder was ruptured, and the cylinder valve had no relief valve or fixed maximum liquid level gauge.

Ultimately, the incident was caused by rupturing of the left cylinder. The cylinder ruptured because the internal pressure exceeded the strength of the cylindrical vessel. The cause of the excessive internal pressure merits further discussion.

The left cylinder had a water capacity (W.C.) equal to 239 pounds, which means it had a total volume of 28.7 gallons and could be correctly filled with 100 pounds or 22.9 gallons (80% of 28.7 gallons) of propane at 60°F. The left cylinder did not have a fixed maximum liquid level gauge as part of its cylinder valve, nor was one provided separately as an add-on appurtenance. Under this condition, it would be difficult to properly fill it to only 80% without weighing the cylinder to determine the amount of propane to add — that is to say, determining the amount of propane to put in the left cylinder without weighing it would amount to guessing.

The left cylinder had a service pressure of 240 PSIG, as indicated by the “240” in ICC-4BA240-717 stamping. The cylinder was likely manufactured with a safety factor of about four, which means it would not fail until about 960 PSIG or significantly above the expected vapor pressure inside the cylinder. On the other hand, as previously discussed, the pressures that can be generated by an incompressible fluid like propane in a liquid-full condition are significant¹⁸.

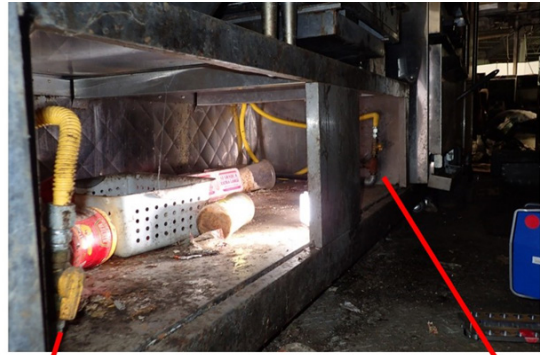
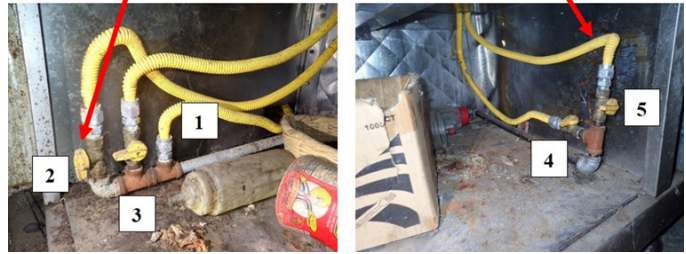
Figure 18

The images show the as-found positions of the manifold valves after the incident.

The four manifold valves supplying gas to the appliances on the left side were found in the following positions (see **Figure 18**): flat top griddle (2) open, charbroiler (3) closed, vertical broiler (4) closed, and range (5) closed.

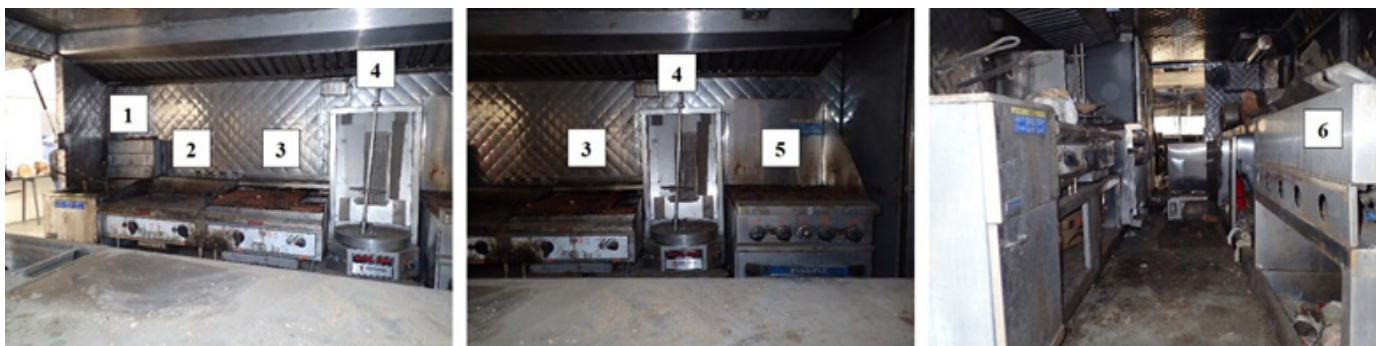
Figure 19

The five appliances on the left side and the one appliance on the right side of the food truck after the explosion are shown in **Figure 19**. The appliance information and as-found valve positions for each appliance are detailed in **Figure 20** (the valves for each appliance were assigned a number). For example, the left valve on the griddle was labeled as “2L,” the left rear valve on the cooktop of the range was labeled “5LR,” and the oven control was labeled “5O.”

Post-explosion images of the six gas appliances inside the food truck, which included a deep fat fryer (1), griddle (2), charbroiler, (3), vertical broiler (4), range (5), and steam table (6).
