Vol. 39 No. 2 December 2022

Meteorology and Physics Analysis of Rail Car Fatality

By Drew Peake, PE, DFE (NAFE 460F) and Muhammad Salman, PhD

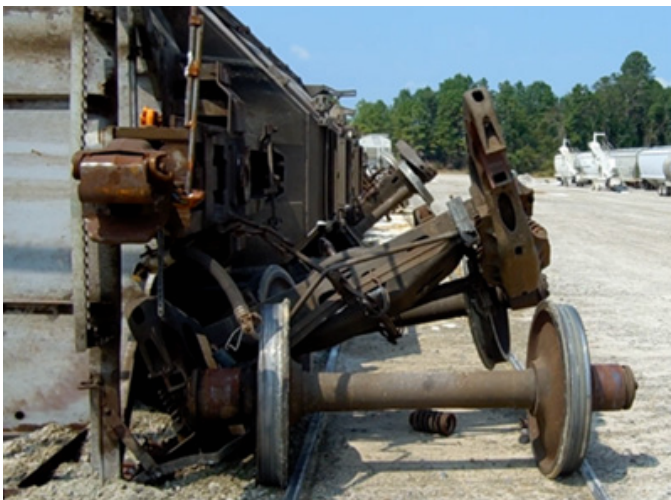
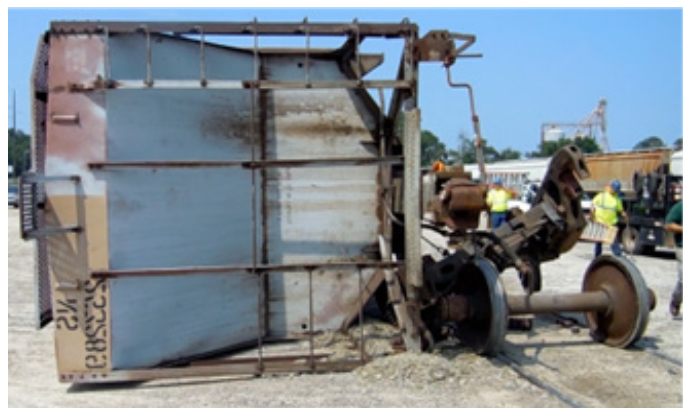
There were two main factors that caused the derailing accident. The main factor of rail car derailment was the shifting of the mass center due to the unbalanced weight of borax (caked on one side); the other one was friction. Static friction held the car upright until the locomotive moved forward slowly at a speed of 4 to 5 miles/hr (kinetic friction). The wheels on the light side rode up on the rail, and the car derailed when the wheel lip left the rail (as shown in **Figure 1**).

Figure 1
Rail car derailed from the tangent track (left);
another view of the derailed rail car (right).

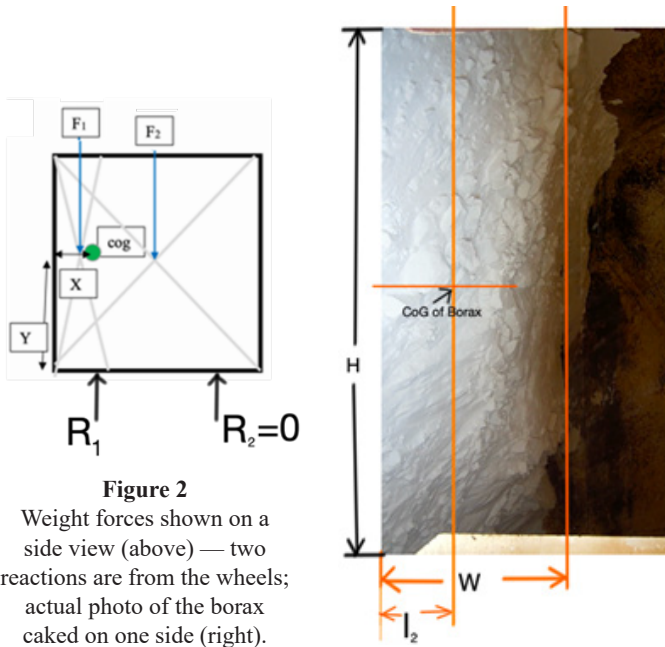
Figure 2

borax remained in one rail car (clumped on one side). The weight of borax remaining in the rail car was determined by weigh scale measurements before and after unloading. There were three cars coupled together. When stationary, static friction held the wheels on the rails. Once the locomotive moved the cars, the drop in friction from static levels to dynamic levels facilitated wheel climb, releasing the wheels. The last rail car (NS 253219) immediately fell, pulling the other two cars with it. Witnesses observed borax clinging to the side of the rail car.

$W = 0.2168 \text{ m}$, CoG of borax from the left edge of the car is located at $l_2 = W/2 = 0.1084 \text{ m}$ and $Y = H/2 = 2.3628 \text{ m}$ (as shown in **Figure 2**).

Weight forces shown on a side view (above) — two reactions are from the wheels; actual photo of the borax caked on one side (right).

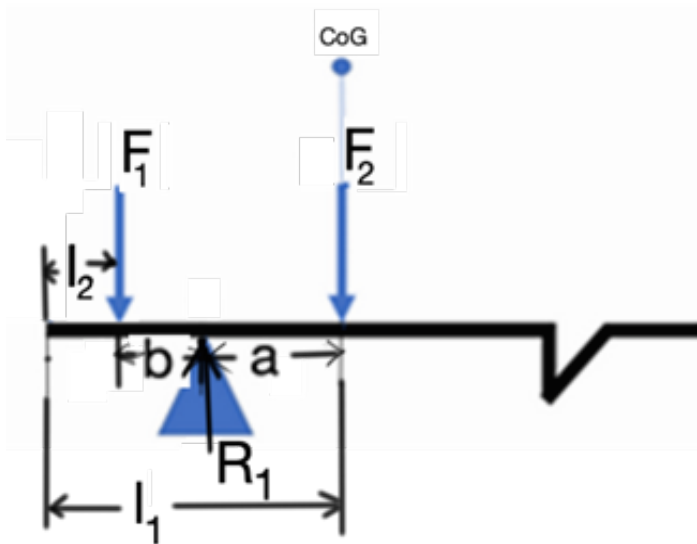
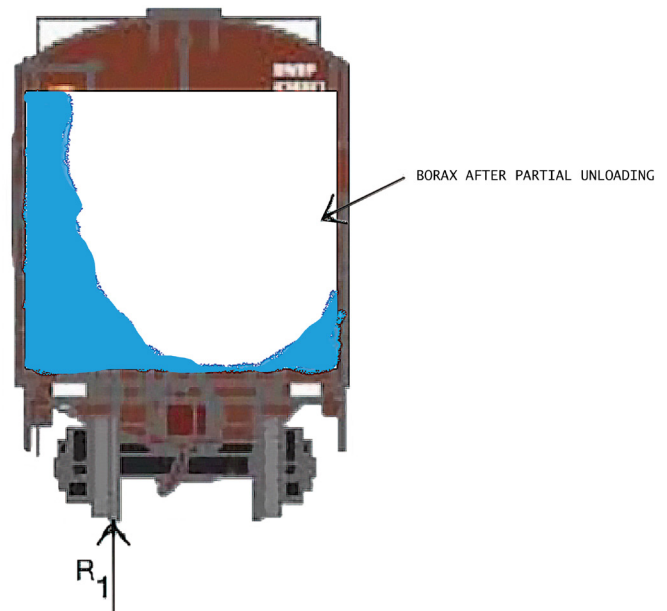
Figure 3

$$M_{R_1} = F_1 (b) - F_2 (a) = 339414 * 0.79 - 278396 * 0.7175 = 68088 \text{ N-m}$$

$$\text{Extra load that caused the tip over} = 339414 - 253130 = 86284 \text{ N} = 19047 \text{ lb}$$

Moments calculations with moment arms.

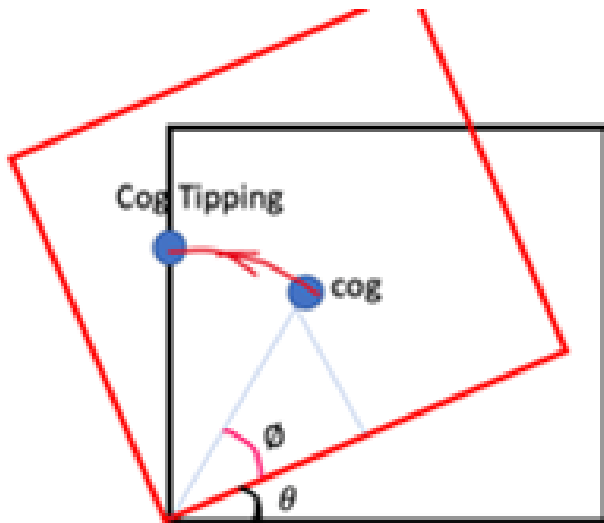
Figure 4
Lean angle calculations.

The lean angle is the threshold angle beyond which it will tip over (as shown in **Figure 4**). It is calculated from the left side of the rail car, which is 26.3° .

$$\text{Lean angle, } \theta = 90 - \Phi = 26.3^\circ$$
