Forensic Analysis of a CNC Lathe Window Guard Failure

By Stephen A. Batzer, PhD, PE, DFE (NAFE 677F)

Abstract

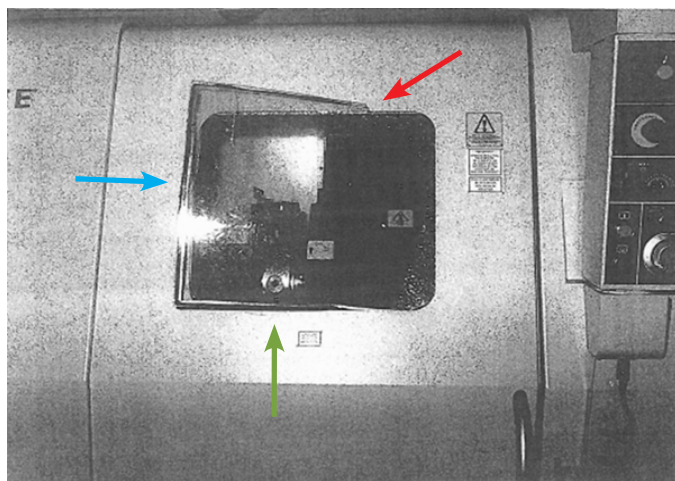
Figure 1

The only surviving exterior photograph of the door and window immediately post-accident is a low-resolution black and white scan (**Figure 1**). The construction of the window was a composite using two different materials. The inner pane nearest the workpiece was made of tempered common window glass (silica-soda-lime), which provided scratch resistance to the metal chips and was inert to the cutting fluid. This inner pane was separated from the outer pane by a modest air gap. The outer pane on the machinist side was made of a kinetic energy absorbing polymer; this outer pane provided the substantive impact protection. **Figure 1** shows the polymer exterior window panel

bowed outward with a hinge-like crease in the center, and the workpiece chuck is visible at the lower center of the window. The angled red arrow in **Figure 1** is included to show that the surviving polymer window pane is slightly bigger in width and height as compared to the overlapping viewing aperture. The vertical green arrow of **Figure 1** shows the position of the workpiece chuck. The horizontal blue arrow of **Figure 1** indicates where the workpiece grazed the inner steel door window frame and dented the sheet metal. A higher quality color image of the damaged door and window assembly is shown in **Figure 2** with the door detached from the lathe enclosure. This photograph shows the door's interior side. The horizontal blue arrow shows the witness mark of the workpiece against the now-bent inner window frame, which corresponds to the arrow shown in **Figure 1**. The cylindrical workpiece grazed and damaged the steel window periphery as it struck the window substantially off window center.

Exterior photograph of the mounted lathe door with the outward-side polymer window pane bent and folded outward.

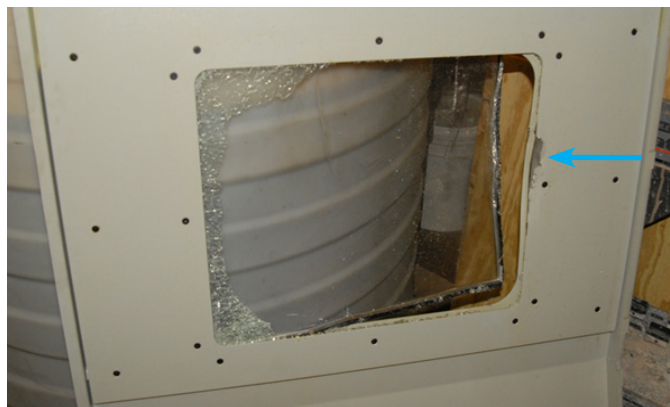
Figure 2

Interior side photograph of the detached door guard showing the interior-side tempered glass fragments of the shattered inner window pane and the witness mark damage against the steel frame.

The relevant portion of the door guard consisted of two offset steel panels that framed the observation window — each sheet being 2.3 mm (0.090 in.) thick. The layered window assembly consisted of a 5.0-mm tempered glass inboard surface for abrasion and chemical resistance, then a 5.5-mm air gap, and finally a 4.5-mm polycarbonate outboard panel used for impact energy absorption. The total window thickness was 15 mm (0.59 in.). The unmounted pane measured 532 mm x 452 mm (20.9 in. x 17.8 in.). The daylight opening was reduced by 15 mm per edge through frame overlap (equal to the composite thickness). The opening also featured modestly radiused corners (see **Figures 2** and **3**). The modest edge overlap of the steel frame to the composite window suggests why the polycarbonate pane was pulled out of its frame and plastically deformed rather than being fractured and directly penetrated.

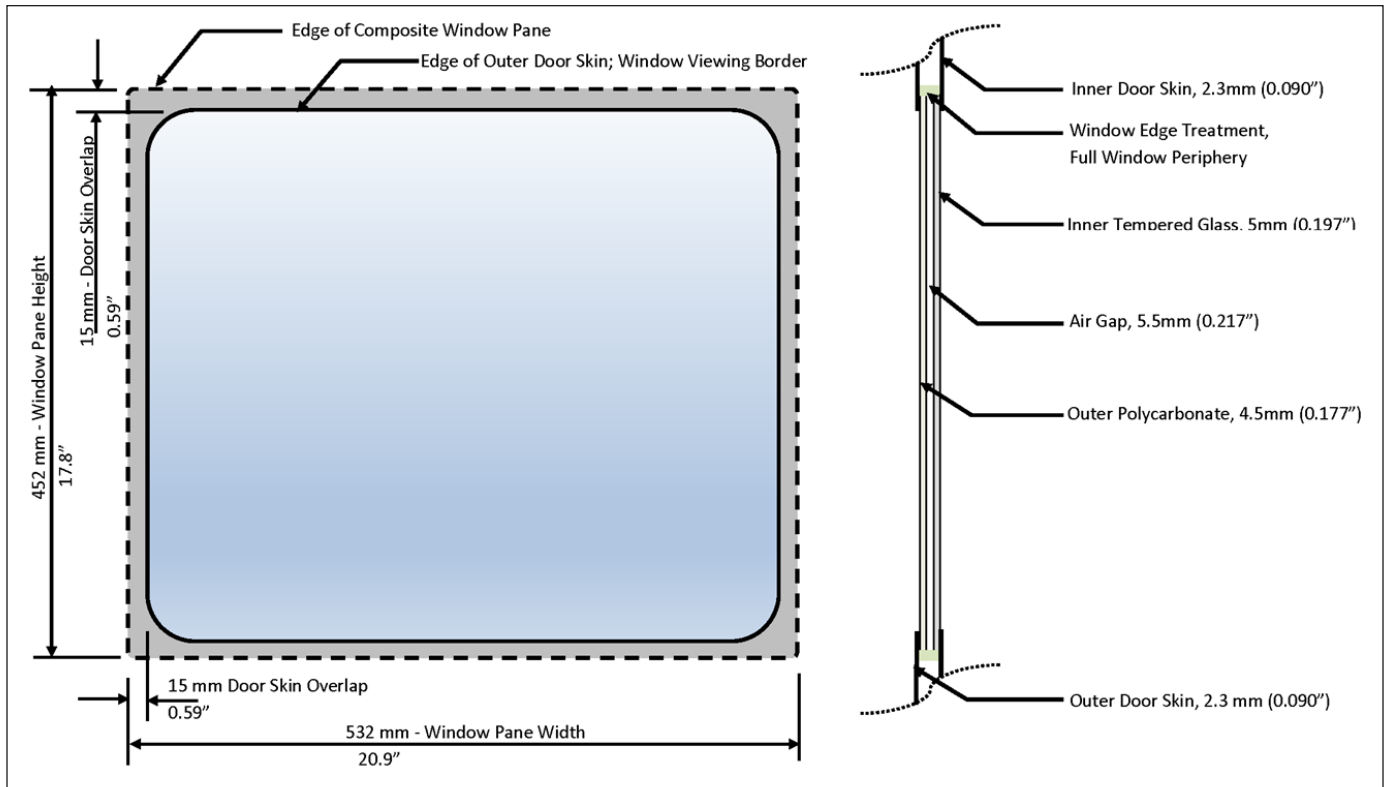
Figure 3

Diagram of the subject composite guard window.

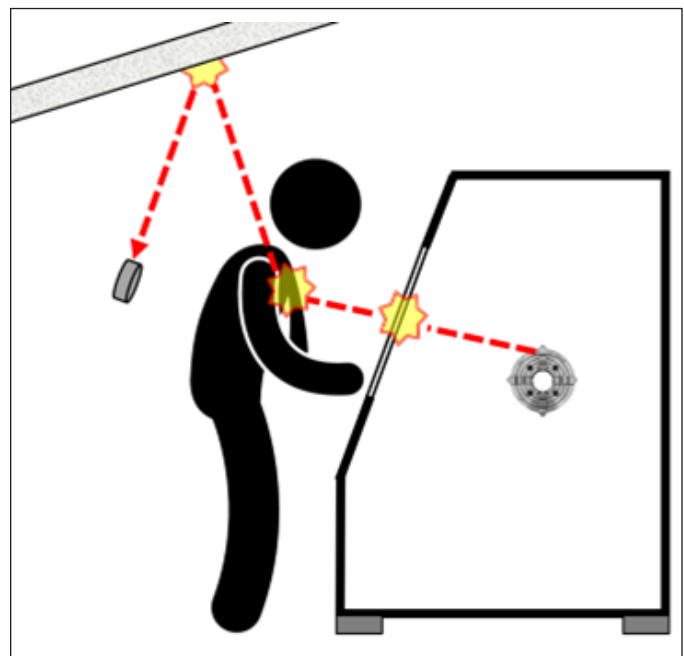
Figure 4

After fracture of the tempered glass inner pane and displacement of the outer polycarbonate pane, the energetic workpiece struck the operator in the chest and was redirected to the ceiling some 3.5 meters (m) — ~ 10 ft — above the point of the operator’s chest. The workpiece superficially damaged a perforated metal ceiling panel and then fell back to the concrete floor. The operator fell and struck the back of his head against this same concrete floor, which caused substantially more severe injuries than did the workpiece impact to his chest (**Figure 4**).

Schematic of the cylindrical workpiece path showing three separate impacts (not to scale).

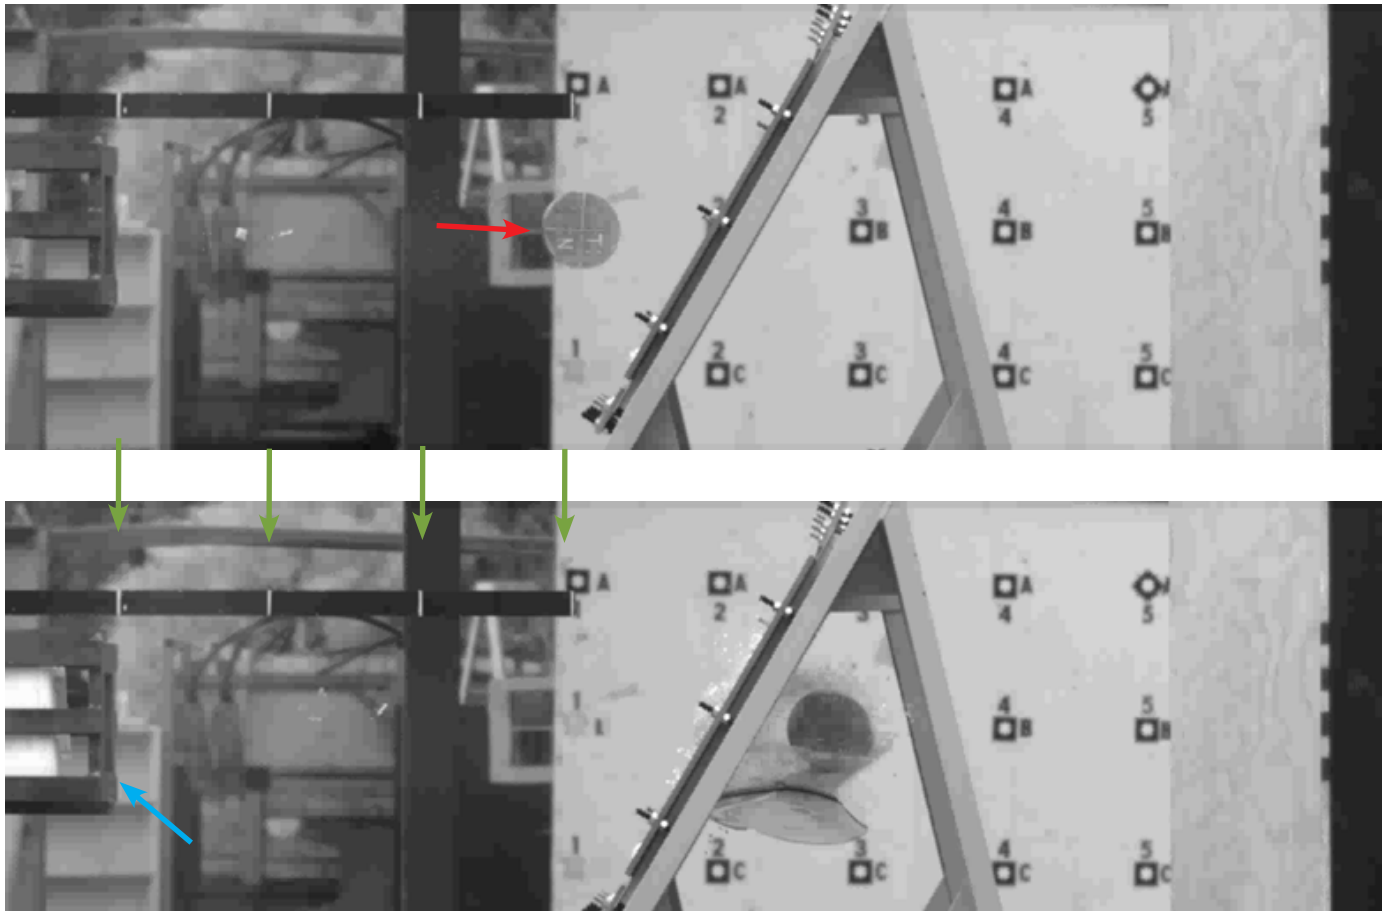
Figure 5

Two photographs of Test 1, with the first exemplar workpiece leaving the pneumatic launcher, are shown in **Figure 5**. The steel cylinder is moving in free flight from left to right horizontally and is called out with a red arrow in the top photograph. The test door is mounted on a test stand such that the projectile will only modestly impact the right edge of the window frame, accurately simulating the accident. The test door is inclined such that the relative angle of impact, ~28° from perpendicular, is identical to that documented with the accident lathe. The “X” inscribed on the right side of the projectile for frame-by-frame distance determination is also visible in the top photograph. The rectangular detail at left (blue arrow) is a “stripper,” which is a barrel end trap that captures the polystyrene sabot after it and the projectile have exited in tandem from the rectangular barrel’s muzzle. The four white vertical lines on the ruler centered above the stripper (four green arrows)

Test 1 — the projectile between the launcher and the inclined test door (top); post window penetration (bottom).

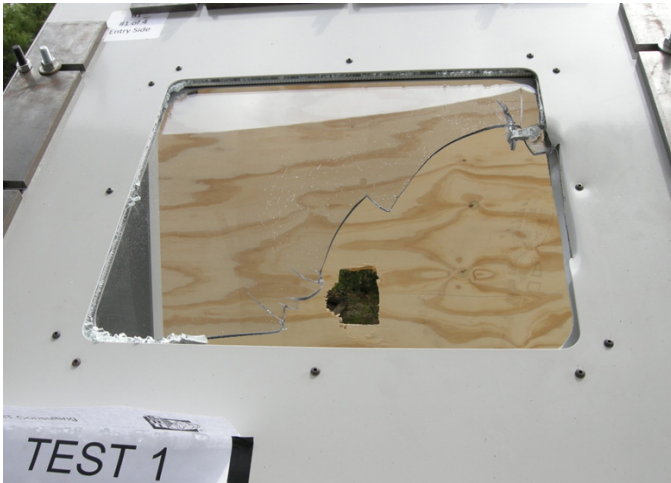
Figure 6

Test 1 — photograph of the door from the inclined impact side, post-test, showing impact damage similar to that shown in **Figure 2**.

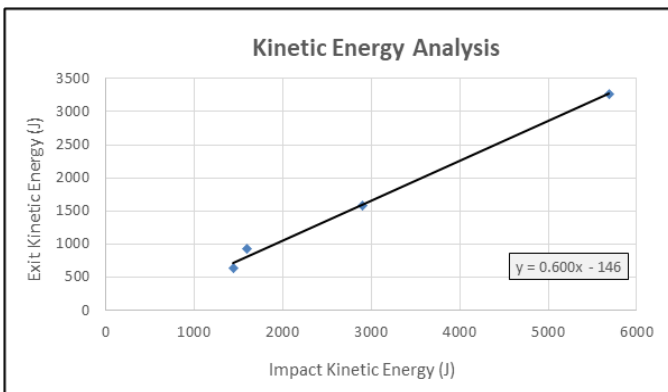
Figure 8

The data from impact Tests 1 – 4 are plotted in **Figure 8**, which also gives a least-squares curve fit of the data determined by the Excel software. The equation in the inset gives the calculated linear relationship between the workpiece impact kinetic energy and the workpiece exit kinetic energy. As the data set is small (limited to four empirical

Using the developed equation $KE_{EXIT} = 0.600 * KE_{IMPACT} - 146$ J and the estimated range of workpiece post-guard penetration kinetic energy (440 J to 613 J), the estimates for workpiece impact kinetic energy are 977 to 1,265 J. This range of estimated workpiece impact severity is significantly less than the estimates of the machine tool manufacturer’s engineers: 3,062 to 5,580 J. Further, the testing-based estimate of window guard energy capacity using the most severe of the two impact estimates (1,265 J) gives an estimated window energy absorption of 652 J. This is also less than the analysis of the manufacturer’s designers, which was a 1,450 J capacity, albeit using a different impact scenario. Any estimated window guard energy capacity developed by this destructive testing necessarily overstates the capacity of the transparent window panes alone compared to impacts against both the window and the steel frame.

Tests 1 – 4 plotted along with a linear curve-fit relationship.

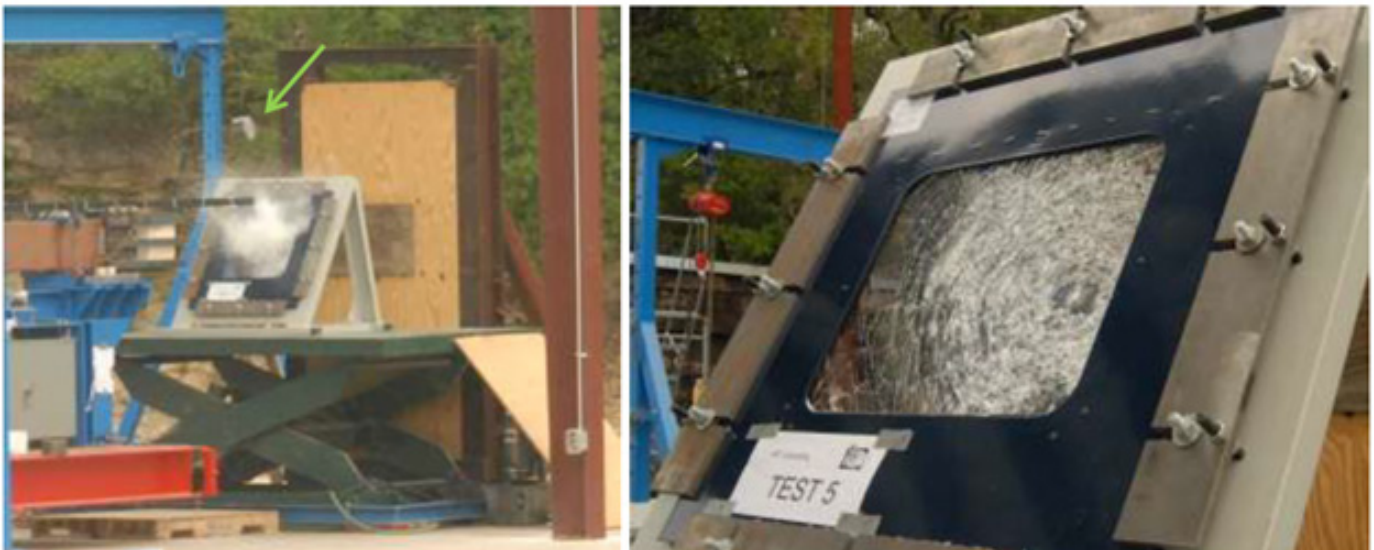
Figure 11
Test 5 – European market CNC lathe window using 12-mm polycarbonate pane.

pullout. Test 5 was conducted to determine if this window design would have adequately retained the workpiece in the subject accident. The workpiece was launched at a velocity of 15.0 m/s (49.1 ft/s) to achieve an impact kinetic energy of 1,439 J (1,061 ft-lb), more than 10% greater than the larger of the two estimates of impact kinetic energy provided by the plaintiff's engineers (1,265 J = 933 ft-lb). At impact, the tempered glass shattered, but the polycarbonate window held — and the workpiece was retained.

a green arrow showing rebound. In this test (and this test only), the workpiece missed the frame edge and interacted only with the window proper, ensuring that no energy was dissipated by frame deformation. The test details of Tests 5 and 6 are recorded in **Figure 13**.

Two additional tests were performed to validate alternative design windows given two different workpiece impact scenarios. Test 5 used a 12-mm polycarbonate window replicating the construction of the window that was sold on the European market. The frame engagement of this test window was also extended from 15 mm to 25 mm to diminish the probability of a peripheral

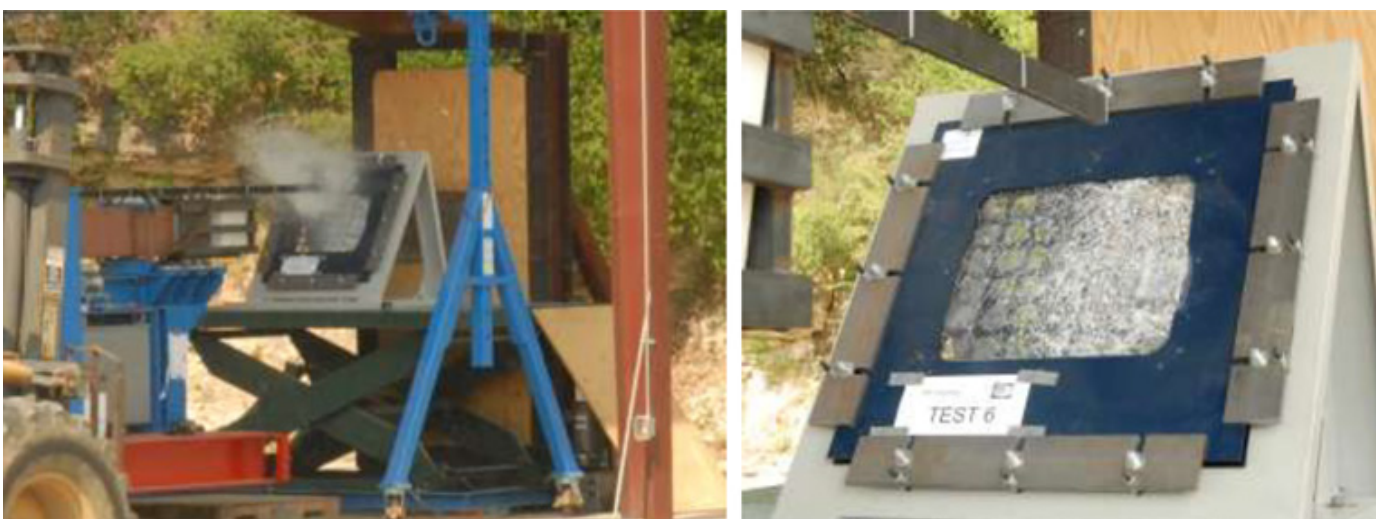
Figure 12
Test 6 – “Maximum Protection” CNC lathe window using muntin bars at exterior surface.

subject accident by any party. This alternative design used thicker steel for the exterior door panel and a lattice work of steel across the viewing pane. Lattice work subdivides the daylight opening of the window into a grid and is called “muntin bars” in glazier jargon. In this case, the muntin bars were intended to absorb impact energy in tandem with the polycarbonate window. The Test 6 workpiece (weighing 12.8 kg) was launched at a velocity of 30.7 m/s (49.1 fps), which developed over four times the kinetic energy estimated for the subject accident. The test was successful in that the door and window were heavily damaged, but the workpiece was retained.

Test 6 was of a hypothetical “maximum protection” window designed to see if a redesigned window could retain the subject workpiece given an impact energy in excess of the highest impact energy estimated for the
