Vol. 39 No. 2 December 2022

# Forensic Engineering Investigation of Factors Contributing to the Explosion of an International Natural Gas Pipeline

By Jahan Rasty, PhD, PE (NAFE 768S), Olin Parker, and Mathew Mills, PE (NAFE 1199C)

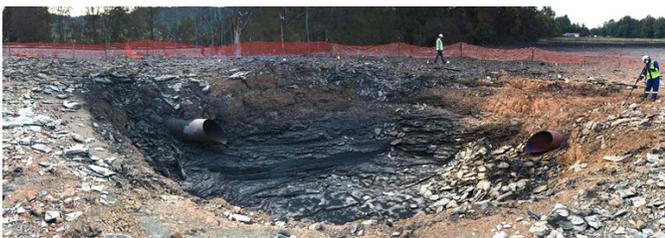
**Figure 3**

Crater left by the pipeline explosion<sup>4</sup>.

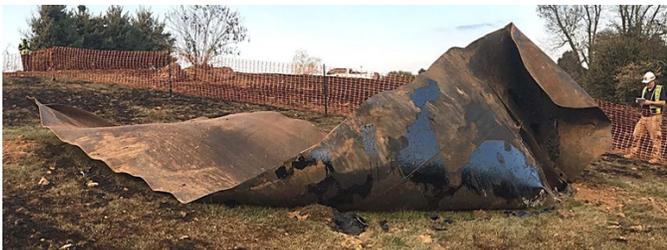
**Figure 5**

The 33-foot-long segment of pipe that was ejected as a result of the explosion<sup>4</sup>.

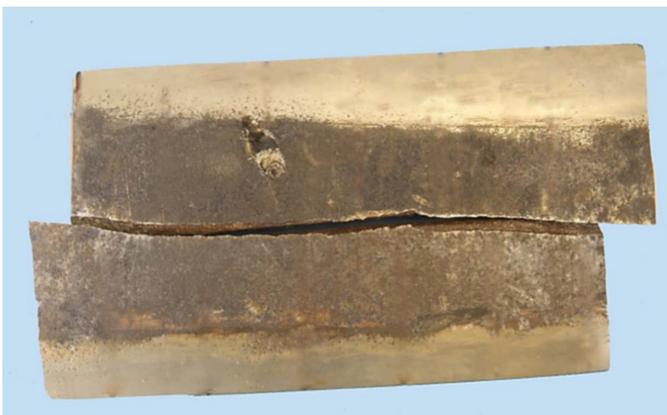
**Figure 6**

Examination of a segment of the ejected pipe section (**Figure 5**) revealed the presence of chevron marks that were utilized to identify the failure origin (**Figure 6** and **Figure 7**). The failure origin was located 90 inches from a girth weld at approximately the 4 o'clock position of the pipe (seam weld at 12 o'clock). Corrosion pitting was also

Sectioned segments of the pipeline at the failure origin<sup>4</sup>.

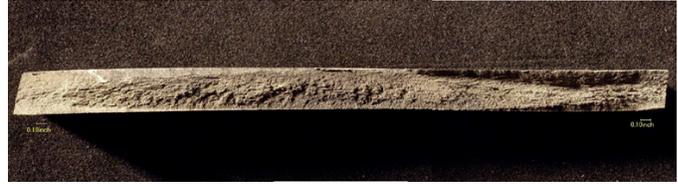
**Figure 7**

The fracture surface of the pipeline at the failure origin<sup>4</sup>.

observed near the failure origin and throughout the surrounding area.

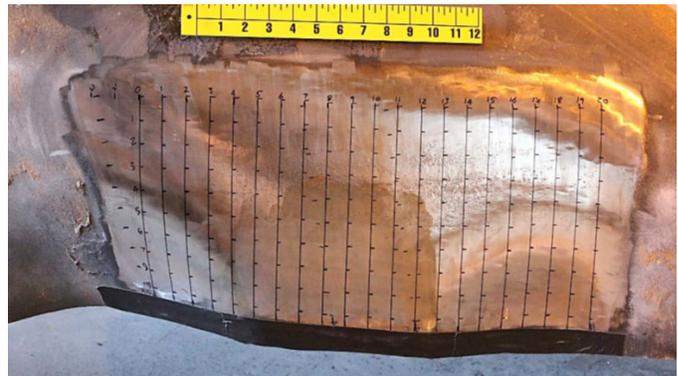
**Figure 8**

The surface of the pipeline segment near the failure origin was ground, polished, and etched to create a grid for the measurement of hardness variation within this area (**Figure 8**). The etched surface revealed a darker region (**Figure 9**) near the failure origin where higher hardness values were measured as compared to areas away from the failure origin (**Figure 10**).

Hardness grid on a polished and etched surface of the pipeline near the failure origin<sup>4</sup>.

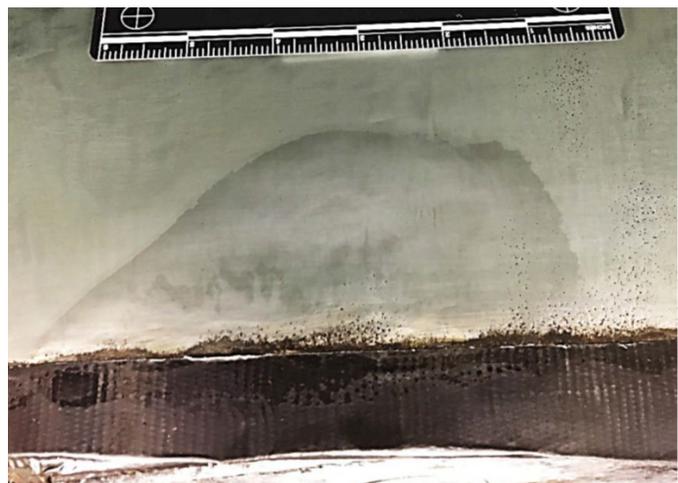
**Figure 9**

Close-up of the polished and etched surface near the failure origin. Note the presence of the darker region where high hardness values were measured, as shown in **Figure 10**<sup>4</sup>.

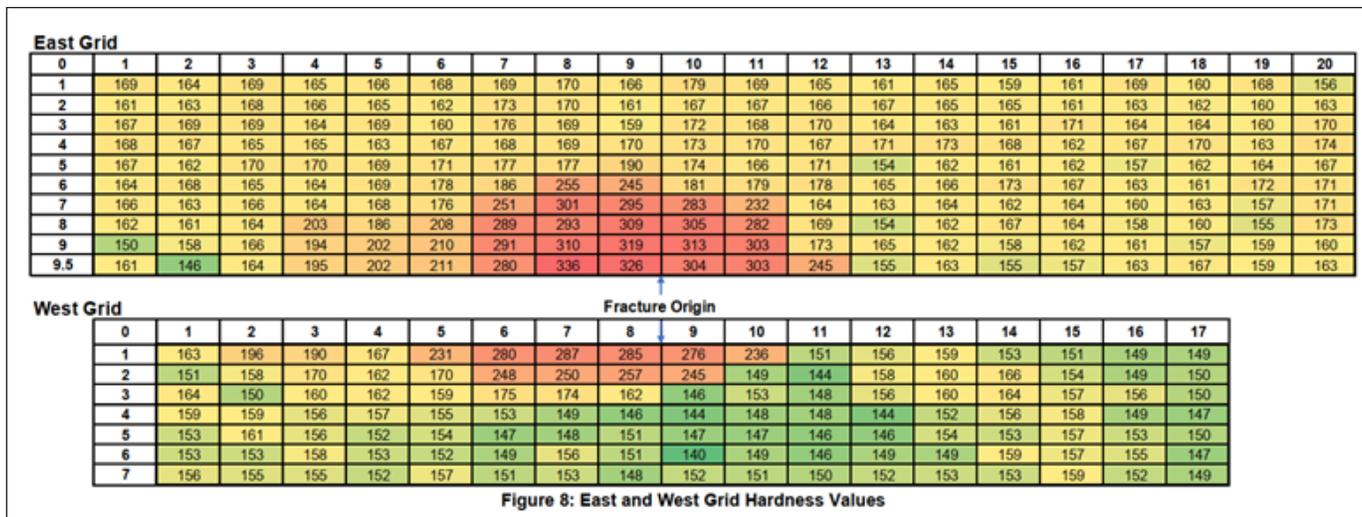
Figure 10

Results of the conducted hardness testing<sup>4</sup>.

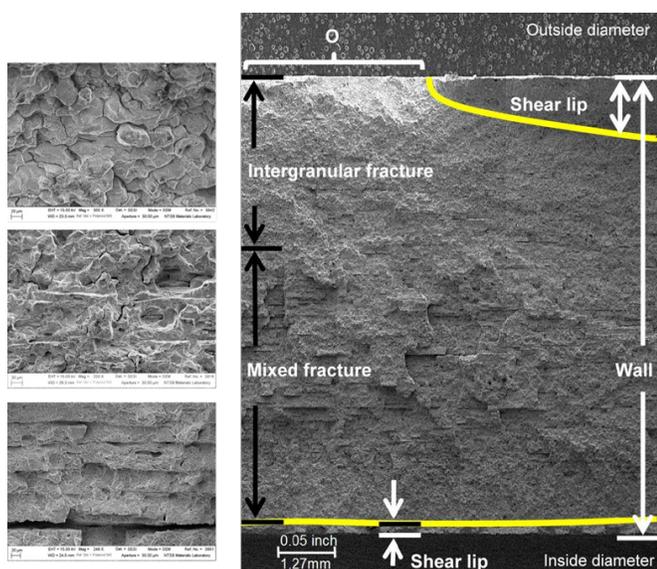
Figure 11

A 6-inch x 1.5-inch segment of the pipe containing the fracture origin was cut out, cleaned, and examined under Scanning Electron Microscope (SEM). As shown in **Figure 11**, the fracture origin was observed to exhibit intergranular fracture from the exterior surface to approximately 0.1 inches below the surface, up to ~30% of the nominal thickness of the pipe. A mixed-mode fracture region was observed from 0.1 inches below the exterior surface up to the edge of a shear lip on the inner surface. The presence of intergranular features was noted to decrease with increasing distance from the exterior surface. Based on the above observations, it was concluded that the exterior surface of the pipeline was exposed to an embrittling

environment.

SEM image of the fracture surface at the fracture origin, displaying regions of intergranular and mixed mode fracture<sup>4</sup>.

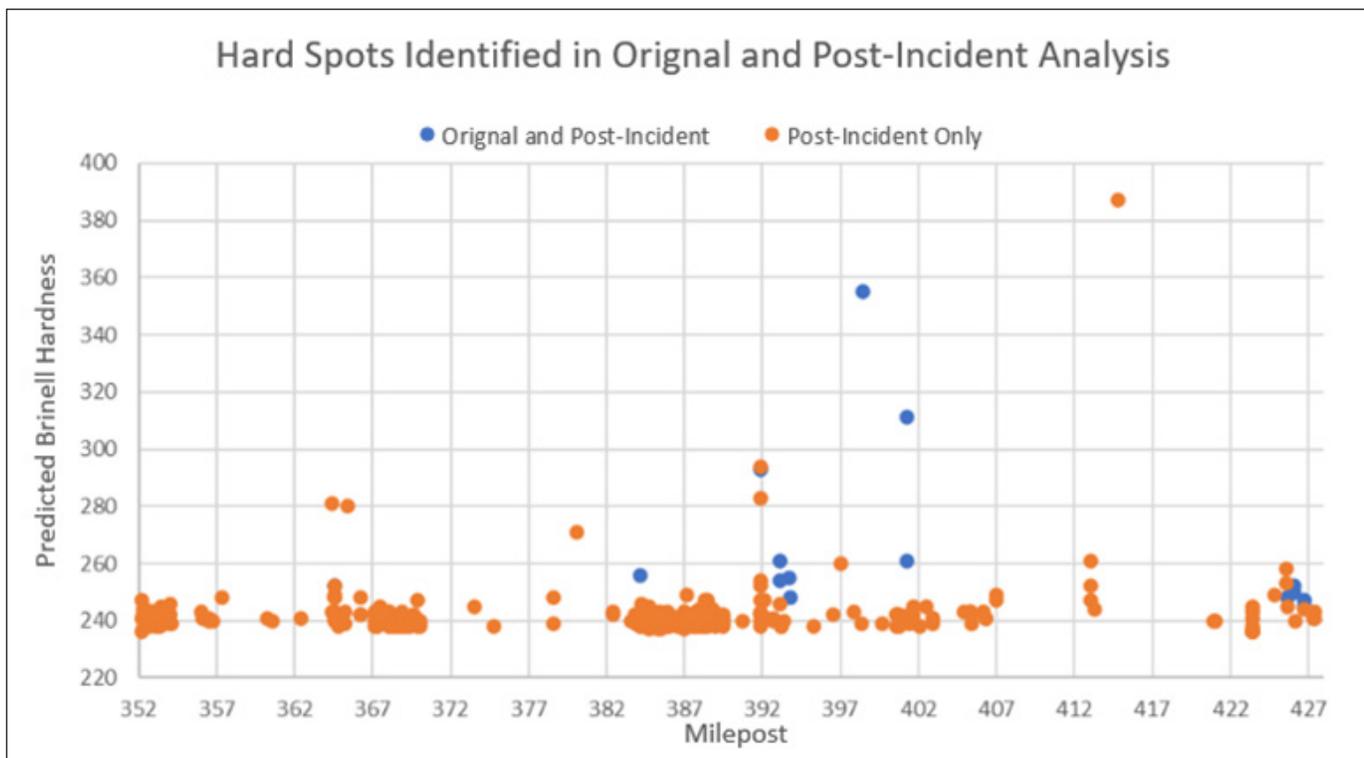
Following the incident, the pipeline inspection company performed a re-analysis of its original data from the inspection performed eight years before the incident. This re-analysis utilized an improved version of the company’s analysis software, which now incorporated AI instead of human operators to identify potential hard spots. As shown in **Figure 12**, this re-analysis revealed a total of 441 hard spots (compared to only 16 that were originally identified), nine of which were located within the same section of pipe that ruptured and one that was located at the failure origin.

**Figure 12**  
Comparison of hard spots identified in the original and post-incident analysis.

program<sup>14</sup>.” As the pipeline at issue was a vintage pipe with a known susceptibility to hard spots, the pipeline owners should have instituted an inspection interval well below the maximum stated interval of seven years in order to account for the increased risk of hard spots presented. Had the pipeline owners run ILI multiple times as required by federal regulations, they would have — in all probability — caught 99% of the defects present in the pipeline, and the incident may likely have been prevented.
