Vol. 39 No. 2 December 2022

# FE Investigation into Manufacturing- and Design-Related Issues Contributing to the Failure of a Climbing Treestand

By Jahan Rasty, PhD, PE, DFE (NAFE 768S), Mathew Mills, PE (NAFE 1199C), and Olin Parker

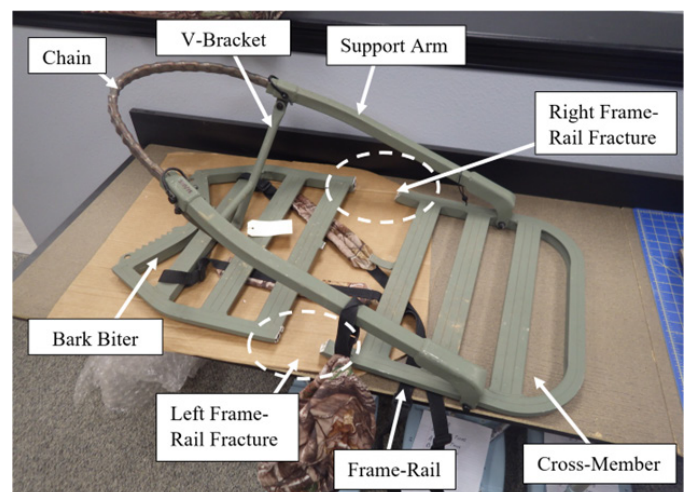
**Figure 2**

Photograph showing overall foot section of treestand with circles indicating failure locations.

The frame rail for the foot section of the treestand fractured at both the right and left sides of the frame rail (approximately halfway between the contact point with the tree and support arm). The bolt, which is used to connect the “V-bracket” to the support arms, was also fractured with its tab plastically deformed.

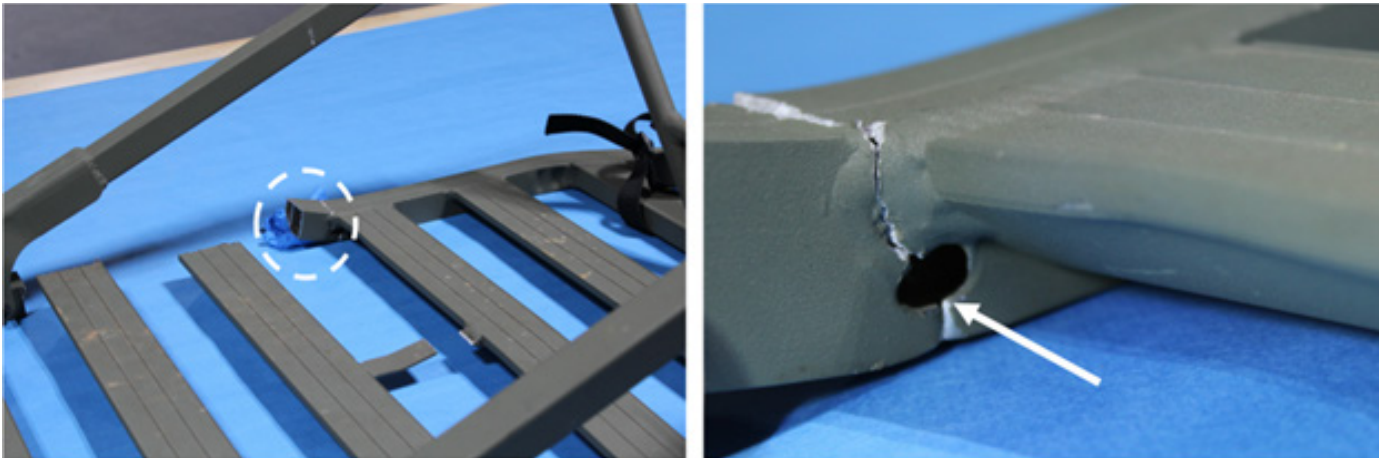
Closer examination of these three failure locations on the foot section revealed the presence of a  $\sim\frac{1}{4}$ -inch hole near a fillet welded cross-member connection to the frame rail (**Figure 3**). This hole, which appears to have been caused by improper welding during manufacturing, was located approximately 0.18 inches from the bottom of the frame rail adjacent to a weldment connecting the cross-member to the frame-rail.

hole is) would be subjected to tensile bending stresses during normal usage of the device when the user is standing at the center of the platform. The presence of a  $\sim\frac{1}{4}$ -inch hole in the portion of the frame railing subjected to tensile bending stresses resulted in increased stresses (due to stress concentration effect of a hole) that exceeded the material’s strength, causing the failure observed in **Figure 4** and **Figure 5**.

**Figure 3**  
Photograph of the left frame-rail fracture in the treestand’s foot section (left) and close-up of the hole (right), showing failure origin and direction of failure.

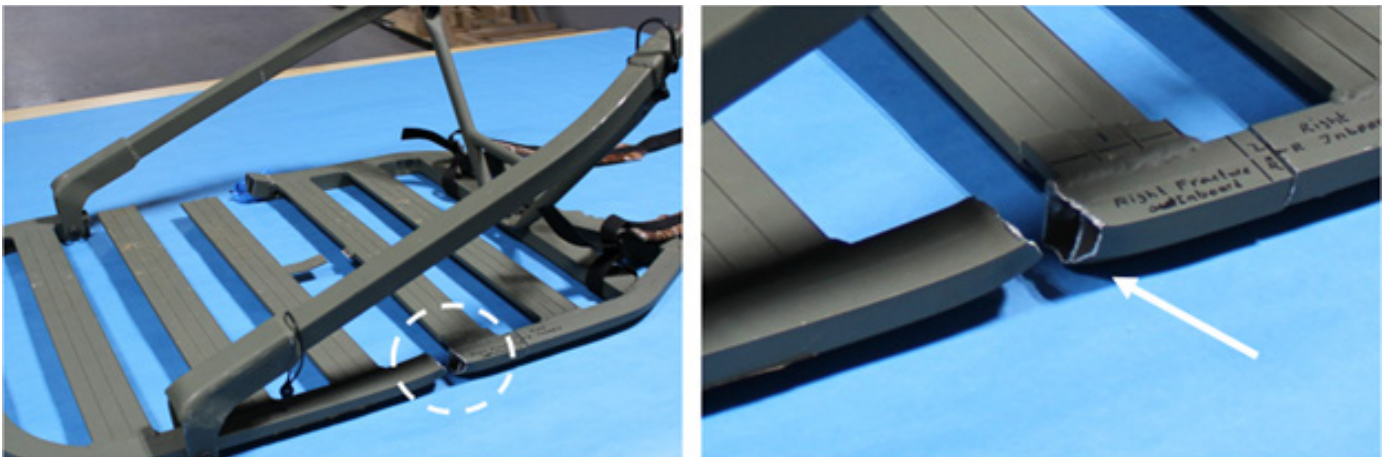
**Figure 4**  
Photograph of the right frame-rail fracture in the treestand’s foot section (left) and close-up of the fracture (right).

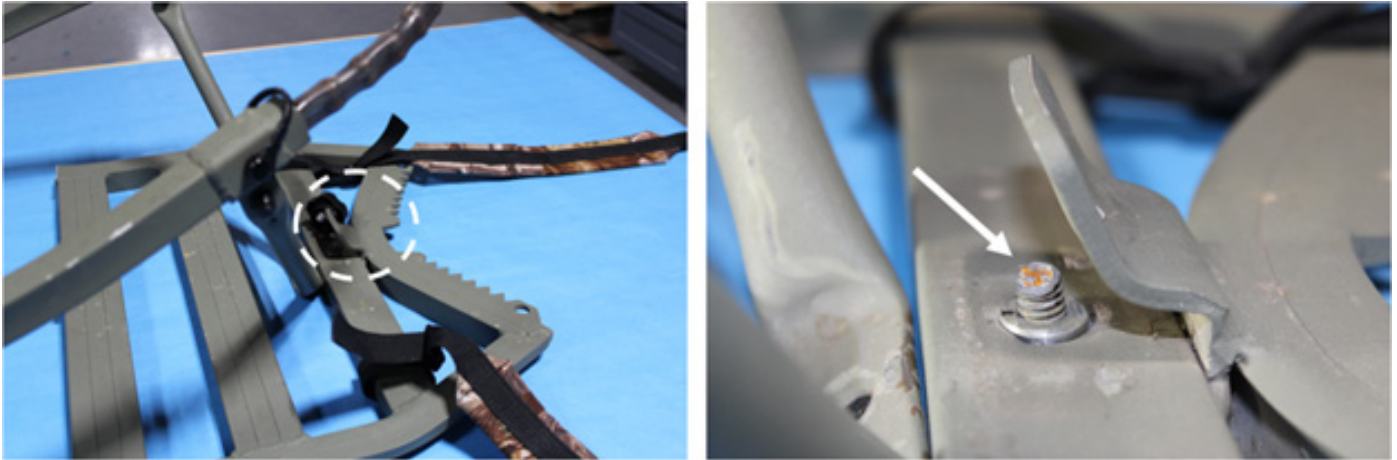
**Figure 5**

Photograph of the bolt fracture in the treestand's foot section (left) and close-up of the bolt fracture and bent tab (right).

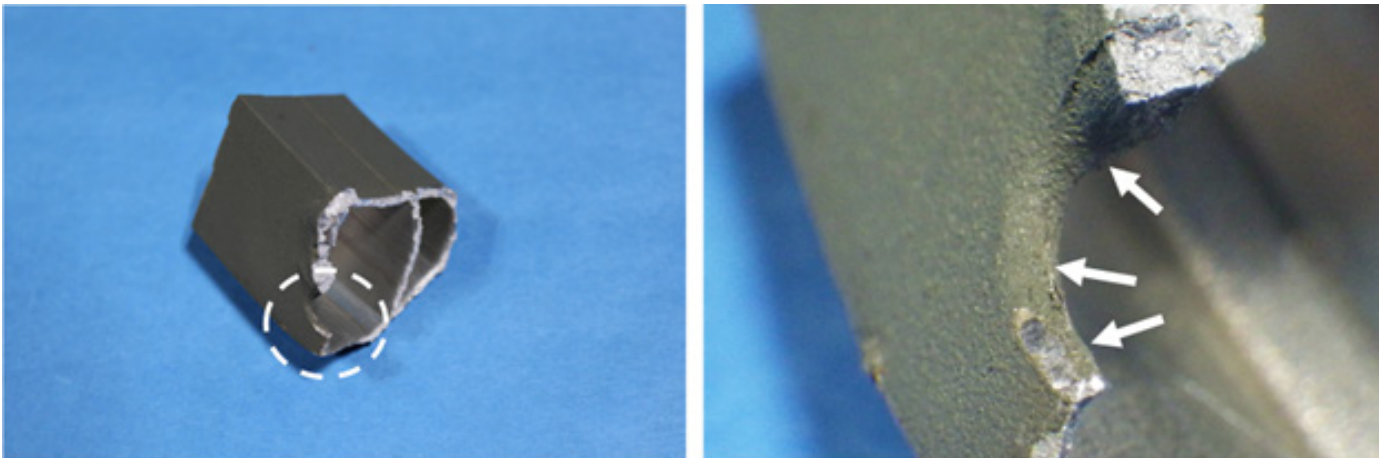
**Figure 6**

The presence of the protective coating on the inner surface of the hole (**Figure 6**) indicates that the hole existed at the time of the treestand’s manufacture. Testimony from the manufacturer representative confirmed that this hole was accidentally created during the process of welding the treestand — and that the presence of such holes was common.

Overall (left) and close-up (right) of the failure area, showing the presence of protective coating around the periphery of the hole, indicative of hole being present prior to the application of coating.

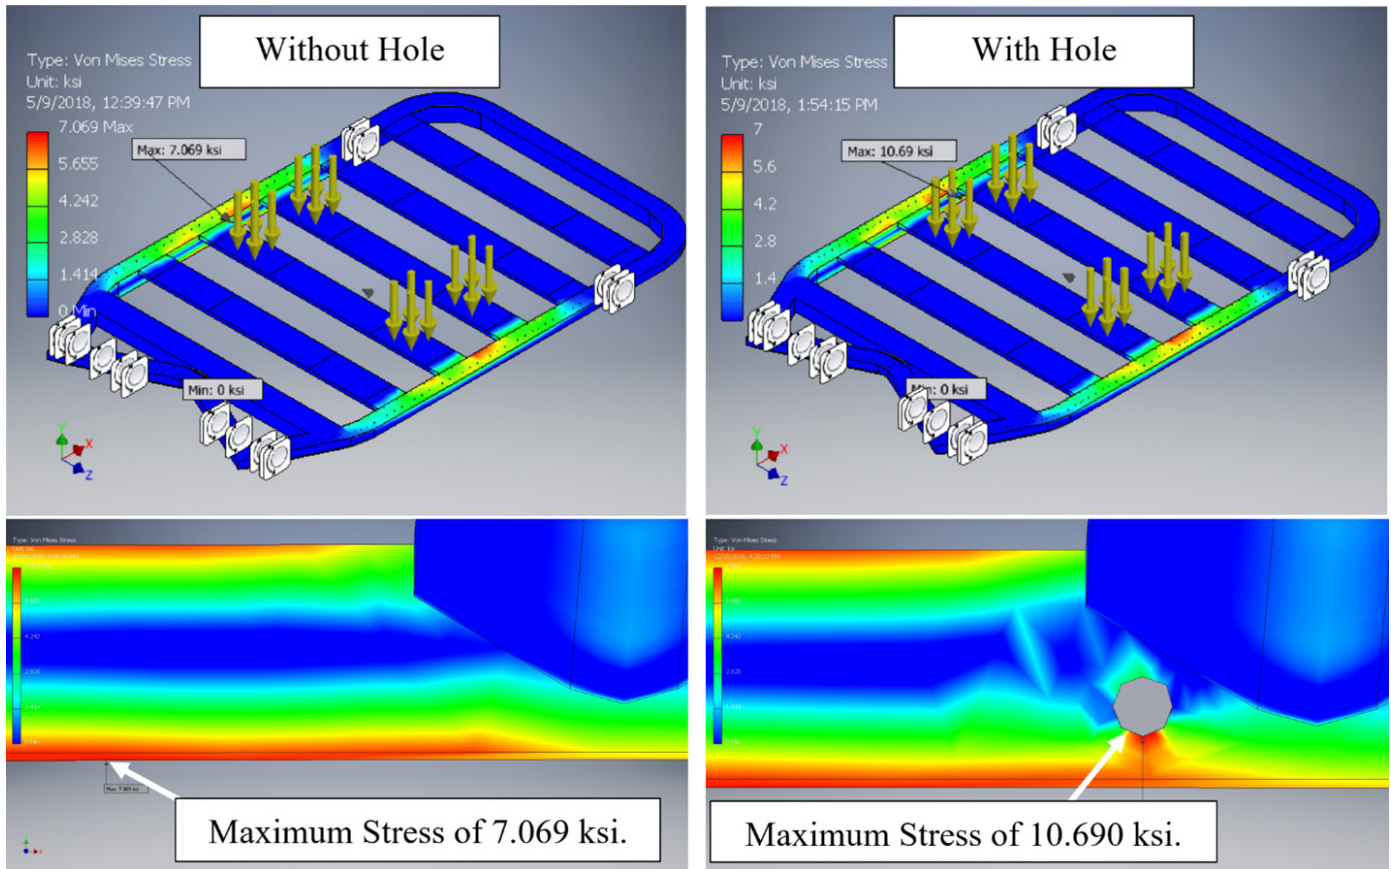
Figure 7

parative study (with and without the discovered ¼-inch diameter hole) to assess the additional stresses created in the railing due to the presence of the hole. As this was comparative in purpose, the V-brace was not considered in the constructed model. The results of the FEA analysis revealed that the presence of the hole (a manufacturing defect) resulted in a 52.2% increase in Von Mises stress at this location — from 7.1 ksi to 10.7 ksi.

FEA analysis results comparing the Von Mises stresses of the frame railing with (right) and without (left) the discovered hole.

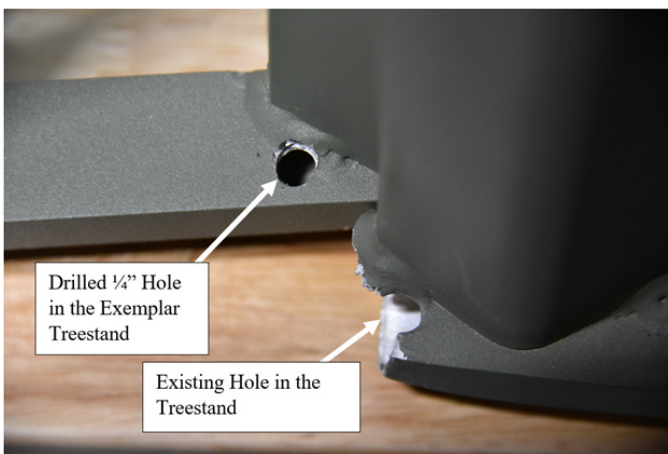
Figure 8

Photograph of hole drilled in exemplar next to manufacturing-induced hole.

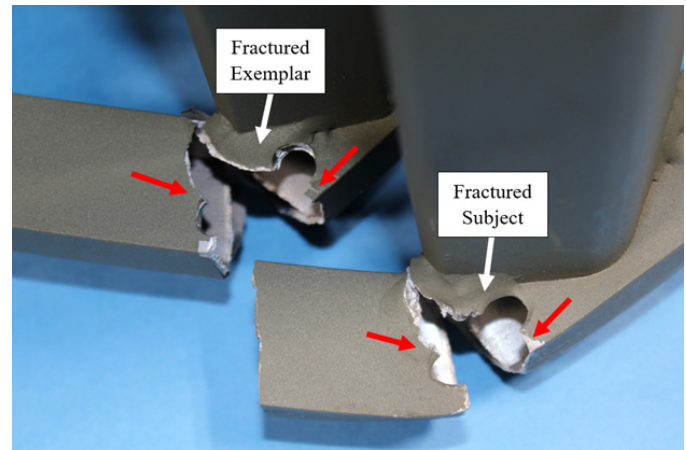
**Figure 10**

Following completion of the tests, comparison of failure characteristics (crack origin and propagation direction) of the exemplar test treestand to that of the subject treestand revealed identical features, which is evidence of the validity of this test setup and

Near identical failure features between exemplar and subject treestands as evidence of the validity of experimental setup and procedures.

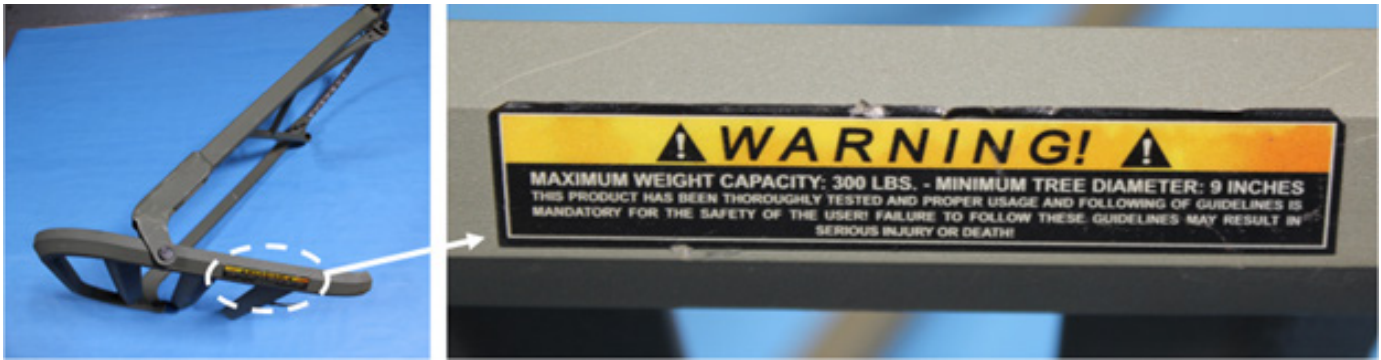
Warning label location on the treestand (left) and close-up of the warning (right).

The label shown in **Figure 11** states “this product has been thoroughly tested...” however, the treestand had never been tested. The overall design was tested under static conditions, but not tested to foreseeable dynamic loading conditions that the manufacturer both knew and had warned about. The manufacturer testified that the treestands are shipped directly from the manufacturer to the supplier without each individual treestand being tested. This indicates that the subject treestand was never tested. Additionally, the manufacturer stated that it had no knowledge as to whether or not the treestand’s foot section was ever inspected.
