Vol. 40 No. 1 June 2023

Nondestructive Forensic Investigation of a Scissor Lift Fatality

By Michael Stichter, PhD, PE, DFE (NAFE 1162M), Zachary Ball, PhD, PE, Carl Jewell, PhD, and Wade Lanning, PhD

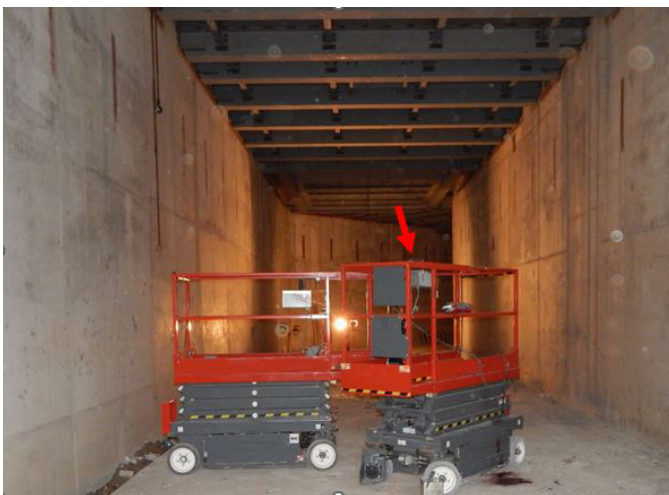
Figure 1

Photo from the incident scene showing the subject scissor lift (red arrow), the other lift used in rescuing the victim, and the overhead beams involved in entrapping the victim.

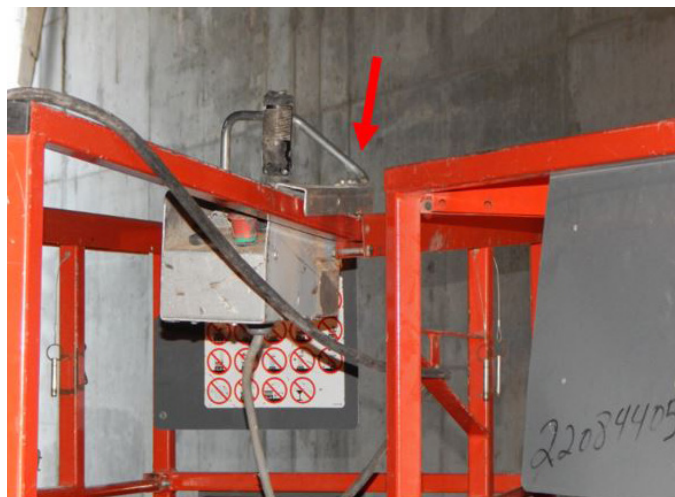
Figure 2

Photo from the accident scene, showing the control console of the subject scissor lift mounted on the top rail. The rail of a second scissor lift, used in an attempt to rescue the victim, is in the foreground. The top rail of the subject scissor lift is bent downward from the force exerted between the scissor lift rail, the victim, and an overhead beam.

- The joystick on the upper controls extended above the small handle/guard (**Figure 2**), making it inadequately guarded against inadvertent activation as required by A92.6 Section 4.7.1(5).
- Although the joystick did have an activation switch, it was integrated into the joystick grip rather than being a separate control. It is debatable whether a button on the joystick satisfies A92.6 Section 4.7.1(3). In the incident, the victim did not release this control even after he was entrapped.
- Due to a flaw in the wiring design, the lower controls could not override the upper controls as required by A92.6 Section 4.7.2(1), which delayed rescue of the victim.

published in 2010 (prior to manufacture of the subject lift), and includes similar requirements to ASTM A92 for a separate activation control and protection of controls from inadvertent activation (Section 4.7.1) and for lower controls that override upper controls (Section 4.7.3). ISO 16368:2010(E) also requires that all signal-transmitting wiring be protected against damage (Section 4.11.3.2), which the exposed control cable of the subject lift (**Figure 2**) did not meet.

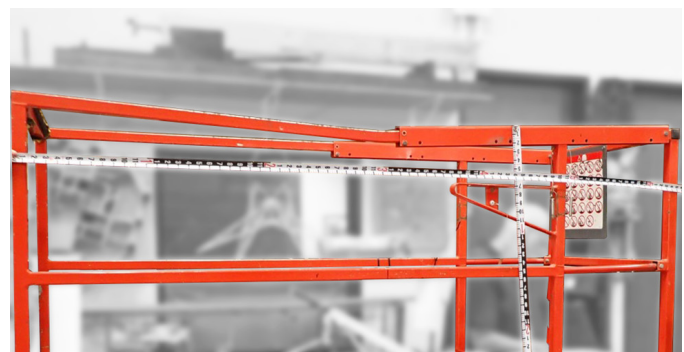
Figure 3

After the incident, the subject scissor lift was removed from the site, stored in a warehouse, and then examined/ tested by investigators several months later. One of the upper rails was bent downward (**Figure 3**), indicating the contact point between the rail, the victim's body, and the overhead beam. Witness testimony and maintenance records indicated that the rail was not bent until after the incident. The force exerted by the lift during the incident bent the top rail and caused the victim's injuries.

Photo from inspection of the lift several months after the accident. The top rail was bent downward where the victim was entrapped between the rail and an overhead beam.

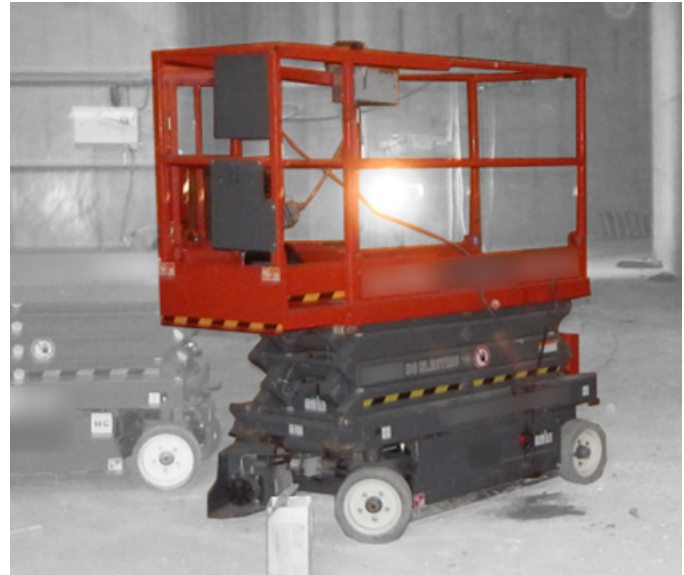
Figure 4

Photographs from the incident scene showed the subject scissor lift's front wheels were steered to the right (**Figure 4**). At the time of the accident, the lift was able to steer to the right. However, during functional testing, the incident control box was unable to steer the wheels to the right. This indicated an intermittent malfunction, of the lift's steering mechanism. An intermittent malfunction was consistent with the victim's colleague referring to "hesitation" and other (non-specific) control malfunctions prior to the incident.

Photograph of the incident scene taken shortly after the incident, showing the subject lift's wheels turned to the right.

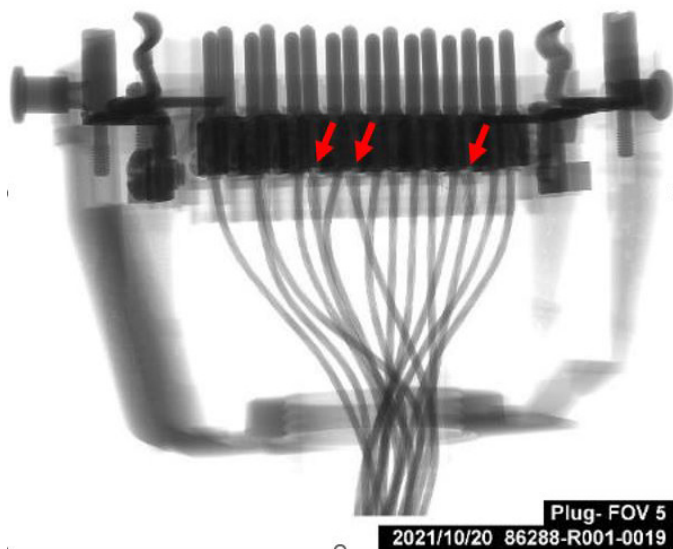
Figure 5

Investigators performed nondestructive 2D X-ray radiography of the subject scissor lift platform control console. In the 2D X-ray radiographs (Figure 5), some of the wires in the cable connector appeared off-center relative to the pins, suggesting that they were not fully inserted into their terminals.

2D X-ray radiographs of the platform control console cable connector. Some of the wires appeared off-center relative to the pins, suggesting possible loose or detached connections. Further radiography was required to resolve the positions of the wires and identify which control functions were affected.

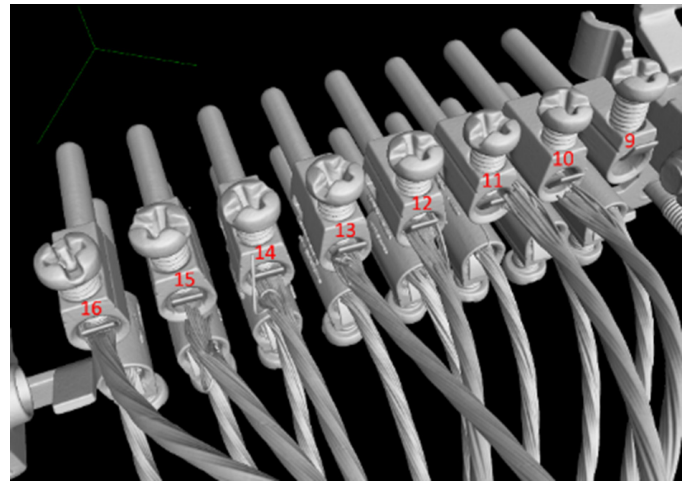
Figure 6

Top view of 3D CT scan of the subject platform control console cable connector. Numbers in red have been added to identify individual pins. Pins 1 through 8 (not numbered, located below pins 9 through 16 in this view) appeared fully secured within the screw terminals. Pins 10 to 15 were loose and withdrawn from the screw terminals. Pin 9 was left empty and had no corresponding wire.

Some, but not all, of the wires inside the connector in the subject platform control console pulled out of the screw terminals used in the cable connector (**Figure 6** and **Figure 7**). The screw terminals in pins 10, 11, and 15 had wires that withdrew completely, and pins 12, 13, and 14 were partially withdrawn. These pins did not provide adequate strain relief to hold their wires in place, but the other screw terminals successfully retained their wires. Pins 10 through 15 were not properly secured to the connector. If they were properly secured, then the connections between the cable and connector (the cable gland and the screw terminals) should have been stronger than the cable and its wires. When a properly secured connector fails, the cable and/or the wires fail rather than the strain relief. No such breakage or damage was visible in the 2D radiographs, CT scans, or physical inspection.

control console connector. Pins 10 through 15 in the platform control console cable connector had wires that were not properly secured, and, as a result, were partially or fully withdrawn from the screw terminals connected to the pins (**Figure 6** and **Figure 7**).

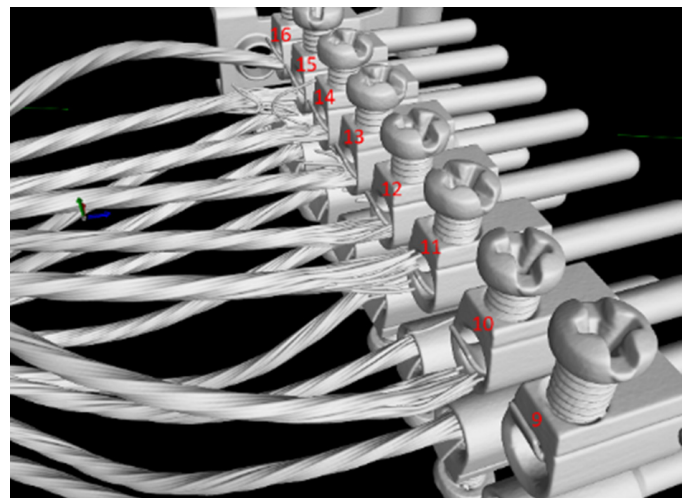
Figure 7

Side view of a 3D CT scan of the subject platform control console cable connector. Numbers in red have been added to identify individual pins. Pins 10 through 15 exhibited varying degrees of being withdrawn from the screw terminals.

from their screw terminals. Out of pins 9 through 16 of the cable connector, only the wires behind pins 14 and 16 appeared fully inserted into and secured within the screw terminal. Pin 9 was not used (by design).

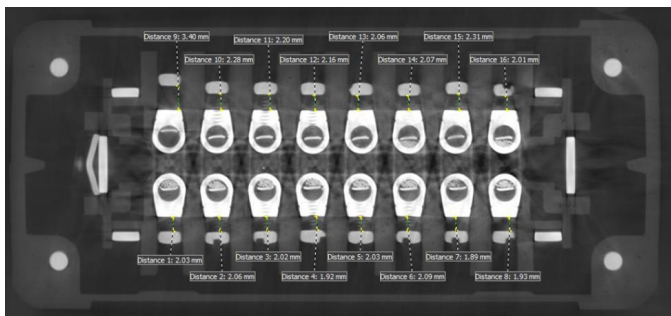
Figure 8

A slice of the 3D CT scan was used to measure the heights of the screws (i.e., how far they were tightened down) as shown in **Figure 8**. The threaded depth of the screw is directly correlated to clamping force of the wire as the screws for each wire connection were all the same size, and the wires were all the same gauge. The largest gap was the unoccupied pin 9 (measuring 3.4 mm between the top of the screw terminal and the bottom of the head of the screw). The next largest gaps were pins 15, 10, and 11 (measuring 2.31 mm, 2.28 mm, and 2.20 mm, respectively).

The reduced clamping force in the affected screw terminals would have made it easier for the wire to be pulled out from the terminal. Additionally, pin 14 was still partially inserted into the terminal, even though pin 13 and pin 15 on either side of it were more withdrawn from their respective terminals (**Figure 8**). If the sole cause of the withdrawal of the wires from the terminals was an excessive force, then one wire would not be expected to remain connected while the wires on either side failed. The fact that only some of the wires were withdrawn from the terminals indicates that those wires were not as firmly secured as the others in the connector.

Slice of a 3D CT scan of the subject platform control console cable connector with threaded depth of the screws marked. Pins 1 through 8 had relatively tightly connected crew terminals. Pins 10 through 15 had relatively loose screw terminals with partially or fully withdrawn wires. The distance labels also correspond to the pin numbers.

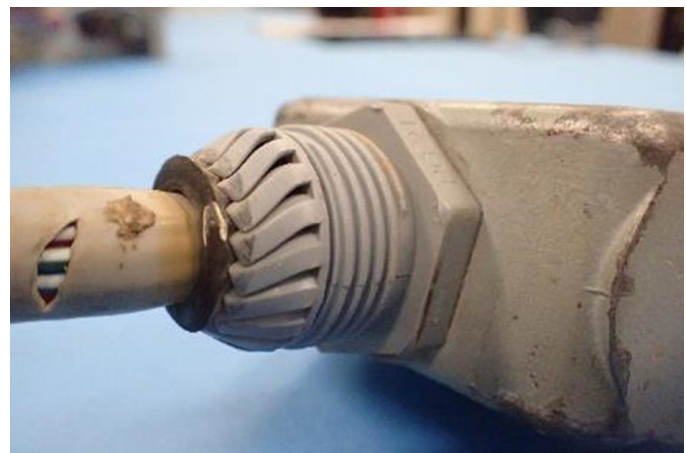
Figure 9

the ends of the stranded wires in place. Cable glands (like those in the subject plug) grip the exterior of the cable insulation and transfer stress from the insulation to the body of the connector plug. Screw terminals grip the ends of the wire, forming a mechanical link from the wire to the plug pins. After nondestructive radiography of the console plug, the cable gland connector was disassembled, revealing evidence that the cable had been pulled through the cable gland (**Figure 9**).

After nondestructive radiography, the cable gland connector on the control console plug was disassembled. The cable exhibited evidence of tension on the cable, such as movement of the cable within the gland and a tear in the outer insulation.

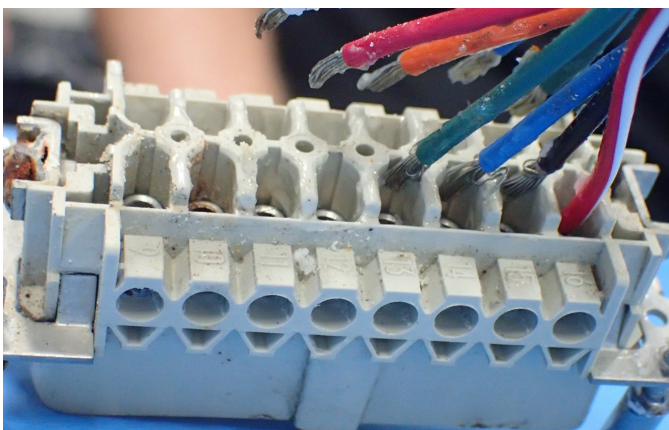
Figure 10

of wires 1 through 8 from the cable terminal block by backing out each of the terminal screws, wires 10 through 15 were free without applying tension to the wires or backing out their respective screws (**Figure 10**).

After nondestructive radioactivity, the cable terminal block was disassembled. The wires in terminals 1 through 8 were removed by backing out the screws on each terminal. Upon backing out the screw for terminal 8, the wires in terminal 10 through 15 slipped out of their respective terminals without applying tension to the wire or backing out the terminal screws.

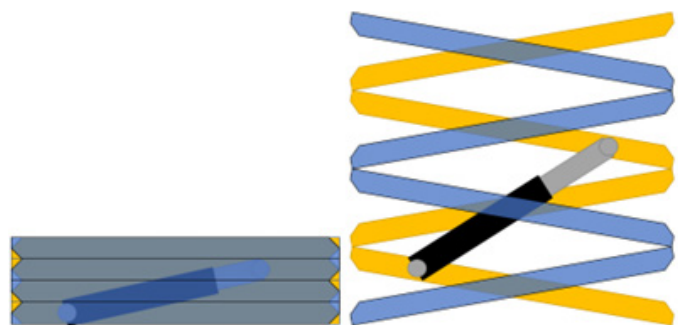
Figure 11

Investigators conducted testing of an exemplar lift matching the model and year of manufacture of the subject lift. They found that in the lowered position, the lift could exert in excess of 900 lb of force when raising the platform into contact with an overhead obstruction. Based on the test results at a 136.5-inch height, the lift could exert in excess of 2,100 lb of force when encountering an overhead obstruction. The increase in force was due to a change in the angle of the hydraulic actuators (lift cylinders) relative to the lift's "scissor" lift mechanism, which increased the magnitude of the moment (torque) created by the actuator

Sketch of a scissor lift mechanism in the lowered (left) and raised (right) position. Note that in the raised position, the lift cylinder and scissor arms rotate to be more nearly perpendicular to one another.
