Journal of the
National
Academy OF
Forensic
Engineers[®]

<http://www.nafe.org>

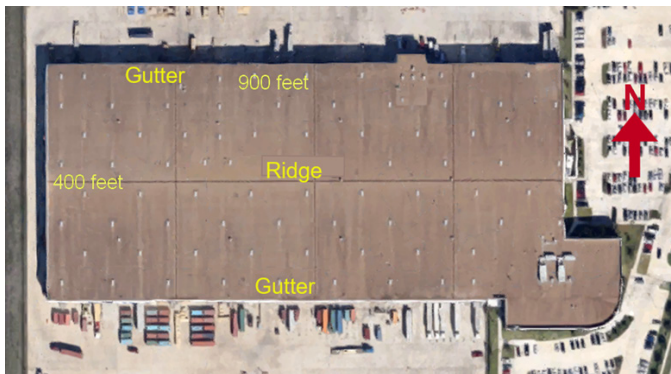
Figure 1
Aerial view of the subject warehouse.

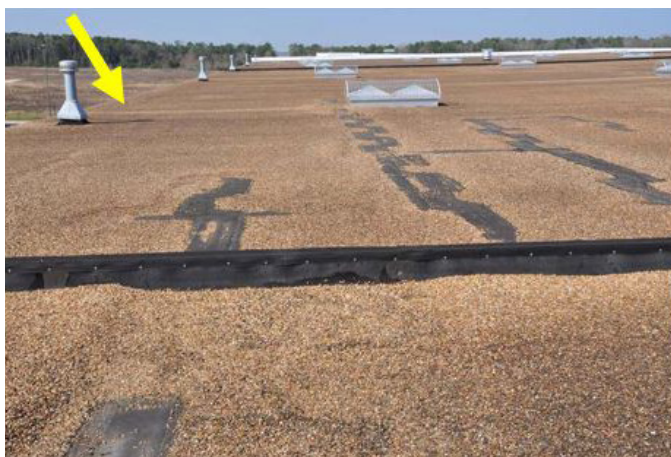
Figure 2
Fractures in the roofing membrane running parallel to the south side of the warehouse. The arrow points to the south edge of the roof.

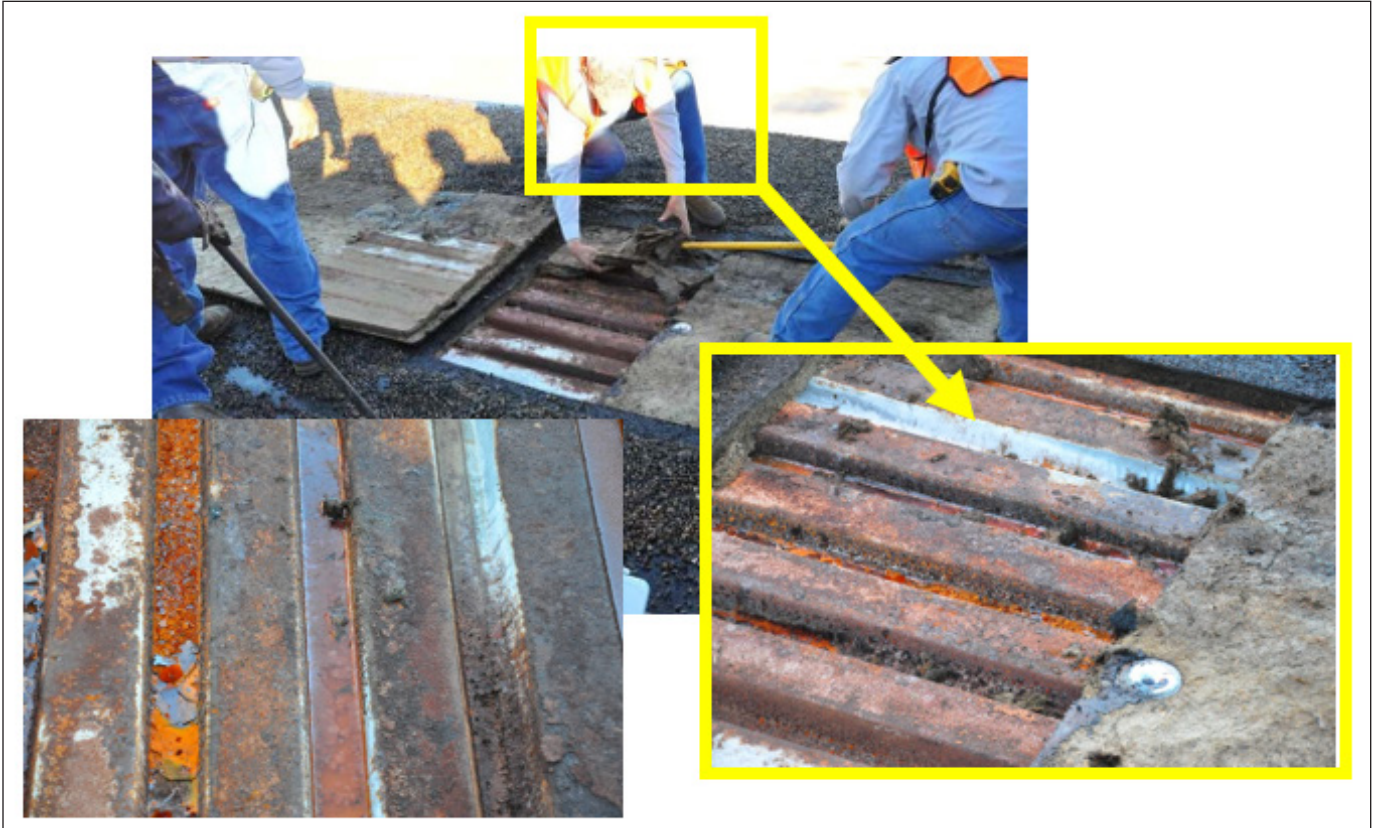
During the investigation of the roof, the plaintiff's experts directed most of the invasive investigation focusing on areas where splits and repairs occurred in the roofing membrane. A request was made to conduct similar coring

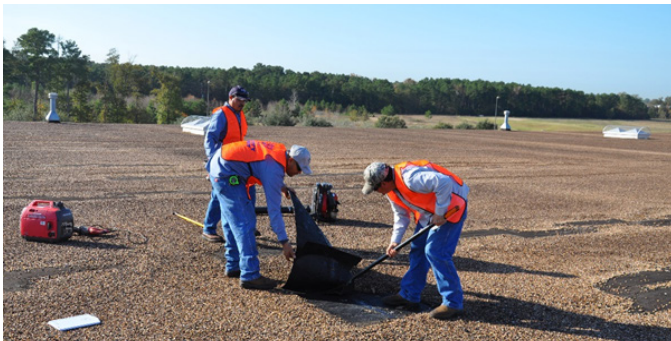
Corrosion of the structural steel roof deck exposed by removal of roofing membrane and fiberboard insulation during destructive testing. Note standing liquid and prevalence of corrosion in the ribs of the steel deck.

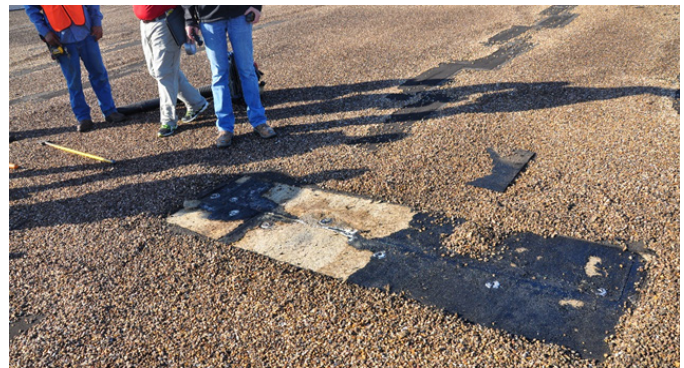
Once the roof membrane was removed — exposing the insulation at the requested location where the roofing membrane showed no signs of deterioration — the insulation appeared wet (**Figure 5**). Removal of the fiberboard revealed that corrosion of the steel deck generally coincided with the joints in the insulation (**Figures 6 and 7**).

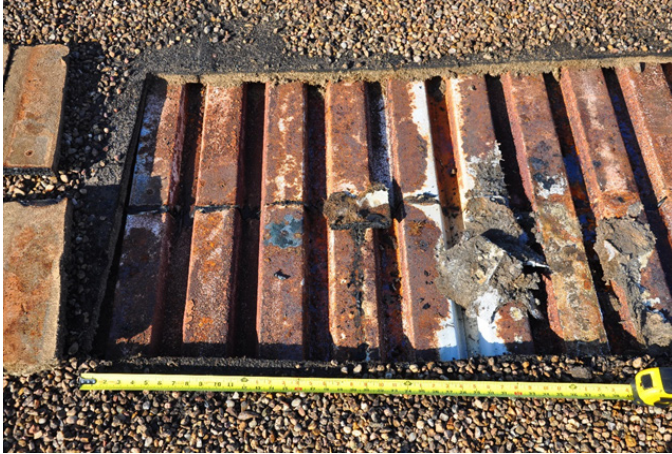
As shown in **Figures 6 and 7**, corrosion of the steel deck was pervasive, regardless of the condition of the overlying roof membrane. The roof investigation discovered that some insulation boards were installed with the joints between the fiberboard panels abutting over the ribs instead of resting on the flutes of the steel deck. This gave validity to the explanation that foot traffic

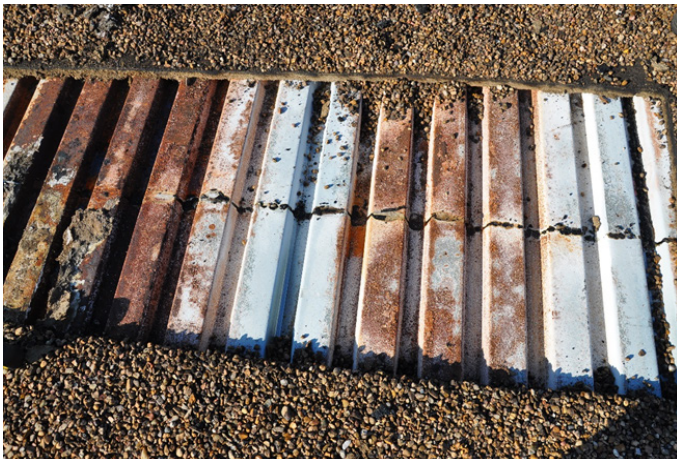
South end of the exposed roof deck. Corrosion of the structural steel deck beneath the fiberboard insulation layer seen in **Figure 4** and **5**. This shows corrosion coinciding with the seams in the insulation and confirms that corrosion can occur beneath undamaged roof membrane.

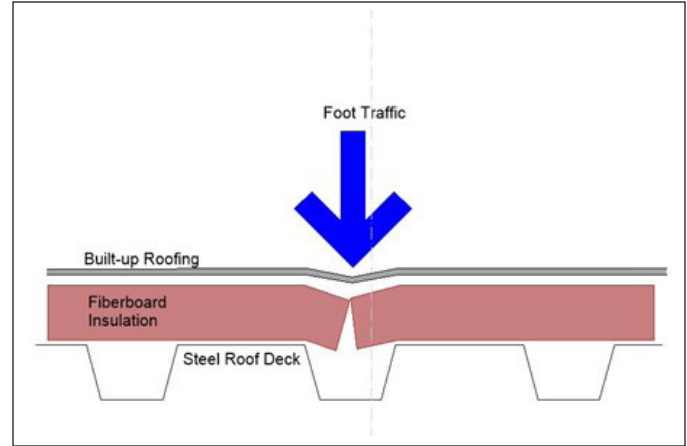
may have deflected the unsupported ends of the boards and damaged the roof membrane (**Figure 8**). It was still unexplained, however, why more roof failures occurred near the edges of the north and south perimeter of the building, why the steel deck corroded beneath undamaged roof membrane, and why some steel deck was not corroded. Once the roof membrane fractures, water can penetrate the roof membrane through those fractures. However, the presence of corrosion where no roof membrane damage occurred suggests that water entered the

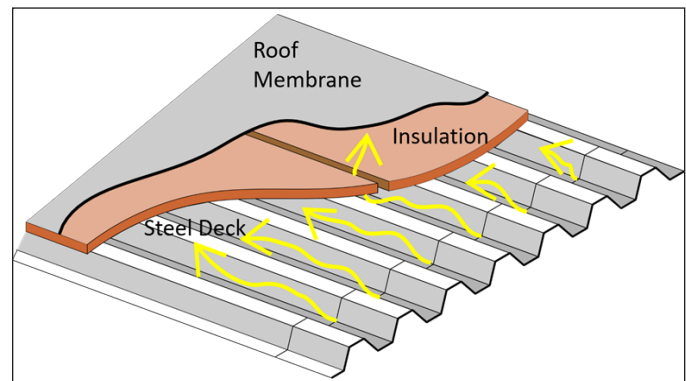
The air below the steel roof deck has elevated humidity since the rising warm air absorbs and carries moisture with it¹⁹. Once inside the roof assembly, this humid air can move through voids in the ribs of the deck and through the seams in the insulation until it reaches the underside of the roof membrane. If the surface of the roof membrane is at or below the dew point, condensation occurs, and the

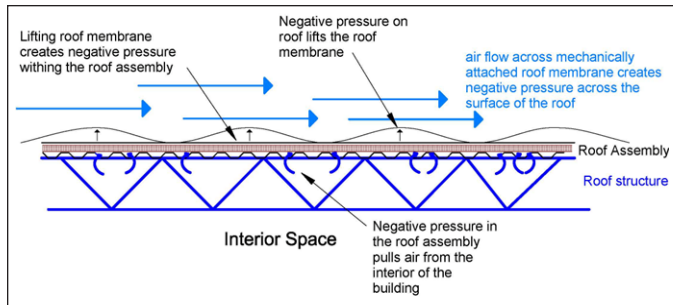
Illustration of the path of air infiltrating the structural steel deck and the fiberboard insulation.

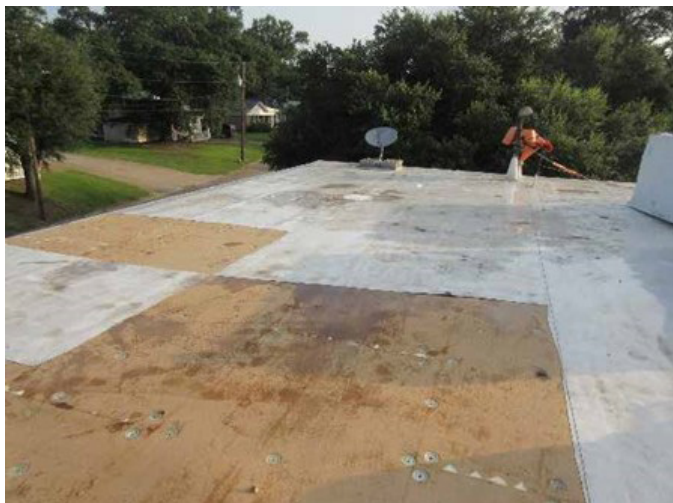
The exposed insulation revealed moisture concentrated around fastener penetrations and along the seams of the insulation panels (**Figure 13** and **14**), reminiscent of observations in the subject warehouse case. The subject building in this case has apartment units heated/cooled using PTAC wall

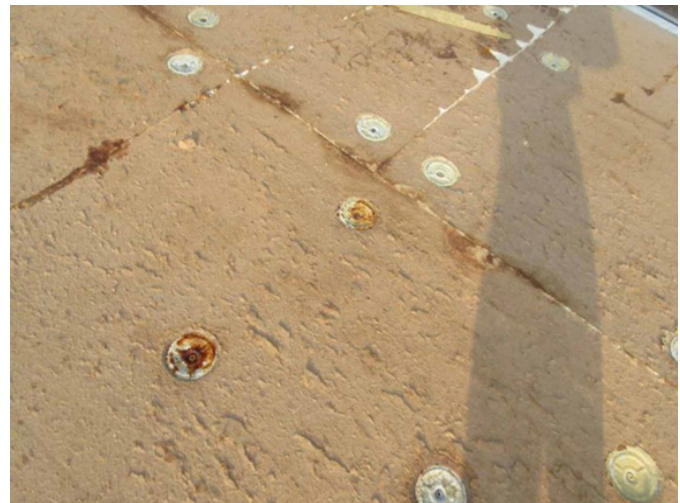
Removal of a TPO roof from polyisocyanurate insulation board. Notice the dark areas indicating moisture due to condensation.
