Journal of the
National
Academy OF
Forensic
Engineers[®]

Ethical Responsibility: When the Forensic Engineer is Faced with Notifying Occupants to Vacate

By Gregory L. Boso, PE, DFE (NAFE 748M)

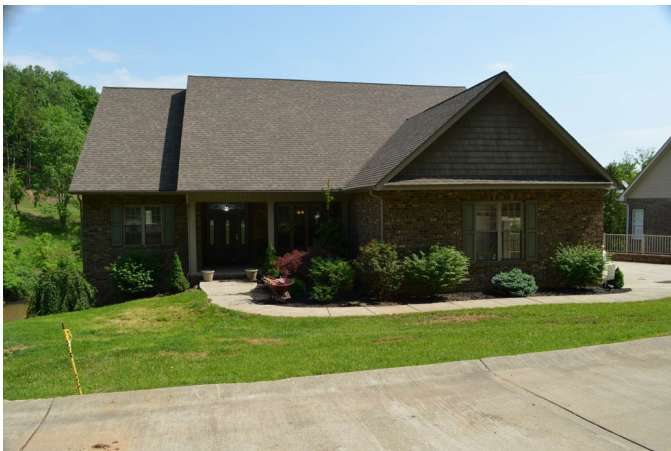
Figure 1

Street view of the subject home's south face.

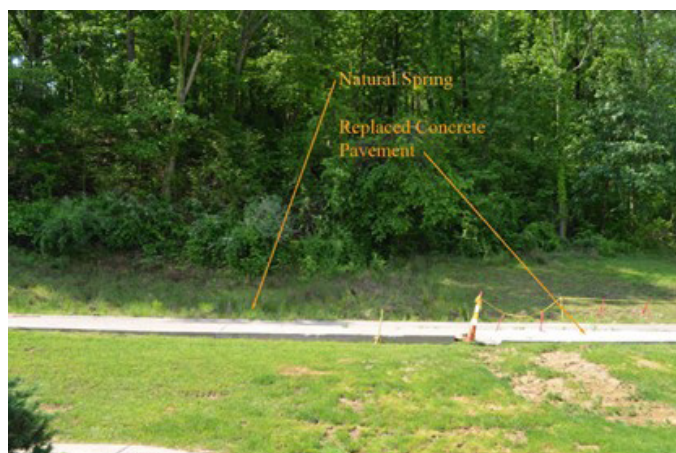
Figure 3

The front and left side yards presented as a “wash-board” where the soil surface was folded with 2- to 3-inch wrinkles (Figure 3). Repairs to approximately 80 feet of the north side of the concrete paved street had been made, evidenced by the newer concrete appearance. However, the north side of the street, which was previously repaired, had moved to the north by approximately 1½ inches, and soils along the vehicle recovery area of the street cross section beyond the northern curb had settled approximately 12 inches at several locations on the subject property

View of street and spring area at the southern boundary of the subject property from the front porch.

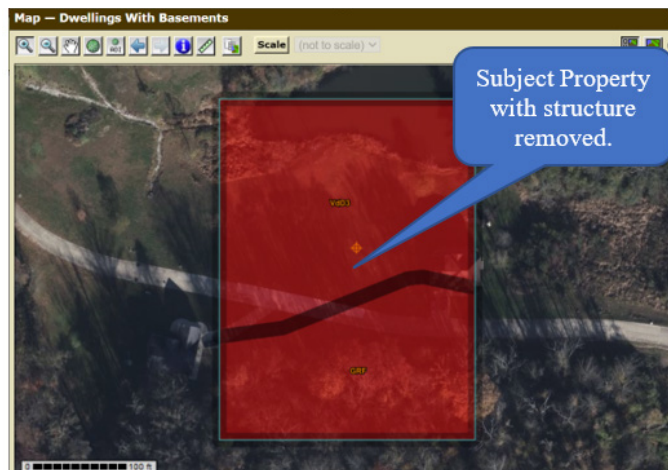
Figure 4

This review revealed that the site soils were of the Gilpin-Upshur (GRF) complex and Vandalia (VdD3) soil series that are fine-grained, well-drained soils with high plasticity indices and low strength and liquid limits on steep slopes (Figure 4)⁶. Gilpin-Upshur soils are clay loams, and Vandalia soils are loamy clays that each have high shrink-swell or linear extensibility characteristics. These soils are common on hillsides in the geographic region of the home and have a propensity for absorbing and retaining water that weakens the interior soil strength while increasing unit mass until failure as a debris flow-type landslide. The site was thus situated in a defined debris flow area. This activity should have been reviewed and the foundation/site conditions designed and constructed around the peril.

NRCS Web Soil Survey of soils on and around the subject parcel, “Soil Slippage Potential” hazard class “High” (red). (U.S. Department of Agriculture, NRCS Web Soil Survey)

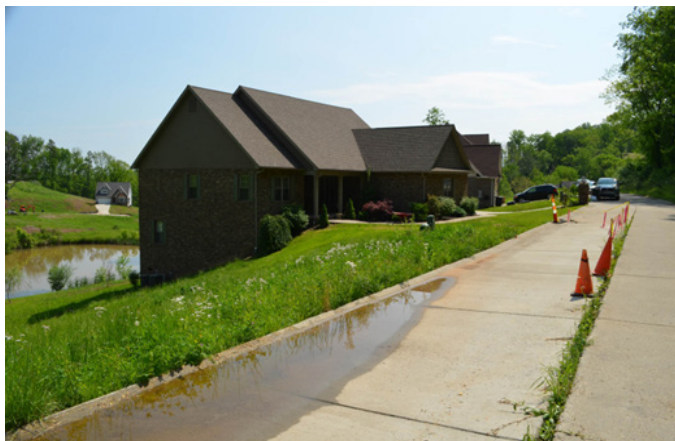
Figure 5
Elevation relief from street to rear of home was approximately 20 feet along left side.

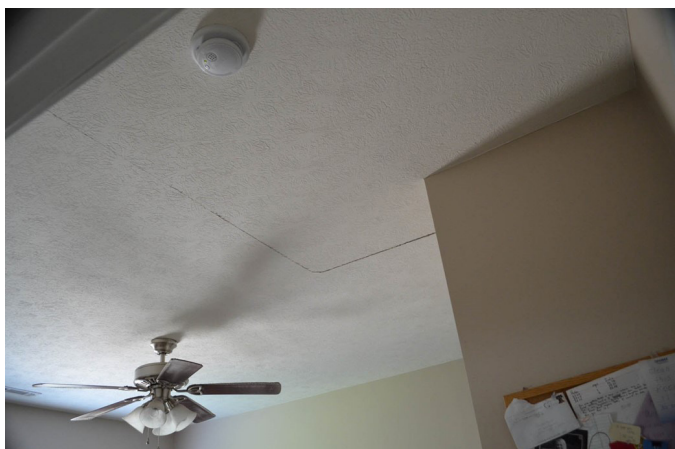
Figure 6
Ceiling of bedroom at right end of the structure with gapping between joints in the drywall field; joints had been previously repaired post-construction.

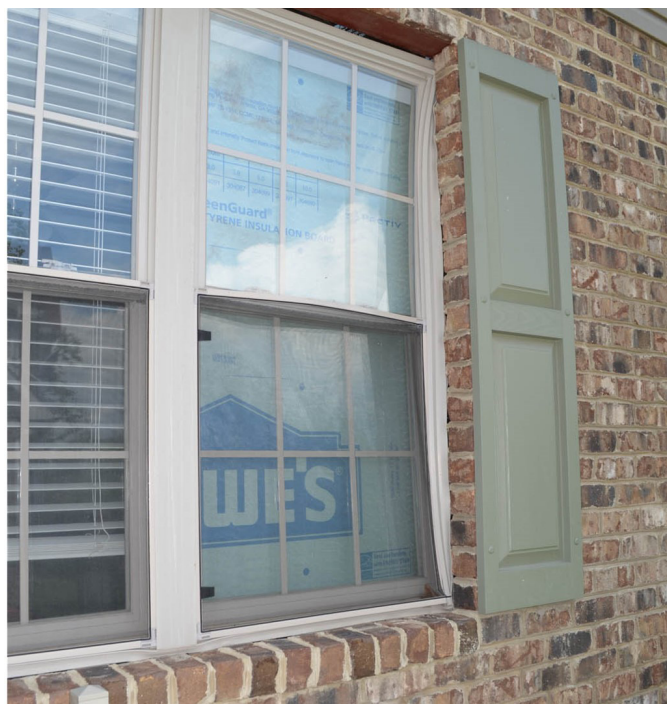
Figure 7
Right bedroom window jamb rolled beneath the right-side brick masonry veneer, buckled window screen and board insulation filling the sash space as protection against glass breakage.

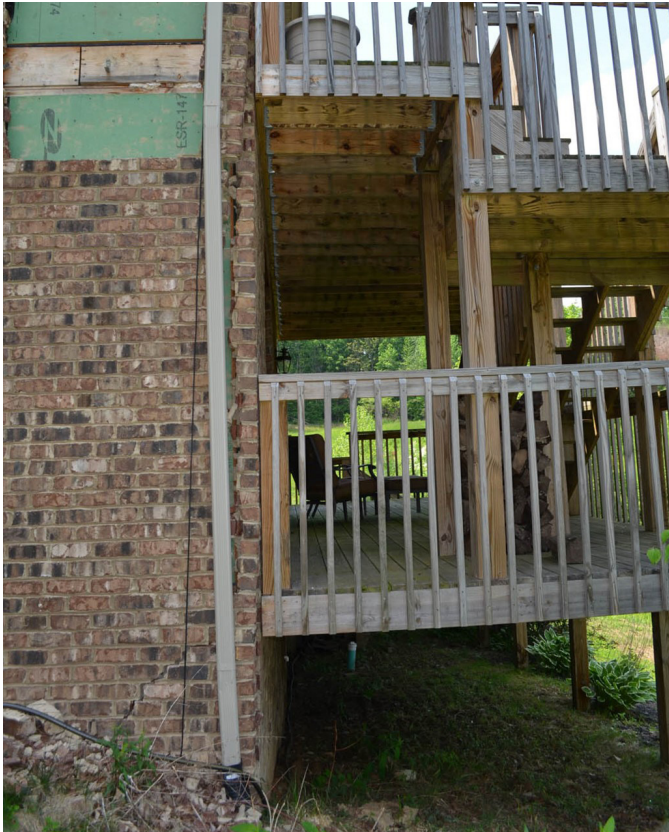
Figure 8

wood-framed rear deck system. The structure of the wood deck system provided additional resistance to movement of the platform framing system toward the rear yard and lake (**Figure 8**).

Right rear corner with vertical veneer fractured at the down-spout.

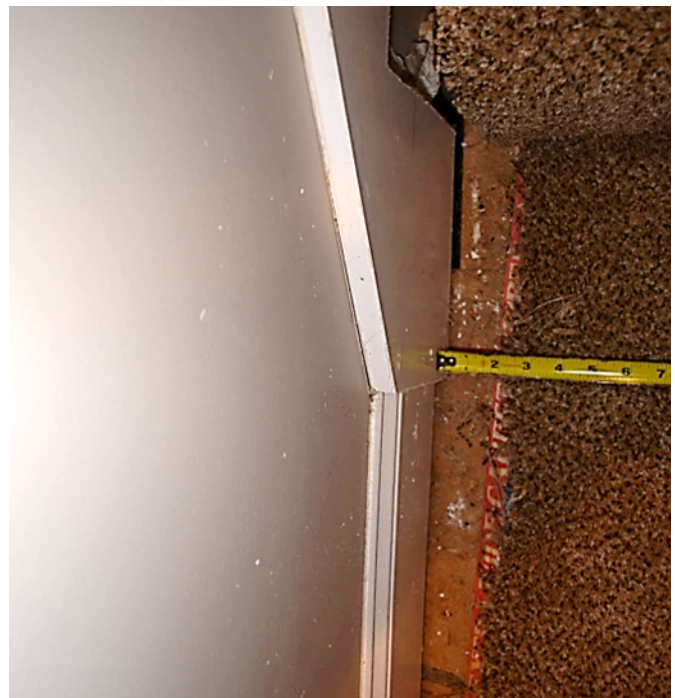
Figure 9

Lower stairway landing at the front foundation wall with an approximate 2-inch gap.

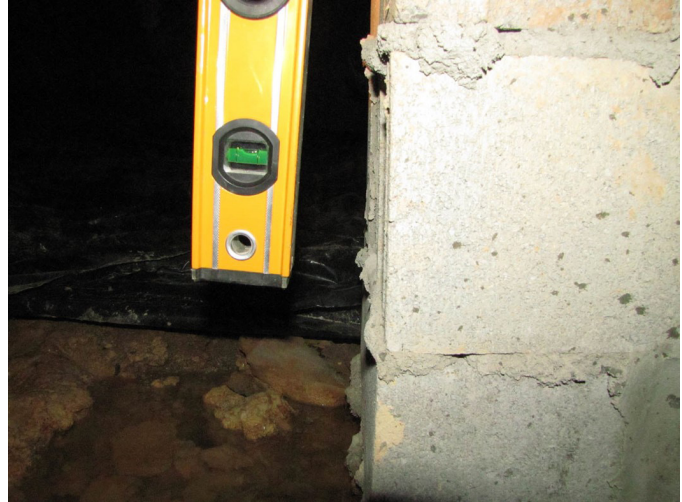
Figure 11

Interior foundation piers in the right crawl space area leaned rearward approximately 2 inches, measured using a 29-inch level (**Figure 11**). Active water movement was observed beneath the polyethylene vapor barrier in the right crawl space region such that the soils of the floor were saturated, soft, and incapable of supporting load. As an example of the soil's condition, while gathering data, A-FE's knees sunk into the mud between 4 and 6 inches throughout most of the right side of the crawl space, while crawl space soil on the left remained reasonably firm and provided resistance to movement. The front foundation wall was broken at interior and exterior wall corners as well as vertical cracks in the field of the wall. Active water movement through the crawl space had eroded soil from

Right-side floor system pier measurement from plumb with active water surrounding the column.

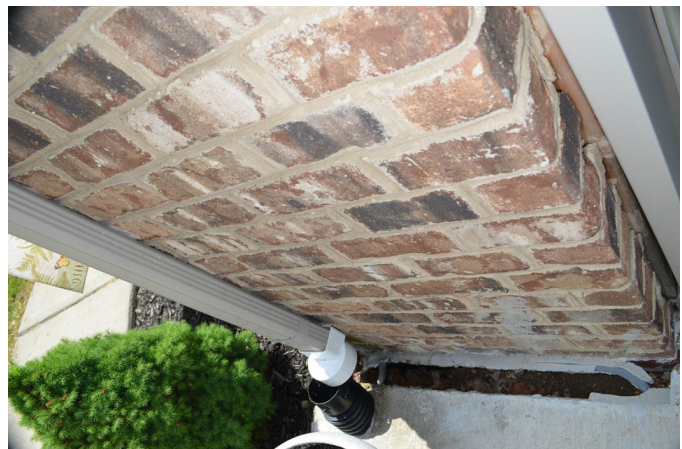
Figure 12

Front right corner of structure at the garage with displacement of structure to the west manifested by gap with driveway and roof drainage down-spout leader connection.

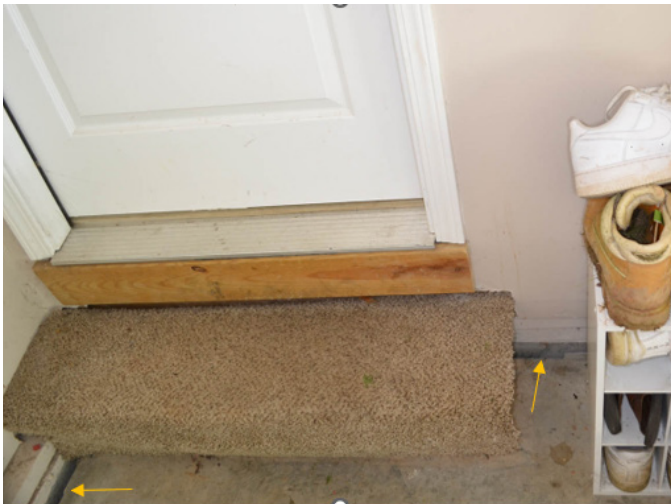
walls (**Figure 13**). The gap at the garage door entrance increased from the rear jamb to the front jamb, indicating that the right-side masonry of the structure was somewhat restricted from movement as compared to the wood framing (**Figure 14**).

Figure 13
Garage floor separation of 1 to 1½ inches from rear and left foundation walls.

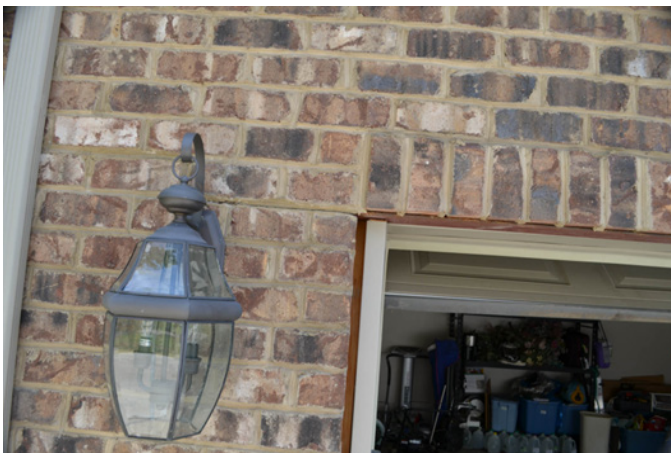
Figure 14
Front garage door jamb separation from brick masonry veneer because first level framing system was being forced rearward by connection to the front foundation wall.

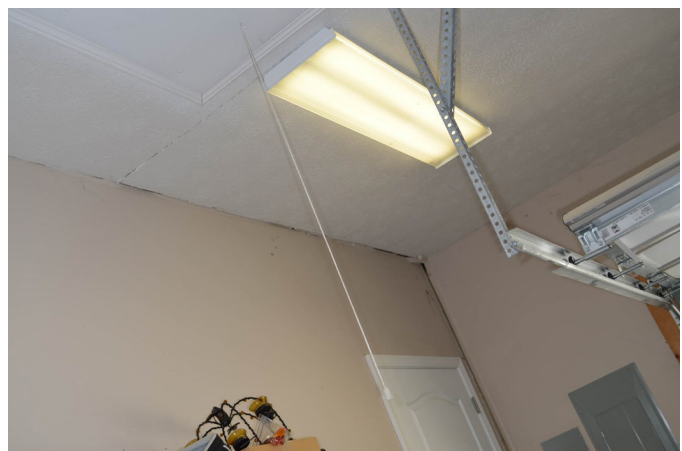
Figure 15
Right rear corner of the garage at the ceiling with displacement of structure manifest by gap with the ceiling and wall at the electrical distribution panel.

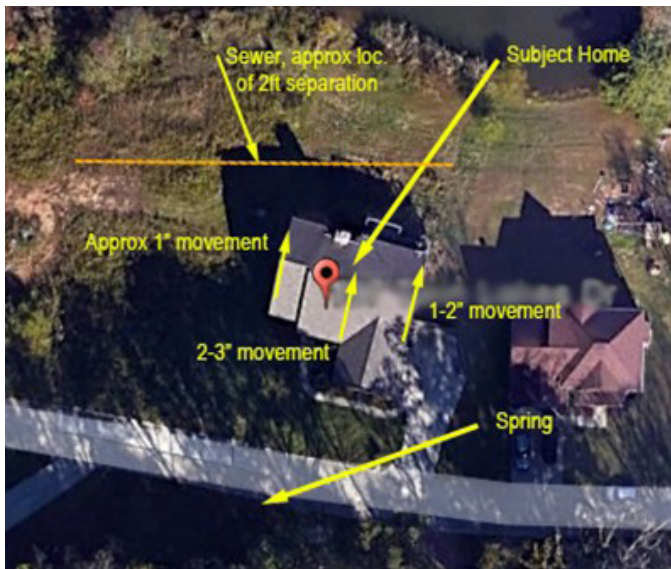
Figure 16

Water from the spring upgradient from the subject structure provided constant water flow that had three cumulative consequences: increased the unit density of the restrained soil behind the foundation wall; reduced the internal friction of the soil structure; and increased hydrostatic pressure bearing on the front foundation wall. The home was not only forced rearward on its foundation but also rotated about the driveway retaining wall, generally at the right side based on the tapered gap between the garage floor slab and driveway slab (viewed north to south). Estimated movement by the structure was approximately 1 inch along the left side wall, approximately 3 to 4 inches of movement at the central region of the basement floor system, and 2 to 3 inches of movement rearward along the right side wall (**Figure 16**).

Site plan showing spring, street and lake in relation to structure and movement observations.
(Aerial imagery from Map West Virginia, mapwv.gov)
