FE Investigation of Design and Quality Control-Related Issues Contributing to Metal-On-Metal Hip Implant Failures

By Olin Parker, Jahan Rasty, PhD, PE, DFE (NAFE 768S), and Matthew Mills, PE, DFE (NAFE 1199A)

Abstract

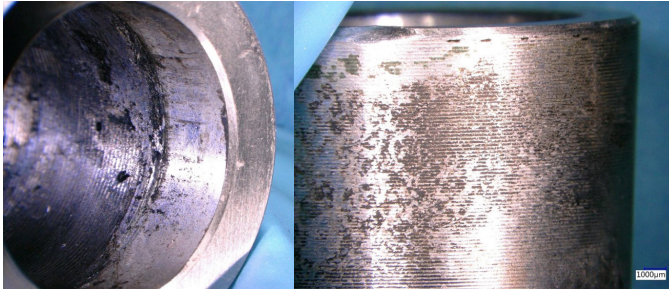
Figure 10

Images of the taper sleeve from one of the retrieved devices, displaying black corrosion features and imprinted lines.

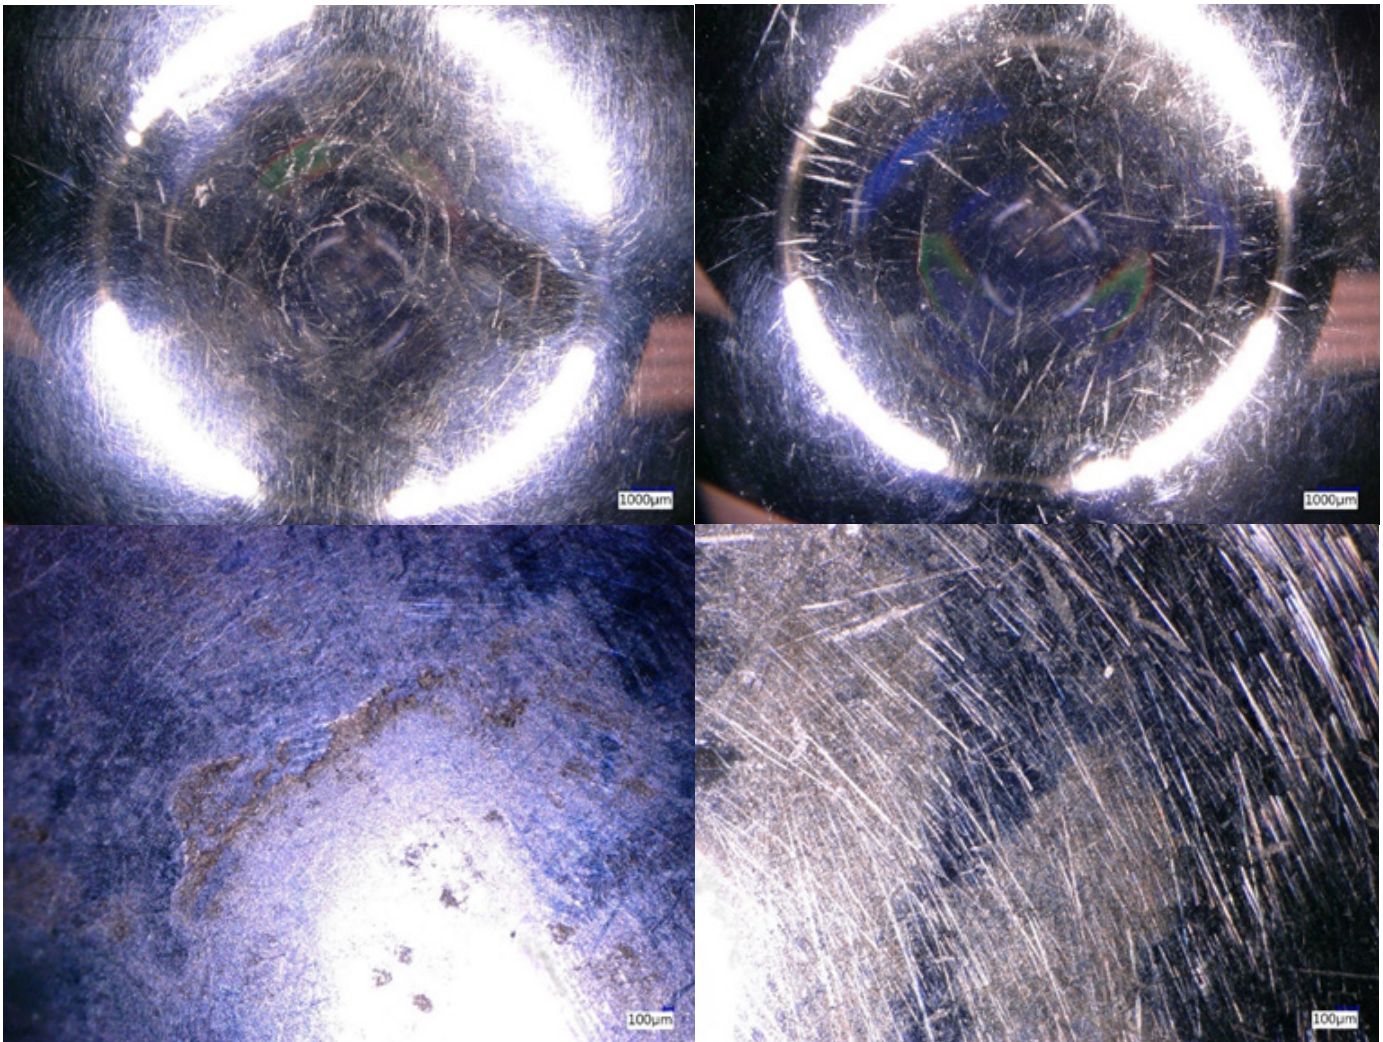
Figure 11

abrasive wear in addition to areas of corrosive degradation (Figure 11).

Image of the top of two femoral heads, showing a large number of surface scratches indicative of abrasive wear as well as corrosion.

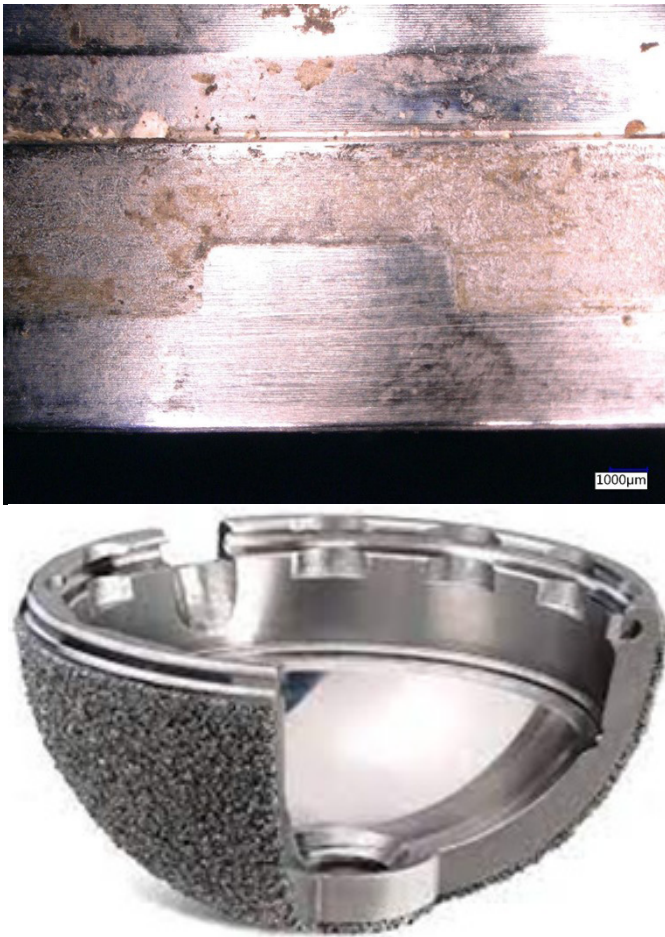
Figure 12

contact with the shell (**Figure 12**). These markings matched up with similarly sized square teeth on the shell, and the areas where direct connection existed between the liner and shell showed an increased level of corrosion and discoloration.

Image of the imprinting marks left behind on the outer surface of the metal liner (top) and a Ti6Al4V shell similar to the one it was connected to, displaying similarly sized rectangular teeth (bottom).

Modular MoM THA devices that utilized metal liners presented yet another modular interface for MACC to occur. As shown by the square teeth-shaped imprinting marks, there were portions of the liners that were directly mated to the shell with the imprinting marks left behind by the areas that were not directly mated as a result of the square gaps in the shell. The micromotion that took place between the metal liner and shell further generated the release of metal ions into the recipients bodies⁴⁸. More recently, dual mobility components consisting of a polyethylene liner, mated between a metal liner and femoral head, have been noted to suffer from elevated metal ions as a result of the coupling between the CoCrMo liner and Ti6Al4V shell. This adds further support for the conclusion that the use of metal liners significantly increased the level of metal ions in a recipient's body^{49,50}.

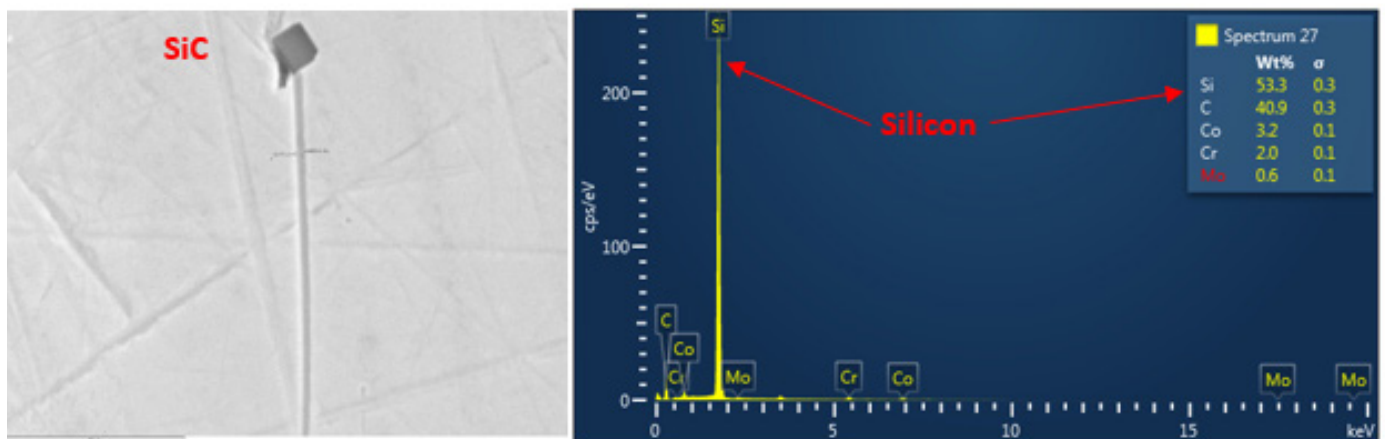
Figure 20

During SEM/EDS examination of the femoral heads, several surface imperfections were discovered, which were found to have an elemental makeup different from the bulk CoCrMo material. EDS results revealed a spike in the amounts of silicon and carbon (**Figures 20 and 21**)

as well as aluminum and oxygen (**Figures 22 and 23**) present in the vast majority of these imperfections. Based on the observed geometry of these particles, it was concluded that these imperfections were SiC particles and Al₂O₃ particles — both being very hard materials often used in surface polishing applications.

SEM image (left) and EDS results (right) showing a high concentration of silicon and carbon. The silicon-based imperfection was also noted to be embedded at the end of a deep surface scratch, most likely caused by said particle.

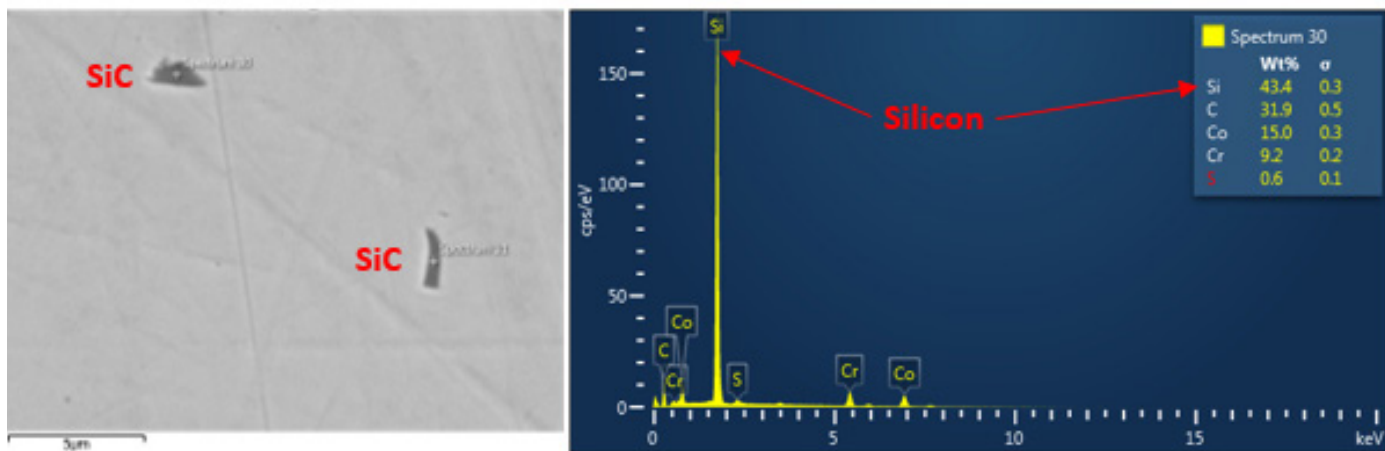
Figure 21

SEM image (left) and EDS results (right) showing embedded particles containing a high concentration of silicon and carbon.

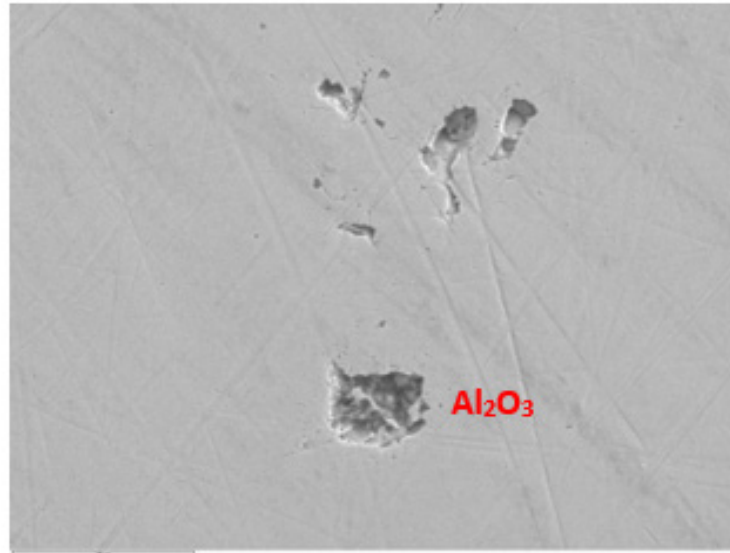
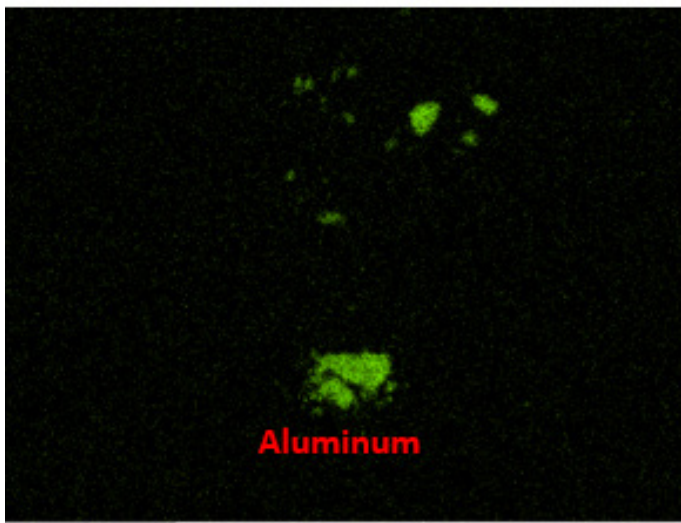
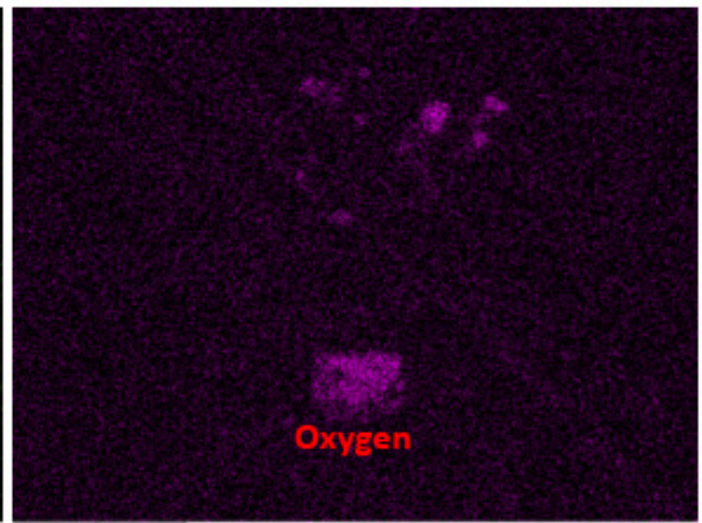
Figure 22

SEM image (top) and its associated EDS maps showing the presence of aluminum (bottom left) and oxygen (bottom right) concentrated in cracks and furrows on the hip, identifying the embedded surface particle as aluminum-oxide, which is routinely used in polishing compounds.

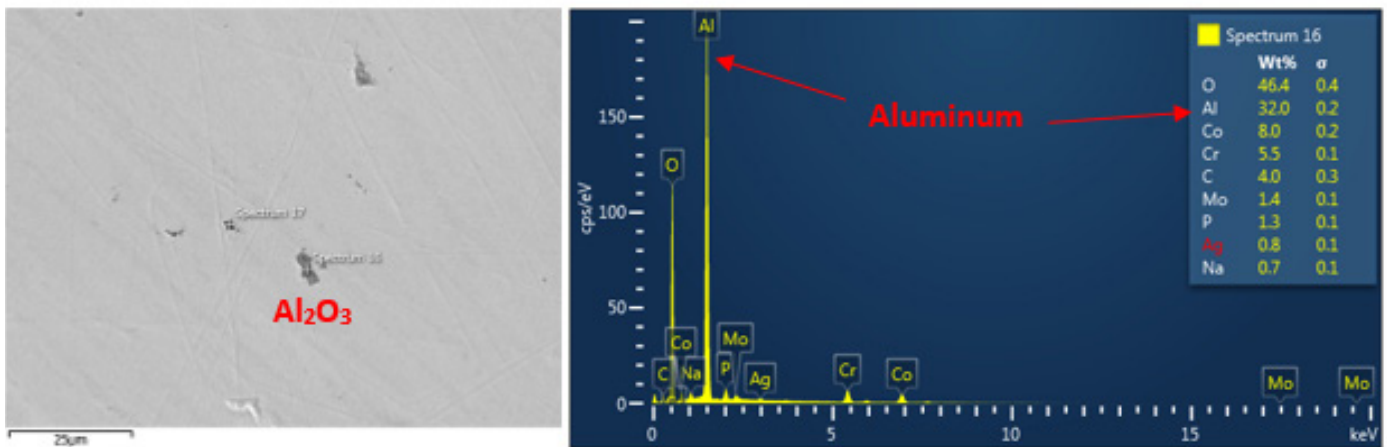
Figure 23

SEM image (left) and EDS results (right) showing high concentration of aluminum and oxygen, indicative of the presence of a micron-sized particle consisting primarily of aluminum and oxygen.

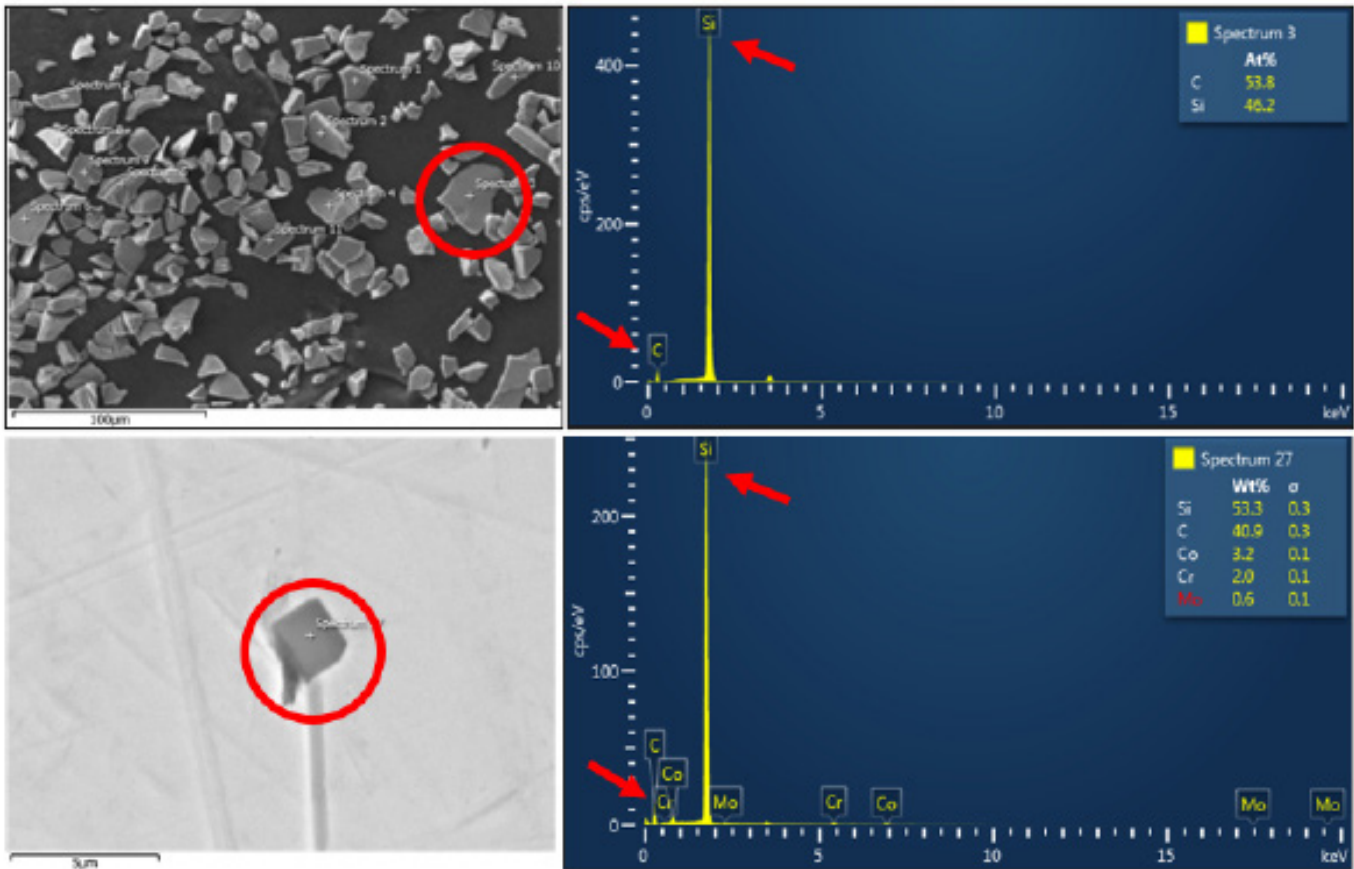
Figure 26

Comparison between exemplar SiC powder (top) and subject explant surface (bottom) with SEM images (left) and EDS results (right). Location of EDS analysis indicated by red circle. Silicon (Si) and carbon (C) EDS results are indicated by red arrows.

Additionally, the morphology of the particles on the explants were very similar to those found in the SiC powder and Al_2O_3 slurry. In the absence of alternative explanations for the presence of these imperfections, it was concluded the particles observed on the surface of the femoral heads were most likely SiC and Al_2O_3 left behind from the

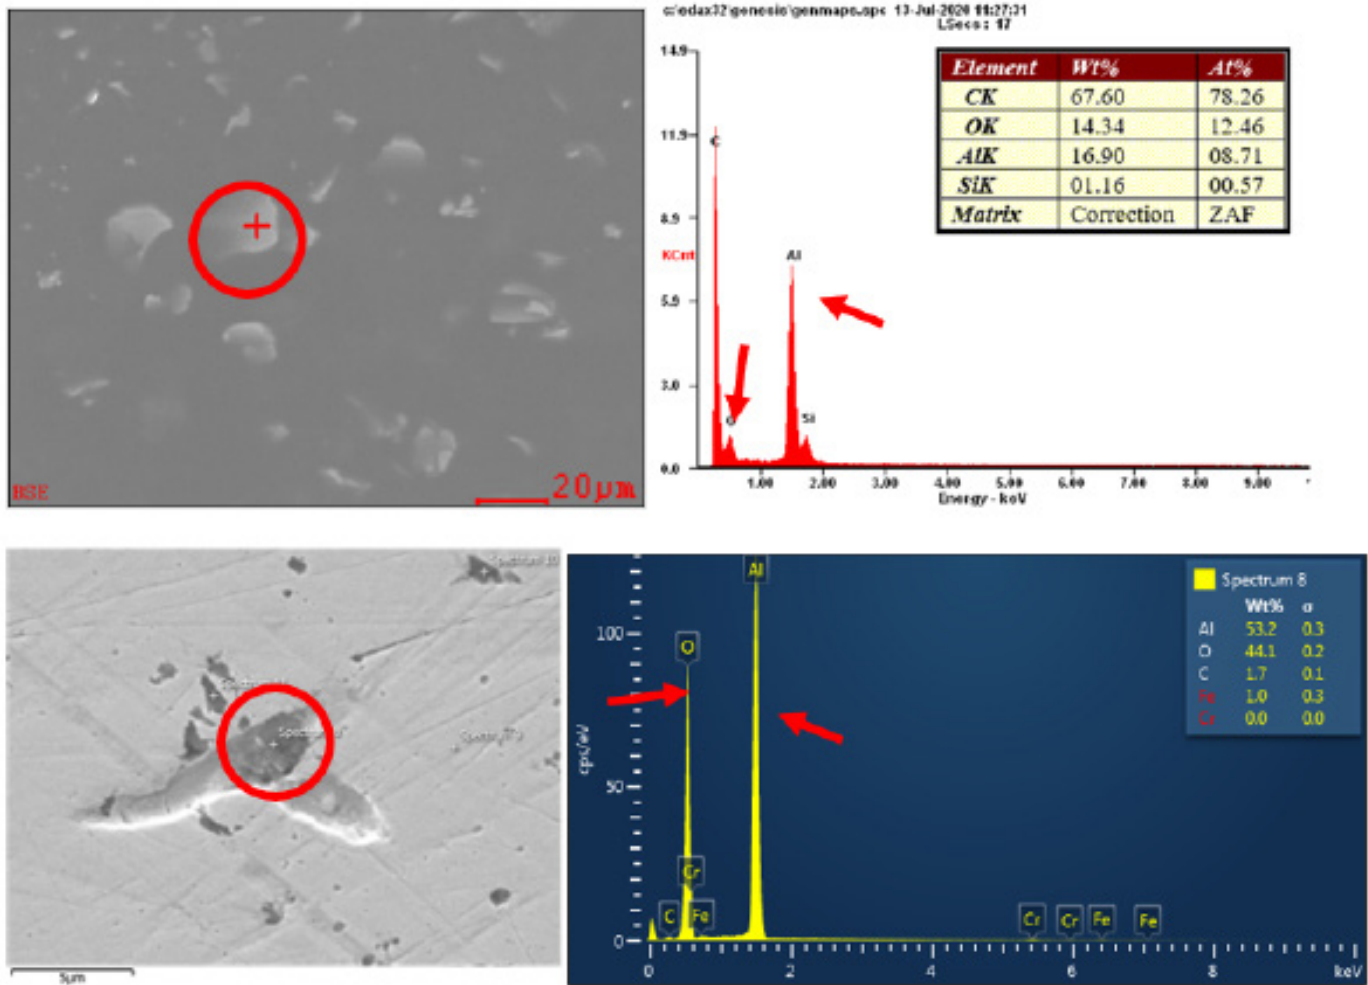
Figure 27

Comparison between exemplar Al_2O_3 slurry (top) and subject explant surface (bottom) with SEM images (left) and EDS results (right). Location of EDS analysis indicated by red circle. Aluminum (Al) and oxygen (O) EDS results are indicated by red arrows.

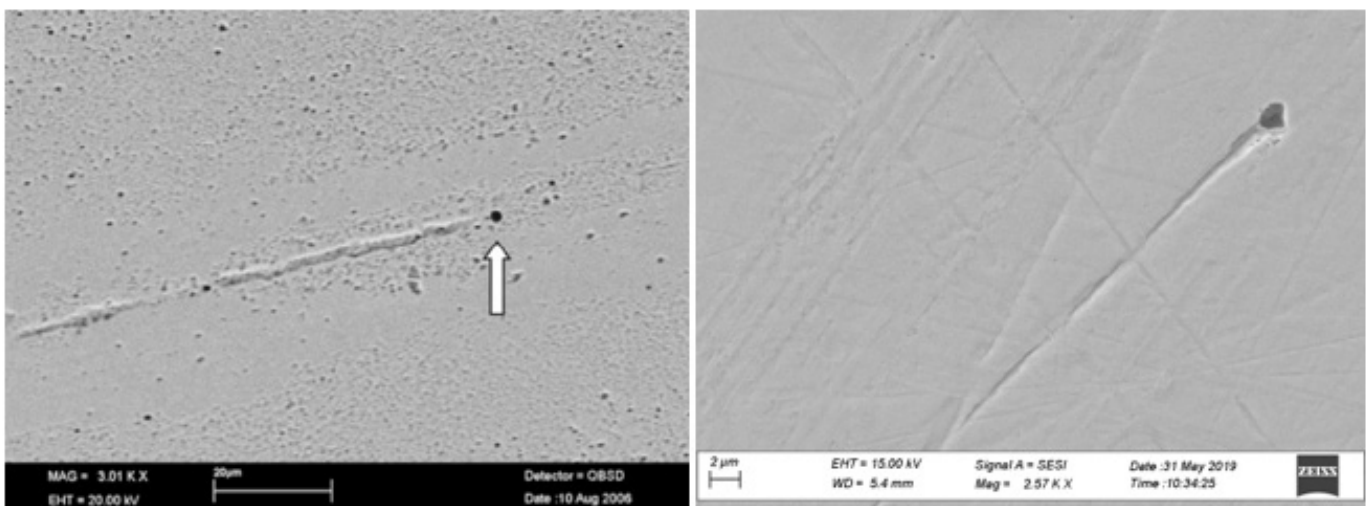
Figure 28

SEM image showing a figure from a study with “scratch originating from alumina filled pit ([white] arrow)” (left) and SEM image from the subject modular S&N femoral head with a similar scratch or furrow adjacent to the pit (right), which exhibited high levels of aluminum (Al) and oxygen (O) consistent with aluminum oxide (Al_2O_3), another polishing agent used during the polishing step of manufacturing.

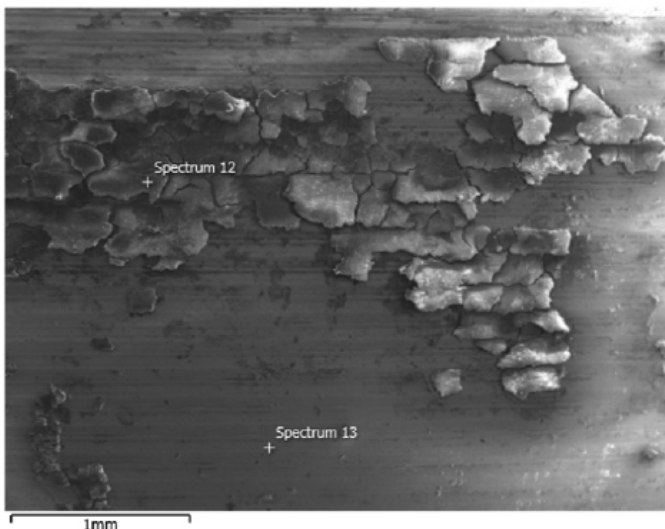
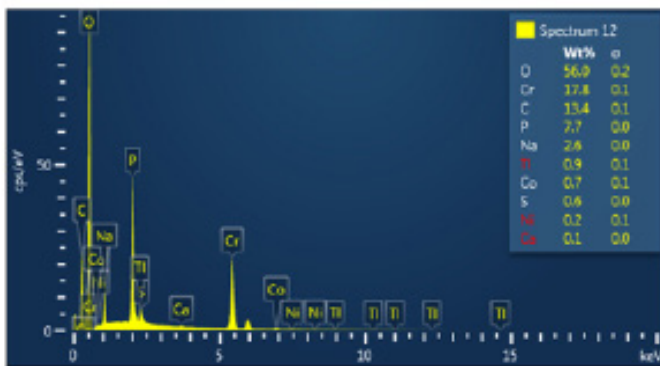
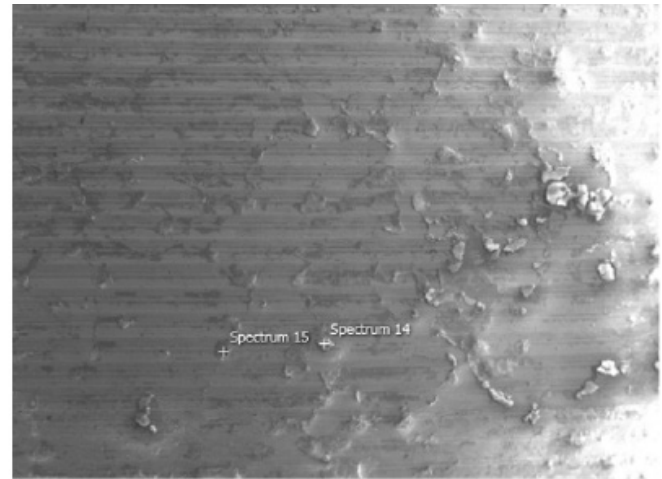
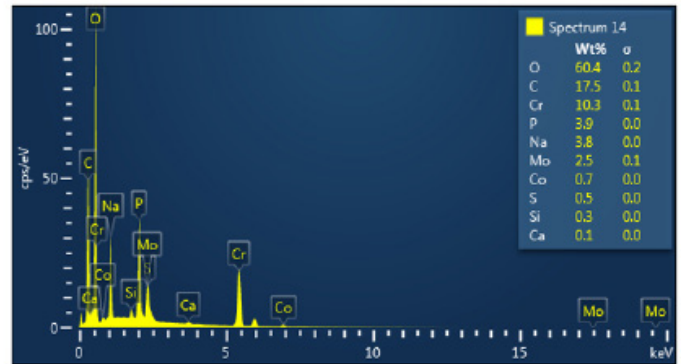
Figure 30

SEM and EDS results from one of the tapers available for such analysis. These images show macroscopically visible particles containing chromium, carbon, and oxygen.

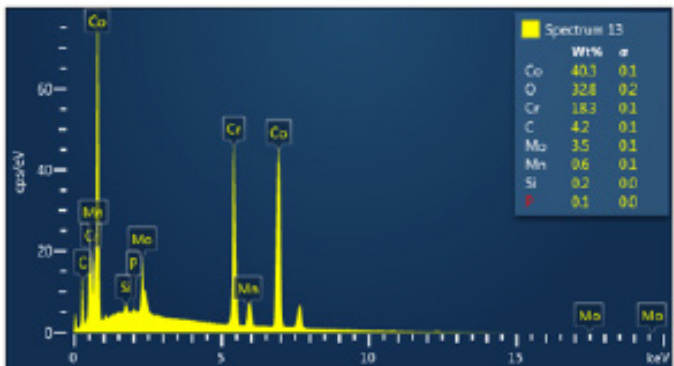
Figure 29

SEM and EDS results from one of the tapers available for such analysis. These images show the presence of chromium and oxygen-rich debris distinct from the base alloy.

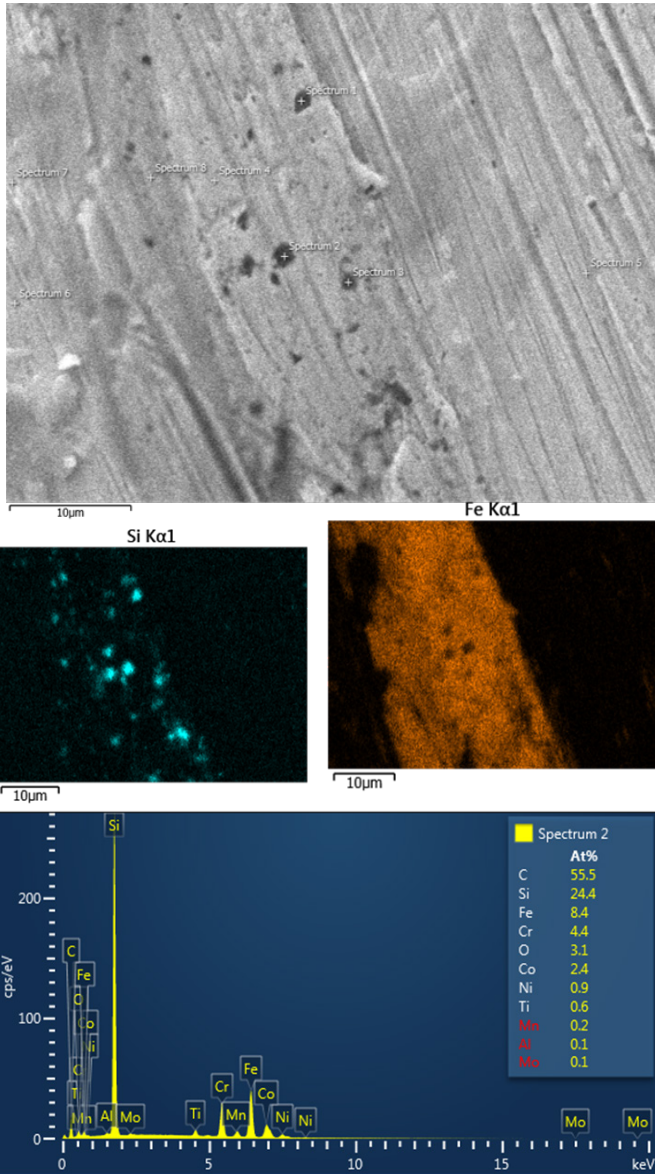
Figure 31

Analysis of the metal liners revealed similar SiC particles to those found on the heads. A coating of iron and nickel was observed on the surface of these liners, likely

SEM and EDS of a metal liner, showing embedded SiC particle and biological products.

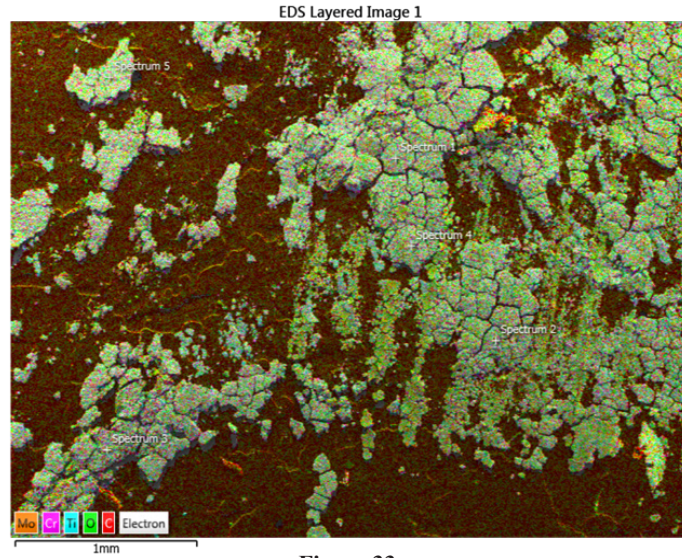
Figure 33

SEM and EDS analysis of the recovered corrosion debris revealed the presence of chromium, molybdenum, titanium, and oxygen (**Figures 33 through 35**).

EDS map of the debris collected from the interior surface of the subject taper sleeve.

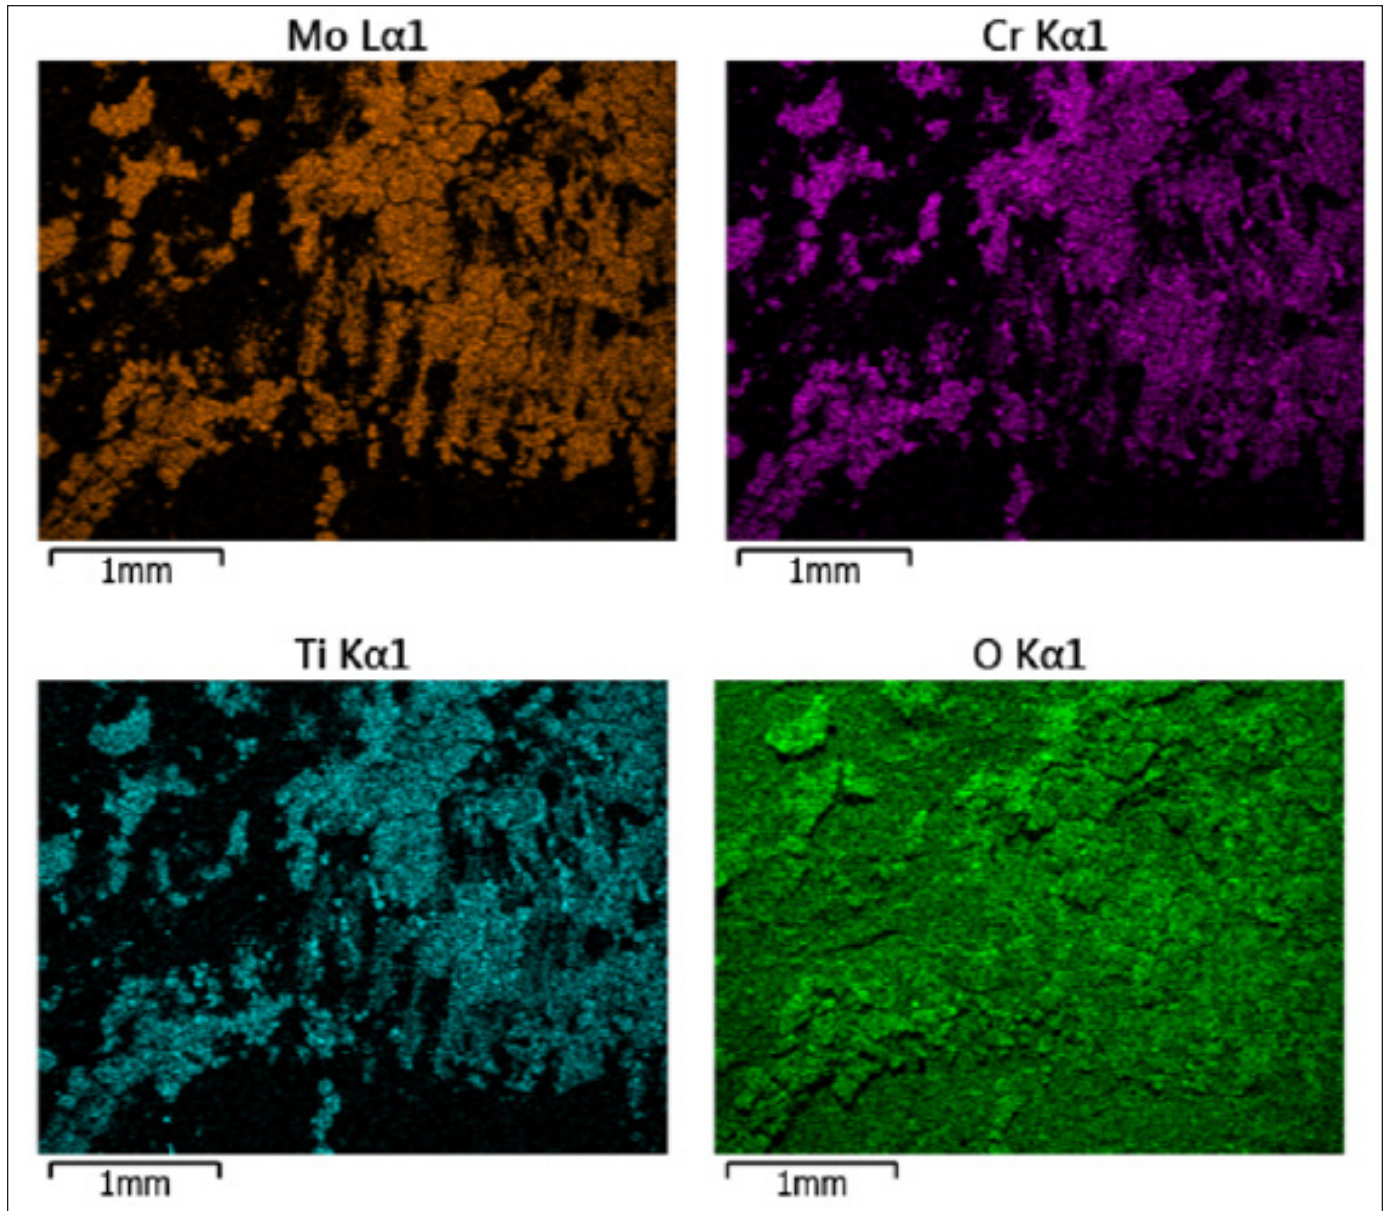
Figure 34

Based upon the results of the conducted test, as well as the information presented in the aforementioned research, the chromium-rich debris along with the elevated levels of cobalt ions found in the blood of the recipients of the devices indicate that, within a reasonable degree of scientific and engineering probability, the majority of wear particulate and metal ions found in their body originated

EDS maps of individual elements from the debris collected from the interior surface of the subject taper sleeve.

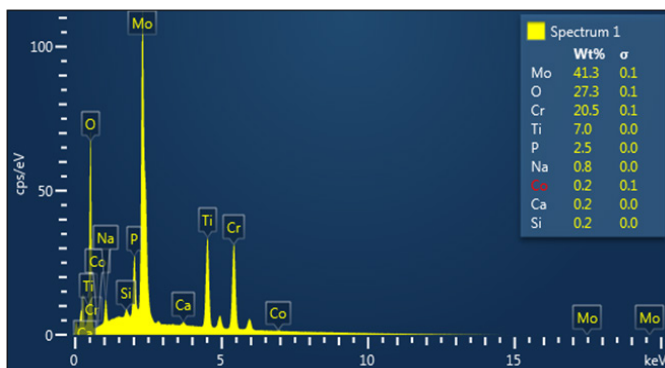
Figure 35

EDS results from the debris collected from the interior surface of the subject taper sleeve.
