FE Investigation of Maintenance and Operational Factors Contributing to the Collapse of a Crane Boom

By Olin Parker, Jahan Rasty, PhD, PE, DFE (NAFE 768S), and Matthew Mills, PE, DFE (NAFE 1199A)

Abstract

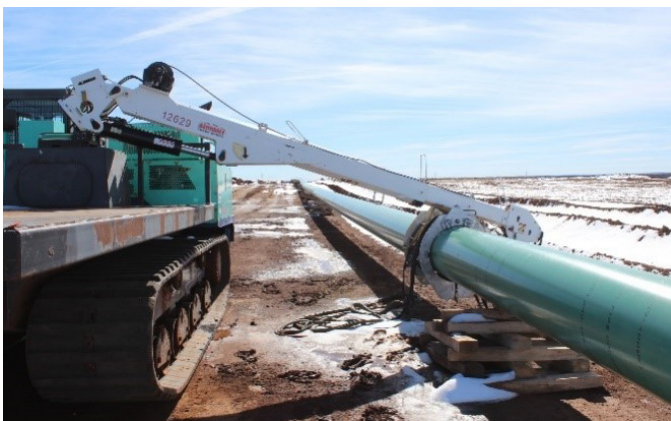
Figure 1

The collapsed crane boom at the site of the incident.

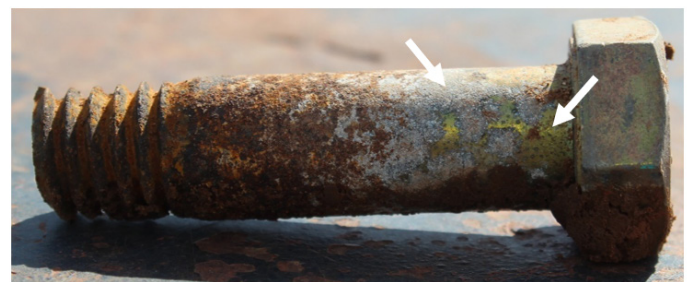
Figure 5

zinc on their heads, and a number of the bolts displayed significant depletion of this coating on the bolt shank and threads (**Figure 5**). It is likely that the yellow zinc coating was depleted from the bolt heads over a long period of exposure to water or other corrosive mediums while these same corrosive mediums stagnated in the notches and bolt holes, allowing for the coating on the body of the bolt to

Heavily oxidized (rusty) surface of bolt #9, displaying iron oxide and traces of the chromate and zinc galvanic coating (highlighted by the white arrows).

be removed and result in the corrosion of the bolt shank and threads. While a small amount of corrosion was noted on the fracture surfaces of some of the bolts (**Figures 6 and 7**), comparison with extensive corrosion noted on the exterior surface of the bolts (**Figure 5**) indicates that this corrosion likely occurred following the failure as the fracture surface was exposed to four days of snowfall before the bolts were retrieved during the authors' inspection.

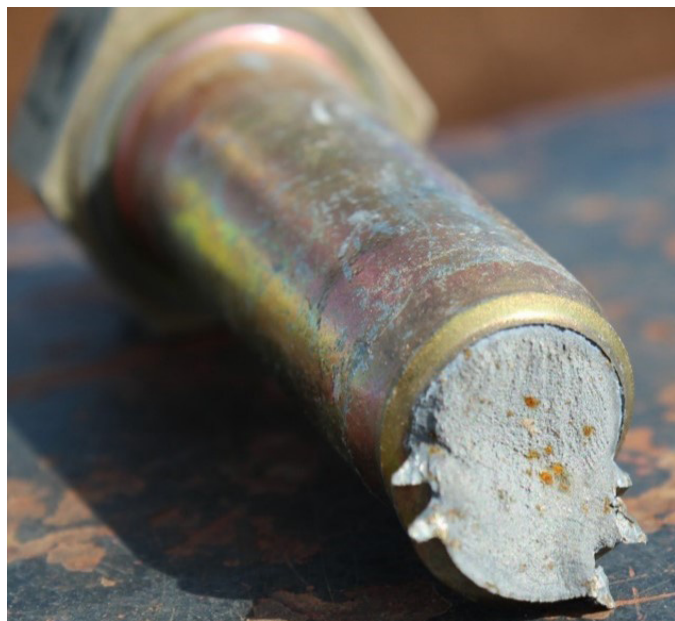
Figure 6

One of the failed bolts, showing a metallic yellow coating characteristic of yellow zinc.

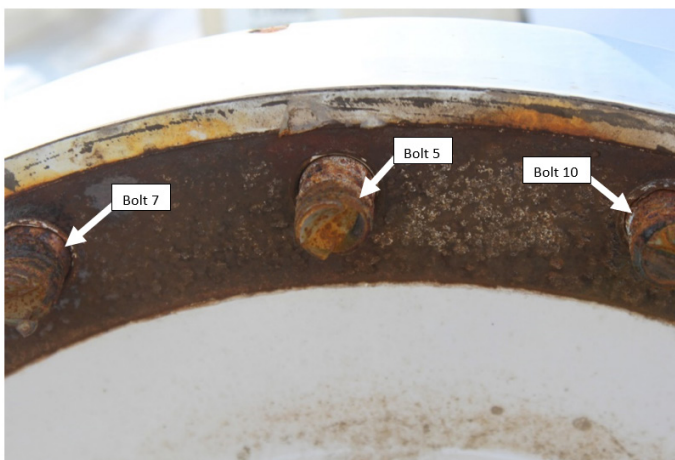
Figure 7

Bolts 7, 5, and 10 — still in their bores at the time of inspection. Note the severity of corrosion.

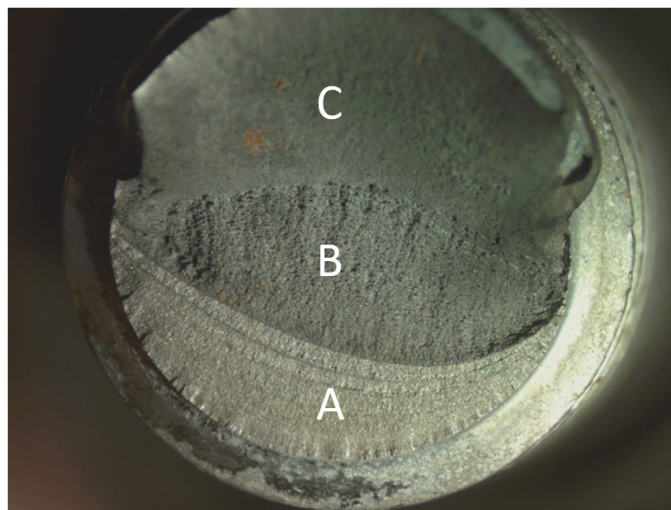
Figure 8

A common fracture pattern noticed amongst the failed bolts was the presence of area (A), having features consistent with fatigue, followed by an intermediate region (B) with rough, parallel crack arrest marks (indicative of

particularly low cycle fatigue), and finally a region (C) indicative of fast fracture through an inclined fracture plane (shear lip), as shown in **Figure 8**.

Fracture regions observed in a typical failed bolt fracture surface: A (fatigue beach marks), B (low-cycle crack arrest marks), and C (final sudden fracture).

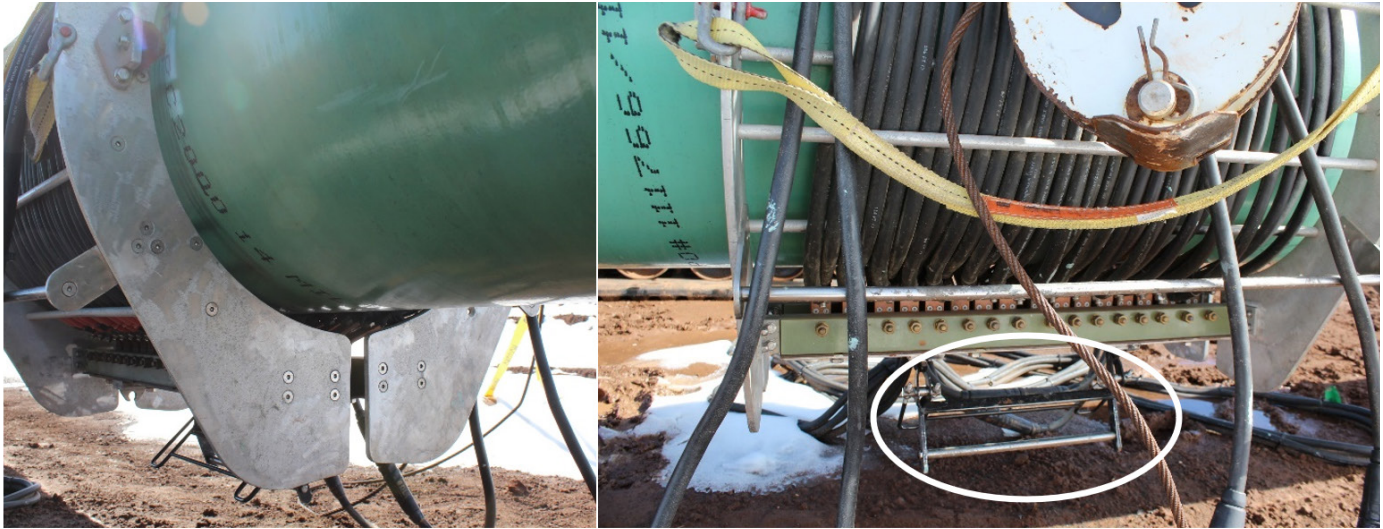
Figure 10

Images of the heating ring, displaying no apparent signs of damage to the ring itself or the securement clamp (circled in white).

heating ring would have failed, or, at a minimum, displayed clear signs of damage if the heating ring had been used to raise any section of the pipe. Visual examination of the heating ring showed no signs of damage to either the clamp joint or the bottom portion of the heating ring itself, indicating that the crane boom was not overloaded through improper detachment of the heating ring. This conclusion was further corroborated by the failure analysis reports of the crane boom manufacturer and bolt manufacturer, both of which came to the conclusion that the heating ring was undamaged, and an overload failure did not occur.

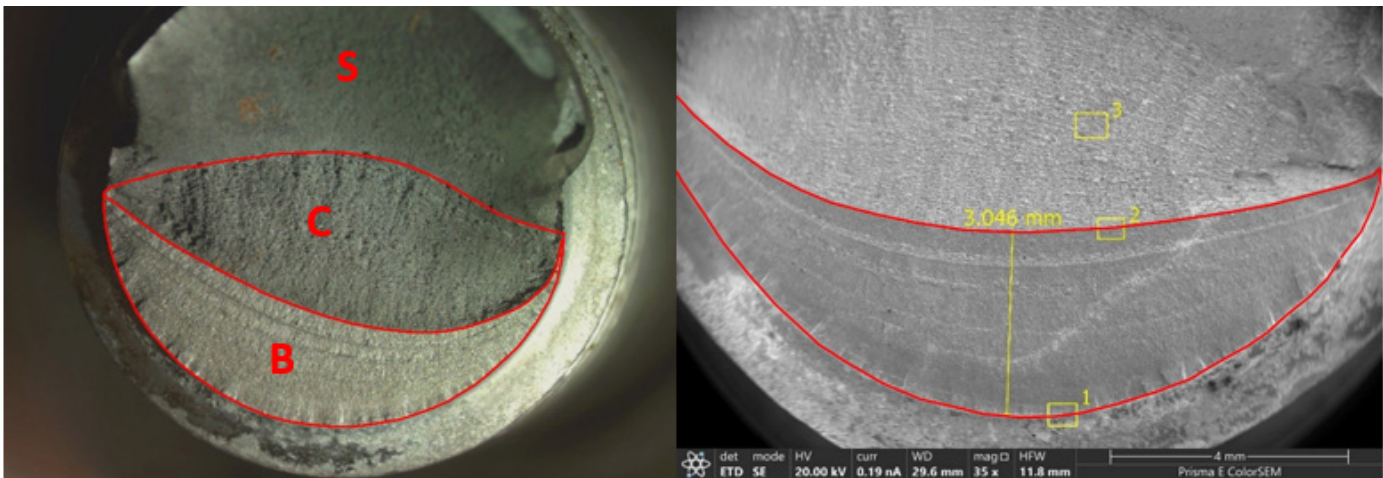
Figure 11

Fracture surface of Bolt #6, displaying three distinct regions. The presence of beach marks (B), parallel crack arrest marks (C), and a shear lip (S), are noted on the figure (left). A closer view of the beach marks and the parallel crack arrest marks are shown in the image to the right.

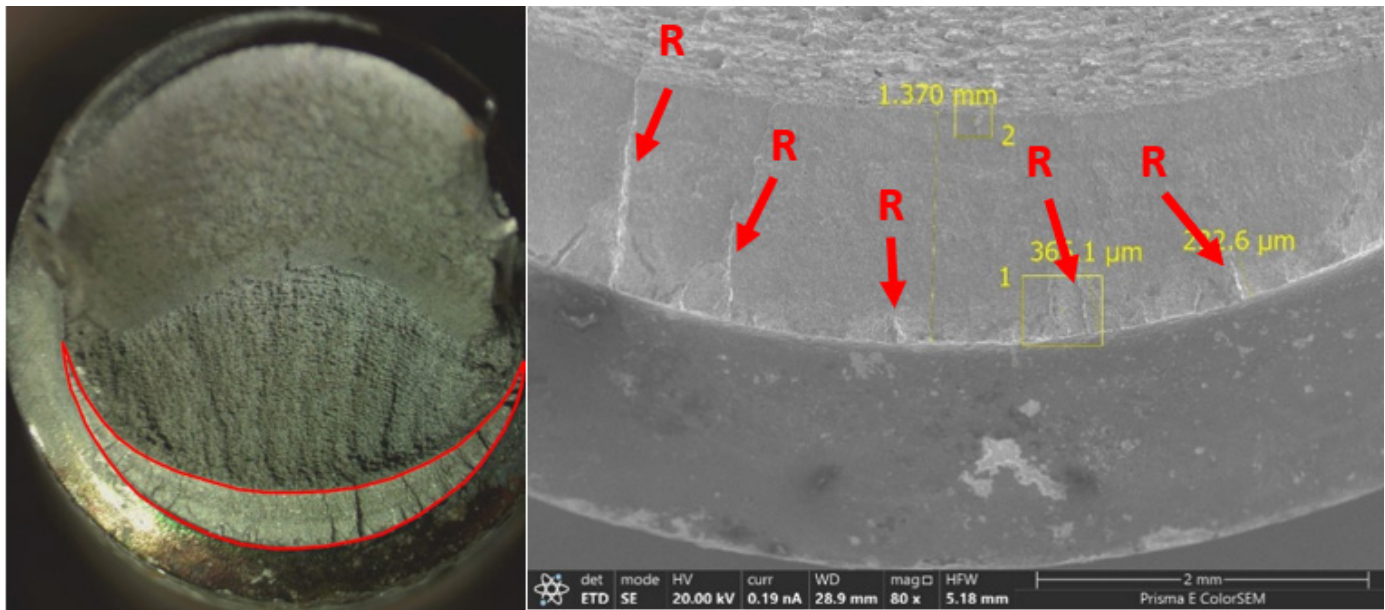
Figure 12

Fracture surface of Bolt #1, displaying crack arrest marks reaching up to the middle of the cross section. A smooth, outer zone with beach marks can be seen, signifying fatigue (left image). The fatigue region of this bolt also displays a number of ratchet marks, highlighted by the red arrows (right image).

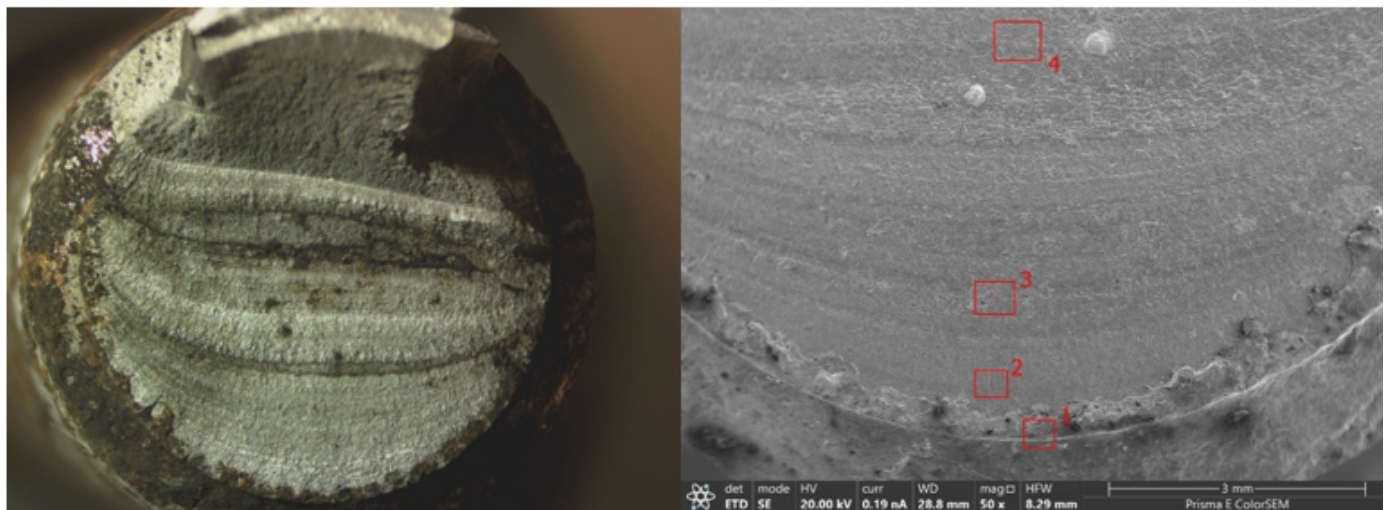
Figure 13

Fracture surface of Bolt #10, displaying a significantly large region of beach marks that extend through a majority of the bolt cross section.

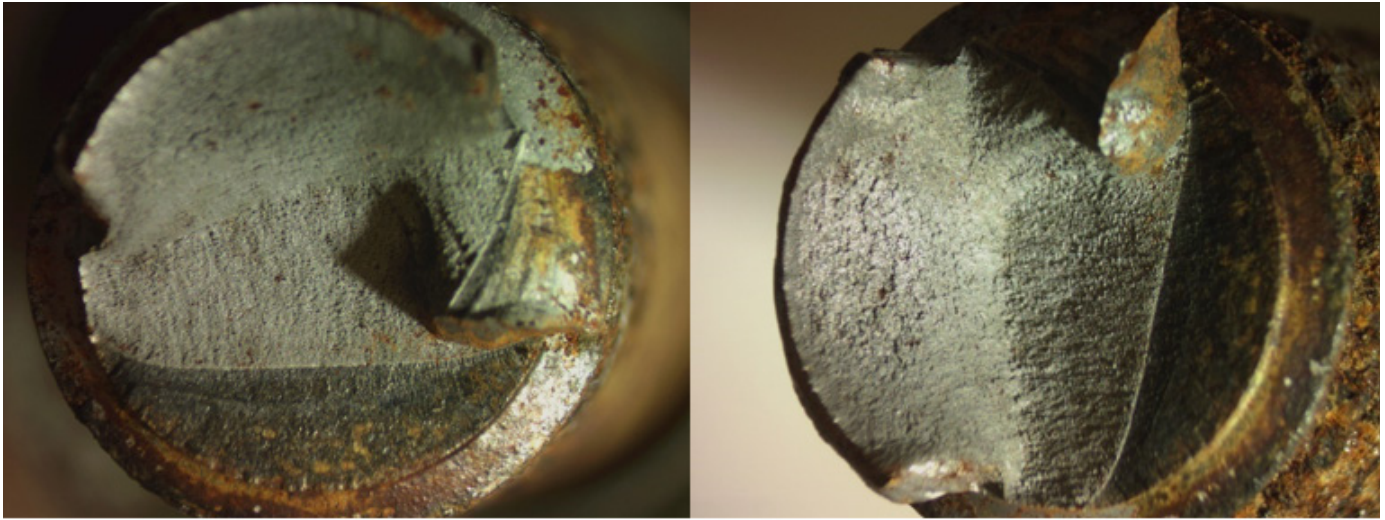
Figure 14

Fracture surface of Bolt #5, displaying a corroded beach marks region, indicative of the exposure of these bolts to a highly corrosive environment after the initial propagation of this fatigue region.

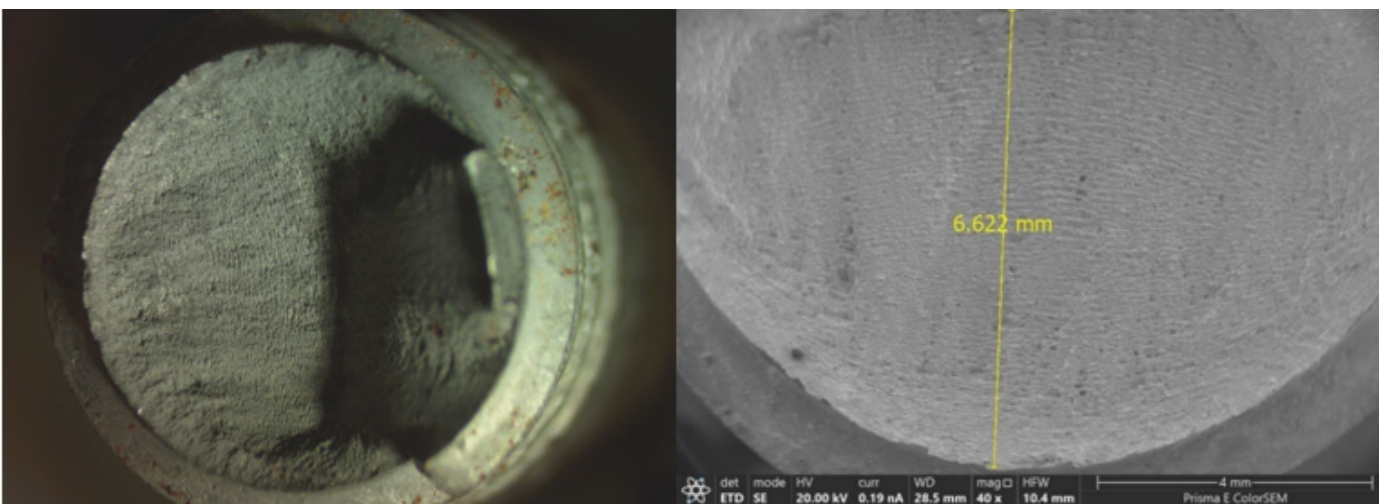
Figure 16

Parallel crack arrest marks observable on Bolt #3, covering more than half of the bolt's surface.

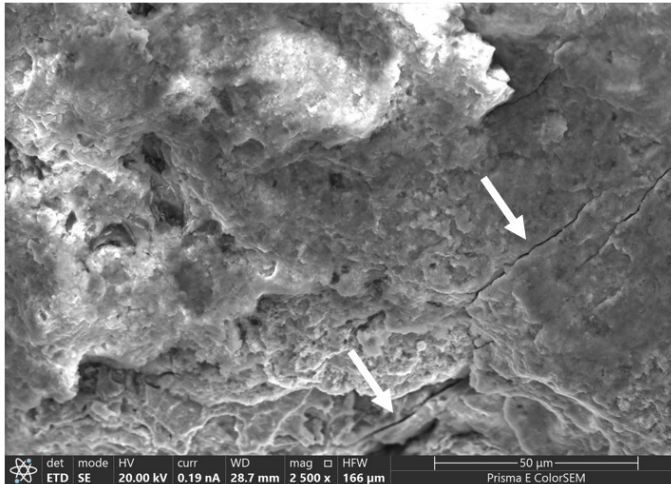
Figure 19

As the subject bolts were found to have hardness values of 39 HRC and were electroplated, hydrogen embrittlement was investigated as a potential factor contributing to the fatigue failure at issue. SEM of the failed bolts identified signs of stair-step cracking and intergranular fracture characteristics with pitting of exposed grains, a telltale sign of hydrogen embrittlement and stress corrosion cracking (**Figures 19 and 20**).

An SEM image of Bolt 10, showing fracture occurring along the grains of the material as well as the presence of stair step cracking along the grains of the material (white arrows).

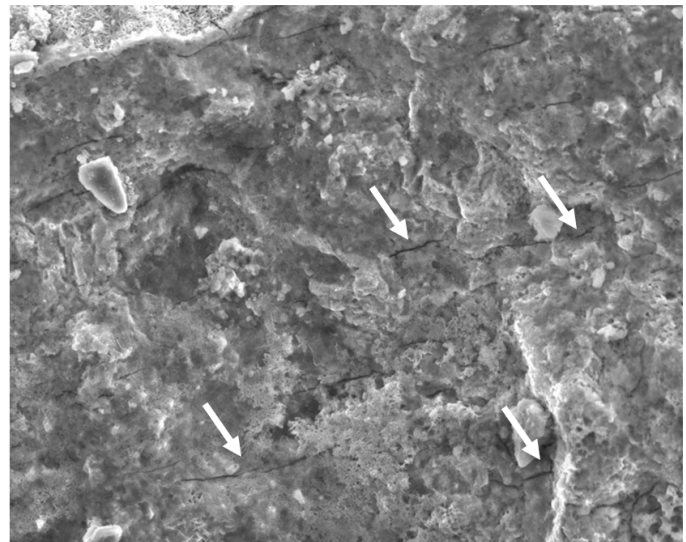
Figure 20

An SEM image of Bolt 5, displaying quasi-cleavage indicative of mixed inter and transgranular fracture.

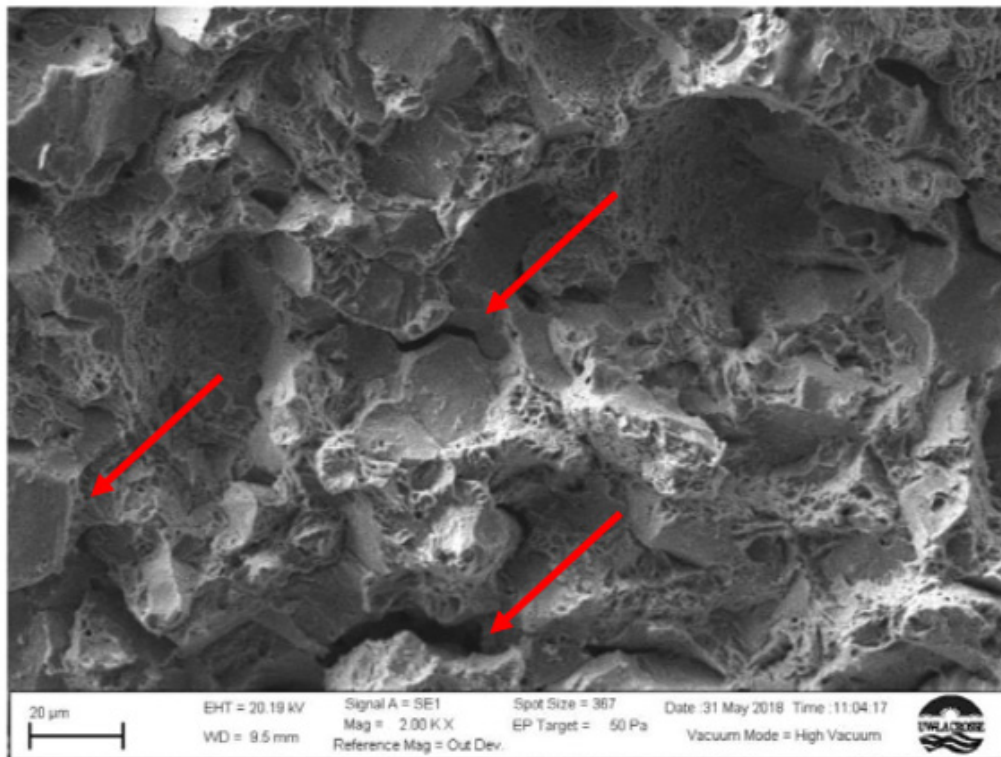
Figure 21

Another one of the cranes produced by the crane manufacturer was noted to have experienced failure in March of 2018, around a year after it was first assembled. As was the case with the previously mentioned incident, all of the 14 bolts on this crane were the same Grade 8 steel fasteners utilized in the subject crane. SEM analysis revealed extensive intergranular and quasi-cleavage fracture morphology typical in bolts subjected to hydrogen embrittlement (**Figure 21**).

Intergranular fracture features on the failed bolts from the 2018 incident, indicating embrittlement took place.
