Vol. 38 No. 1 June 2021

Lessons Learned from a Forensic Engineering Investigation of a Scaffold Support Failure

By John N. Schwartzberg, PE (NAFE 639F)

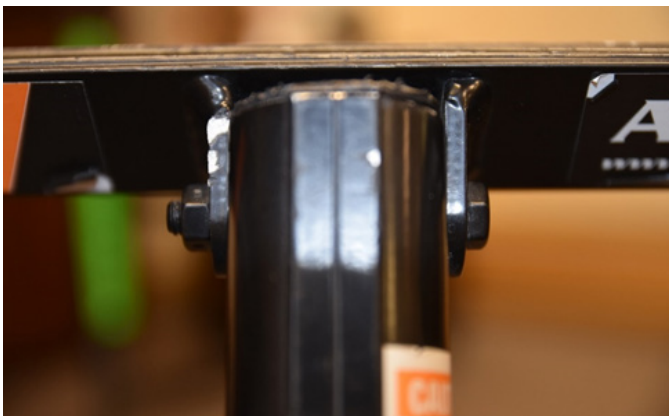
The tripod leg is attached to the top horizontal member (cross-brace) of the frame via a hinge mechanism, as shown in **Figure 2**. Two aluminum alloy 6061-T6 lugs are welded to the aluminum alloy 6005-T6 extruded member. The top of the tripod leg is secured between the lugs by a cap screw. Each lug is welded to the top cross-brace with a 0.25-inch fillet weld on the outside of the lug.

Figure 2
Arrangement of lugs and attachment of top of tripod leg to upper cross-brace.

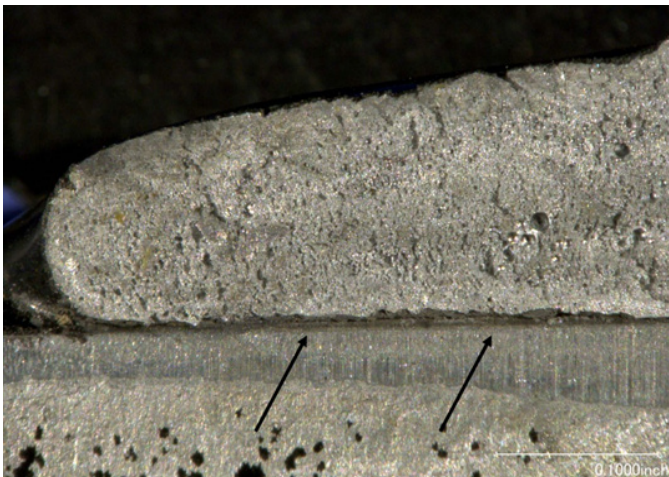
Figure 3

electron microscopy (SEM)* on one or both fractured lugs from the failed support. The radiography and SEM examination (coupled with optical microscopy), it was claimed, confirmed that the weld was defective. Examples are shown in **Figure 3** and **Figure 4**, which contain a photomicrograph of one of the lugs and X-ray of both lug locations.

Photomicrograph from the plaintiff's expert's preliminary report, highlighting lack of root penetration.

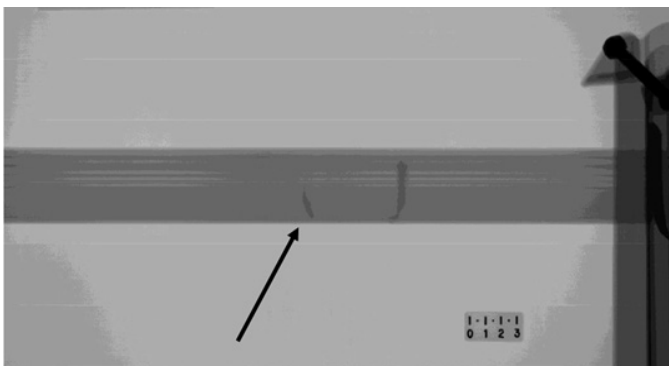
Figure 4

Photograph of radiograph from the plaintiff's preliminary report, indicating "very little weld penetration" on one of two failed lugs.

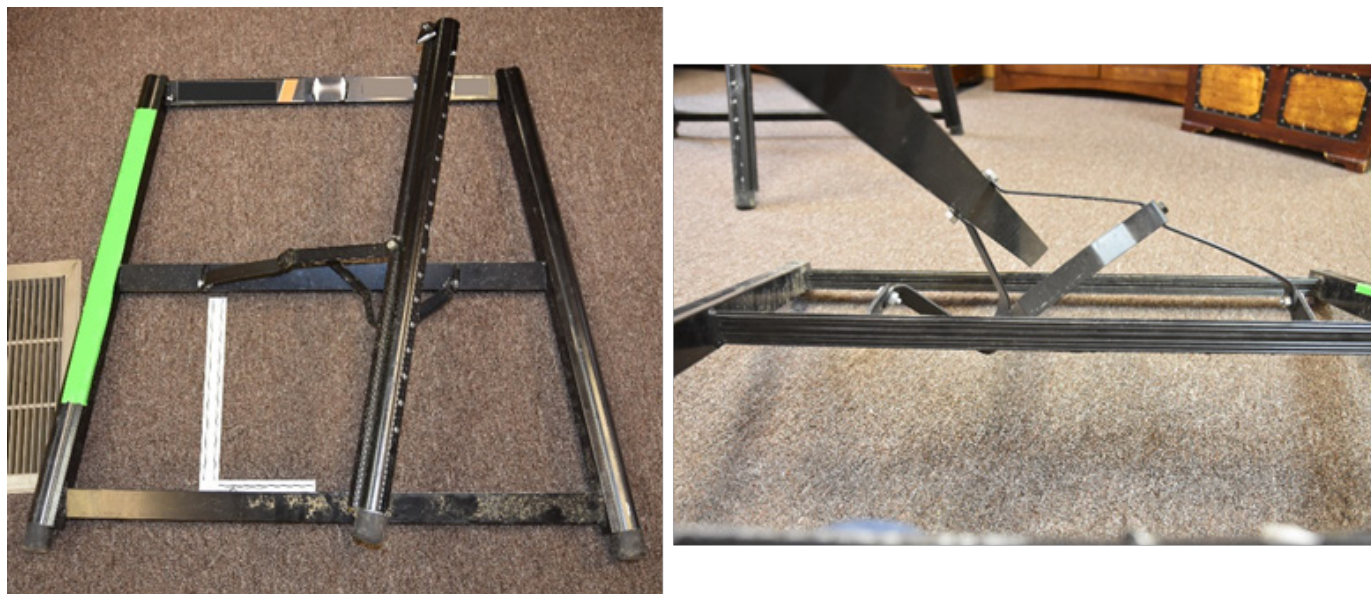
Figure 5

Examination of the physical evidence and review of this expert's documentation showed that the failed weld exhibited (at best) modest penetration at the root of the weld. However, the lugs exhibited evidence of a small amount of ductile deformation or permanent bending. This indicated that the weld was able to withstand sufficient load to allow the lugs to bend prior to fracture, which is inconsistent with the plaintiff's expert's claim that the weld failed at low loads and in a brittle manner. Two views of the failed support are presented in **Figure 5**.

Two overall views of failed scaffold support with legs collapsed. Note the fractured lug welds at top of left image and deformation of spreader bar assembly visible in both views.

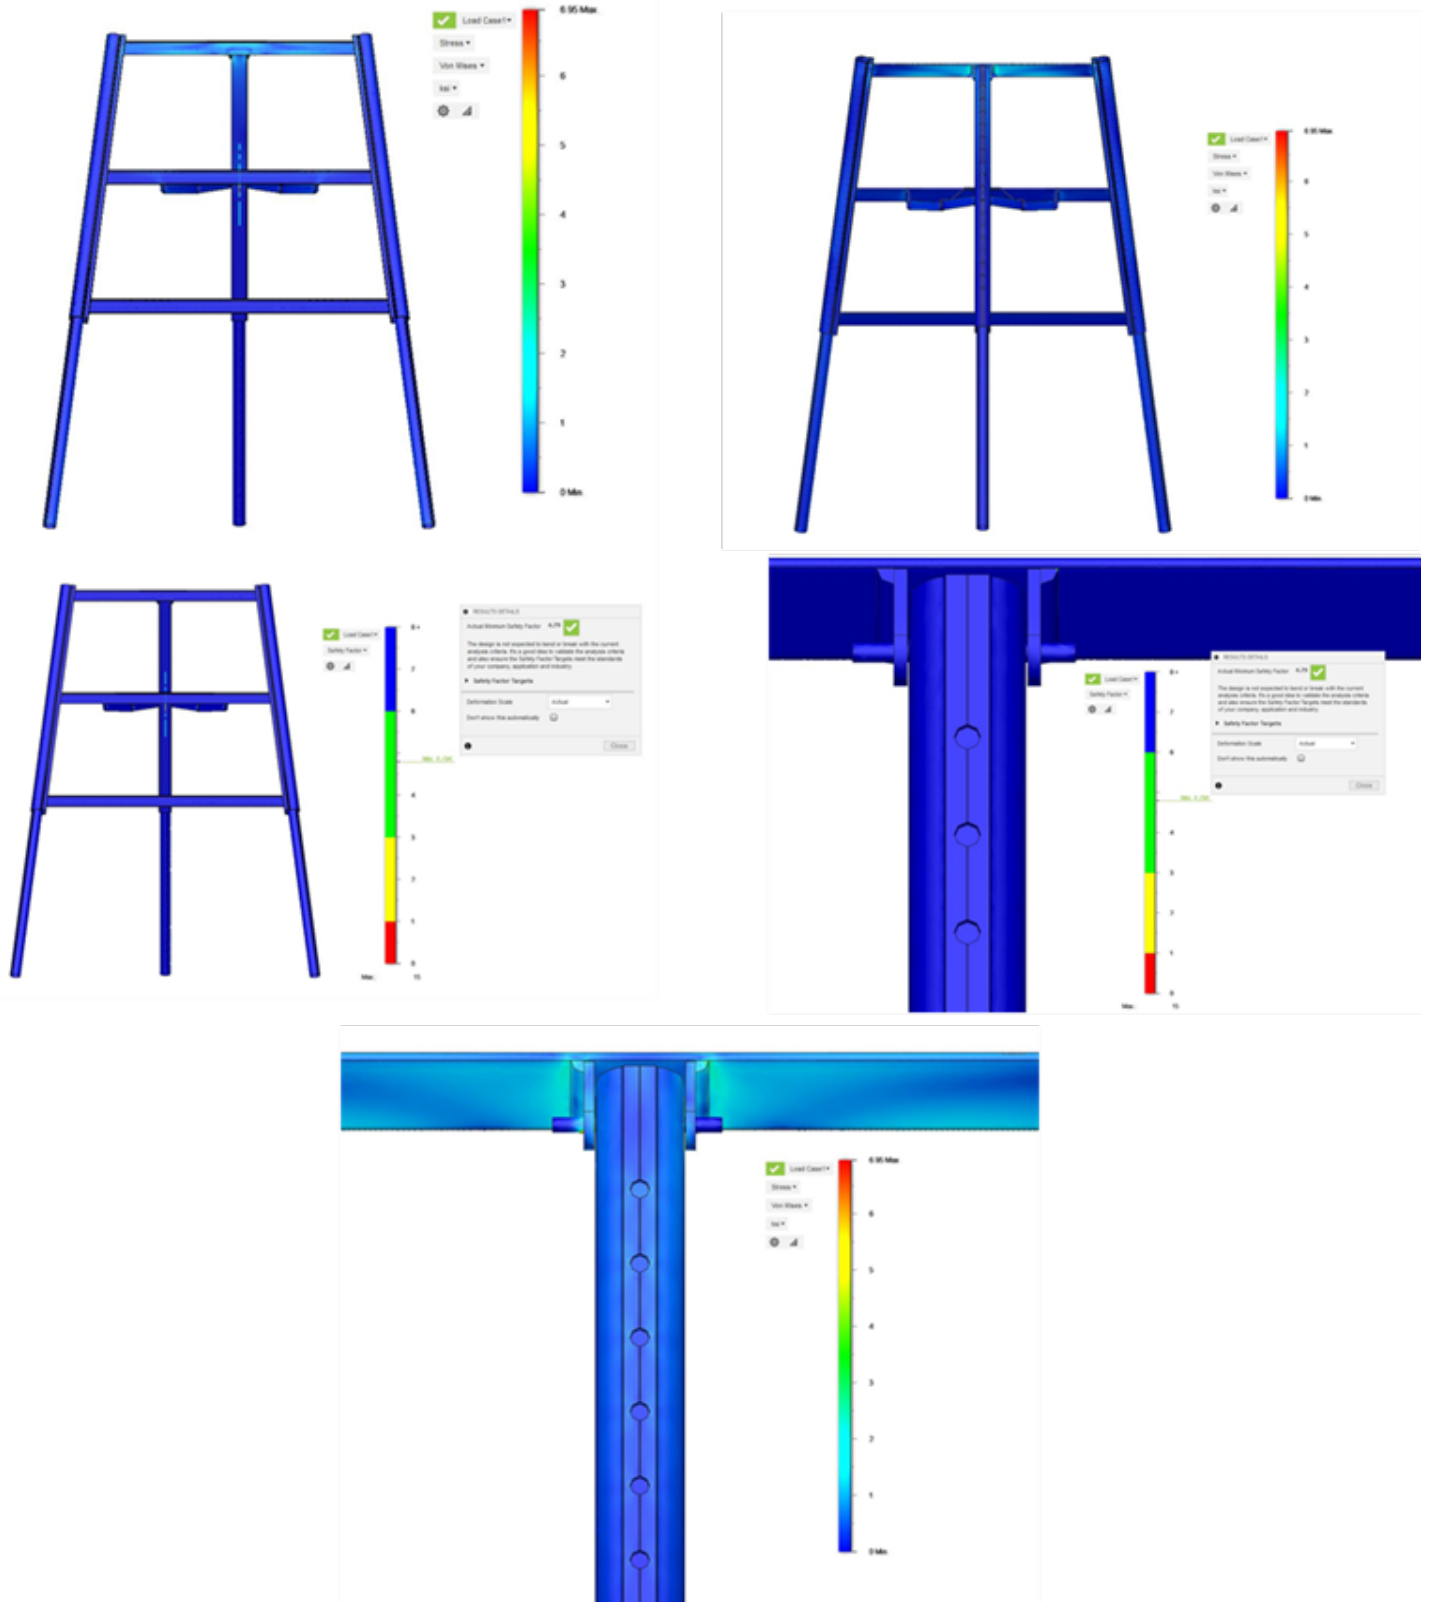
Figure 8

Results of this analysis showed that the scaffold easily bore the rated load applied in the manner shown in **Figure 7**, with Factors of Safety (against the yield strength of the materials) in excess of 4.8 and maximum (Von Mises) stress of 6.95 ksi. The maximum stress occurred in the tripod leg near hinge pin hole. The maximum stress in the scaffold frame was approximately 4 ksi and occurred in the scaffold top brace adjacent to (but not in) the weld. Results of the analysis are shown in various views in **Figure 8**.

Graphical representations of results of FEA of rated load analysis (300 lbf). Upper left shows front view Von Mises stress (ksi). Upper right shows rear view Von Mises stress (ksi). Middle left view shows front view factor of safety (against yield). Middle right view shows factor of safety in area of top brace lug welds. Bottom view shows Von Mises stress (ksi) in area of top brace welds.

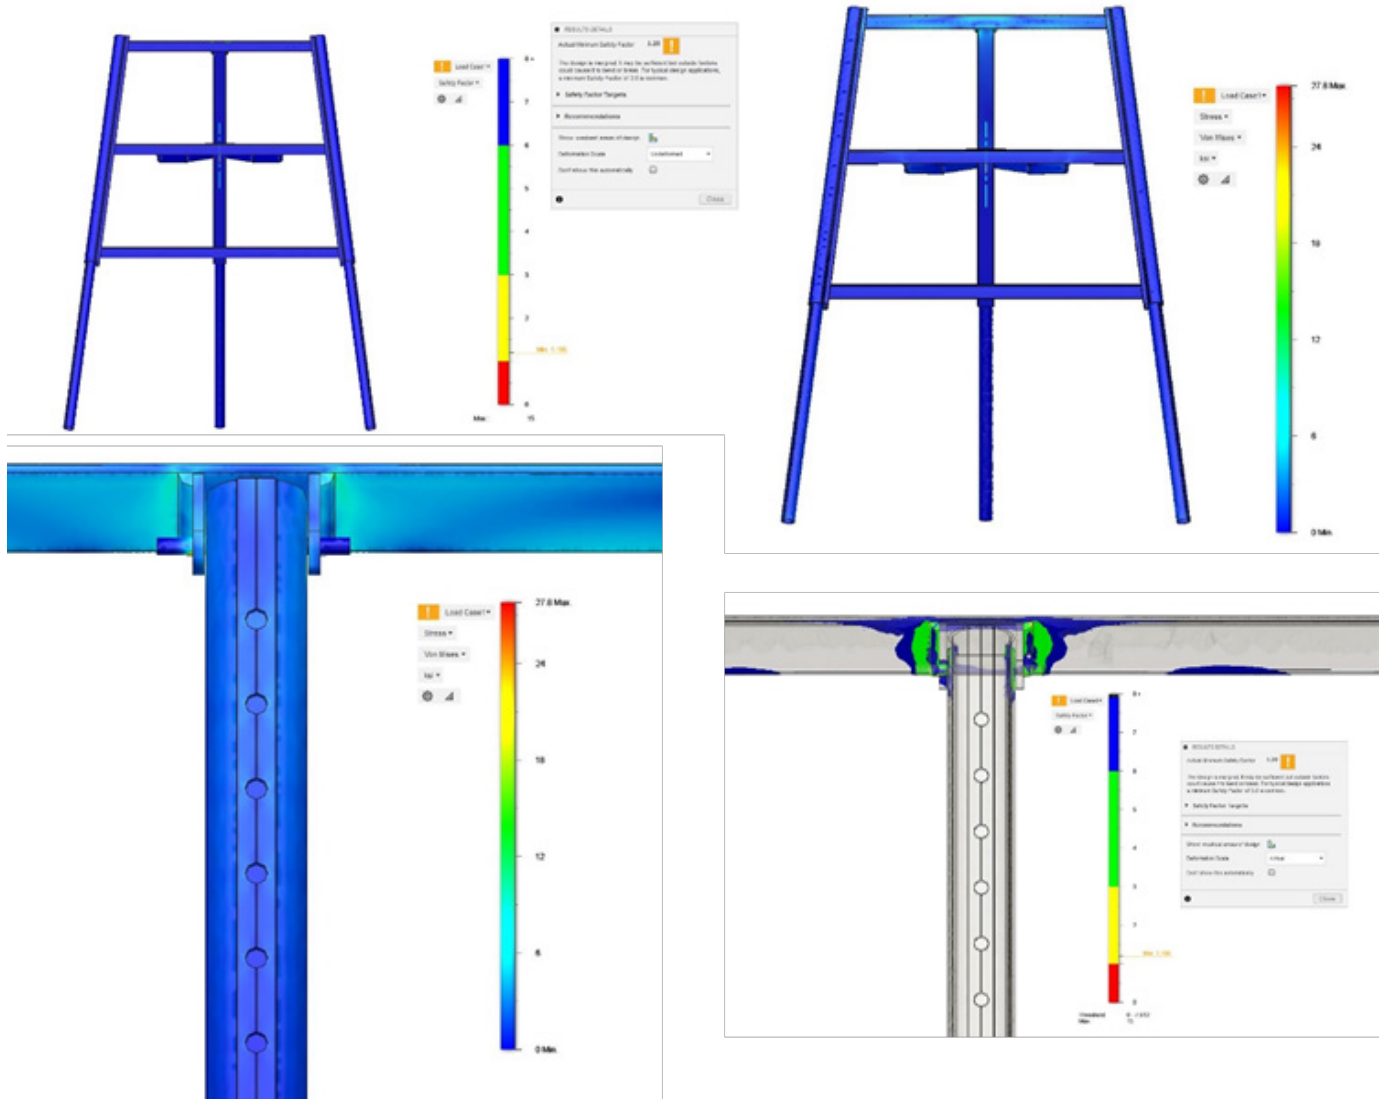
Figure 9

The analysis was repeated using the same model, but with an applied load of 1200 lbf, which is approximately the load specified as the proof load in ANSI A10.8-2001. The same constraints were used as in the previous analysis. Results of this analysis, which are presented graphically in **Figure 9**, showed that the peak stress occurred in the tripod leg near the hinge hole. The maximum stress in the scaffold frame structure occurred in the top brace adjacent to the weld at a magnitude of between 15 and 18 ksi, which is less than half the minimum expected yield strength for the aluminum alloy 6005-T6 member.

Graphical representations of results of 1200 lbf proof load FEA. Upper left: front view factor of safety. Upper right: front view Von Mises stress (ksi). Lower left: Close-up of Von Mises stress (ksi) in weld area. Lower right: close-up of weld area showing factor of safety.

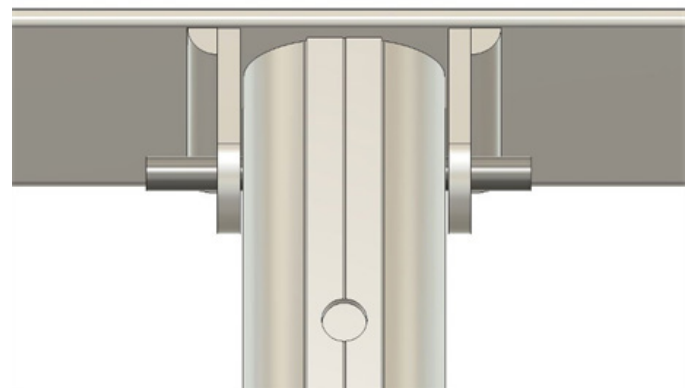
Figure 10

Close-up of lug-to-top brace weld area showing details of model for analyses with one weld detached from top brace. This condition represents complete lack of fusion/lack of penetration of the left-hand weld.

frame occurred in the tripod leg around the hinge hole at a magnitude of approximately 15.2 ksi. The highest stress in the weld area was approximately 4 to 5 ksi in the weld that remained fully bonded. This represented a safety factor between 3.6 and 4.5 against yielding at the rated load — even with one lug weld completely detached.
