# Failure of a Climbing Treestand Due to Corrosion and Selective Leaching of Cable's Galvanic Layer: Failure Analysis and Experimental Study

By Olin Parker (NAFE 1334A), Jahan Rasty, PhD, PE (NAFE 768S), and Matthew Mills, PE (NAFE 1199A)

*Both supporting cables of a climbing treestand failed when a user stepped onto the stand's foot platform. Analysis of the failed cables revealed extensive corrosion and selective zinc leaching of the galvanized steel cables due to an electrical connection between the treestand cables and the steel frame. Experimental measurements of corrosion rates were performed through accelerated immersion tests utilizing mass-loss and DC current measurements as well as cyclic voltammetry. Results indicated a ~79% to 300% increase in the rate of corrosion as measured by millimeters of cross-sectional area reduction per year. Flaws in the design that led to the creation of a galvanic cell between the treestand cable and its frame are discussed, and alternative designs are proposed. Finally, the manufacturer's failure to properly account for anticipated use environment of the treestand in its design while being aware of similar prior incidents as well as their

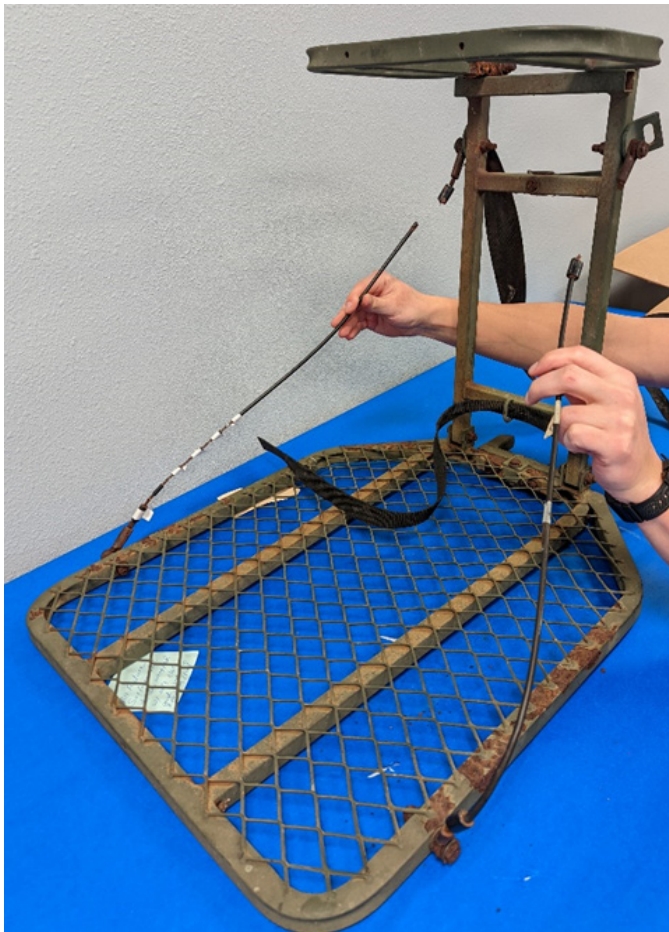
**Figure 1**

Image of the subject treestand taken by the authors.

The two galvanized steel cables that support the foot platform were found to have separated at their connection points to the vertical support (**Figure 1**). Evidence of corrosion was observed on the cables, the cable eyelets, and their attachment bolts.

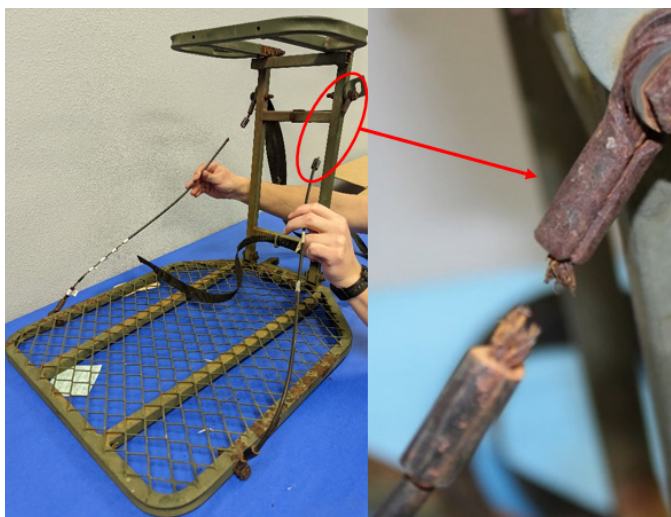
**Figure 3**  
Failure location on the left-side cable.

The left-side cable also failed adjacent to the eyelet in the segment between the copper crimp and the eyelet (**Figure 3**). The right-side cable failed near where it connects to the frame's vertical support. The right-side cable broke between the copper crimp and the plastic-coated section of the cable (**Figure 4**). Brittle fracture failure of the right-side cable occurred immediately adjacent to the copper crimp near the vertical support (**Figure 4**).

Based on the analysis of the right- and left-side cables, it was determined that the failure of the cables did not occur simultaneously. The failure of the left-side cable likely occurred first due to corrosion degradation and loss of strength in the cable segment between the eyelet and copper crimp, as shown in **Figure 3**. The corrosion degradation and the ensuing loss of strength in the failed segment of the left-side cable are evidenced by the fact that the cable segment adjacent to and below the crimp — having one-half of the cross-sectional area as the failed area and subjected to the same forces — did not fail.

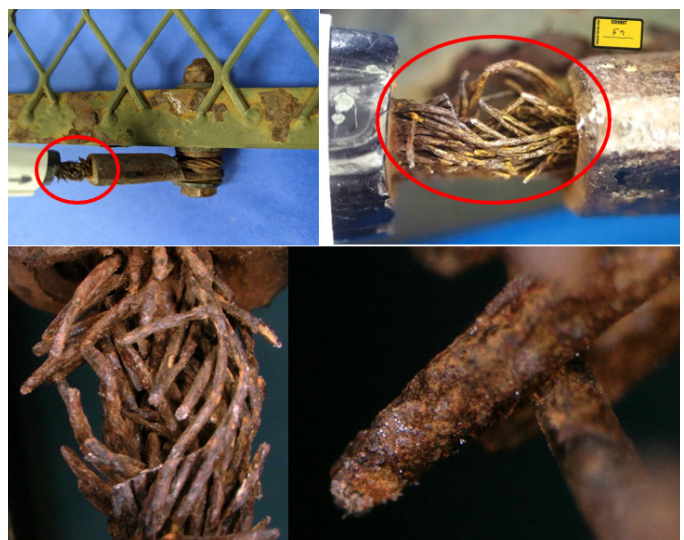
**Figure 5**  
Right-side cable foot platform attachment and the frayed segment between the eyelet and crimp with focus on elongated strands, characteristic of ductile failure.

attached backward, which likely introduced additional bending stresses on the cable at the area next to the eyelet. This segment of the cable between the eyelet and the copper crimp showed moderate signs of fraying attributable to ductile overload, as evidenced by the elongated fractured tips of the individual wire strands in the frayed area (**Figure 5**). As evidenced by the ductile nature of the individual strand failure, the fraying observed in the segment of the cable between the crimp and eyelet near the foot platform was limited to the loading experienced during the failure event due to overload and not a condition that pre-existed the failure.

Following the failure of the left-side cable, the right-side cable was subjected to dynamic loading that resulted in brittle failure of the right-side cable at the segment adjacent to and just below the copper crimp due to the small cross-sectional area of the cable combined with stress concentration effect of the copper crimp at this location (**Figure 4**). Additionally, this dynamic loading of the right-side cable, following the failure of the left-side cable, is evidenced by the fraying of some wire stands near the foot platform, as shown in **Figure 5**. Further evidence of dynamic loading of the right-side cable, following the failure of the left-side cable, can be seen in the brittle fracture of the cable coating next to the failed cable segment as well as outward bending of the cable segment between the copper crimp and the eyelet (**Figure 6**).

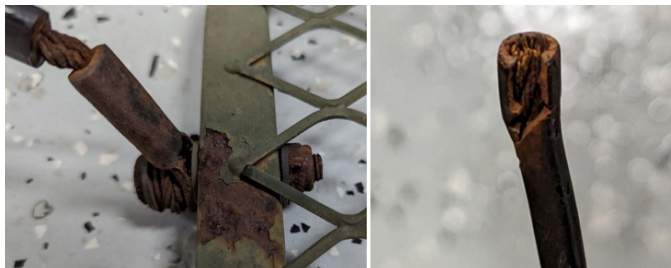
**Figure 6**

Signs overload on the left-cable eyelet attached to the foot platform and signs of brittle failure of the polymer coating.

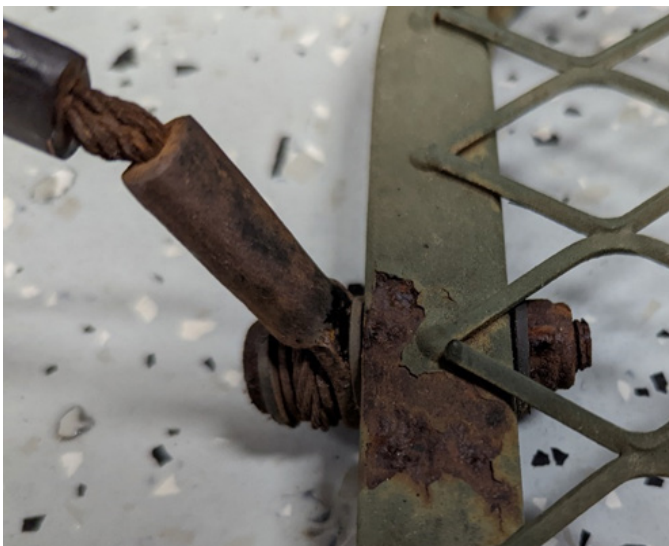
**Figure 12**

Connection between the foot platform and left-cable eyelet on the subject treestand.

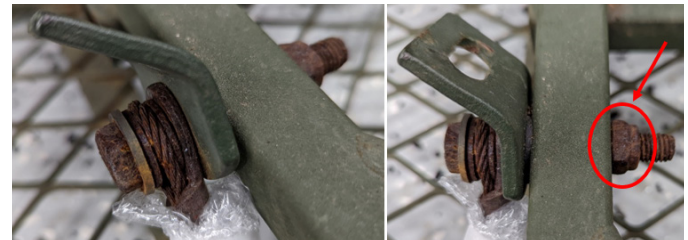
**Figure 13**

The bolts connecting the cable eyelets to the vertical support of the treestand have 55 mm of thread — around 10 mm longer than the bolts used on the foot platform, which provides more surface area for corrosion to occur on and accelerate the depletion of the cable's zinc coating. It can also be seen that a bracket intended for use with the tree strap is affixed to these bolts. While washers are present at this connection as well, there is no washer separating the bolt nut and vertical support (**Figure 13**). This results in an enhanced electrical connection between the treestand and galvanized cable, further accelerating zinc depletion. It is likely that the increased corrosion of these nearby components caused more rapid dealloying of the galvanized steel cables, which resulted in the cables failing near their attachments to the vertical support where the cable's degradation and loss of nominal strength was greatest.

Connection between the vertical support and left-cable eyelet on the subject treestand, displaying the direct coupling of the nut and frame.

the washers exactly as shown in the owner's manual, the lack of an additional washer behind the bracket allows yet another large piece of metal to be electrically connected to the galvanized cable and provide an even larger surface for contact with the vertical support, enhancing the strength of the electrical connection and thus the rate of corrosion<sup>21</sup>.

It is well known that relatively small anode-to-cathode area ratios will corrode significantly faster at the anode than relatively large anode-to-cathode area ratios<sup>21</sup>. For the subject cable, the relative surface area of the exposed galvanized steel was significantly smaller when compared to the large surface area of the exposed surface on the bolt, eyelet, and treestand frame. As a result, the protective zinc coating of the galvanized cable depleted at a significantly higher rate in order to protect all the components it was connected to.

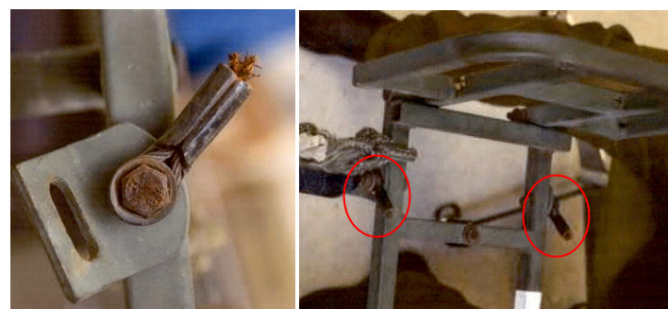
**Figure 29**

Discovery documentation revealed a number of previous incidents similar to the one that occurred in the subject incident (i.e., involving failure of the company's treestands due to cable corrosion). In the first of these similar incidents, failure was observed in the segment between the right-cable eyelet and copper crimp near the vertical support. However, in the case being investigated here, the left-cable and right-cable both failed in the segment between the crimp and cable eyelet (**Figure 29**).

Failures observed on the treestand of the first similar incident with both failures occurring between the eyelet and crimp.

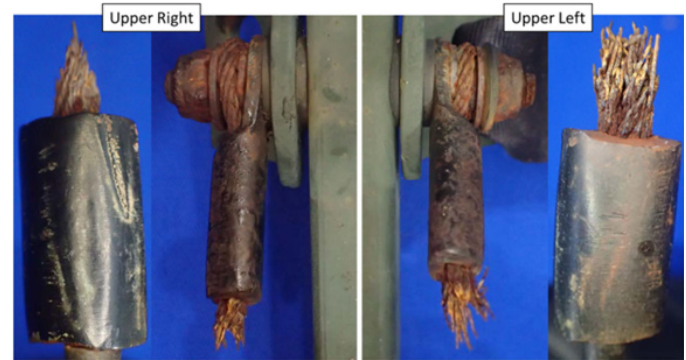
**Figure 31**

Locations of failure observed on treestand in the third similar incident.

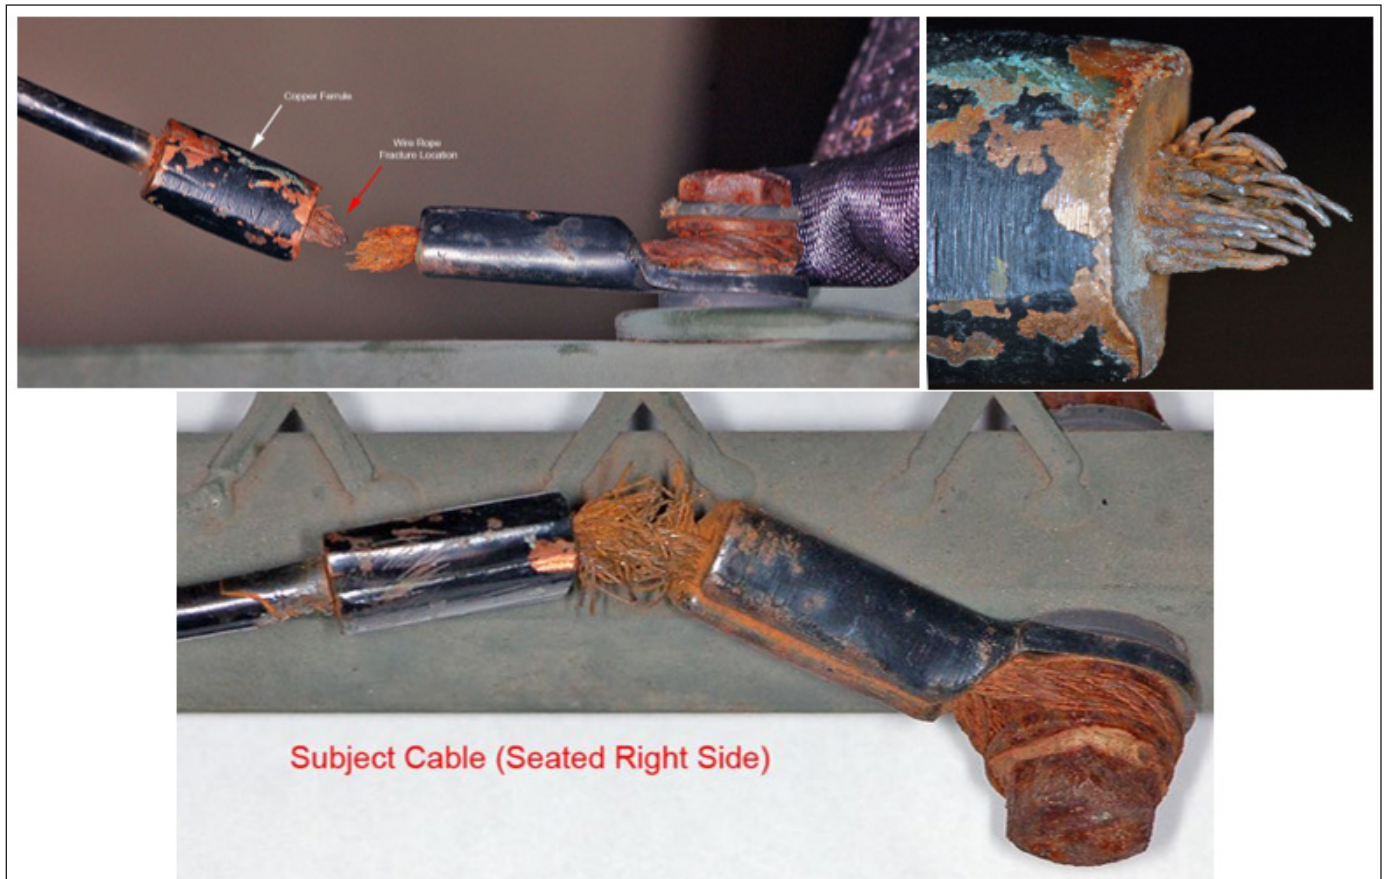
**Figure 30**

cables failed at the segments between the eyelet and crimp near the vertical support (**Figure 30**). The fracture surface of the right-side cable showed clear signs of ductile failure. Fraying of the right-side cable was observed in the segment between the cable eyelet and the crimp due to dynamic loading experience when the other cable failed suddenly, shifting the force to this side — similar to what happened in the subject incident.

Cable failure in the second similar incident.

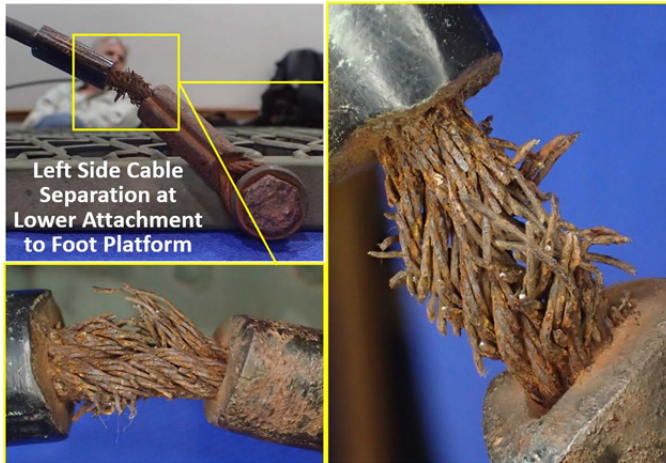
**Figure 32**

Fraying of wire strands in the segment between the eyelet and crimp that occurred following the initial failure.

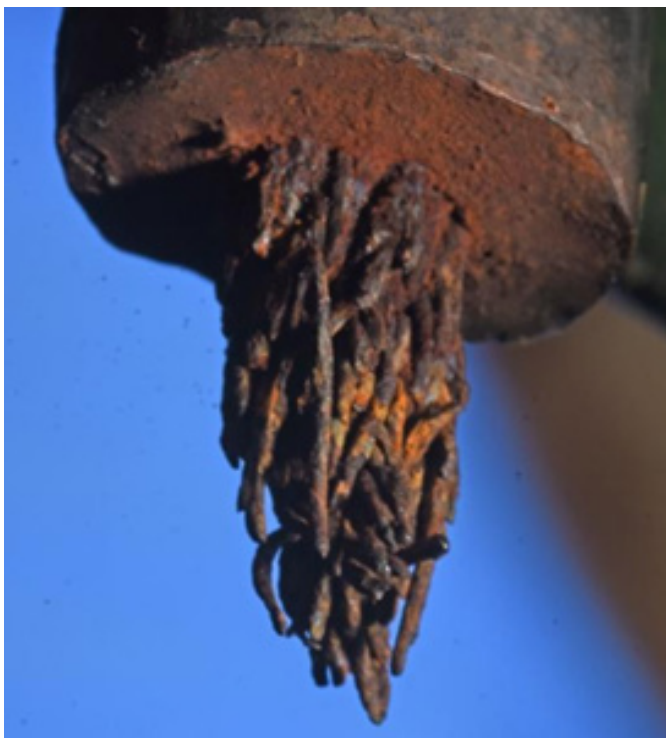
**Figure 33**

Close-up view of cable failure in the third similar incident.

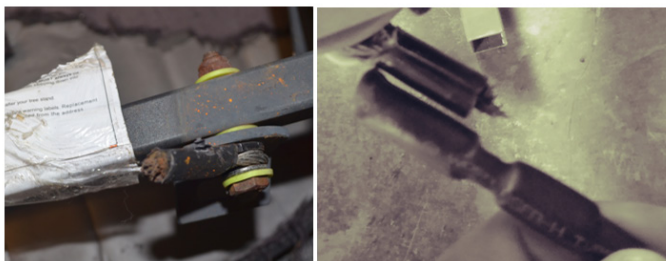
**Figure 34**

The fourth similar incident involved a newer model of the manufacturer's treestand. As shown in **Figure 34**, newer models of the manufacturer's treestands come with a thermoplastic coating over the cables. This coating, however, is loosely attached and allows water to easily seep and become trapped on the inside, corroding the cable. At the same time, the coating prevents users from observing the degradation state of the cables.

Failed cables the fourth similar incident.

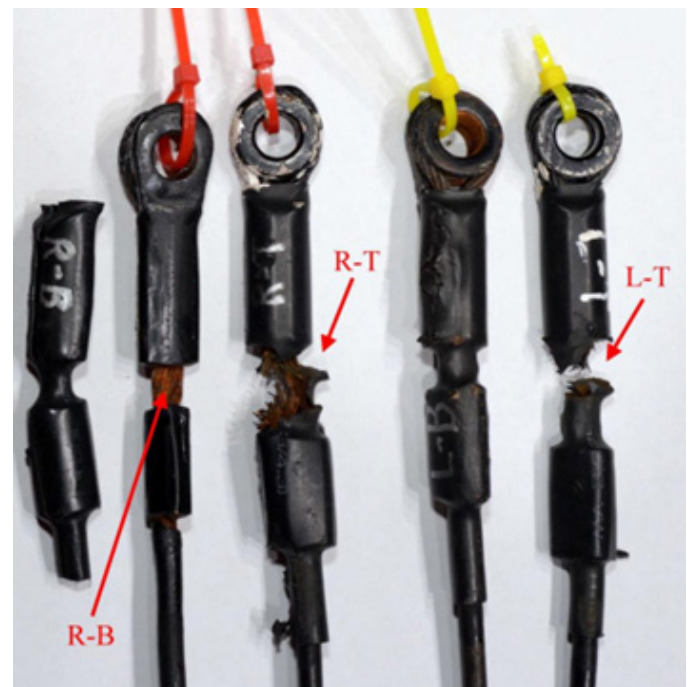
**Figure 35**

Failed cables from the treestand in the fifth similar incident displaying extensive corrosion.

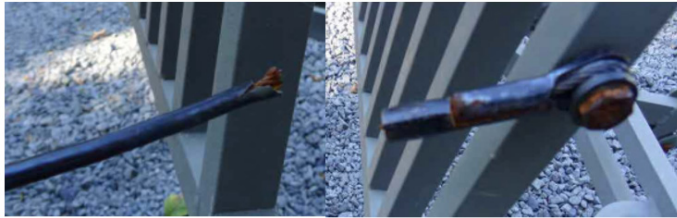
**Figure 36**

The failed cable on the climber treestand fractured between the copper crimp and plastic coating, showing the same design as the subject cable in the subject case.

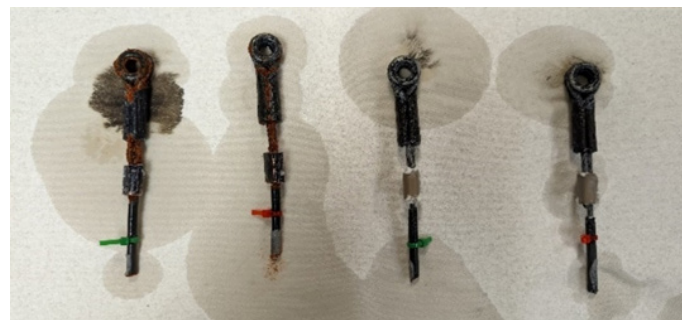
**Figure 40**

Corrosion present on the copper (right two) and aluminum (left two) crimp samples after 28 days of immersion.
