Vol. 37 No. 1 December 2020

# Metallurgical and Mechanical Failure Analysis of an Aftermarket Flywheel

By Nikhil Kar, PhD, PE (NAFE 1095M)

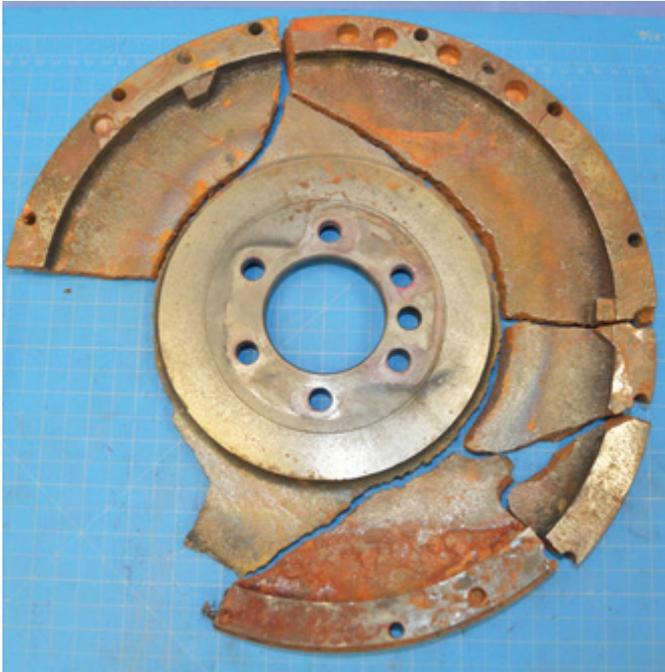
**Figure 1a**

Overall photograph of fractured flywheel showing side that would mate to crankshaft. Note crankshaft seal outline near center hub.

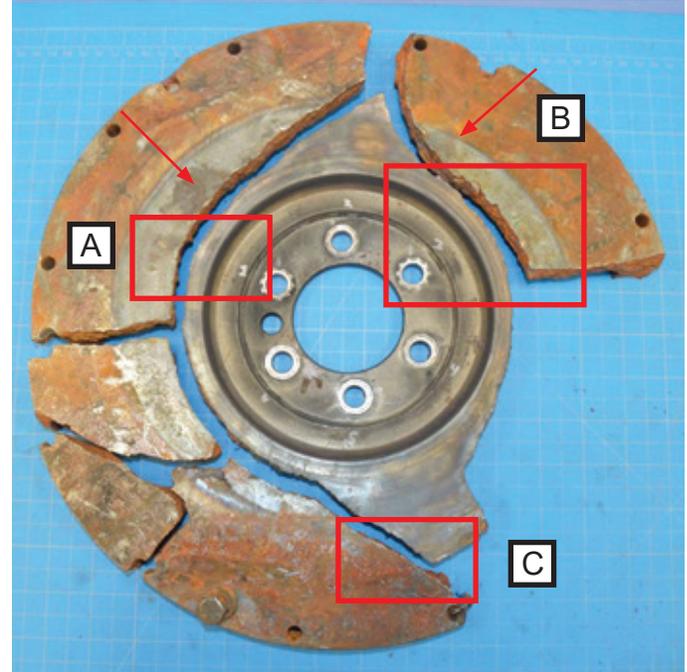
**Figure 1b**

Overall photograph of fractured flywheel showing side that would mate with clutch disk surface. Note heat damage to areas A, B, and C.

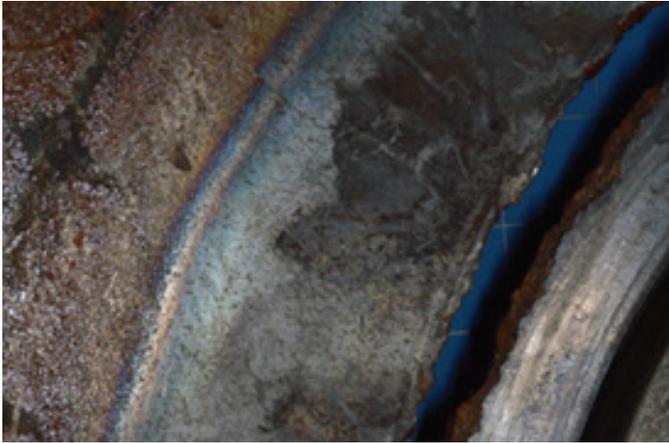
**Figure 2a**

Macroscopic inspection photographs of the fracture surface are shown in **Figure 2** at locations A, B, and C as indicated in **Figure 1**. These surfaces show heat tinting, discoloration, and radial fissure cracks on the side of the flywheel that would make contact with the clutch pad disk. The central portion of the remnant flywheel containing the bolt holes for mounting the flywheel to the crankshaft had a complete circumferential fracture surface that was examined in detail using visual examination, optical microscopy, and scanning electron microscopy techniques. Location C was unique, as it was the only area that contained both radial and circumferential fracture surfaces, as shown in **Figure 2c**.

Close-up photomicrograph in location A shows heat tinting and fissure cracks.

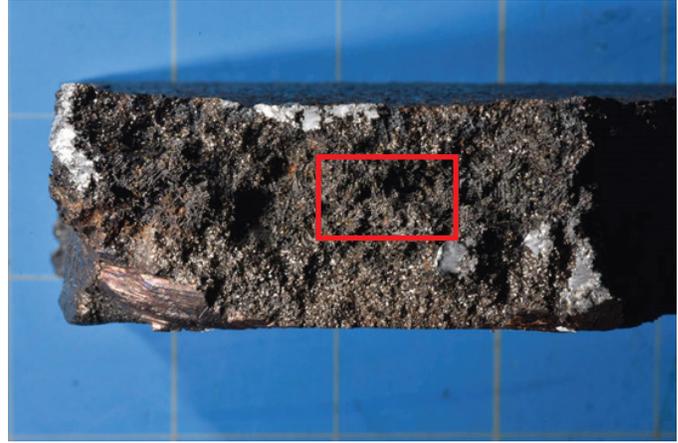
**Figure 3a**

An end-on photograph of the circumferential fracture surface at location C is shown in **Figure 3a**. The majority of the fracture surface appears dull, with a small band of a shiny fracture surface near the lower left and lower right region. SEM examination in the dull location as shown in **Figure 3b** shows that the dull surface was comprised of dendrites, porosity, and material that was not fractured, but rather it was liquid that solidified and did not fuse with any other material when casting of the flywheel occurred. The figure shows the surface contains dendrites, an indication that this entire surface separated and contained porosity; a

End on view of location C shows dull fracture surface.

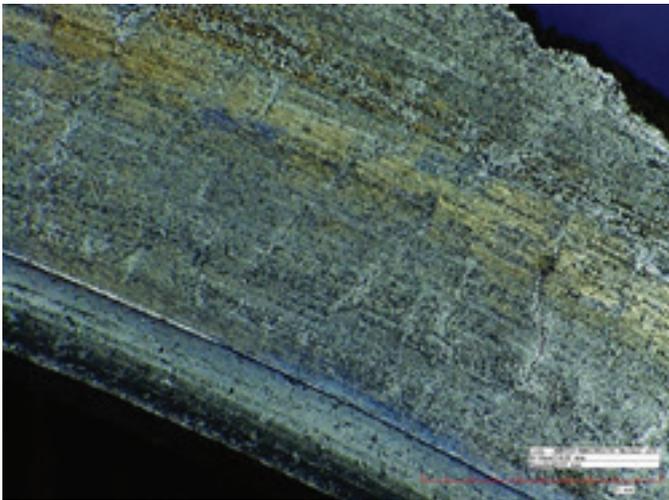
**Figure 2b**

Close-up photomicrograph in location B shows heat tinting and fissure cracks.

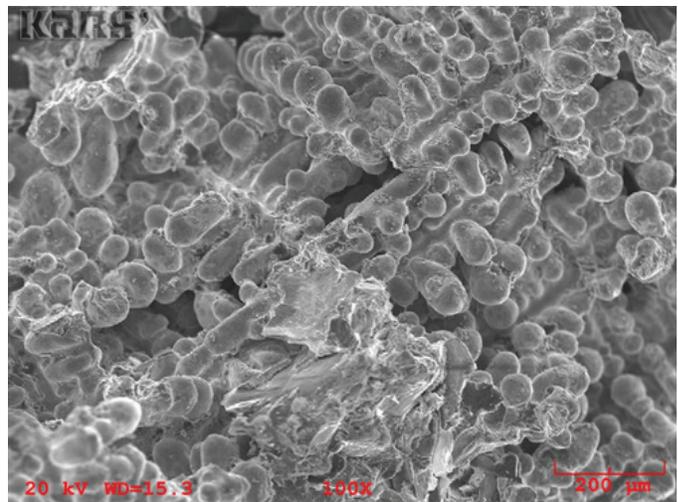
**Figure 3b**

High magnification SEM image in dull fracture surface area shows dendrites and solidified droplets that were not fractured.

likely initiation site that led to catastrophic failure of the entire flywheel. While all castings may contain some level of porosity that is generated due to internal gas entrapment and material shrinkage during solidification, it is important to identify and quantify the amount of porosity from a manufacturing quality standpoint.

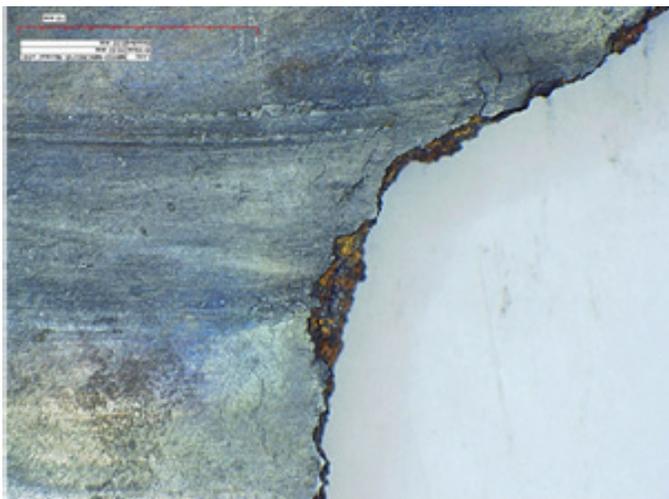
**Figure 2c**

Close up photomicrograph in location C shows heat tinting and fissure cracks.

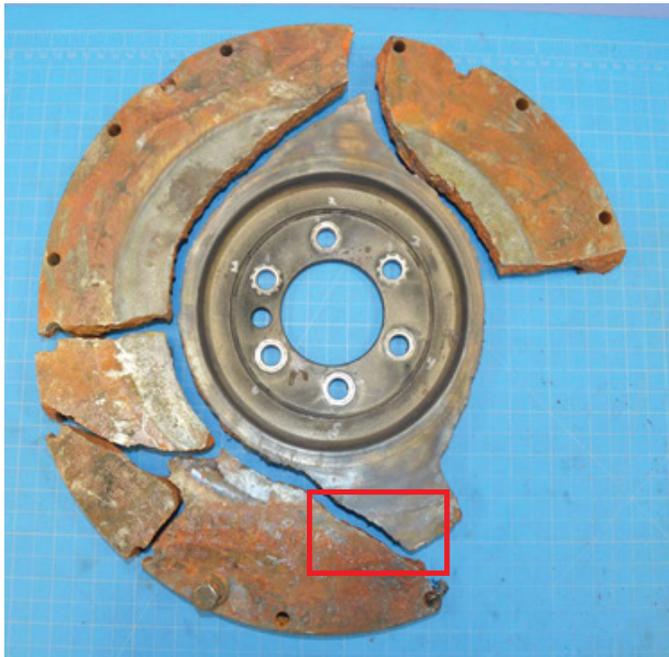
**Figure 4a**

Overall view of flywheel remnants and location for computed tomography.

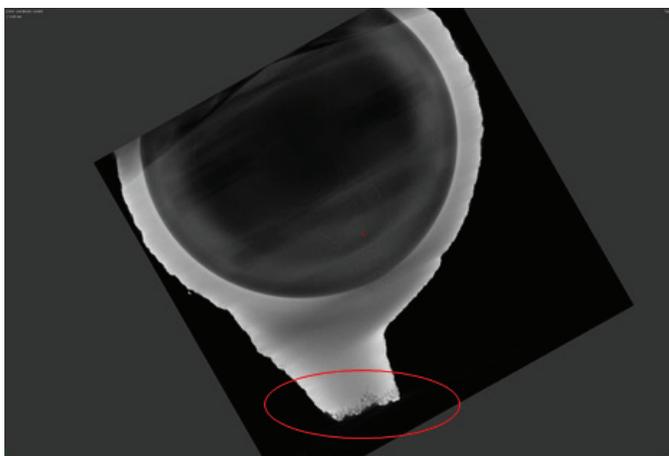
**Figure 4b**

CT slice shows no porosity except near fracture surface as indicated.

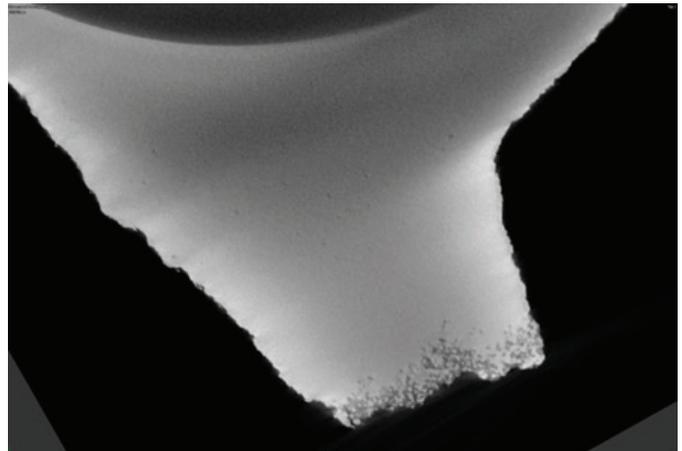
**Figure 5**

**Figure 4a** shows the location of area C in the flywheel and the reference CT slice data in **Figure 4b**. **Figure 5**, a magnified CT slice view of area C, indicates that the porosity envelopes the entire width of the fracture surface, which is 1.6 in. in length.

High magnification CT slice shows porosity and dendrites along fracture surface location.

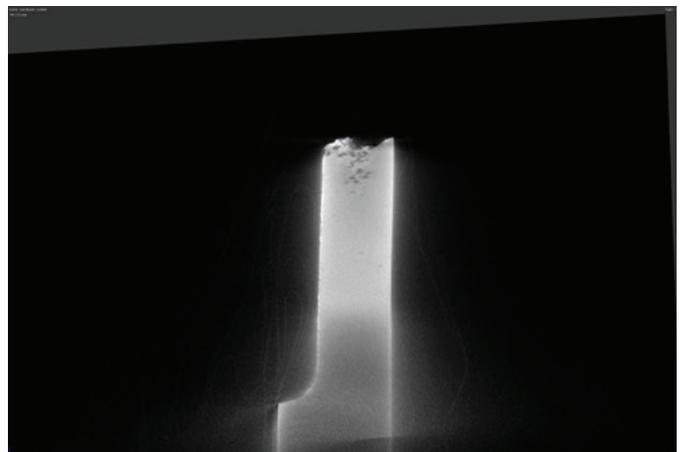
**Figure 6** shows a CT slice transverse view of location C, an indication to the depth of the porosity, which was measured to be 0.4 in. deep. The slices provide information regarding the amount of porosity and proximal location to the fracture surface, which cannot be seen using

High magnification transverse CT slice shows porosity depth and dendrites along fracture surface.

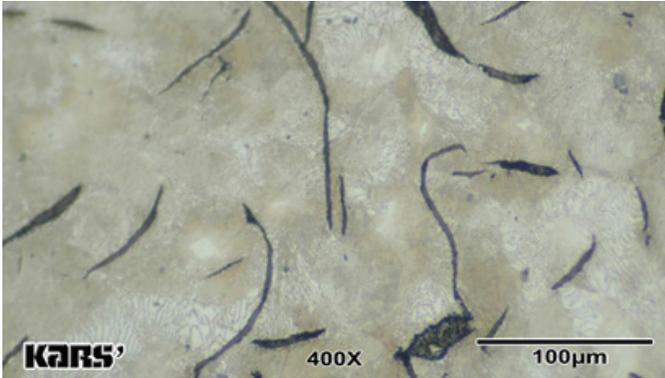
**Figure 7a**

Photomicrograph of base cast gray iron microstructure shows ferrite pearlite matrix with graphite flakes.

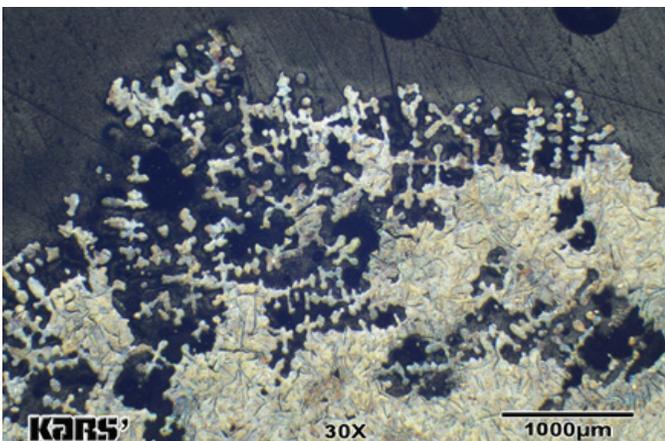
**Figure 7c**

Photomicrograph shows casting porosity and dendrites, indicating poor casting procedures.

and porosity due to rapid solidification and shrinkage during casting are shown in **Figure 7c**. This cross section was taken from area C as discussed in **Figure 3** and **4**. These areas were found on, and within the radial and circumferential fracture surface (Area 3), where it is believed the failure initiated.

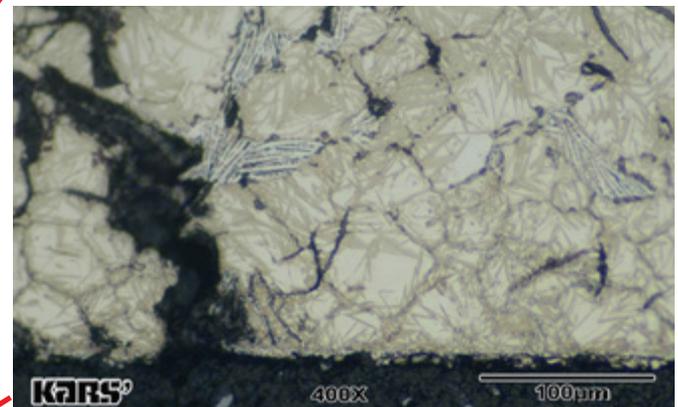
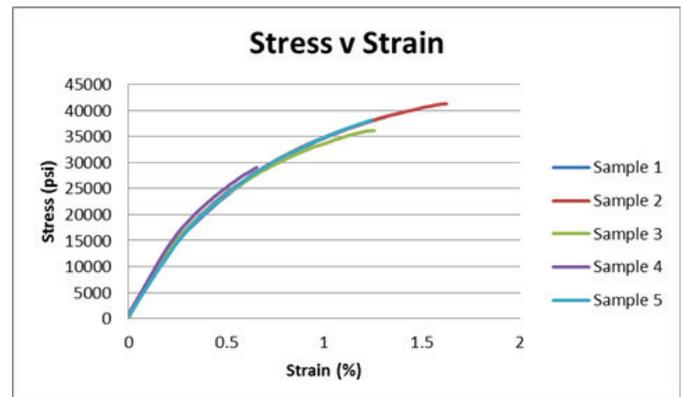
Sub-specimen flat dogbone tensile coupons consistent with ASTM E8 were machined away from the heat-affected zone in the subject flywheel to determine mechanical properties, the results of which are shown in **Figure 8** and **Figure 9**. These results confirm that the material was manufactured from gray cast iron with a tensile strength similar to that of SAE G3500 (35 KSI) and

Tensile stress versus elongation of five tensile coupons machined from failed flywheel away from heat affected zone.

hardness of 215 HRB. Similar testing was performed on an OEM flywheel, and the testing results showed the OEM flywheel was manufactured out of ASTM A536 ductile iron with a tensile strength of 80 KSI, a yield strength of 55 KSI and an elongation of 6%. Gray cast iron materials are brittle, and — when subject to metallurgical defects — heat and substantive stresses rapid and catastrophic fracture can occur.
