# Investigation and Root Cause Analysis of Transformer Metering Destruction by Arc Flash

By John F. Wade, PhD, PE, DFE (NAFE #1174A) and David J. Icove, PhD, PE, DFE (NAFE #899F)

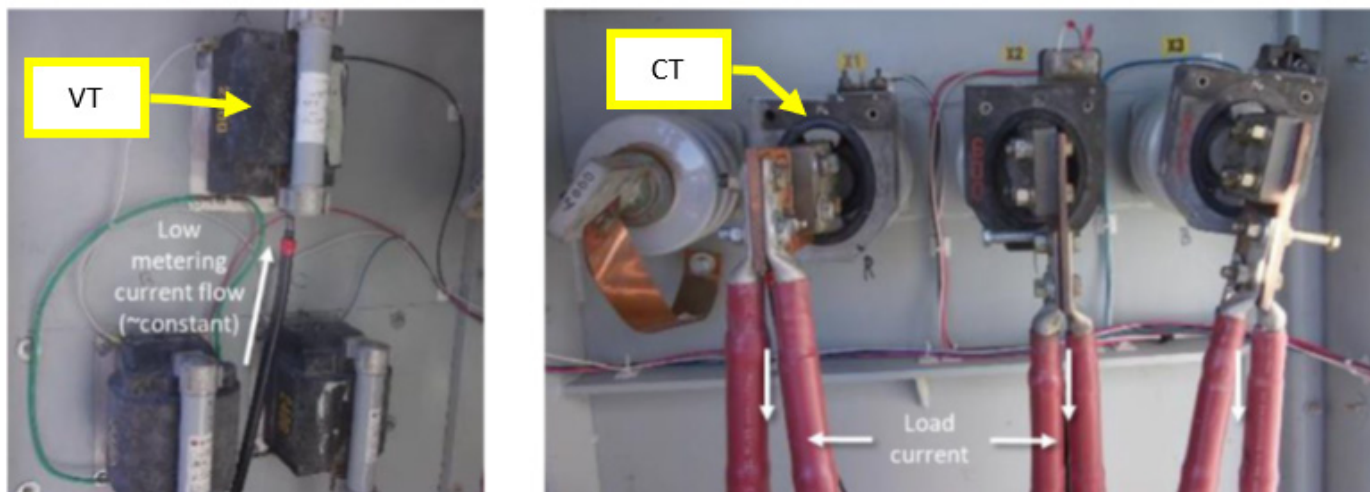
**Figure 1**  
Newly installed VTs and CTs inside secondary compartment.

devices added to the interior of the transformer secondary compartment included three voltage transformers (VTs) on the left wall to step each of the three 4,160-volt phases down to 120 volts for connection to the power meter. Around each of three phase legs coming out of the transformer is a current transformer (CT) measuring amps and connected to the power meter. Photos of the completed installation were taken to submit with the work package completion, as shown in **Figure 1**. These images provided an important basis for comparison.

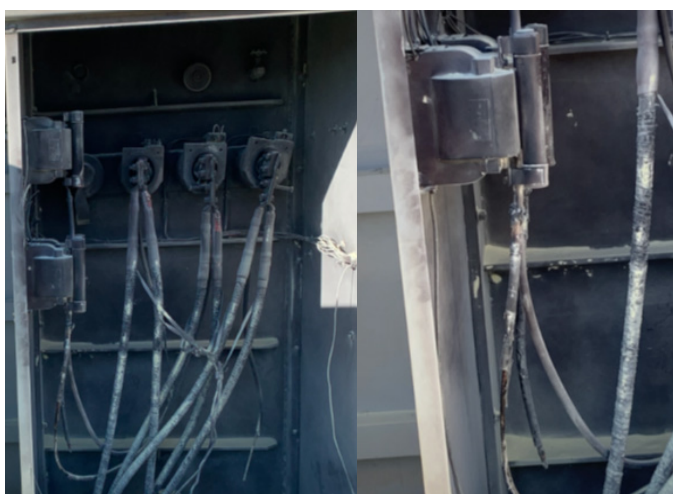
**Figure 2** shows the extensive heat damage to cables and equipment. The outer jackets on the large load cables were charred. Insulation on the medium-sized cables connected to the VTs was burned away in several places; one cable was missing a 12-inch section. The VTs were so damaged that all were scrapped.

**Figure 2**  
Post-event photos.

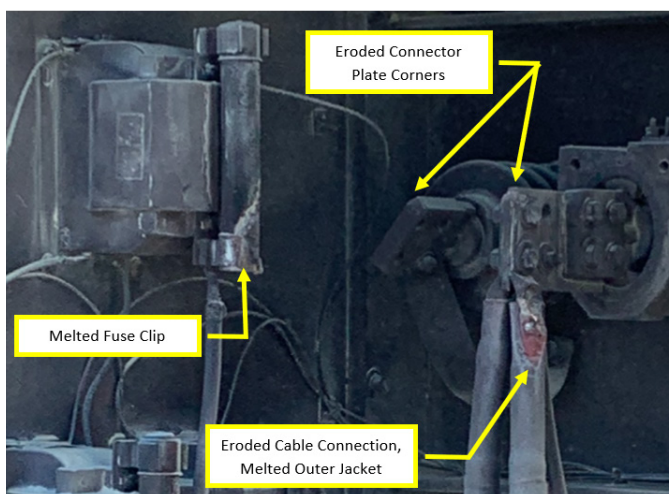
**Figure 3** shows the arc erosion of the large copper connector plates, erosion and melting of one cable end, and destruction of the VT “A” fuse clip. The loss of copper (erosion) at corners and edges is characteristic of arc endpoints: highly localized hot spots vaporized conductor material wherever arcs originated. Insulation in the nearby area melted due to the heat radiated from these arcs.

**Figure 3**  
Arc erosion of connectors and cables.

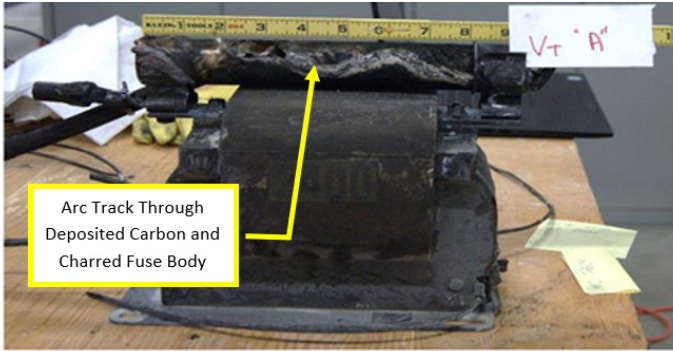
**Figure 4** shows destruction of the “A” phase VT fuse due to textbook “arcing through char”<sup>6,7</sup> — a phenomenon

Post-event VT with arc tracking across destroyed fuse.

where carbonized material becomes an electrically conductive path. All these indications pointed at a powerful arc event — likely an arc flash.

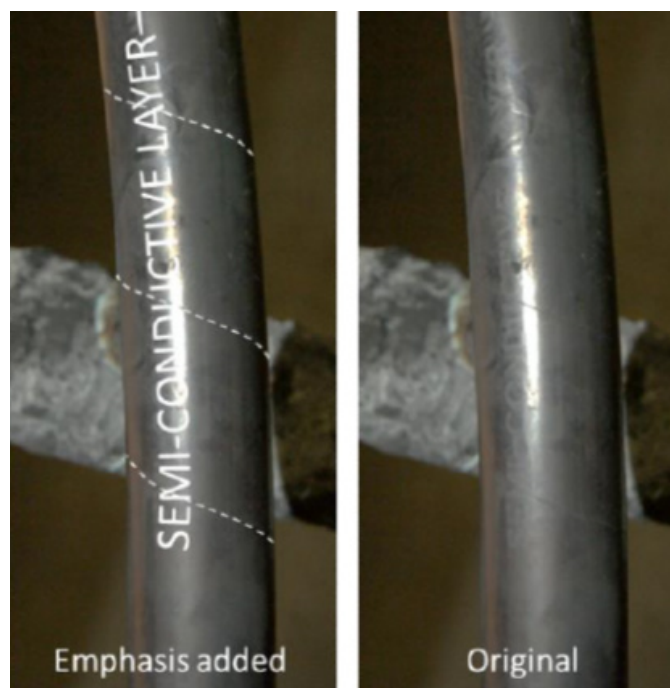
Not all wiring in the compartment was burned. Some escaped damage, allowing direct examination of installed material. An example (**Figure 7**) shows the cables between utility transformer secondary and VT primaries were missing both the copper foil shield and the protective jacket.

This was evidenced by the absence of cable type identification print, the still visible “semi-conductive layer” print on this undamaged piece, and the spiral grooves showing where edges of the wound copper foil shield had been.

Using photographs of the open secondary compartment, the team used 3-point perspective<sup>13</sup> to create a geometric model of the compartment interior. This model revealed the cable from the transformer to the Phase “B” VT looped down and behind the others, laying against the edge of one of the transformer structural ribs or against another VT cable. Once energized, this would have allowed a concentration of electric field to produce a hot spot to form in the deficient cable, yielding burn-through and arcing. Chafing due to vibration of the unrestrained cable due to magnetic effects may have exacerbated friction erosion of the exposed semi-conductive insulation layer.

**Figure 7**  
Faulty VT cable as installed.

3. Codes and Standards Compliance — The cable material used for the VT connections was altered from its manufactured form and did not meet installation requirements of NEC Article 311<sup>10</sup>. The altered and deficient nature, and unverifiable provenance, of the cable material also violated

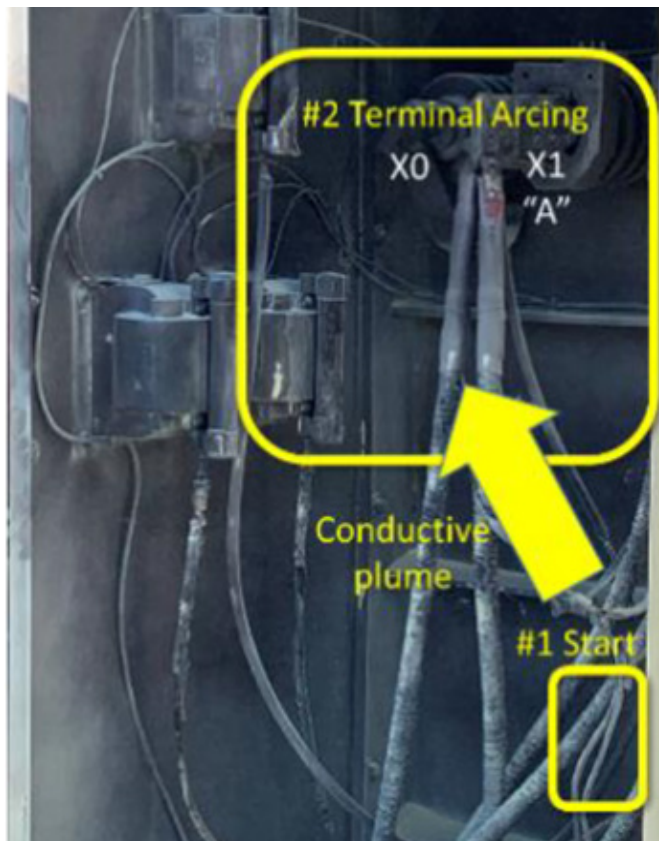
and the exposed parts of the VTs. A conductive plume from the initial Phase “B” cable arc likely billowed up inside the secondary compartment. Such a plume was created around the initial arc flash (**Figure 8** event #1) when conductor material was vaporized yielding carbon from incinerated cable insulation and, more importantly, copper vapor<sup>14,15</sup>. The plume triggered additional arc events (**Figure 8** event #2) when convection carried metal vapor away from the initial arc flash location, dramatically increasing the conductivity of the air around the exposed transformer terminals and other equipment. But the question remained: What chain of technical and organizational precursors allowed this event to occur?

**Figure 8**  
Arc flash propagation most-likely sequence.

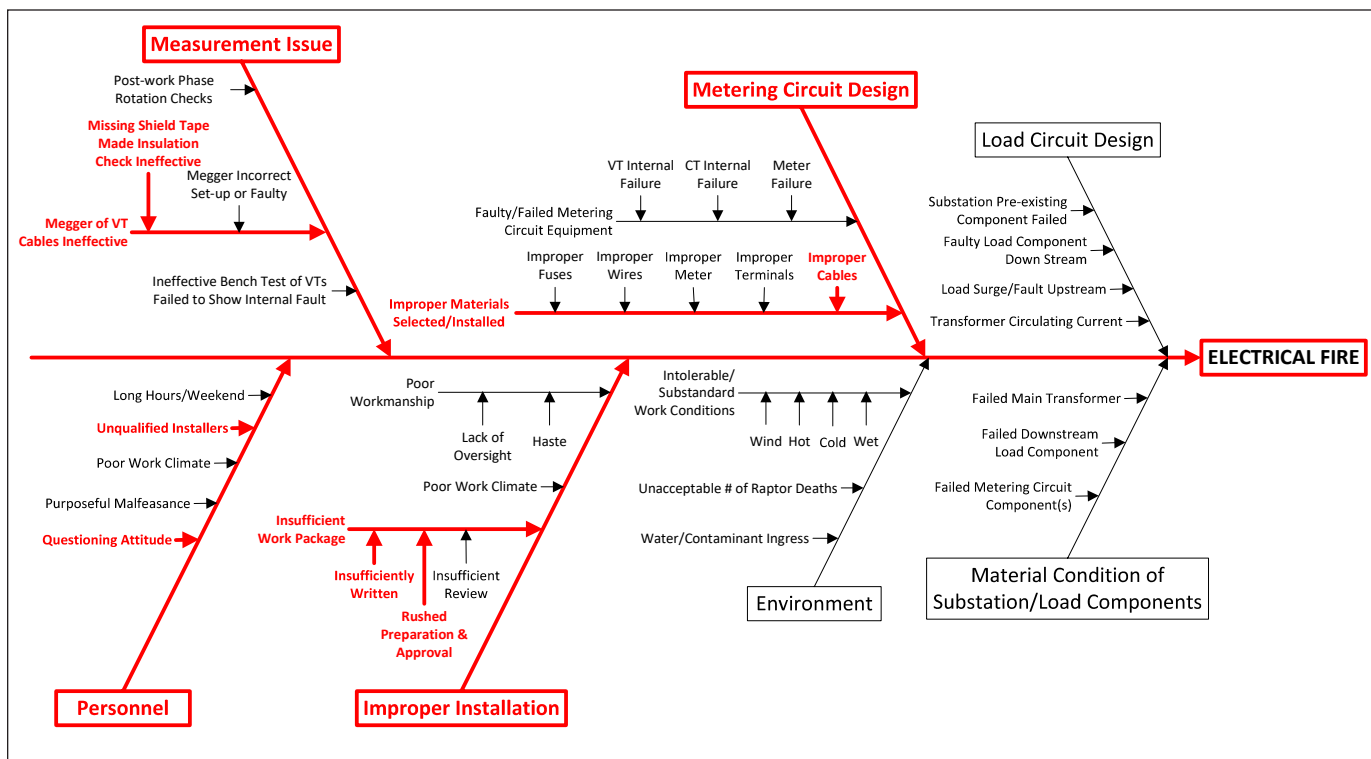
While the physical reconstruction of the debris was key to understanding the physics of “what” happened, careful dissection of the client’s organizational dynamics was central to identifying direct causal and contributory factors explaining “why” it happened. The forensic team found several ingrained institutional issues. These issues are included in an Ishikawa “fishbone” diagram<sup>16,17</sup>, as shown in **Figure 9** and in the details following. Out of the full set of factors identified, the items and paths highlighted in red were those the team found to be most-likely

**Figure 9**  
Ishikawa diagram.

primary contributors.
