Journal of the
National
Academy OF
Forensic
Engineers[®]

Forensic Engineering Analysis of a Residential Fire Caused by an Open Neutral

By Steve Pietropaolo, PE, DFE (NAFE 769S) and Yoandi Interian, PE, DFE (NAFE 1260M)

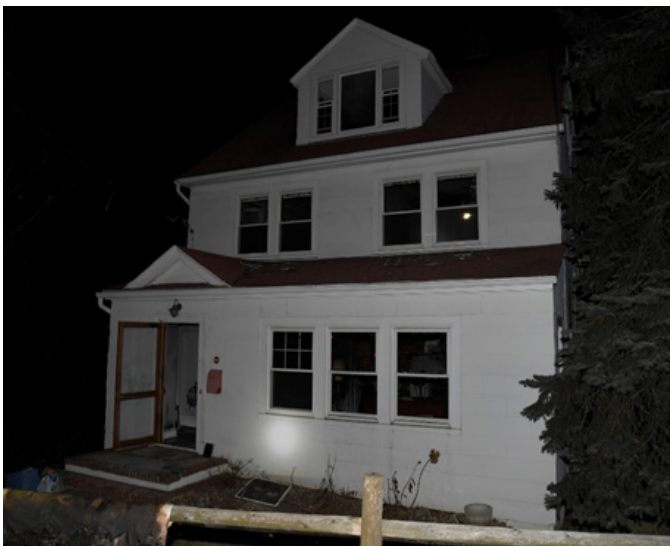
Figure 1

Front view of the subject two-story single-family residential house.
Photo taken by utility company on the night of the fire.

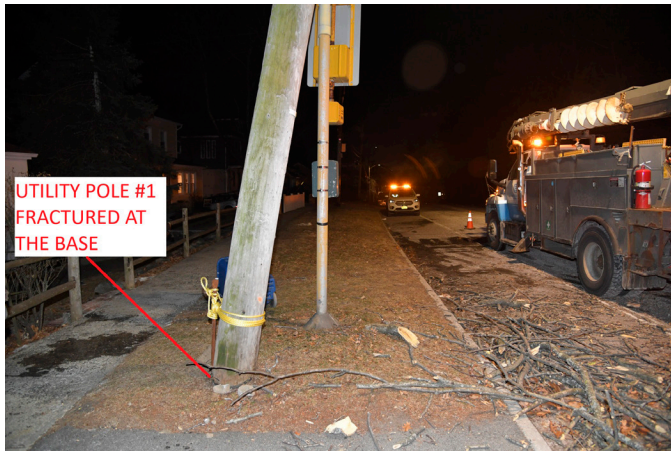
View of the utility pole #1 leaning away from the house.

Utility pole #1 (located directly in front of the house on the east side of the street) had fractured at the base and was leaning toward the street (**Figures 6 and 7**). The utility pole was found leaning on the main power lines running in the north-south direction along the street. No guyed wires were found attached to utility pole #1. Directly across the street (on the west side of the street) was another utility pole (utility pole #2). Power lines crossed the subject street from utility pole #1 to utility pole #2 to feed a nearby school.

The subject tree that fell was located approximately 30 feet north of utility pole #2. The tree fell onto the primary feeder lines, crossing between utility pole #1 and utility pole #2. Utility pole #1 was pulled in a southwest direction and fractured the utility pole at the base.

Utility pole #1 fractured at the base (night of the fire).

Based on the location of utility pole #1, the pole was a dead-end pole for the power lines extending toward the west. Rule 264 of NESC-1997 provides that the use of "guys, braces, or other suitable construction" shall be provided to provide additional strength when the loads on the structure are greater than can be supported by the structure alone⁸. NESC-1997 further provides that "such measures shall also be used where necessary to limit the increase of sags and provide sufficient strength for those supports on which the loads are sufficiently unbalanced, for example, at corners, angles, dead-ends, large differences in span lengths"⁸. However, at the time of the joint-scene examination, utility pole #1 did not contain any guyed wires or braces. The use of guyed wires at this location would have been expected to have provided additional lateral support to utility pole #1 and significantly decreased the forces exerted on the service drop conductors.

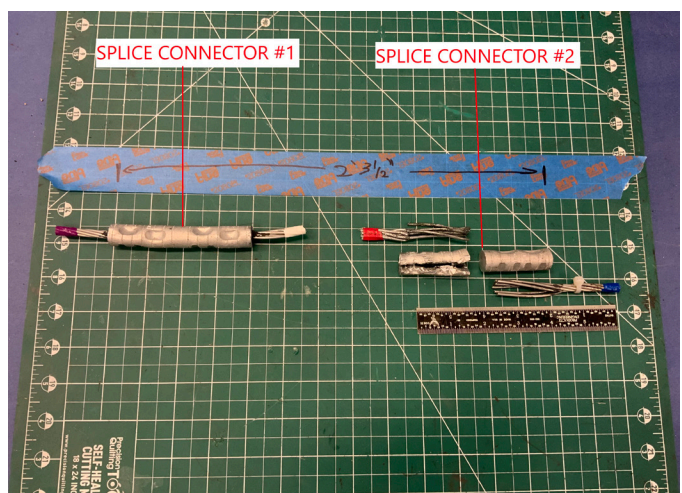
Figure 10

The messenger neutral conductor was examined at the scene and in the lab. The bare conductor contained two compression-type splices approximately 2 feet from each other (Figure 10)⁷. A compression splice is designed to connect two ends of a conductor.

A destructive examination of both the intact and separated splices was performed during a lab examination. Splice connector #1 was intact, and both conductors were still attached. Before destructive examination, the section of the messenger neutral conductor with the purple taped end extended toward utility pole #1. The section of the messenger neutral conductor between splice connectors

Splice connector #1 and #2 examined during a destructive lab examination.

#1 and #2 are identified by the white and red taped ends. The red taped end of the messenger neutral conductor was intentionally pulled from splice connector #2 during the examination. The conductor connected to the “house” side of splice connector #2 (shown taped in blue) had separated because of the tree fall, resulting in the “open” neutral condition. X-ray examination showed that the crimp was within manufacturer guidelines/specifications (**Figures 11 and 12**).

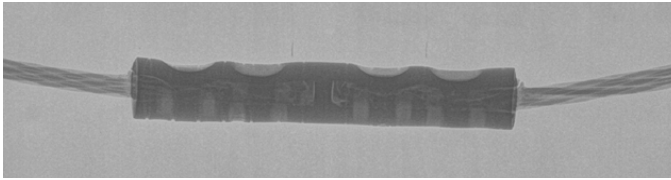
Figure 11

X-ray of splice connector #1 showing proper embedment of the conductors.

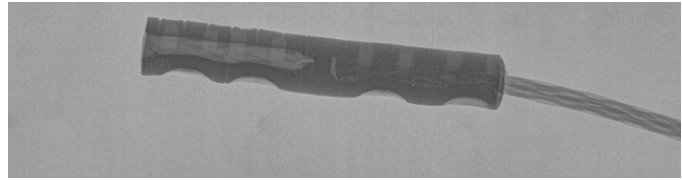
Figure 12

X-ray of splice connector #2 showing proper adequate embedment of “house”-side conductor.

Based on the manufacturer's information for the subject splice on the neutral wire closest to the house, the subject splice had a holding strength of approximately 700 pounds. Under the force of the fallen tree, the subject splice was subjected to a force much greater than 700 pounds and thus resulted in the failure of the neutral splice

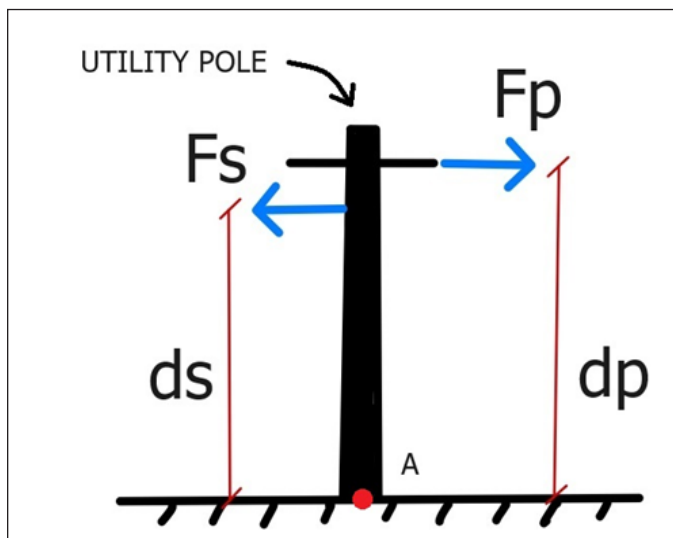
Figure 13 is a free-body diagram of utility pole #1 showing the various forces acting on the utility pole following the tree fall and immediately after the utility pole fractured. The utility pole represents a cantilevered beam with a circular cross-section. At the top of the member, the forces acting on the pole are represented by F_p , the force exerted by the primary power lines crossing the street between utility pole #1 and pole #2, and by F_s , the force resisted by the service drop conductors extending toward the subject house. The distance from the ground to the primary power lines is represented by d_p , and the distance from the ground to the service drop is represented by d_s .

Free-body diagram showing the forces acting on utility pole #1 at the time of the tree fall.

Based on the above calculations, a force of approximately 6,300 pounds was exerted on the service drop conductors as it resisted the net bending moment exerted on utility pole #1 by the fallen tree.
