Vol. 42 No. 1 June 2025

# Forensic Deformation Analysis of a Farm Clevis Using Photographs and Exemplar Tests

By Michael Stichter, PhD, PE, DFE (NAFE 1162S) and Wade Lanning, PhD

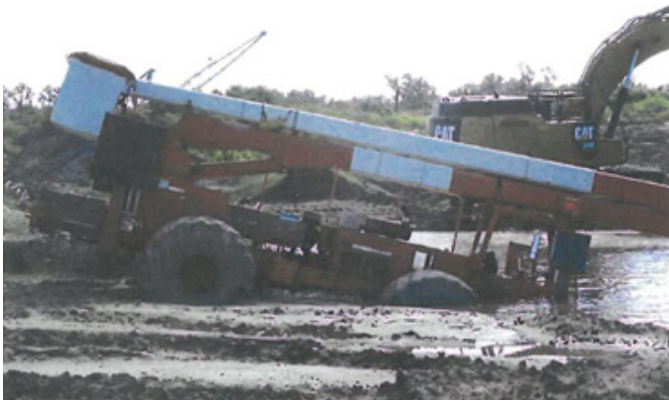
**Figure 1**

The MSHA citation included photographs of the mired equipment.

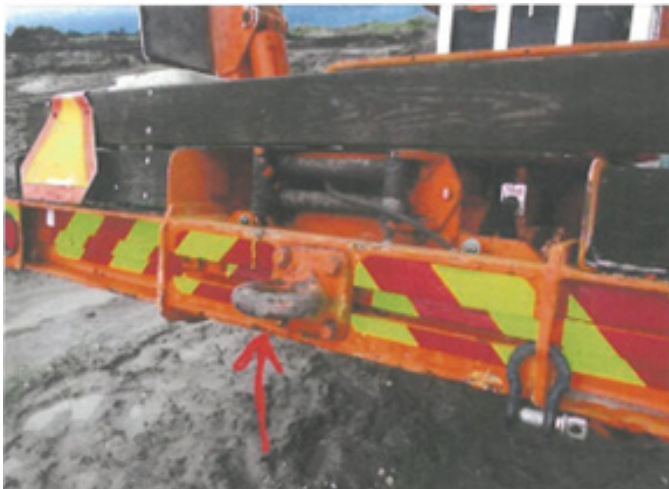
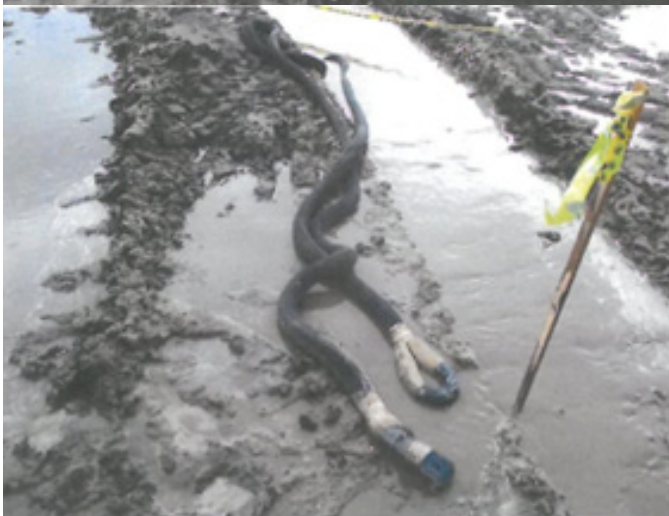
**Figure 2**

The MSHA citation included photographs of the hitch where the clevis was connected to the mired equipment (top) and the rope used to attempt to recover the mired equipment (bottom).

The difference in deformation is due to the difference in how those forces were applied. The more extensively deformed clevis was connected with its pin passing through a ring-shaped hitch on the mired vehicle (**Figure 2**), while

the less deformed clevis was connected with its pin passing through a bracket on the bulldozer. The ring on the mired vehicle (with its round shape) would tend to concentrate stress at the center of the pin, inducing a three-point bending condition. The bracket on the bulldozer would distribute the stress more evenly across its pin. Nevertheless, the presence of some permanent deformation (however slight) on this other clevis indicates that it had also exceeded its elastic limit. The failed clevis was essentially loaded in three-point bending while the clevis connected to the bulldozer was in double-shear loading. Thus, even though both clevises were subjected to the same force, the clevis with a more concentrated force acting on its pin exhibited more extensive deformation and failed first.

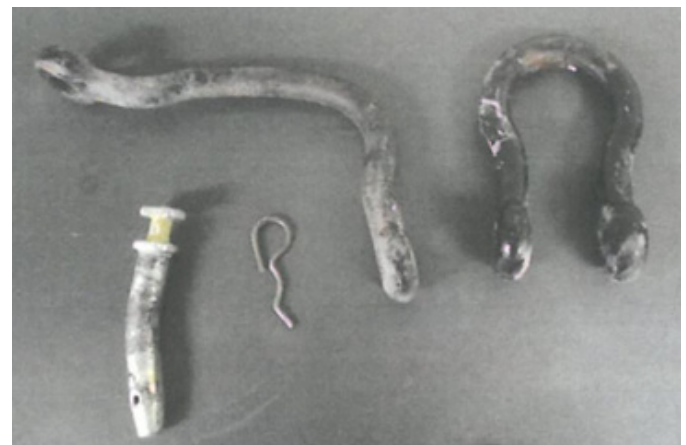
**Figure 4**

The MSHA citation included a photograph of the clevis and pin that were connected to the mired equipment (left) and the clevis that was connected to the bulldozer (right).

Differences among the deformations exhibited by different clevises were most likely due to the distribution of external forces acting upon the clevises. There were two clevises in use at the time of the accident — one connected to the bulldozer and one connected to the mired vehicle (**Figure 4**). Even though the clevises were identical to one another and were subjected to the same total amount of force, the clevis connected to the bulldozer exhibited only slight spreading of its ears; it was significantly less deformed than the clevis connected to the mired vehicle.

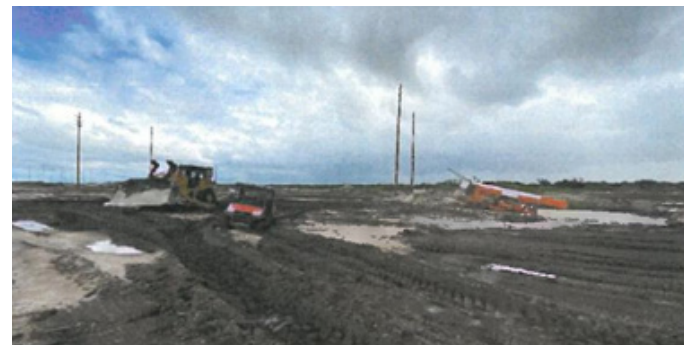
**Figure 5**

Photograph of the accident scene included in the contractor incident report. The mired equipment is mired in the mud on the right, and the CAT D8T bulldozer is positioned on the left of the image with a side-by-side UTV positioned in the foreground between the bulldozer and the mired equipment.

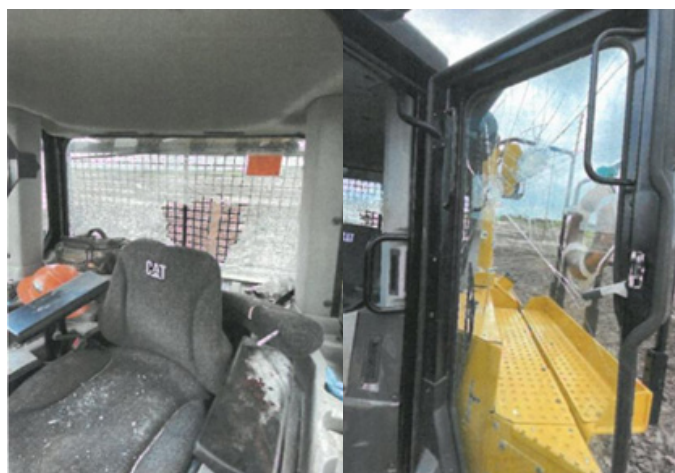
**Figure 6**

When the bulldozer pulled on the recovery rope in an attempt to recover the mired equipment, the clevis connected to the mired equipment failed and was launched by the elastic energy stored in the stretched tow rope toward the bulldozer. The clevis pin traveled toward the bulldozer cab, penetrated the steel grate on the rear window, penetrated the window, broke the headrest off the operator station, struck the operator with a glancing blow to the back of his head, and then fractured a front side window. The clevis bow also traveled toward the bulldozer, but did not

Photographs of the bulldozer cab included in the contractor incident report showing damage to a steel guard and the rear window (left) and fractured left front cab window (right).

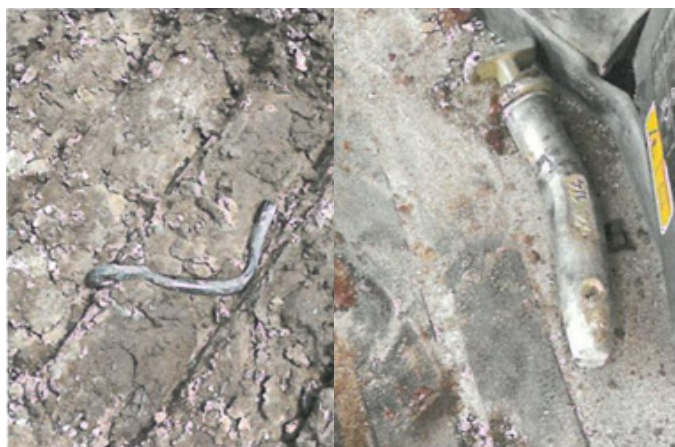
**Figure 7**

The locations where the clevis bow and clevis pin were found are shown in **Figure 7**. Although the exact distance that the clevis bow traveled is unknown, photographs of where it was recovered showed it embedded in soil that exhibited an impression from the bulldozer track.

Most likely, when the clevis failed and departed from the mired equipment, the clevis bow traveled past the bulldozer, landed on the ground in front of the bulldozer, and was then run over when the bulldozer continued to roll forward — after the operator was incapacitated by the head injury from the clevis pin. The clevis appeared to have sunk into the mud under the track, and did not exhibit any deformation or damage from being run over.

Failed clevis found some distance beyond the bulldozer (left) and clevis pin found inside the bulldozer (right) from photographs included in the contractor incident report.

The subject clevis also had a bent pin, and the ear that retained the pin was significantly more deformed than the other ear (**Figure 7** and **Figure 13**). Similarities between post-failure conditions of the subject clevis and one of the exemplars (**Figure 18**) indicated that they followed a similar series of deformation steps. Thus, the subject clevis failed by the same sequence of deformation and load transfer as the exemplars — and with similar forces in excess of the clevis' rating. The MSHA was correct to cite the mine operator for using the clevis above its rating.

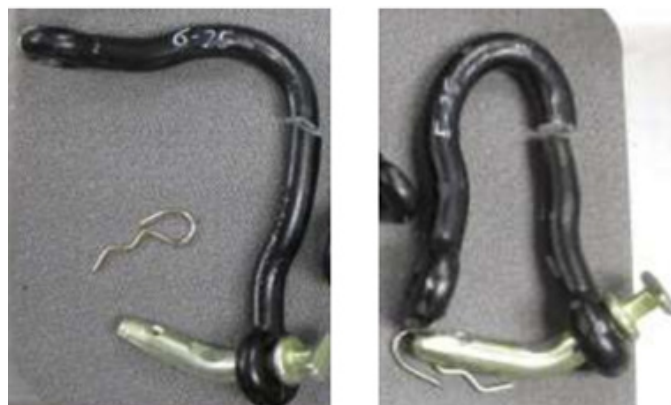
**Figure 8**

clevises in tension (**Figures 8 through 10**). The MSHA tests used polymer webbing to load the exemplar clevises, attempting to simulate the vehicle recovery operation. The clevises that were tested in-line (no side-loading) or with slight side-loading all withstood 60,000 pounds-force or more. The side-loaded clevises failed at 22,500 pounds-force or less. The failure mode of the subject clevis resembled the failure mode of the exemplars tested in-line, but

Exemplar clevises that were tested in-line (no side-loading).

The MSHA-tested shackles that were in-line or only slightly side-loaded (longitudinal loading) all had bent pins (**Figure 8** and **Figure 9**), and failed at more than twice the shackle's load rating. Bending of the pins indicates a three-point loading condition that existed before the pin disengaged from the clevis ears. Most likely, the maximum force during the test was at the yield point of the pin, which was loaded in three-point bending with relatively short moment arms.

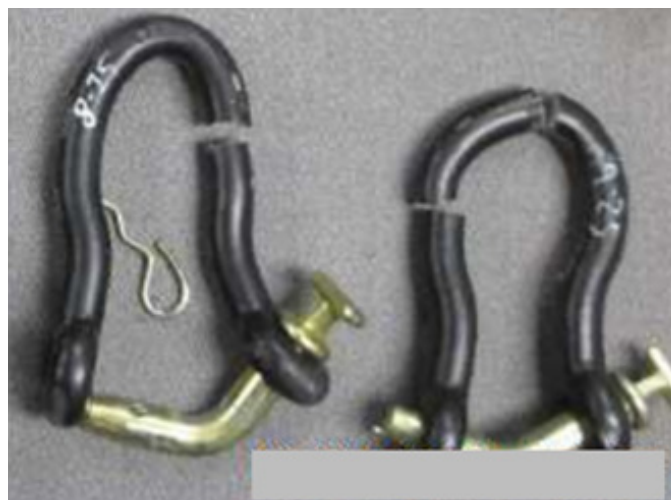
**Figure 9**

Exemplar clevises that were tested slightly off-axis (slight side-loading).

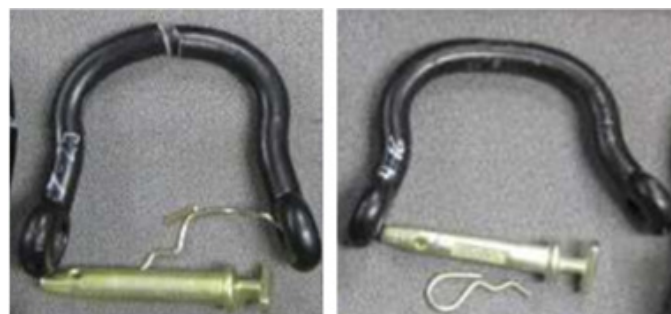
**Figure 10**

Exemplar clevises that were tested with severe side-loading.

arm. Thus, the MSHA's report that the exemplars tested in extreme side-loading (**Figure 10**) failed at a force beneath the clevis' rating was predictable. Since there was no deformation of the pin in severe side loading (but there was deformation of the pin in the subject shackle), the logical finding is that the subject shackle was not severely side-loaded.

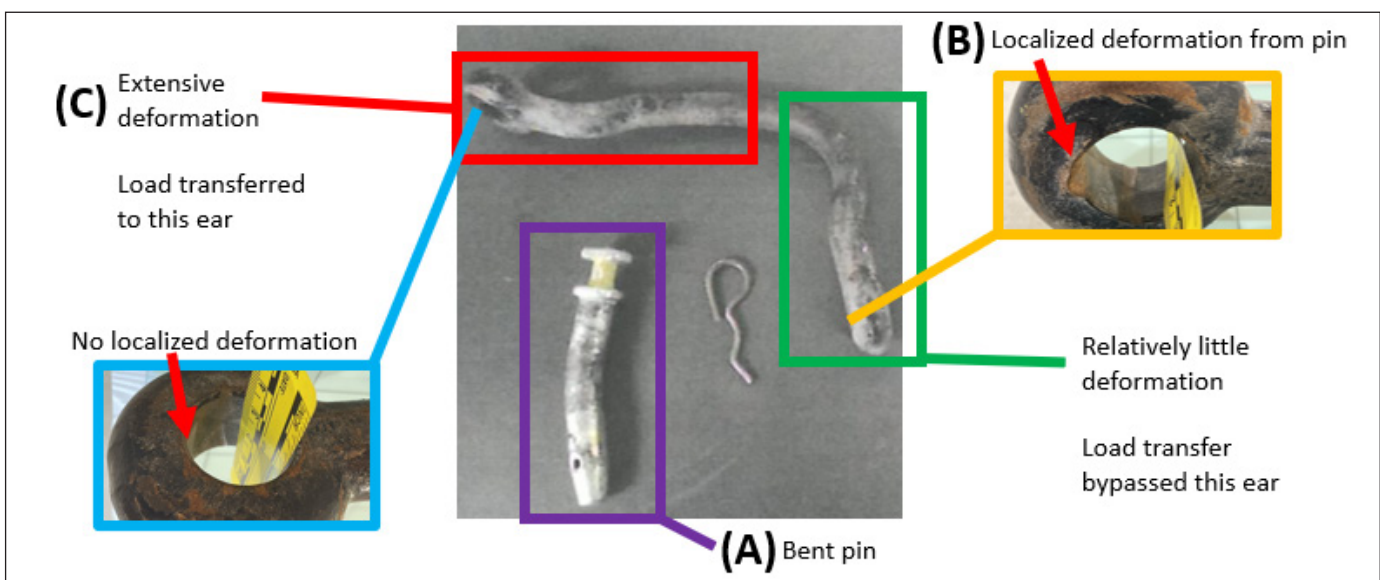
**Figure 13**

Notable areas of deformation or absence of deformation in the subject clevis.

Deformation at that location was not apparent in the available photographs. Therefore, the bend in the pin occurred before the ears began to spread. Bending of the pin was the first step in the failure (**Figure 13A**). Before the pin bent, force between the pin and the clevis ears would have been parallel to the overall tensile forces. After the pin bent, the angle of the bend would have resulted in a horizontal component of forces between the clevis ears and pin,

From photographs, it appeared that shearing of the cotter pin did not induce enough stress on the ear to cause visible deformation. The tip of the pin sliding out of the eye created the contact damage present on the inside of one ear (**Figure 13B**). Before the pin disengaged, both sides of the clevis bow and both ears would be under load — and, to the extent they deformed, would be symmetrical. After the pin disengaged, only the side of the shackle that retained the pin would be under load, and deformation would no longer be symmetrical (**Figure 15**).

side as the ear with the contact damage — because that ear disconnected from the pin first. All load transfer would be through the other ear, which would continue to deform (**Figure 13C**). Deformation would continue to change the angle of the pin relative to the tensile direction, up until the point where the pin was able to slide out of its connection point to the mired equipment (**Figure 17**). This is why the other leg was more severely deformed, and went from its original curved shape to nearly straight. Deformation of the left side of the shackle bow continued until the shackle slid off of its connection point to the mired vehicle (**Figure 17**).

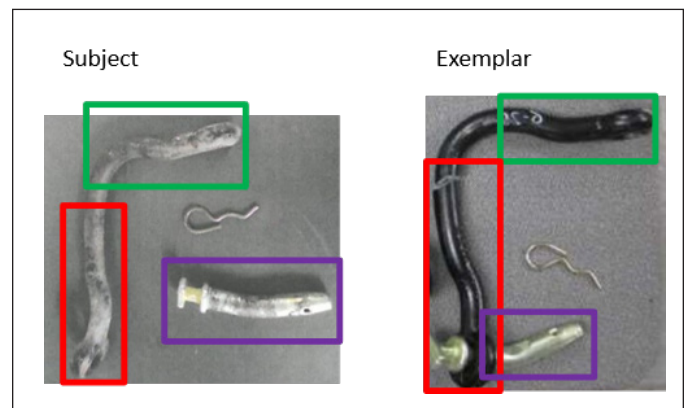
**Figure 18**

The most significant difference between the exemplar and subject clevises (**Figure 18**) was that the exemplars fractured. This fracture may be due to the testing equipment used with the exemplars. The quasi-static test conducted by MSHA involved less dynamic loading, and therefore less likelihood that the clevis could disconnect from the load frame in the manner that the subject clevis disconnected from the mired vehicle. Thus, the MSHA exemplar continued to be loaded until final fracture, while the subject clevis disconnected from the mired vehicle before it could fracture.

Similarities between the subject clevis and exemplar clevis indicate that they followed a similar sequence of deformation steps and that the subject clevis failed at a similar force to the exemplar clevis.

The subject bulldozer, like most similar equipment, had instructions to this effect in its manual. The bulldozer's manual recommended choosing recovery straps, shackles, etc., rated for at least 150% the weight of the towing vehicle. The best practice in this case would have been to use the 85,000 pounds-weight of the bulldozer to select a tow strap and shackles rated for at least 127,500 pounds-force. This way, if the force to recover the mired vehicle was higher than expected, the bulldozer would be more likely to spin its treads than break the towing equipment. Using the subject shackle (with its 25,000 pounds-force working load limit) went against the bulldozer manual's instructions and would foreseeably result in overloading and breaking the shackle.
