Analysis of a UTV Axle Fracture Associated with Rollover

By Stephen A. Batzer, PhD, PE (NAFE #677F)

Abstract

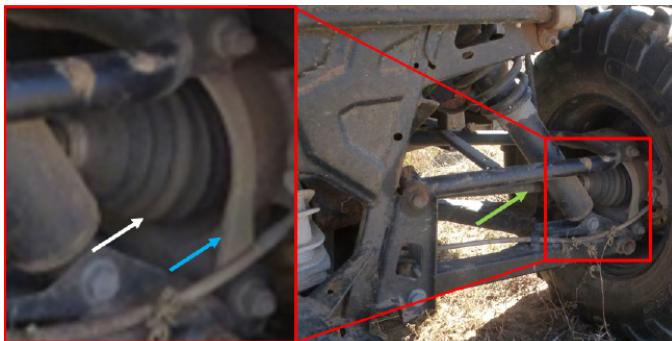
Figure 1

Right rear wheel assembly showing drive axle with normal CV boot indicative of axle shaft and joint rotating in tandem. Green arrow = axle main shaft; white arrow = right axle; and blue arrow = bearing carrier.

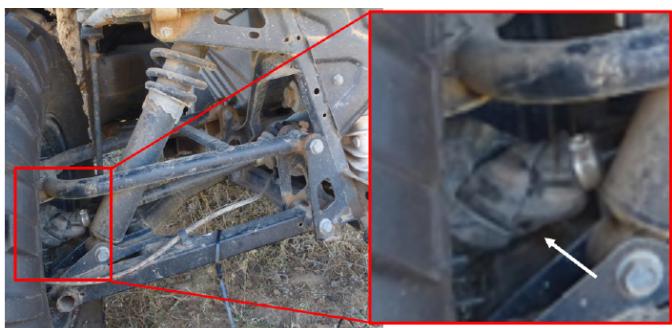
Figure 2 shows the damaged left axle with a distorted CV boot at the outboard position. The twisted outboard CV boot, indicative of an axle fracture and the axle shaft rotating independently of the CV joint, is highlighted with a white arrow.

Left rear wheel assembly showing twisted CV boot indicative of axle shaft and joint turning independently. White arrow = twisted CV joint boot.

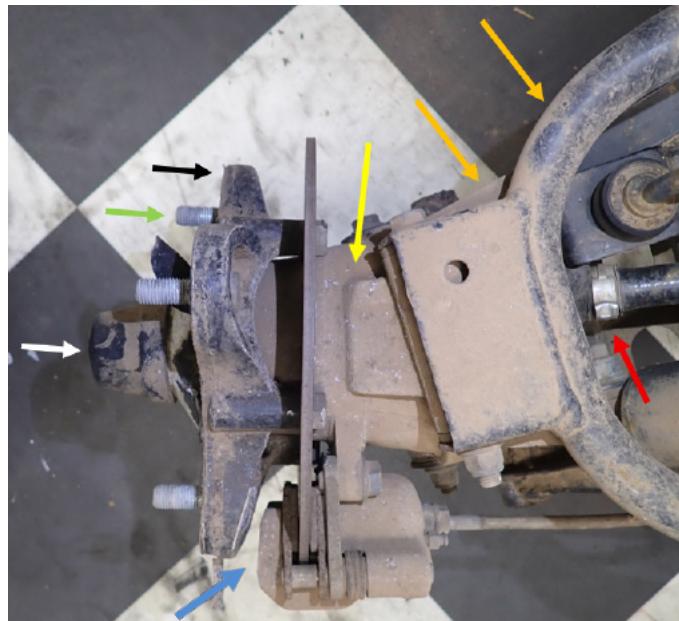
Figure 3

Left rear drive assembly, overhead view, tire and wheel dismounted. White arrow = grease cap; green arrow = lug stud; black arrow = hub; yellow arrow = bearing carrier; blue arrow = brake shoe assembly; orange arrows = A-arms; and red arrow = half shaft showing black axle, CV joint polymer boot, and mounting clip.

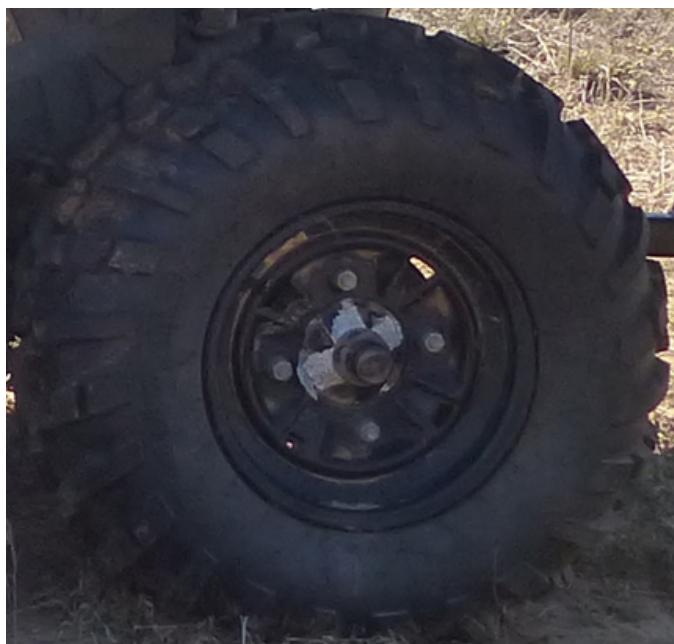
Figure 5

In addition to the CV boot, other relevant external damage at the left rear wheel position of the incident vehicle included a circumferentially fractured cast aluminum wheel hub, as shown in **Figures 5** and **6**. In **Figure 6**, note the chipped edges of the central fragment as indicated by red arrows. This chipping was consistent with damage after the circumferential crack separated the central and outer hub segments, during relative movement between the fractured segments.

Left rear wheel and tire showing paint spalling at the cast aluminum center hub.

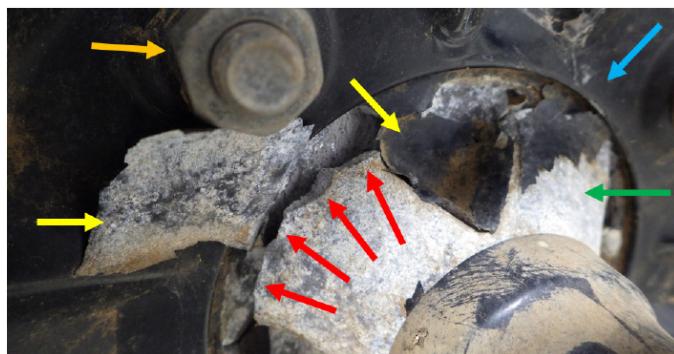
Figure 6

Close-up of left rear wheel assembly showing the black painted steel wheel (blue arrow) that is secured by four threaded lugs and nuts (orange arrow), aluminum wheel hub (green arrow), spalling black factory paint to include a detached large flake at left (yellow arrows), and the circumferential hub crack with edge chipping (red arrows).

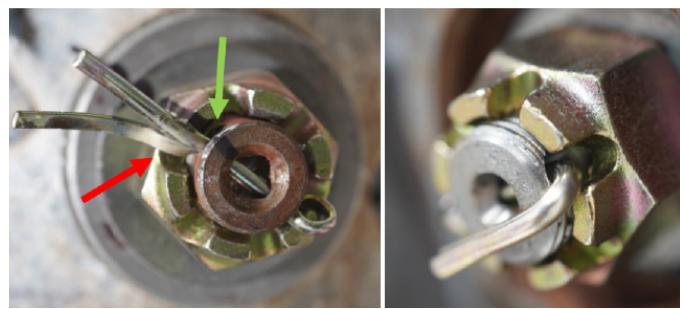
Figure 7

Notice how the right rear cotter pin through-hole in the threaded axle stub aligns with the castellated nut slot, while the left rear transverse axle stub cotter pin hole does not align properly with the cotter pin recess. The left rear

Left rear axle cotter pin showing post-installation misalignment of the axle cross hole and castellated nut slot (left). Right rear axle cotter pin showing undisturbed factory-installed alignment (right).

cotter pin segment in the foreground aligns with the axle transverse hole (green arrow), while the cotter pin segment in the background aligns with the castellated nut slot (red arrow); the head of the left cotter pin is also deformed. This is consistent with the threaded driving axle stub turning $\sim 10^\circ$ clockwise relative to the castellated nut after the cotter pin had been installed. Like the chipped wheel fracture surface shown in **Figure 6**, this is an indication that the axle and wheel damage occurred while the vehicle was in motion.

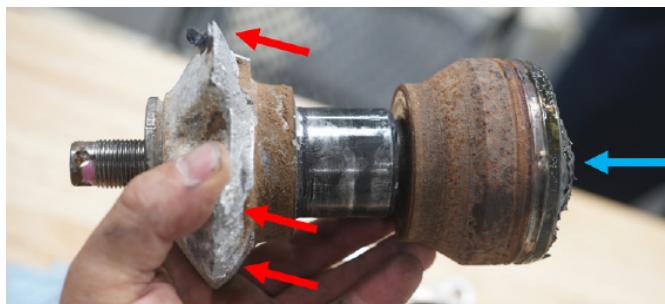
Figure 8

The burnished regions on both sides of the mating conical cast aluminum wheel hub fracture surfaces are from high points rubbing against each other (see **Figures 8** and **9**, red arrows). Also shown with a yellow arrow in **Figure 9** is the polished precision cylindrical interface surface for the wheel bearing; the blue arrow shows the splined internal recess for interaction with the driving end of the axle assembly, which is the outer race "bell housing" of the CV joint.

Left rear-threaded axle stub, aluminum wheel hub fragment, bearing, CV joint outer bell. Red arrows indicate representative burnished surfaces; blue arrow shows the installation point of the fractured main axle shaft.

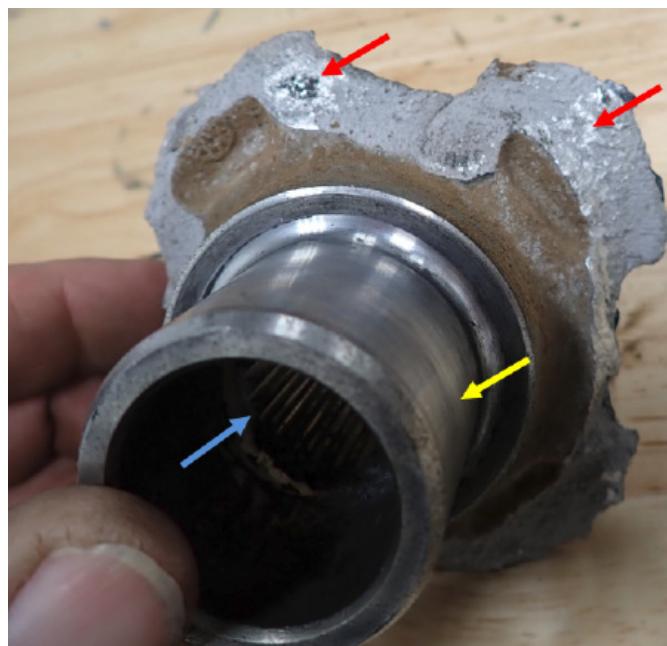
Figure 9

Central detached fragment of aluminum wheel hub, shown from inboard side.

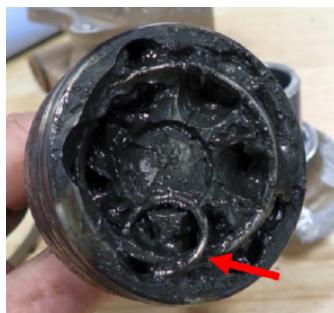
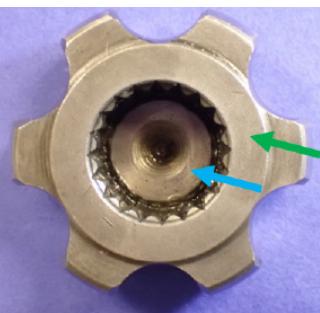
Figure 10

The left rear CV joint, detached from the wheel assembly and with the damaged flexible rubber boot removed, is shown from the inboard side in **Figure 10** (left). Although covered with grease, many details are apparent. From exterior to interior is the bell housing (outer race), the cage, the inner race with six cavities for hardened steel ball bearings with the balls removed, the retaining circlip near the bottom, and the fractured stub of the left rear drive axle in the center. **Figure 10** (right) shows the degreased inner race from the outboard side and the axle stub in the splined inner recess, which is not properly positioned fully outboard.

Left: Inboard view of CV joint bell housing showing fractured end of the main axle shaft and retaining circlip (red arrow). Right: Outboard view of degreased inner race; the stub end of the main axle is inappropriately inboard as the outboard face of the axle shaft (blue arrow) should be above flush of the outboard face of the inner race (green arrow).

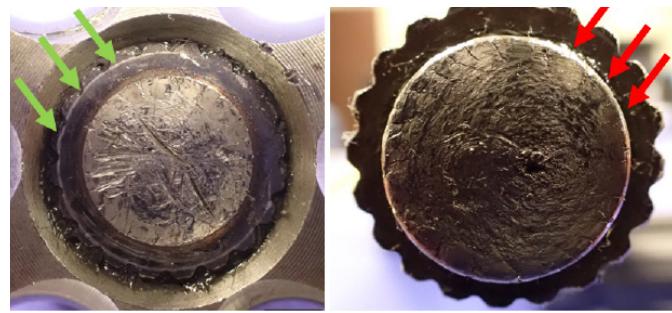
Figure 11 shows that the fatigue break occurred at the end of the main axle shaft at the outboard side of the circlip groove nearest the inner race. The fracture surface developed at the region of greatest axle bending moment and minimum cross section. The entire axial width of the circlip groove was present on the longer inboard axle shaft fragment (**Figure 11**, right). As a rotating cylindrical member, the fatigue crack progressed semi-uniformly planar to the shaft axis from outside to inside. This also ensured rotary compressive loading of the circlip as the axle shaft and the end past the groove became misaligned; a light in color witness mark of this compression is visible in **Figure 11** (left) — see green arrows.

The arc-like impressions on the main face of the outboard main shaft fragment are consistent with the interfacing rim of the detached inboard axle shaft pressing against the outboard stub during rotation, producing the fracture of the aluminum wheel hub with an inboard to outboard force. The light-colored groove end perimeter in **Figure 11** (right, red arrows) is no longer sharp but presents an

Left: Inboard end of CV inner race and fractured axle end showing a circlip compression mark and multiple arc-shaped impressions from the detached axle main shaft. Right: Outboard side of fractured axle shaft showing classic topographic macro features of fatigue fracture.

irregular beveled interface of the groove wall at the fracture surface. This was caused by cold work compression of this inboard edge against the outboard axle stub center segment during vehicle travel. The fracture surface on the inboard axle shaft fragment is better preserved for macro features of fatigue (**Figure 11**, right). Notable features include³⁻⁵:

- A. The overall planar fracture surface that is perpendicular to the shaft axis.
- B. The ratchet marks that initiated the planar crack perpendicular to the shaft axis once the axle shaft had backed off sufficiently for the circlip groove to be exposed past the splined region;
- C. Radial spaced arc-like markings of crack progression from exterior to interior; and
- D. An identifiable point of final fracture near the shaft centerline. These macro features were plainly visible with low power optical microscopy and did not require scanning electron microscope (SEM) examination.

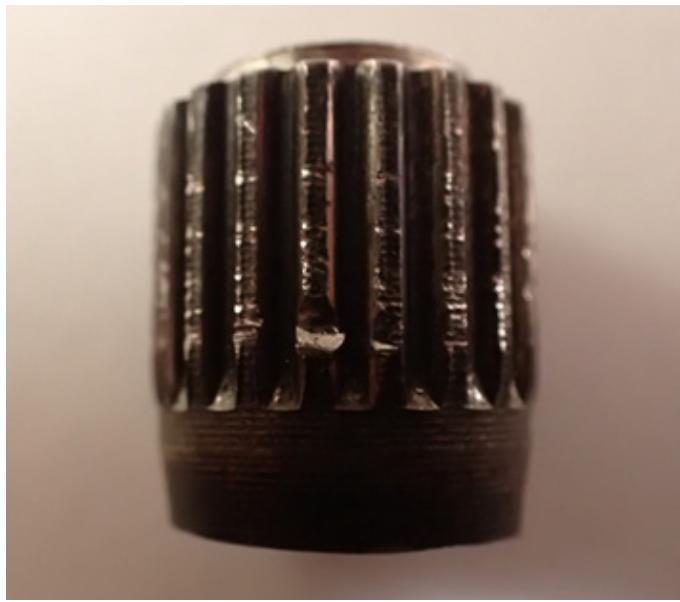
Figure 12

Witness marks about the circlip were consistent with the axle main shaft having been inserted some distance into the inner race, but these marks could not confirm that the main shaft had been fully inserted with circlip expansion at the factory during half shaft assembly. On the main splined surface of the axle were circumferential compression marks documenting bending loading on the axle as the end moved incrementally inboard relative to the CV joint inner race (**Figure 12**). These marks strongly indicate that the shaft was, at least, nearly fully inserted — though perhaps not fully inserted — which would be one potential failure mode mechanism of the shaft backing out. The axle

Sawn-off end of main axle stub, which fractured at circlip groove (top), showing circumferential compression marks developed while it backed out of the mating splines of the inner race.

fragment shown in **Figure 12** is the profile view of the segment shown in **Figure 11** at right.

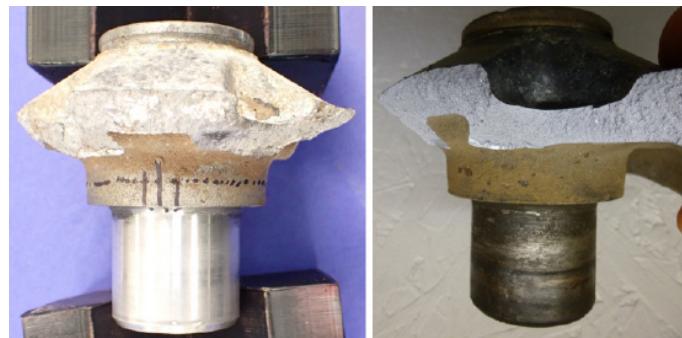
Figure 14

The general shape of the fracture surface from the in-board-to-outboard loading produced an angular wheel hub fracture surface, reasonably matching the incident wheel hub (**Figure 14**). While the incident hub was rotating at least 5 revolutions per second at the initiation of yaw and of loss of control, the fracture is a form of “Hertzian cone” in which the principal tensile stresses within the brittle material subjected to focal compressive loading ensures an angular, conical crack progression⁷. As an analogy to the instant fracture, a lead pellet that is discharged from an air rifle into common annealed window glass will produce an entry hole the same diameter as the pellet, a conical fracture downstream of impact through the glass thickness, and, finally, a larger damage diameter hole at the exit plane.

Incident wheel hub (left); Tested wheel hub given inside-to-outside loading (right).

The inboard concentrated load produced a conical fracture surface that diverged from inboard to outboard. The outboard concentrated load produced a conical fracture surface that diverged angularly from outboard to inboard.
