Journal of the
National
Academy OF
Forensic
Engineers[®]

Vol. 42 No. 1 June 2025

Forensic Analysis of an Elevated Pool Vault

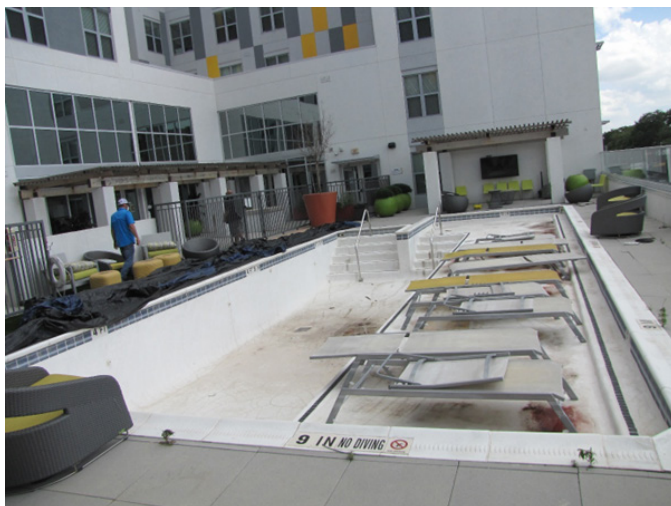
Figure 2

General view of the subject pool and adjacent deck surfaces.

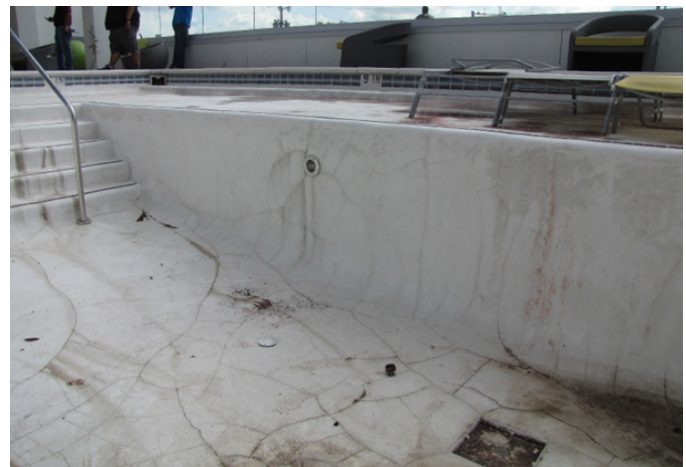
Figure 3

with the largest crack measured at $\frac{1}{8}$ (0.125) of an inch in width. The cracks observed in the plaster lining of the pool were oriented horizontal, vertical, and diagonal, and most of the cracks appeared to exhibit a pattern consistent with craze cracks or map cracks, as defined in ACI 201.1R-08 and illustrated in **Figure 3**¹.

Cracks observed in the plaster lining of the pool shell.

As previously stated, most of the cracks observed in the plaster lining of the pool appeared to exhibit a pattern consistent with craze cracks or map cracks, which is consistent with distress patterns causally related to ASR. As a result, the authors determined that the distress observed in the plaster lining and gunite/shotcrete of the pool shell was causally related to ASR. In addition, the distress related to ASR was exacerbated by construction deficiencies associated with the thickness of the pool shell and the depth of gunite/shotcrete cover over the reinforcement steel, which likely increased the volume of reactive materials available for ASR to occur and located the tensile reinforcement

Based upon the magnitude of distress causally related to ASR within the pool shell — in conjunction with the likelihood for such distress to continue — it was recommended by the authors, as well as various other consulting firms (including the owner's consultant), that the pool shell be removed and replaced.

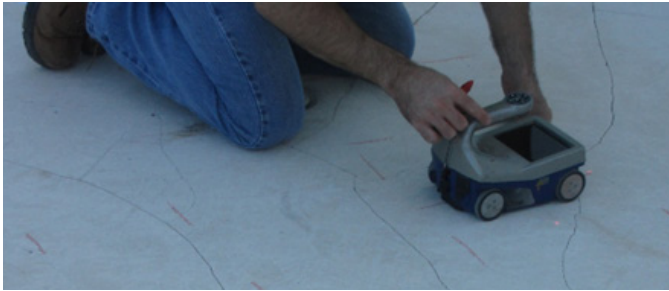
Figure 4

GPR survey performed on the floor of the pool shell.

GPR surveys were performed within the pool structure to evaluate the placement of steel reinforcement within the floor and walls of the pool shell, as illustrated in **Figure 4**. The GPR surveys performed on the floor of the pool shell did not detect any salient signs of steel reinforcement; however, it should be noted that the presence of cracks and/or moisture may have limited the effectiveness of the surveys². A GPR survey performed on one wall of the pool shell detected the presence of steel reinforcement spaced at approximately 12 inches on center horizontally and vertically. The same GPR survey also indicated an average gunite/shotcrete cover of approximately $3\frac{1}{2}$ inches (horizontal bars) to $3\frac{3}{4}$ inches (vertical bars). A GPR survey performed on another wall of the pool shell detected the presence of steel reinforcement spaced at approximately 9 to 14 inches on center vertically and approximately 12 inches on center horizontally. The same GPR survey also indicated an average gunite/shotcrete cover of approximately $5\frac{1}{4}$ inches (horizontal bars) to $5\frac{3}{4}$ inches (vertical bars).

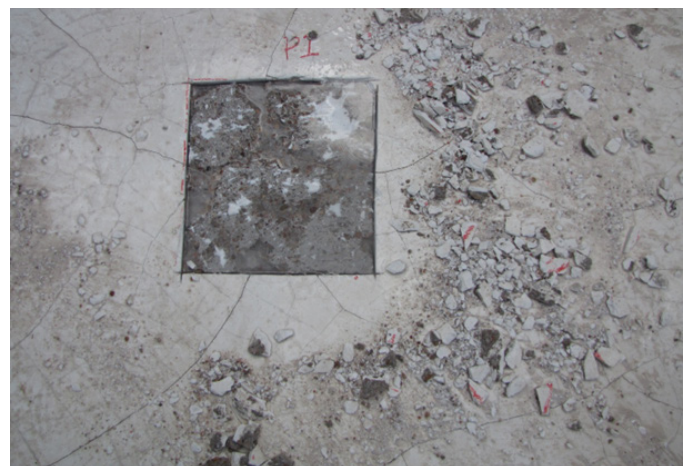
Figure 5

Selective demolition was performed within the pool shell, as illustrated in **Figure 5**, in order to determine whether the cracks observed in the plaster lining continued into the gunite/shotcrete and to verify the locations of the steel reinforcement indicated in the previous GPR surveys. An exploratory opening located near the central portion of the pool shell extended into the gunite/shotcrete, and it was intended to locate the steel reinforcement in the floor of the pool shell; however, no steel reinforcement was encountered at this location.

Selective demolition performed within the horizontal floor surface of the pool shell.

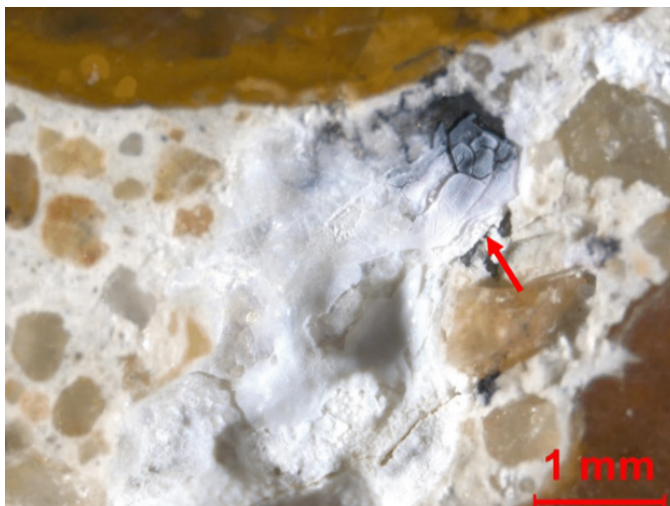
Figure 6

Through petrographic examination, it was determined that all of the applicable gunite/shotcrete core samples contained macro-cracks, microcracking, and abundant evidence of alkali-silica reaction (ASR) that radiated from chert (hard, fine-grained sedimentary rock) aggregates, cracked chert aggregates, partially-consumed chert aggregates, and/or desiccated alkali-silica gel within voids as illustrated in **Figure 6**.

Desiccated alkali-silica gel adjacent to a chert aggregate viewed under microscope.

Curative treatments for structures affected by ASR are not easily performed, if at all possible. Isolated repairs of damaged sections are possible; however, ASR can be expected to continue in non-repaired portions of the affected structure. Due to the presence of desiccated alkali-silica gel within voids, as identified in the gunite/shotcrete core samples, it was expected that the distress would likely continue to manifest as the desiccated alkali-silica gel experienced additional hydration and expansion. In some cases, the rate of ASR can be retarded through the application of a waterproofing membrane, which can reduce the volume of water available to fuel the expansion of the alkali-silica gel; however, this treatment was not practical for a pool structure due to the likelihood of contact between the gunite/shotcrete and moisture from the pool water⁶.

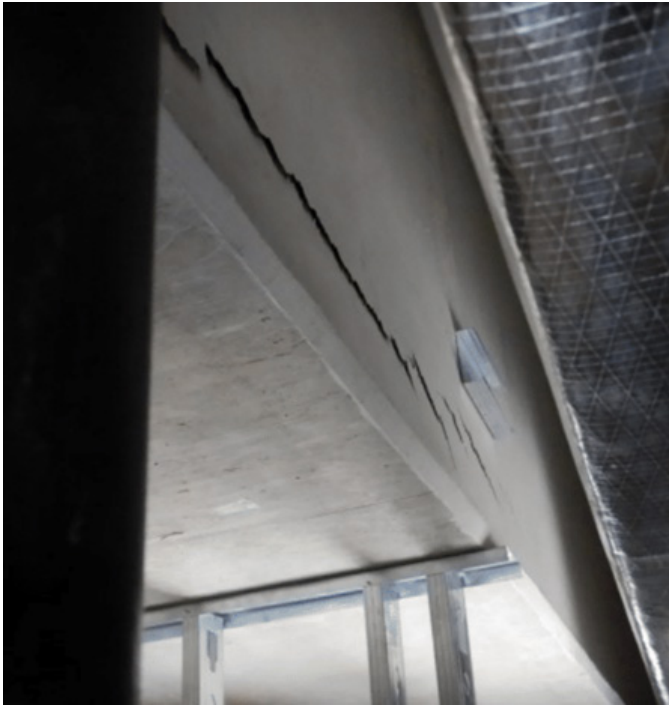
Figure 7

During demolition of the pool shell, cracks were observed at various locations in the concrete support structure underlying the pool shell. Of particular concern was a horizontal crack that exhibited lateral displacement located in the outside face of the vault wall near the abutment of the vault wall and the vault floor as shown in **Figure 7**.

Horizontal crack exhibiting lateral displacement near the abutment of the vault wall and the vault floor.

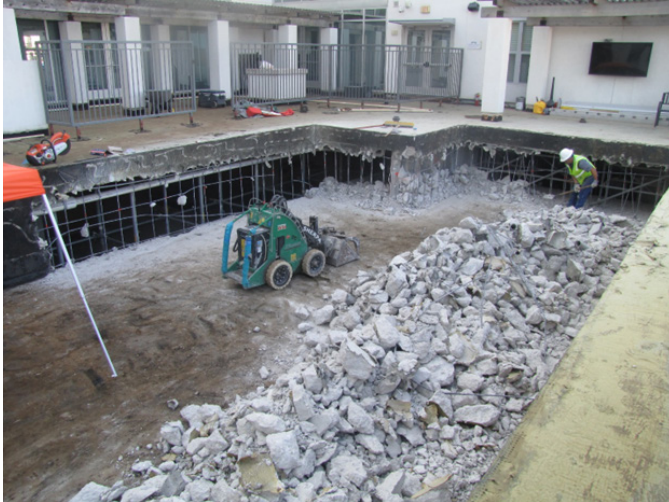
Figure 8

As a result, all consultants collectively agreed that selective demolition was warranted in isolated areas of interest, and the demolition would progress as necessary until the as-built construction of the pool vault could be determined with a reasonable degree of certainty to allow for structural analyses of the as-built structure. Ultimately, the selective demolition progressed until it was determined that corner bars/hooks were omitted from the as-built structure. Independent structural analyses performed by each consultant, considering the omission of corner bars/hooks, indicated that the concrete pool vault was not structurally adequate to support the required design loads of the superstructure, and the concrete pool vault was subsequently demolished in its entirety, as illustrated in **Figure 8**.

Selective demolition of the pool vault.

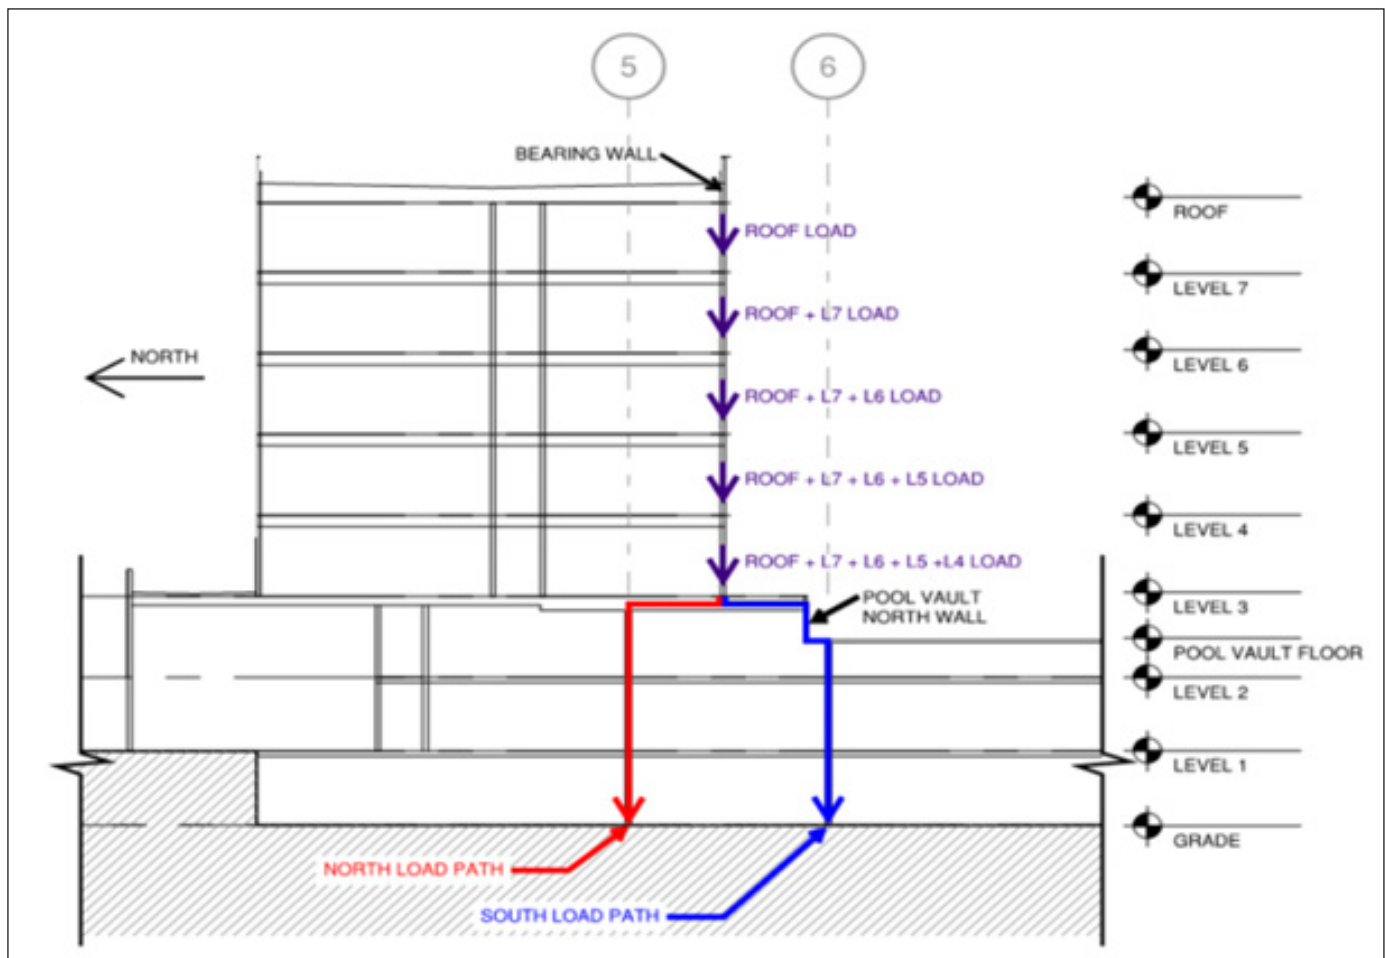
It should be noted that a load-bearing wall that supported the wood-framed superstructure from the fourth-floor to the roof was supported on the third-floor podium slab approximately 11 feet away from the concrete pool vault. Based upon the aforementioned structural analyses, it was determined by both the authors and the owner's consultant that the SEOR failed to accurately consider the portion of the design load applied from the aforementioned load-bearing wall that would be transferred through the third-floor podium slab into the concrete pool vault, which contributed to the structural inadequacy of the engineered design, as illustrated in **Figure 10**.

Figure 10
Load-bearing wall supported on the third-floor podium slab.

Based upon a review of the structural engineering plans for the subject building, the authors found that the SEOR did not include any sections or details associated with the abutment/connection of the floor of the concrete pool vault to the walls of the concrete pool vault, including the construction of a shear key at the abutment/connection of the floor and walls, if necessary. The owner's consultant concluded that the SEOR was responsible for a design deficiency associated with the failure to incorporate an abutment/connection of the floor of the concrete pool vault to the walls of the concrete pool vault; however, the SEOR's consultant contested that an adequate load path was provided.

While the general contractor and/or its subcontractors should review the construction drawings related to the constructability of the design, the general contractor and/or its subcontractors are not responsible for (or capable of) performing an independent peer review of the structural engineering plans to verify that the design is structurally adequate or determine whether a shear key should have been incorporated into the design.
