Vol. 37 No. 1 December 2020

# Forensic Engineering Analysis of a Wheel Spindle Failure Due to Pre-Load and Fatigue

By David A. Danaher, PE (NAFE 703F)

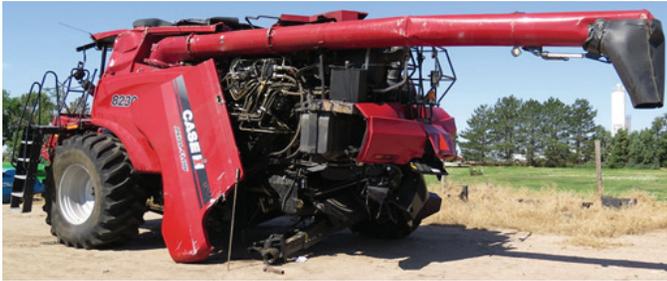
**Figure 5**  
Left rear corner of combine.

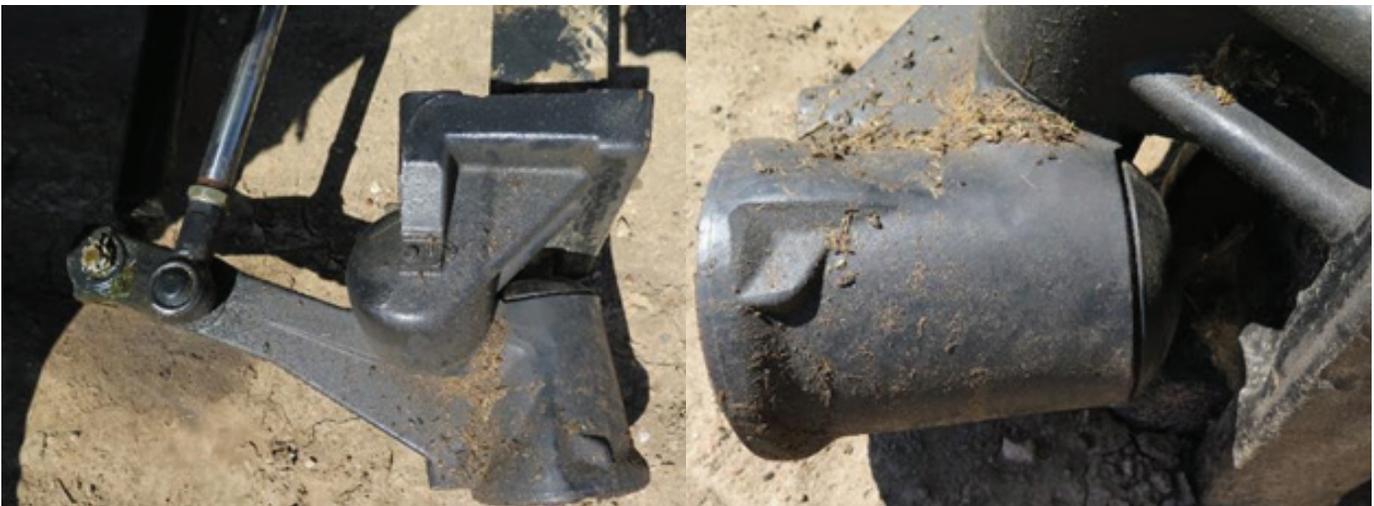
At the time of the inspection, the left rear steering knuckle/housing were still attached to the rear axle. As depicted in **Figure 12**, the outer surface of the knuckle did not show signs of failure and was still attached to the combine.

**Figure 12**  
Left and right images oriented with vehicle's front to the left and top, respectively.

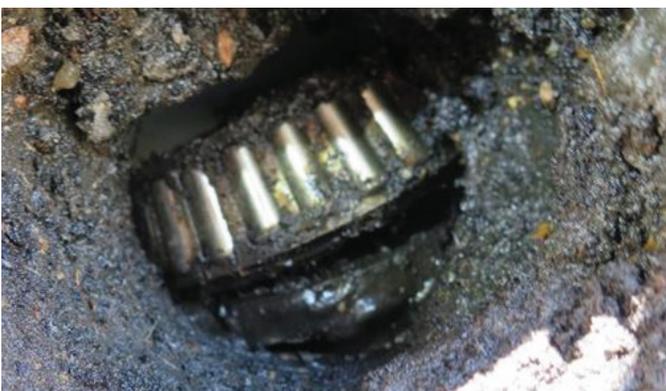
Additionally, the dust/grease cap was still attached to the inboard portion of the steering knuckle. At the time of this engineer's inspection, several components (such as the inner bearing, washer, and nut) were found inside the housing as well as an adequate amount of grease (see **Figure 13**). Within the steering knuckle housing, the tapered roller bearing, washer, castle nut, and cotter pin were removed and cleaned. **Figure 14** depicts these components cleaned as well as the dust/grease cap.

**Figure 13**  
View inside left rear steering knuckle showing spindle components and grease.

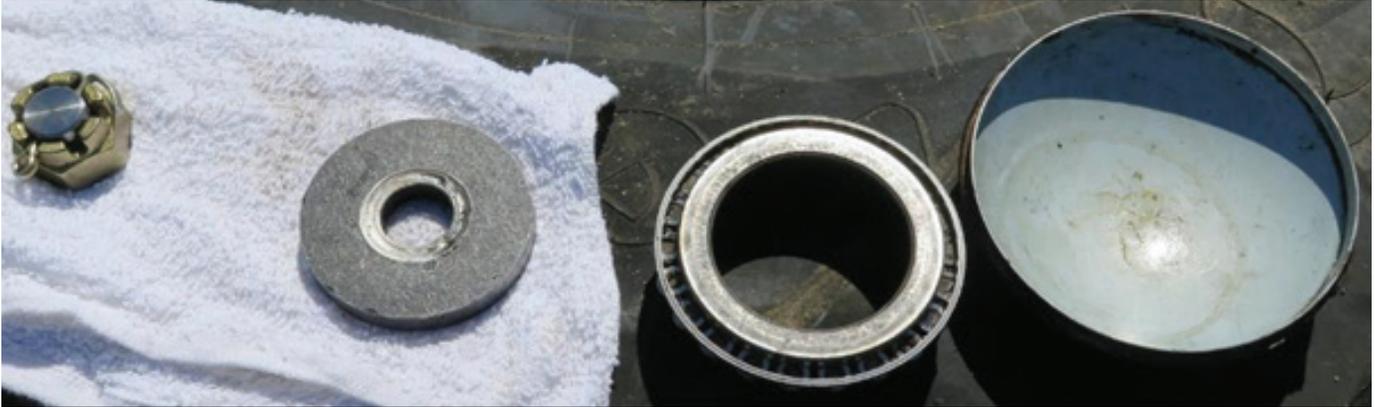
**Figure 14**

From left to right – castle nut, washer, inner bearing, and dust/grease cap.

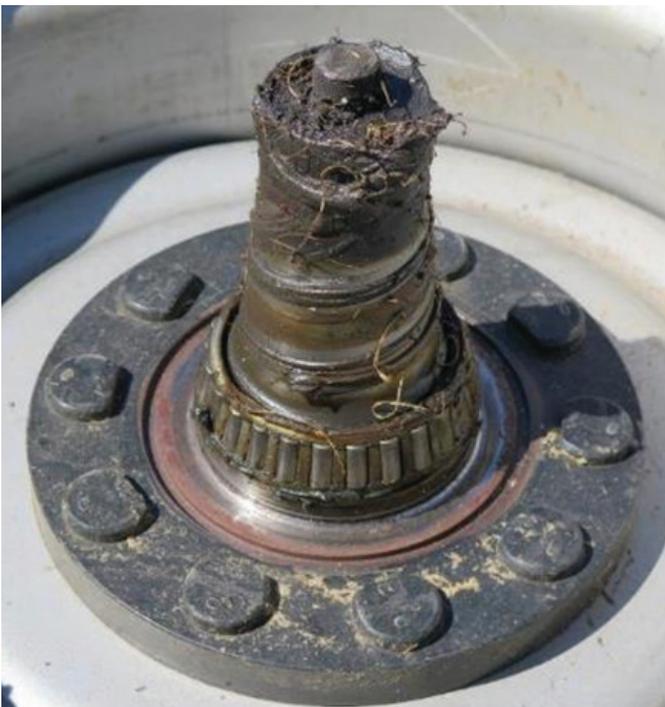
**Figure 15**

At the time of the inspection the left wheel was located next to the vehicle. The spindle, shown in **Figure 15**, was still attached to the wheel, covered in grease, and still had the outer tapered bearing seated on the spindle.

Attached section of the spindle and outer bearing.

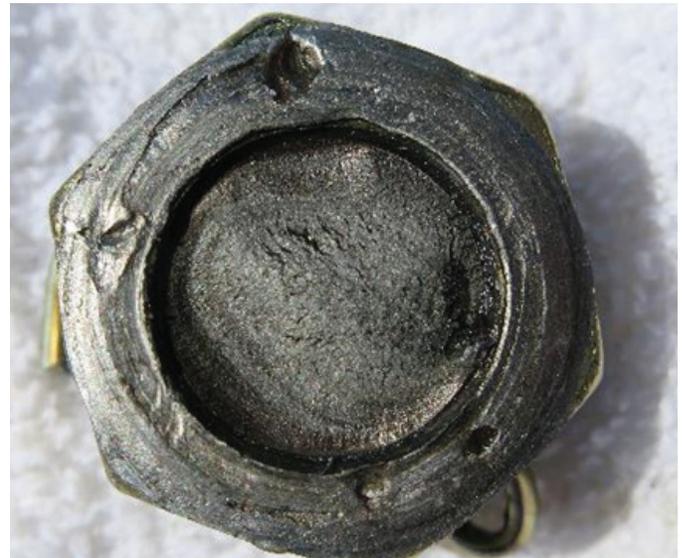
**Figure 17**

As shown in **Figure 17**, a portion of the threaded shaft

Nut, washer side.

is still attached to the nut, and there is damage to the surface of the nut that mates to the washer. The damage to the surface of the nut was due to the rotation of the nut relative to the washer and displaced/removed material from the mating surface. Furthermore, the damage and removal of the material to the nut would have increased the distance in the assembly, thereby decreasing the axial load, allowing more displacement of the bearing, and increasing misalignment in the assembly.

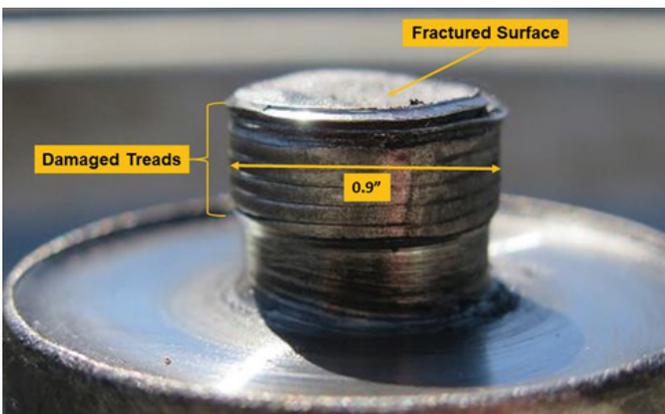
**Figure 16**

The diameter of the threaded portion of the spindle measures approximately 0.9 in. Examination of the spindle shows that the threaded portion where the castle nut attaches was damaged (**Figure 16**). The threads were damaged in two ways: the end portion of the threads was fractured off and remained in the castle nut, and the remaining threads were flattened around the circumference of the shaft.

Spindle threads.

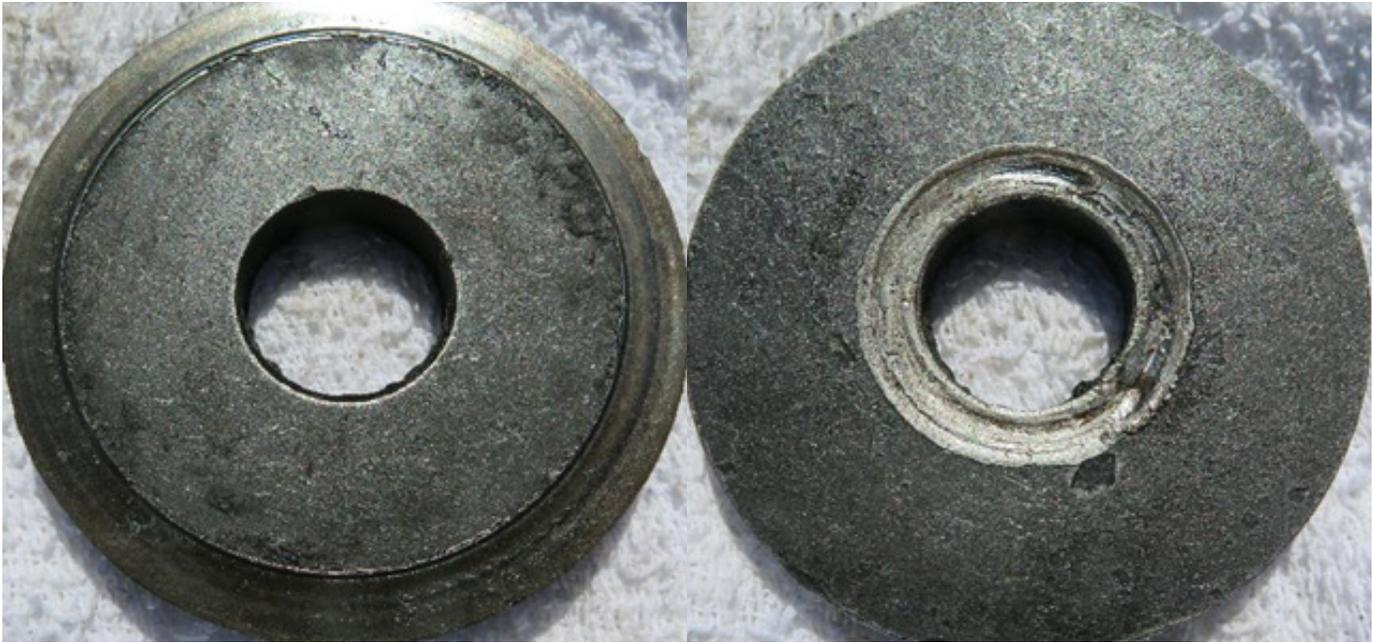
The washer in **Figure 18** was damaged with material displaced/removed on both sides from the contact with the inner bearing and the nut. The washer depicted in **Figure 18** shows damage from the rotation and impact damage of the washer relative to the bearing on the left and the nut on the right. The damage displaced some of the material of the washer, which is a softer

**Figure 18**  
Washer bearing side (left), nut side (right).

material than the bearing. A depression was made on both sides of the washer, increasing the amount of axial and radial movement of the spindle and also decreasing the pre-load. All three components — the washer, the tapered bearing, and the castle nut — were assembled on site and are shown in **Figure 19**.

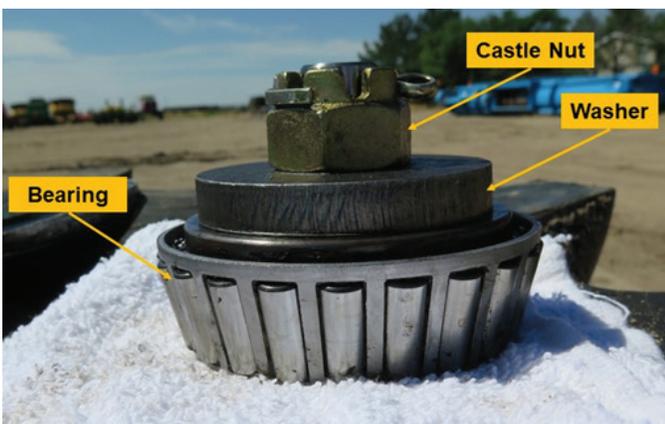
**Figure 19**  
Assembly of the tapered bearing, washer, and castle nut.

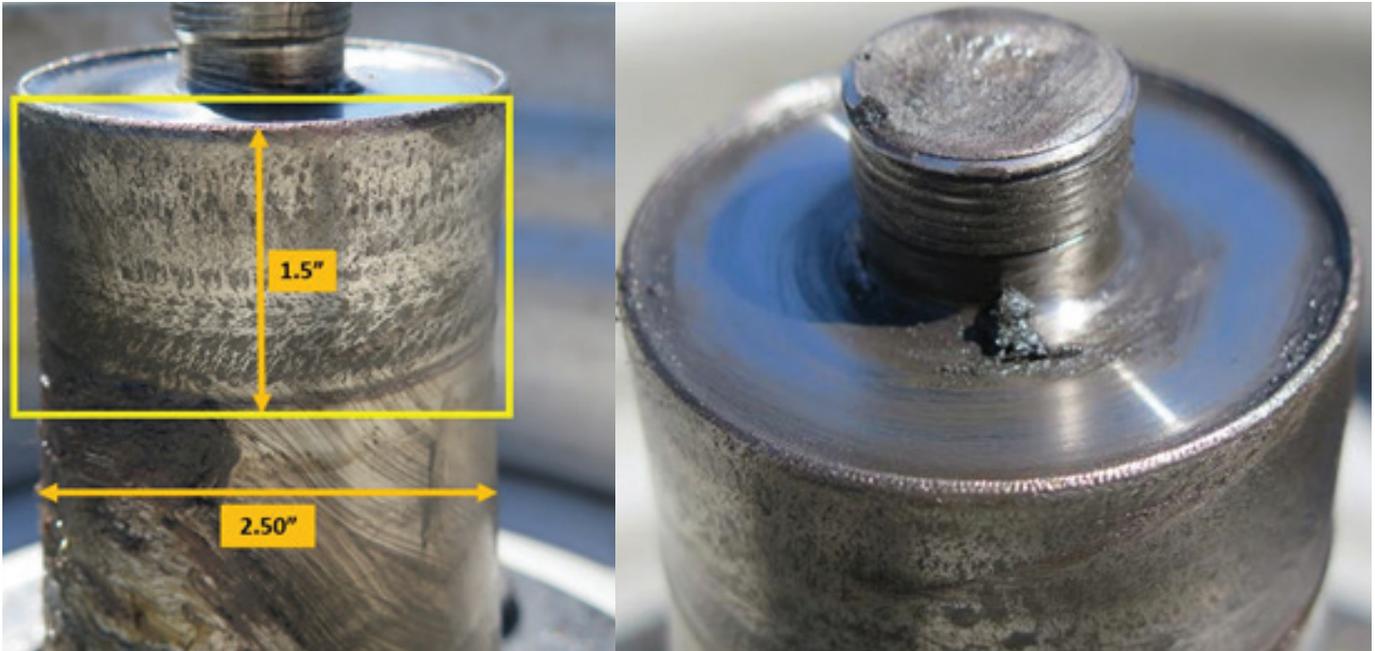
**Figure 20**

The spindle measures approximately 2.50 in. in diameter and had visible signs of damage near the threaded end of the shaft. The damage was the result of the inner bearing race moving relative to the spindle. The damage to the spindle shaft as well as the described dimensions is shown in **Figure 20**. In this photograph, the area denoted by the yellow rectangle shows where the inner race of the

inner bearing was rotating and impacting on the spindle. The damaged area to the spindle outlined in yellow is approximately 1.50 in. in width, approximately 0.25 in. greater than the width of the bearing. Furthermore, at the bottom of the rectangle, there is also a depression from the spinning race that dug into the spindle. This damage to the spindle was consistent with the relative movement of the bearing on the spindle. On the right in **Figure 20**, material was also displaced over the surface where the diameter changes from the bearing landing to the threaded section, giving the end of the spindle a dished shape.

Spindle section attached to the separated wheel of the combine.

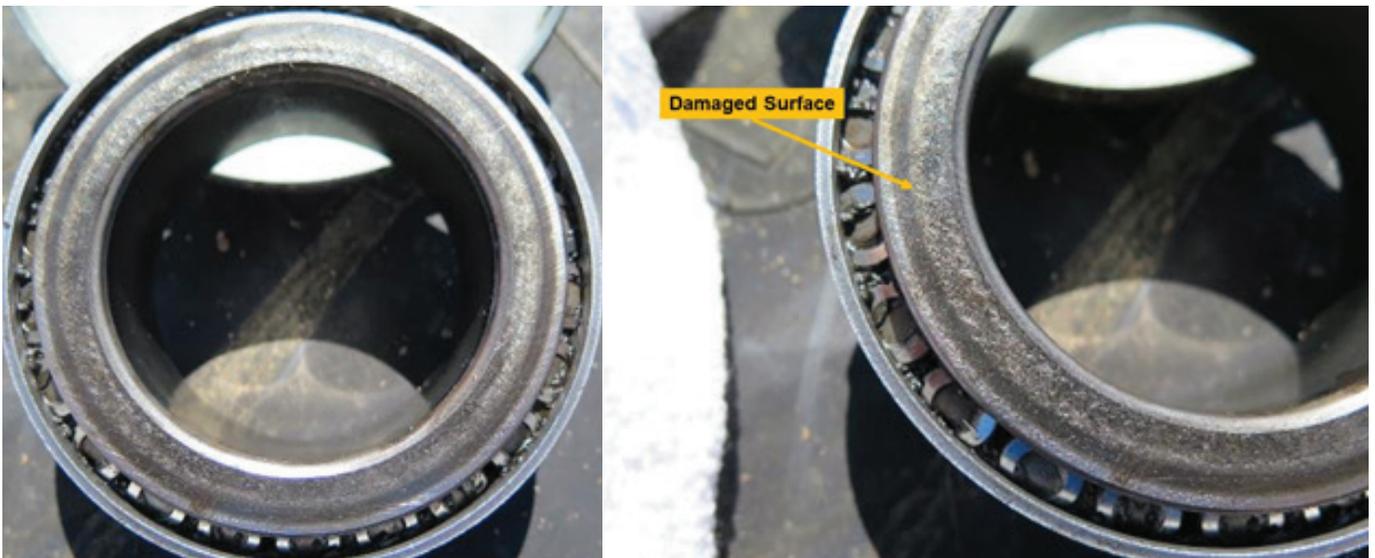
**Figure 21**

The thickness of the bearing measures approximately 1.25 in. with an inner diameter of approximately 2.50 in. The inner bearing showed markings on the edge of the inner race from contact with the washer. The bearing shown in **Figures 21** and **22** shows the scratches to the race and the condition of the cylindrical roller bearings.

In the right image of **Figure 21**, marks can be seen from the bearing moving against the washer, causing abrasion marks. This indicates that the inner race of the bearing was allowed to move relative to the washer<sup>16,17</sup>. **Figure 22** depicts the rollers of the bearing. The faces of the roller bearings are smooth with no gouge or pitting marks evident as well as no discoloration, which would indicate that there was proper lubrication to the bearing at the time of the spindle failure<sup>17</sup>.

Scratch pattern on inner race edge.

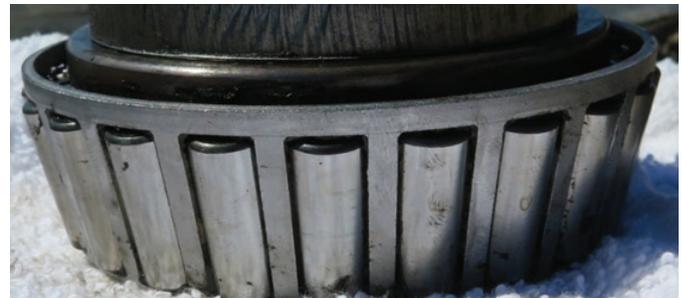
**Figure 22**

Outer roller bearing.

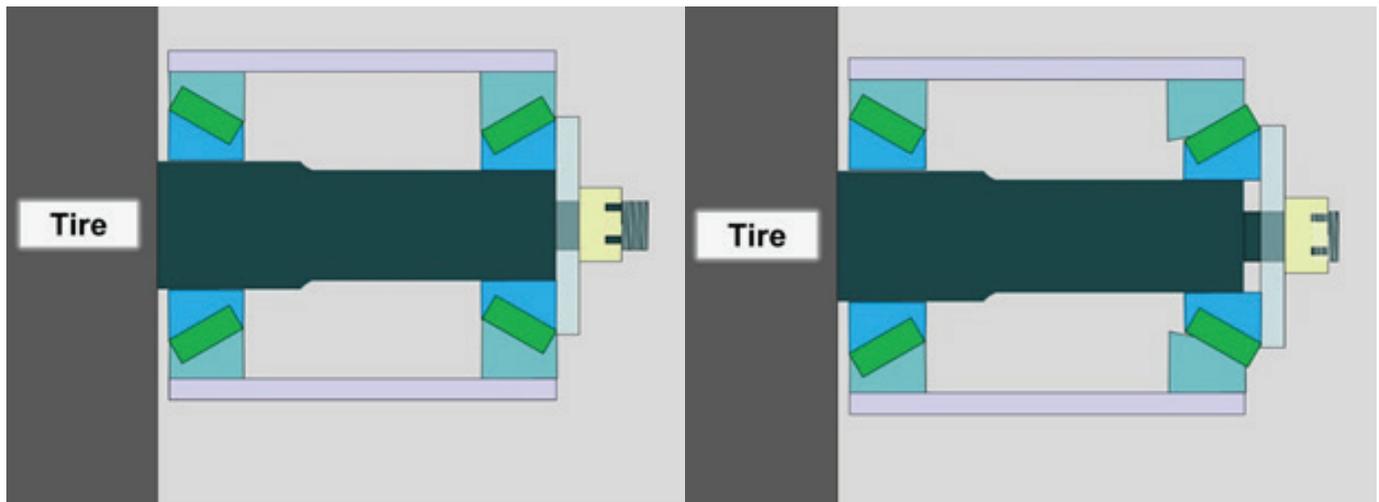
The root cause of the spindle, bearing, washer, and nut moving independently of each other was the insufficient pre-load on the bearings<sup>18,19,20,21</sup>. The lack of pre-load resulted in insufficient frictional force between the components and allowed relative rotation of the mating parts. The lack of pre-load also allowed the increase in axial force from the weight of the combine, which results in a thrusting force toward the castle nut that should be applied perpendicular to the axel. Once the components started to move relative to each other, the washer and spindle began

to wear, further exacerbating the problem. The increased axial and radial motion increased the stress in the spindle thread area and generated an unintended moment about the threaded portion of the spindle. In the left image of **Figure 23**, the castle nut is properly tightened, and the tapered bearings are fully seated on the spindle. In the right image of **Figure 23**, the nut is now loose, allowing the inner bearing to unseat from the outer race and the spindle.

**Figure 23**  
(Left image) properly tightened nut – (right image) improperly tightened nut.

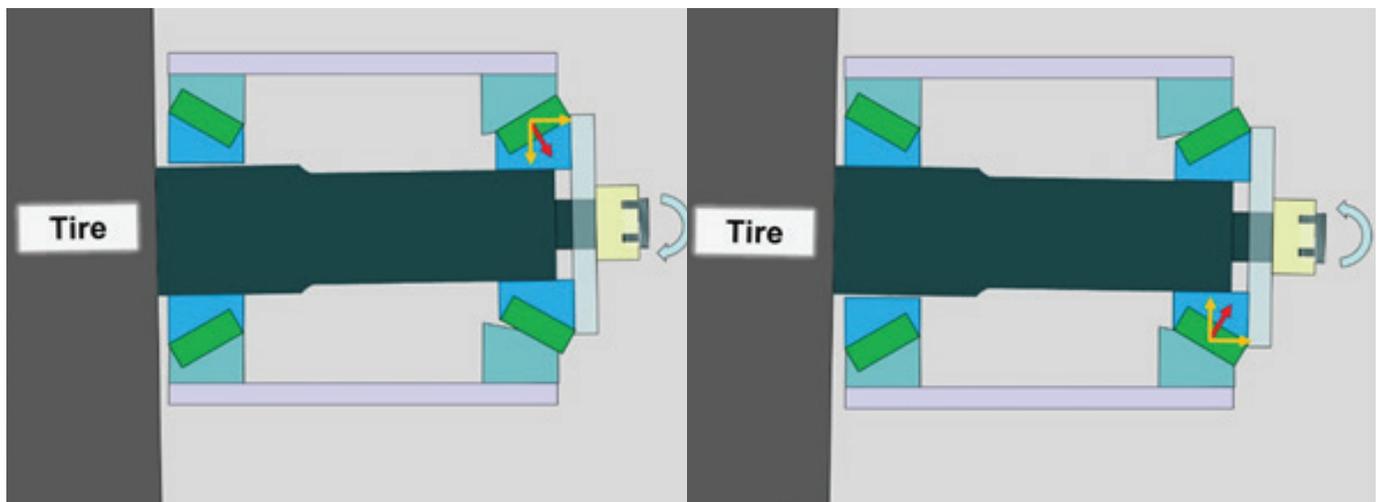
The movement of the inner bearing toward the threaded portion of the spindle places a moment not only on the smallest cross section of the spindle, but also on the greatest location of stress concentrations, namely the threads. **Figure 24** shows the moment placed on the threaded portion of the spindle and the corresponding forces as the spindle is allowed to freely move inside the housing.

**Figure 24**  
Moment placed on the threaded portion of the spindle.

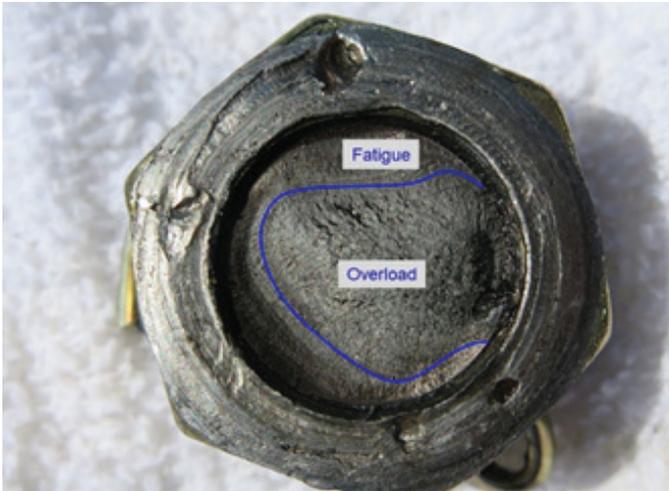
Examination of the fracture surface shows that the threaded area was subjected to repetitive overloading and fatigue. For comparison, the fracture surface of the spindle thread is shown in **Figure 25**, and an example of a fracture surface that failed due to fatigue is shown in **Figure 26**.

In **Figure 25**, a relatively smooth area with beach marks can be seen as well as a rougher area with no beach lines. This is consistent with the example of a fatigue failure in **Figure 26**, specifically the presence of an area of fatigue and an area of overload.

**Figure 25**  
Fracture surface on castle nut.
