Vol. 42 No. 1 June 2025

# FE Analysis of a Modular Fireplace Fire with an Improperly Constructed Hearth Extension

By Jerry R. Tindal, PE (NAFE 642S)

## Abstract

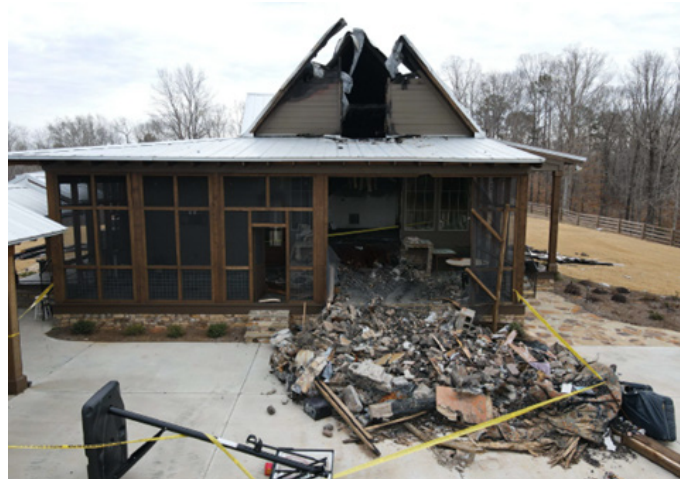
**Figure 2**

A view of the south side of the home after the fire with the remains of the stone veneered chimney and fireplace chase. The fire department utilized a track hoe during overhaul operations, making reconstruction more difficult.

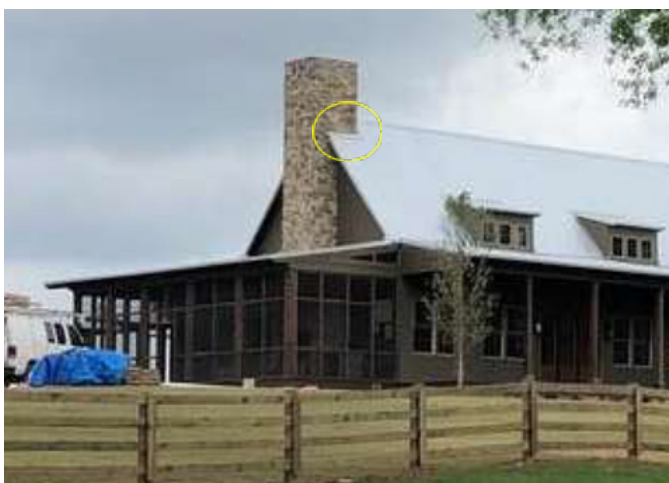
**Figure 1**

A view of the south side of the home prior to the fire with the stone veneered chimney and fireplace chase bisecting the wall between the living room and covered porch. The first observed flames were at the juncture of the roof and chimney chase (circled in yellow but on the opposing side).

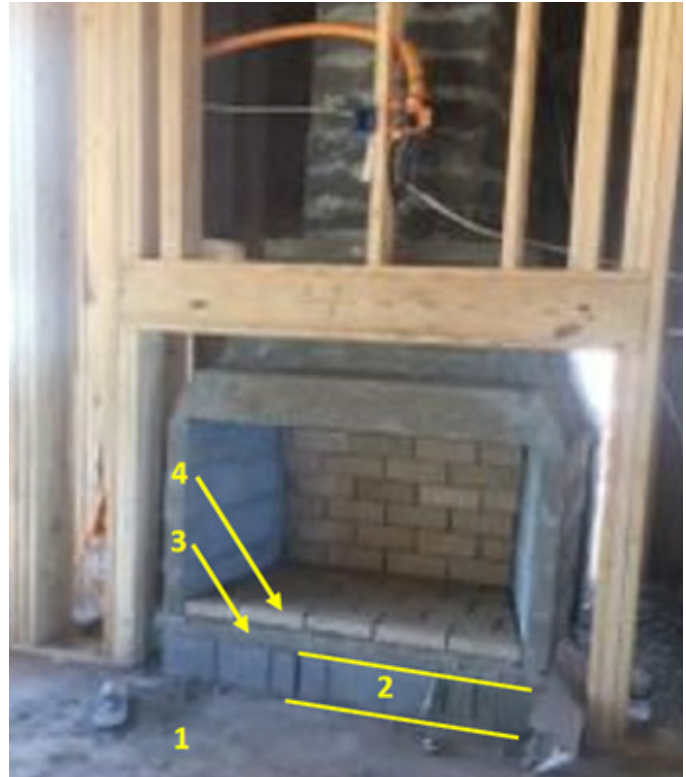
**Figure 9**

A view of the living room fireplace prior to chase enclosure. Notes: 1) wood floor; 2) CMU riser; 3) base plate; and 4) hearth refractory brick.

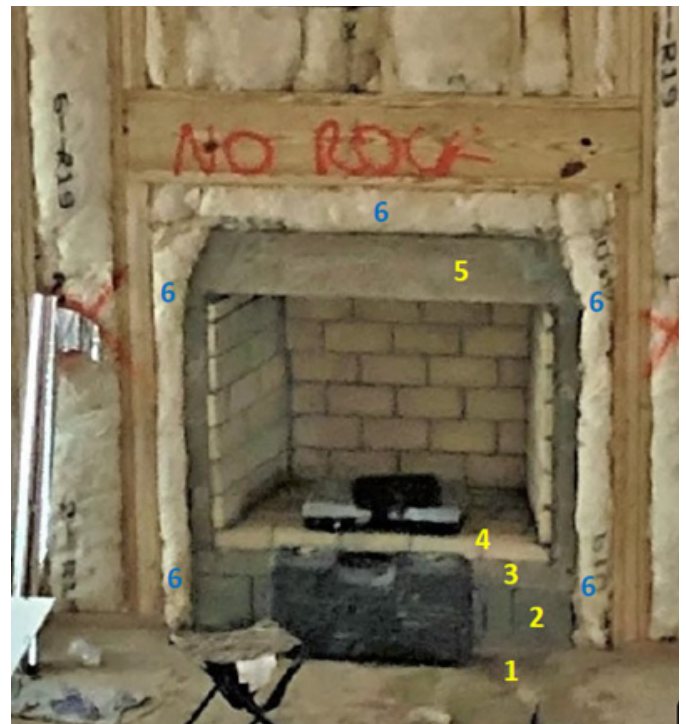
**Figure 10**

Another view of the living room fireplace with fiberglass batt insulation prior to chase enclosure. Notes: 1) wood floor; 2) CMU riser; 3) base plate; 4) hearth refractory brick; 5) radius throat front (RTF) block component; and 6) insulated air clearance spaces around the firebox (in blue font).

As previously observed in **Figures 10** and **14**, fiberglass batt insulation was installed in the air clearance spaces between the firebox and the wall framing in violation of the manufacturer’s installation instructions. The instructions state that (in multiple locations of the manual) no insulation is to be placed in the air clearance spaces around the fireplace. Insulating air clearance spaces around the perimeter of the firebox will result in higher operating temperatures of those faces and, in particular, any combustibles in (improper) contact with or in close proximity to them.

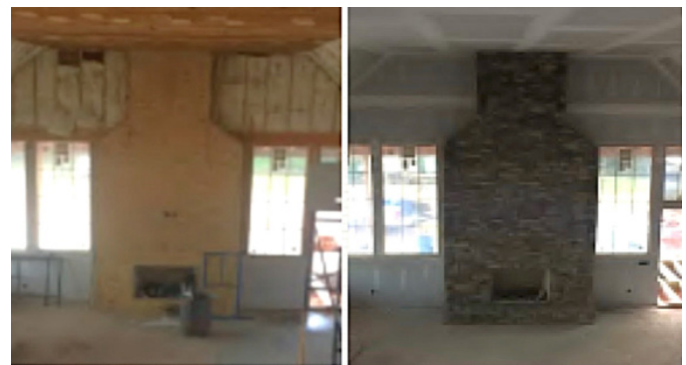
**Figure 12**

The A and B lines approximately define the rectangular firebox opening and illustrate the very close proximity of the OSB to the opening edges. A/B (and other) ratios within the two photographs are equivalent. The light green dash-dot line across the windowsills provides a frame of reference to the top of the firebox. The Radius Throat Front (RTF) block (previously referenced in **Figure 10**) of the firebox begins at the top edge of the firebox opening and runs vertically up  $9\frac{3}{16}$  inches toward the green dash-dot line. As seen in **Figure 10** and again in **Figure 14**, the RTF block forms a trapezoid shape (front face) with interlocking side blocks. The RTF block is clearly covered by the OSB depicted in **Figure 13**. OSB also extends over to the sides of the firebox near the opening edge. The area near the top of the hearth, extending down to the floor and running across the width of the firebox, is clearly

Photographs from near the same perspective/viewpoint and angle of the chase with OSB and then with the stone veneer and hearth extension in place. The stone finish in the right-side image defines the top edge of the firebox opening, which is consistent with the top edge of the OSB above the firebox opening in the left-side image.

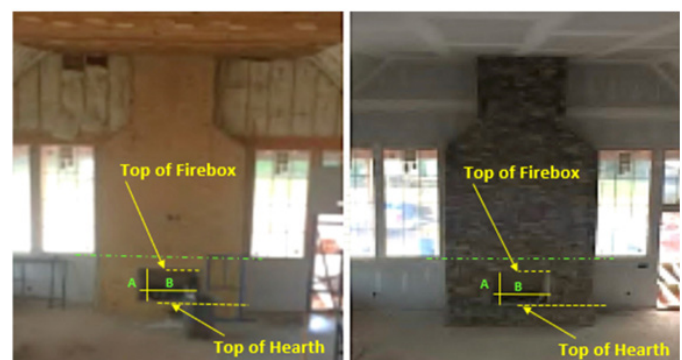
**Figure 13**

Annotations added to the photographs of Figure 12.

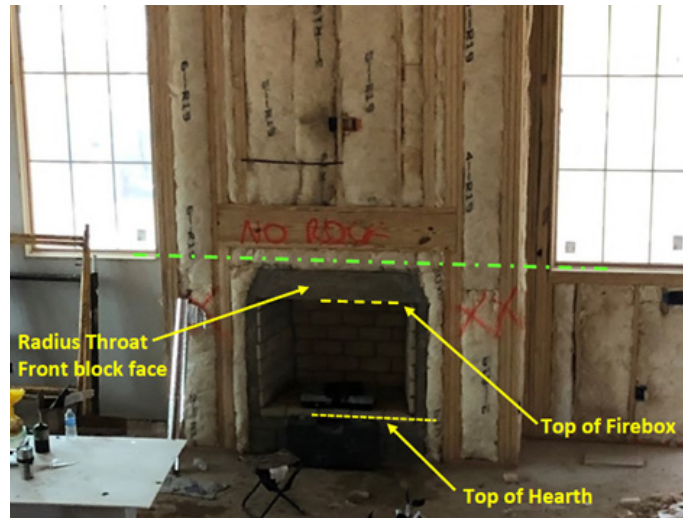
**Figure 14**

An annotated photograph of the living room fireplace prior to OSB and stone veneer enclosure.

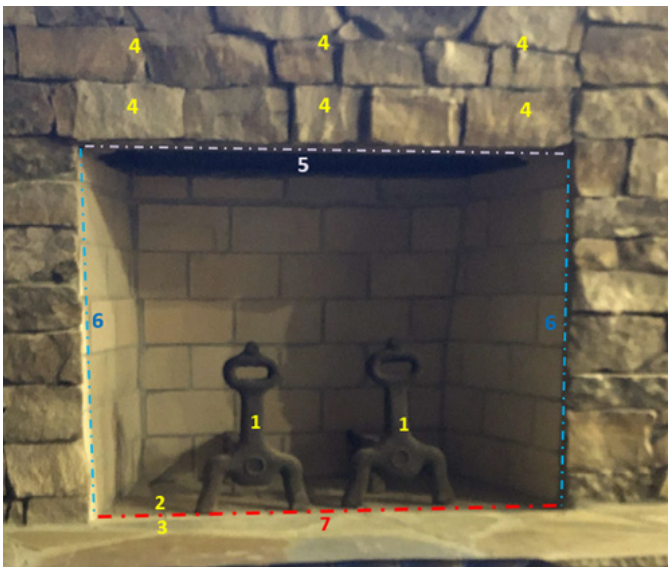
**Figure 17**

A view of the finished fireplace opening and hearth extension in front of the fireplace. Notes: 1) andirons (used to support logs during fireplace use); 2) fireplace hearth (note proximity of mortar joint 7, red dash-dot line); 3) fireplace (flush) hearth extension; 4) stone/mortar covering OSB running across and in direct contact with the face of the RTF block and with air/clearance spaces above the RTF block packed with fiberglass insulation; 5) mortar joint covering the edge of the OSB sheathing projecting beyond and around the perimeter face of the fireplace opening (trim projection); and sandwiched between the stone veneer and the RTF block face along the top of the firebox opening; 6) mortar joint covering the edge of the OSB sheathing projecting beyond and around the perimeter face of the fireplace opening on the sides (trim projection) and sandwiched between the stone veneer and firebox side faces. Blue dash-dot line. The OSB is also in direct contact with the vertical front face of the firebox sidewall; and 7) mortar joint covering the edge of the OSB sheathing projecting beyond and around the perimeter face of the fireplace opening and sandwiched between the hearth and hearth extension. Red dash-dot line. Subject to intense radiant, conduction and convection heat transfer processes during operation of the fireplace.

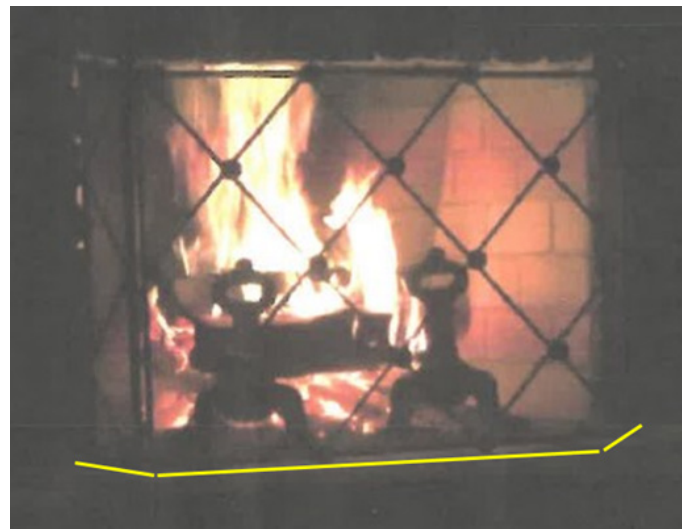
**Figure 18**

A view of the subject fireplace in use (on a different occasion) sometime prior to the incident. Note the spark screen forms a trapezoid projection (yellow outline) out into the hearth extension. Also note the hot burning coals and ash accumulating beneath the burning logs and andirons on the hearth surface.

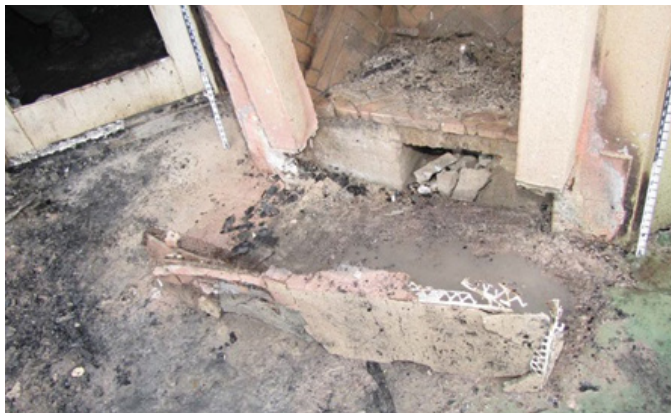
**Figure 19**

Prior Case #4. A view of the fireplace during excavation and reconstruction at the fire scene.

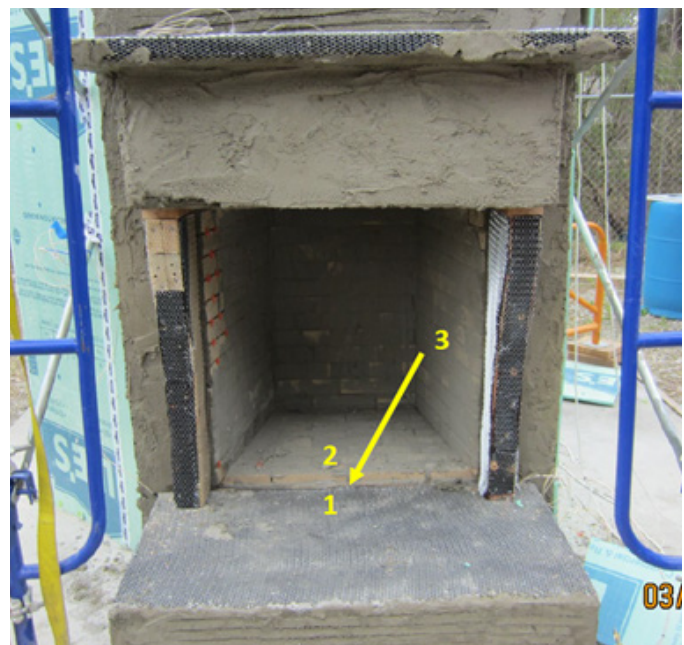
**Figure 20**

Prior Case #4. A view of the fireplace, chase, and hearth extension during laboratory reconstruction (per data from the fire investigators scene exam) and instrumentation prior to covering the hearth extension and surround with masonry. Notes: 1) wood framed hearth extension covered with plywood, felt paper and metal lathe prior to covering with masonry mortar; 2) hearth refractory; and 3) joint between hearth and hearth extension.

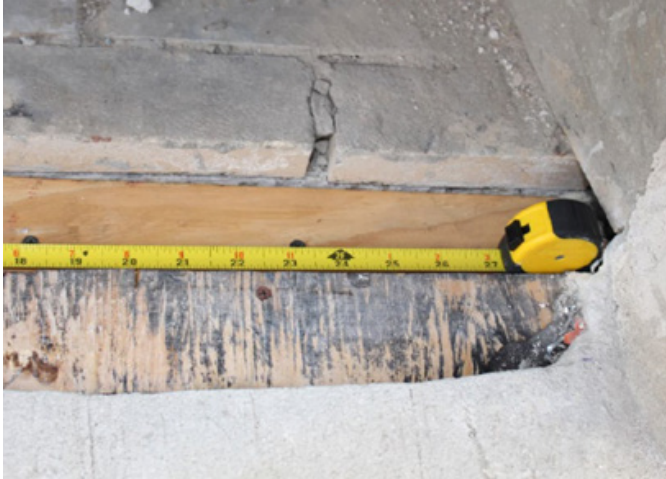
**Figure 21**

Prior Case #4. Joint between the hearth and hearth extension (fitted with new wood after a prior test run) prior to thermocouple instrumentation, filling and covering with masonry. The wood framing is beneath the hearth refractory brick surface (approximately 1.5 inches) and in contact with the base plate. The joint as well as the surface of the hearth extension were filled and covered with masonry to make it flush with the hearth.

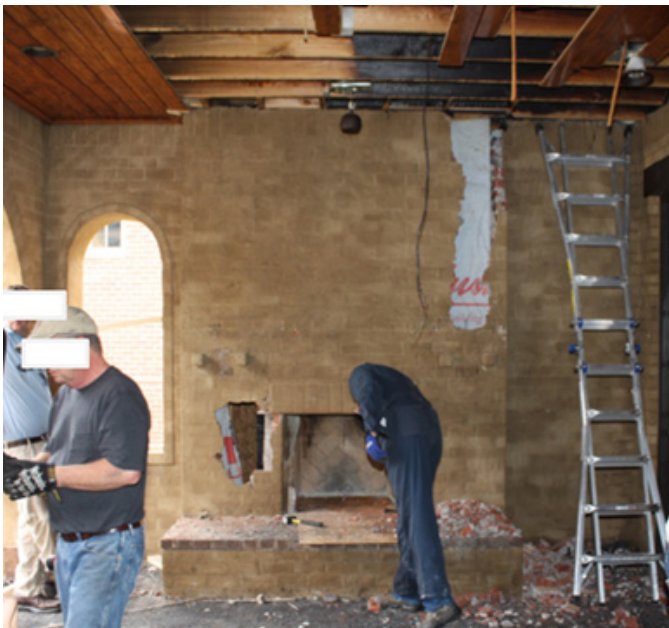
**Figure 23**

Prior Case #5. A view of the modular fireplace during delayering of the brick veneer.

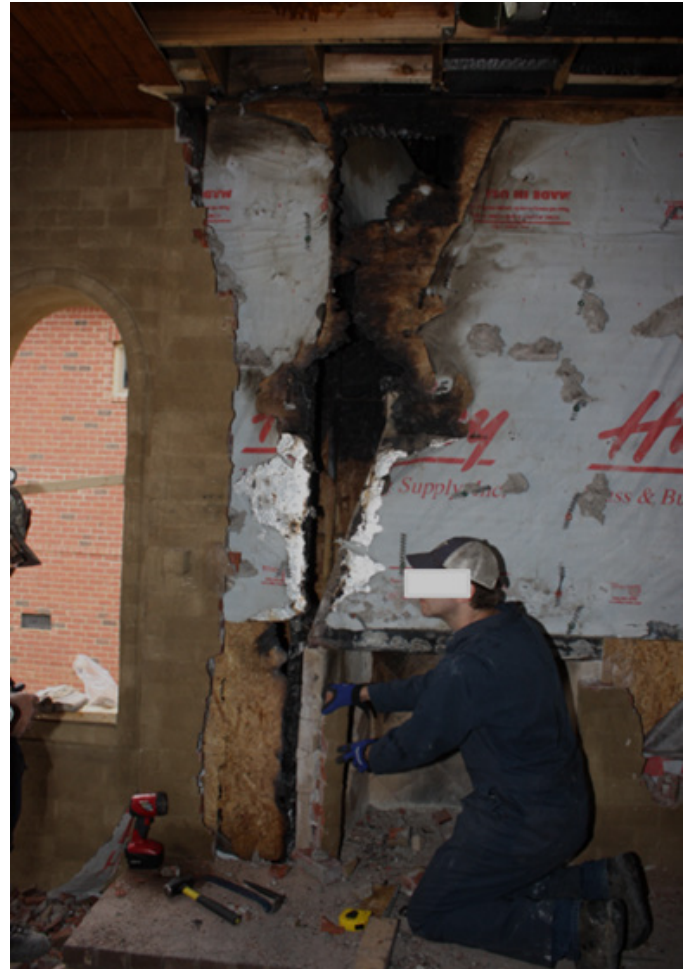
**Figure 24**

Prior Case #5. Another view of the fireplace during progressive delayering. Fire spread from near the base of the fireplace and up the wall and into the attic.

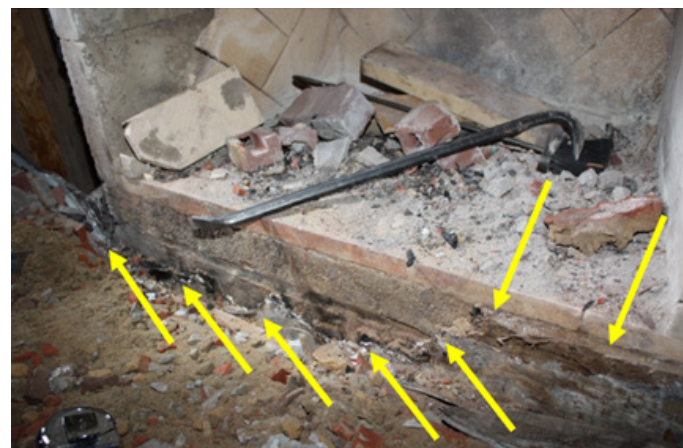
**Figure 25**

Prior Case #5. A view with the hearth extension masonry removed, exposing the joint between the hearth and the hearth extension. The yellow arrows indicate the OSB remains and burned-away portions of the OSB that was sandwiched between the hearth and the hearth extension. The fire spread until reaching the left side of the fireplace where the interior side of the OSB ran vertically up the chase.

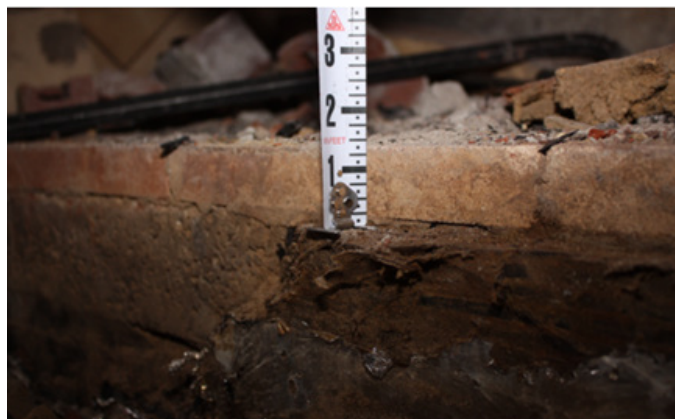
**Figure 26**

Prior Case #5. The OSB had been installed approximately 1.5 inches below the surface of the hearth.
