Vol. 43 No. 1 June 2026

# Barrel Failure in an Over and Under Shotgun

By Stephen A. Batzer, PhD, PE (NAFE #677F)

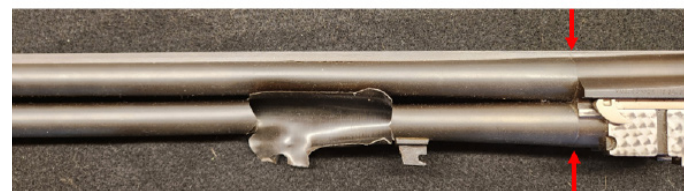
**Figure 1**

On approximately the sixth round fired, which was the first shell discharged through the lower barrel by the owner, a catastrophic failure occurred. The lower barrel ruptured along the left side, resulting in the destruction of the fore-end and severe injury to the shooter's left hand, as depicted in **Figure 1**. Additional evidence available for examination included fragments of the fore-end, the printed owner's manual, three unfired shotgun shells, and five spent shotgun hulls previously fired through the firearm, including the final Winchester shell.

Photo of the ruptured carbon steel lower barrel from the left side; red arrows indicate the chamber region welding point to the thinner and longer barrel segments leading to the muzzle.

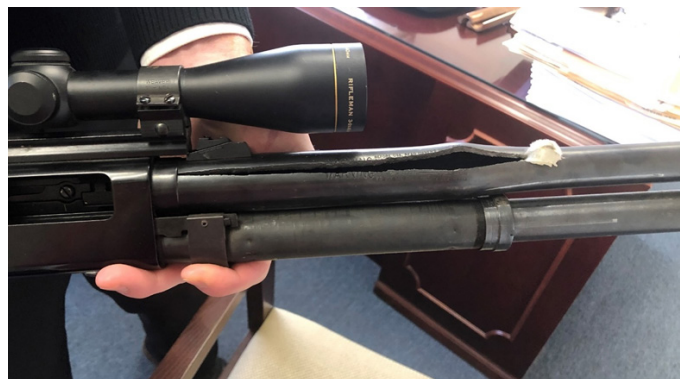
**Figure 4**

In the case of the well-used pump action shotgun depicted in **Figures 4** and **5**, the owner reported a barrel rupture during the first discharge of the season. According to him, the barrel contained only a factory-loaded shotgun shell and residual oil from the previous season's final cleaning. A circumferential ring, located away from the chamber and formed incrementally prior to the rupture, served as a diagnostic indicator of overpressure caused by an obstruction. The existing literature does not describe a mechanism whereby the peak combustion pressure from fast-burning nitrocellulose powder propagates down a shotgun bore to induce this failure mode. However, numerous reports document secondary explosive effects from underloaded cartridges with slow-burning nitrocellulose powders [2], [15]-[17].

Ruptured pump-action shotgun barrel due to bore obstruction with wad retention observed at the distal end of the fracture.

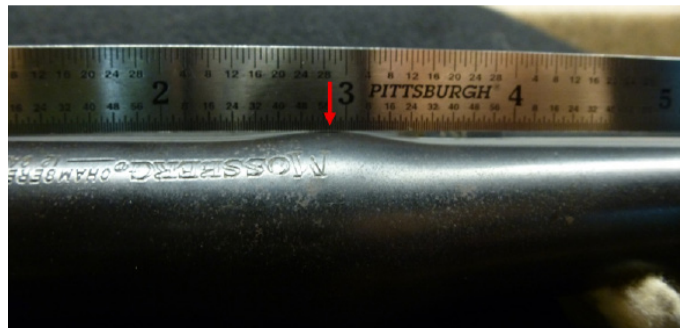
**Figure 5**

Circumferential ring indicative of local gas stress maximum due to a barrel obstruction in the region of the red arrow.

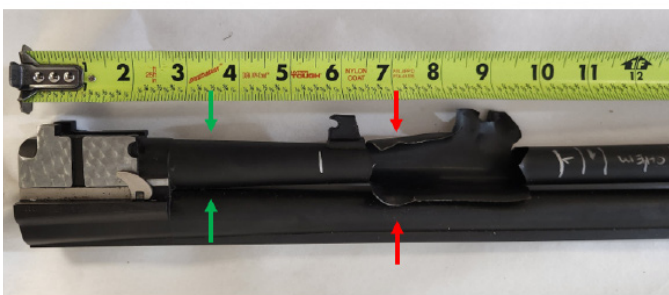
One potential, though improbable, user error that could have contributed to the overpressure event is the inadvertent insertion of a 20-gauge shotgun shell into the chamber prior to the destructive shot; this barrel contamination would have acted as a barrel obstruction [18]-[19]. To investigate this possibility, a dummy 20-gauge shell was inserted into the lower barrel, and its farthest forward position was recorded. The 20-gauge test shell passed easily through the 12-gauge chamber but was halted by its rim at the forcing cone downstream of the chamber. The face of the 20-gauge dummy shell was positioned 3.4 inches from the breech face, whereas the approximate initiation point of the barrel fracture was approximately 7 inches from the breech face, as shown in **Figure 6** (where the barrel set is depicted inverted from its standard over-under configuration for clarity). Thus, this inadvertent improper ammunition substitution explanation was discarded.

Close-up photo of the inverted barrel pair; green arrows mark the lodging point of the rimmed base of the 20-gauge test round, while red arrows indicate the approximate location of fracture initiation.

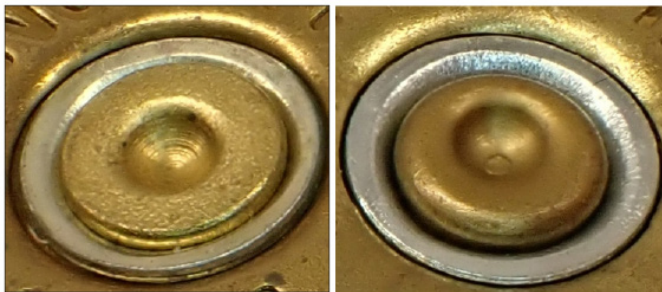
Consequently, the quantity of shot was diminished, yet the polymer case mouth still failed to form the neat star crimp seen in the original rounds. Such a visibly imperfect and underweight round is unlikely to leave a modern ammunition factory. The test was conducted by remotely firing the double-propellant round from the lower barrel of the sample shotgun in an open area, using a fixture and trigger lanyard for safety. The shotgun fired without issue, showing no cracks, bulges, dimensional changes in the barrel, or damage to other components. **Figure 9** juxtaposes the primers of the incident round and the double-propellant round. Notably, the incident primer appears flatter than the double-propellant round's primer, supporting Naramore's [20] view that primer shape analysis is unreliable. These rounds likely came from different production lots. While both used type 209 shotgun Boxer primers, their designs may not be identical.

Primers of two shotgun shells; ruptured barrel final round at left, double-propellant exemplar test round at right.

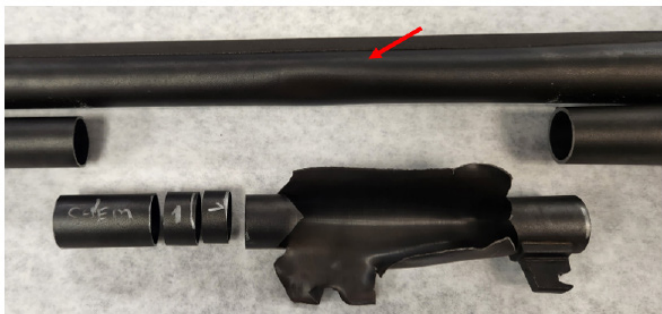
A metallurgical analysis was conducted at a commercial laboratory to examine the barrel's properties. The barrel was marked for sampling and then sectioned using a diamond saw, as shown in **Figure 10**. The upper barrel ex-

hibits significant compression deformation, resulting from the impact of hot combustion gases during the rupture of the lower barrel.

Segments of the lower barrel post diamond sawing and the deformed area of the upper barrel.

Cutting the barrel downstream from the fracture exposed the critical defect responsible for the barrel rupture. The barrel was incorrectly bored using a damaged or misaligned reamer or gun drill, resulting in uneven wall thickness. The right side of the barrel was visibly thicker than the left side due to a collinearity machining error. This produced a region near the chamber with abnormally high local tensile wall stress during firing. The defect is visually evident in the mounted specimen shown in **Figure 14**, which gives the local thickness of the barrel in the text boxes. This specimen is the short cylindrical specimen nearest the rupture in **Figure 10** marked with a rightward-facing arrow.

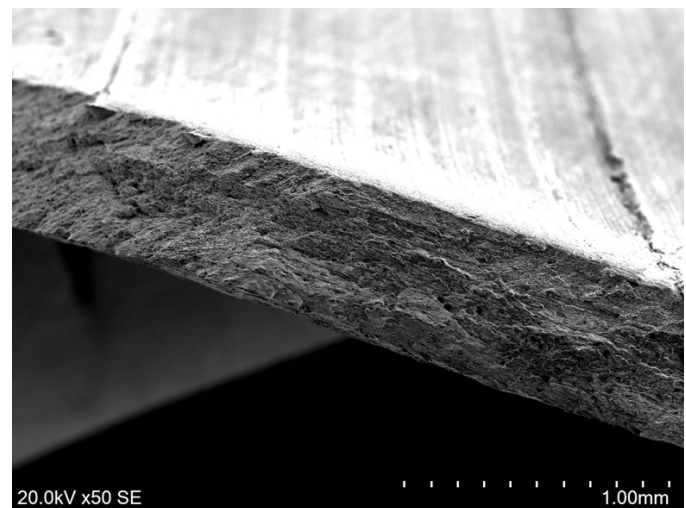
**Figure 11**

Once cut free, the fracture surface was analyzed using a scanning electron microscope, as shown in **Figure 11**. The examination revealed a ductile fracture surface without undesirable features such as porosity, inclusions, or laps.

Scanning electron microscope image of fracture surface of the ~0.020" barrel local wall thickness with bore interior surface visible showing circumferential machining marks.

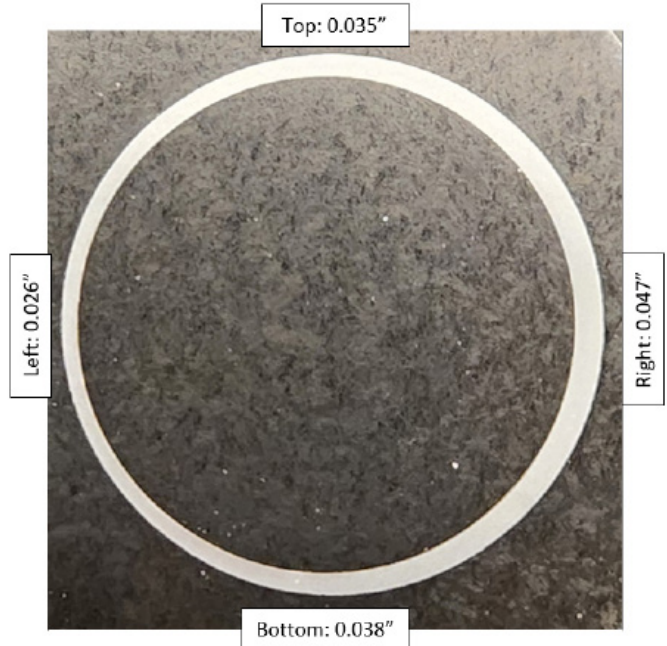
**Figure 14**

The polished and mounted barrel cross-section sample was taken forward of the rupture, documenting an improperly bored interior wall.

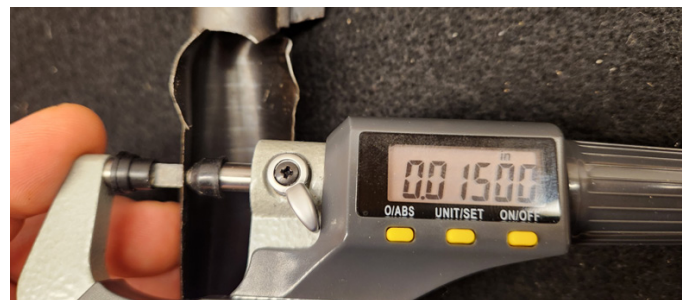
**Figure 15**

Caliper measurements of the barrel thickness near the fracture were recorded, with a representative measurement shown in **Figure 15**. The wall thickness, as thin as cardstock paper, was uniform across several inches of the ruptured area.

Barrel thickness measurement at the region of rupture propagation.

As a further check of this forensic analysis, the C.I.P. standard regarding Material Quality and Wall Thickness of Barrel and Chamber of Small Arms (Recommendation) was consulted [25]. The C.I.P. is a SAAMI-affiliated organization for European manufacturers and importers. This standard indicates that for 12-gauge shotguns with barrels manufactured from Category 1 steel (200-249 HB hardness, perlite + ferrite microstructure), at 200 mm = 7.9” past the breech face, the minimum wall thickness of the barrel is 1.90 mm = 0.075”. At the 7.9” position of the incident barrel, the wall thickness on the mis-bored left side measured 0.015”, 20% of the C.I.P. safety recommendation.

handguard, making it undetectable to the user. Since the shotgun failed on its second normal-pressure discharge, the defective barrel could likely have been identified at the factory using high-pressure “proof” rounds, which would have either caused a rupture on this first shot or created a noticeable ring. Prior to proof testing at the factory, there would be reason to not install the polymer handguard. After a nominally successful proof-load discharge, the technician could simply visually inspect the barrel pair and/or run a hand down the barrel, checking for any irregularity. A substantially bulged barrel would also make installation of the tight-fitting polymer fore-end difficult.
