Journal of the
National
Academy of
Forensic
Engineers[®]

Unreliable at the Boundary: Analysis of Two Sub-Optimum Crossbow Trigger Designs

By Stephen A. Batzer, PhD, PE (NAFE #677F)

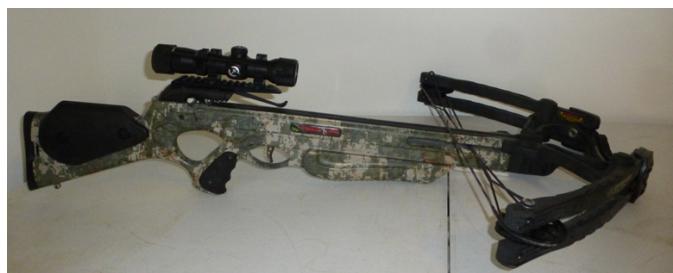
Figure 3
Case Study 1 incident crossbow assembled circa 2017.

In the initial unintended discharge incident, the owner acquired the crossbow in new but non-standard condition, as depicted in **Figure 3**. The crossbow, which was assembled from factory components, lacked a serial number sticker, indicating that it was neither sold through wholesale nor retail channels. Instead, it was privately sold by an employee of the local crossbow factory to an acquaintance. This modern crossbow, constructed from synthetic materials, belongs to an earlier design generation compared to the model shown in **Figure 1**. It was assembled circa 2017 and features an optical sight, a rudimentary anti-dry fire (ADF) mechanism (components that prevent cocked bowstring discharge in the absence of an arrow), cams (rotating wheels at the outboard position of the limbs), and power cables crossing beneath the barrel (the axial "flight rail" of the crossbow).

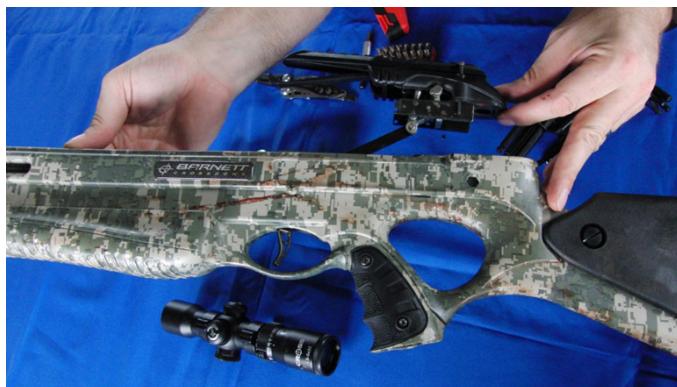
Figure 4

An inspection of the crossbow was performed, including removal of the trigger mechanism, as shown in **Figure 4**. Similar to the crossbow trigger mechanism previously

Incident crossbow showing removal of trigger mechanism and scope mount with draw bar leading to trigger shoe.

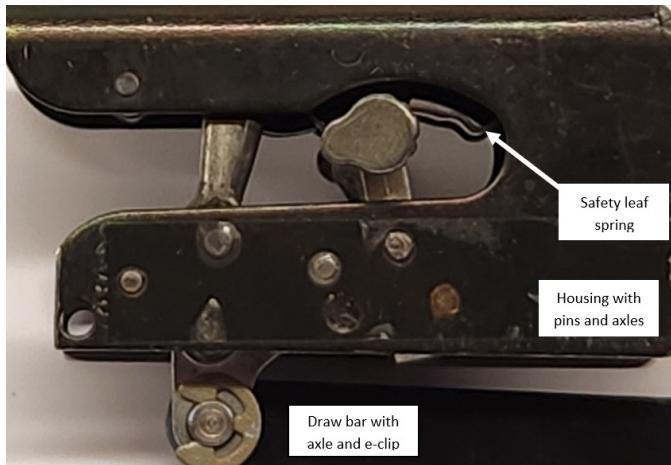
Figure 5 shows the trigger mechanism removed from the crossbow stock with the trigger draw bar rotated backward. The basically rectangular stamped steel housing is perforated to mount transverse pins that act as axles, torsional spring posts, and component stops. An internal-stamped steel leaf spring near the top of the housing is

Incident crossbow trigger mechanism, ready, with the safety in the FIRE position with trigger draw bar folded ~180° rearward.

indicated with a white arrow in Figure 5. Recesses in the spring act as detents to keep the pivoting safety lever either fully forward or backward.

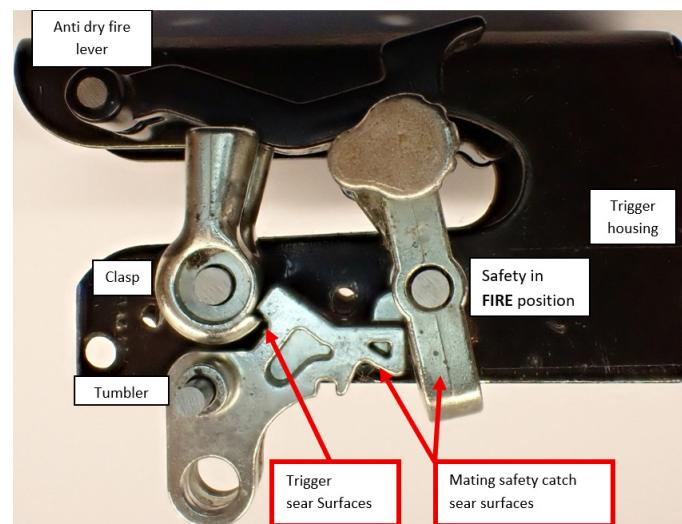
Figure 6

The trigger mechanism components and their axles were removed from the stamped steel box housing, and longer gage pins were inserted into the component axle holes from the left side to facilitate a positional layout of the major moving components, as shown in Figure 6. The multiple torsion springs, which bias individual component motion, are not shown. The biasing springs rotate the anti-dry fire (ADF) lever DOWN, the clasp VERTICAL, the tumbler ENGAGED (as shown, fully counter-clockwise), and the safety fixed either fully forward or backward as a detent. In Figure 6, the sear surface of the tumbler is in the engaged position — such that the clasp cannot rotate forward counter-clockwise into its released position.

Incident crossbow trigger mechanism with internal components and axles removed with the four major components affixed to the left exterior side of the housing and the trigger bar removed from the sear.

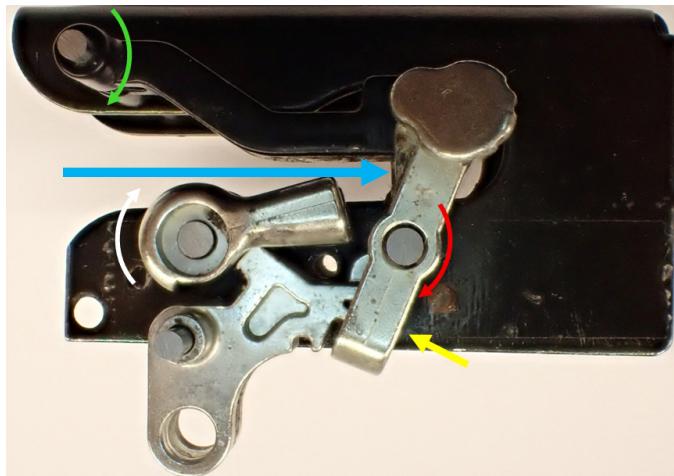
To cock this model of crossbow, a rope cocking device with two hooks is attached to the bowstring on either side of the barrel. The user places his foot in the stirrup at the discharge end of the crossbow and pulls the two handles of the rope cocking device upward toward his shoulders. See Figure 7 for an explanatory image of the cocking of the incident crossbow. The two hooks ensure that the center portion of the drawn bowstring is locally flat and perpendicular to the flight rail, and the bowstring itself (blue arrow) glides over the clasp and causes it to rotate out of the way (white arrow). At full draw, the safety rotates clockwise, and its bottom U-shaped cavity engages against the mating surface of the tumbler (yellow arrow), restraining

Incident crossbow trigger mechanism showing full draw position of bowstring represented by a blue arrow.

it from rotational motion. Also at full draw, the ADF rotates downward (green arrow). It will prevent the safety from rotating back to the FIRE position until the ADF is rotated back upward by the insertion of an arrow and nock onto the bowstring.

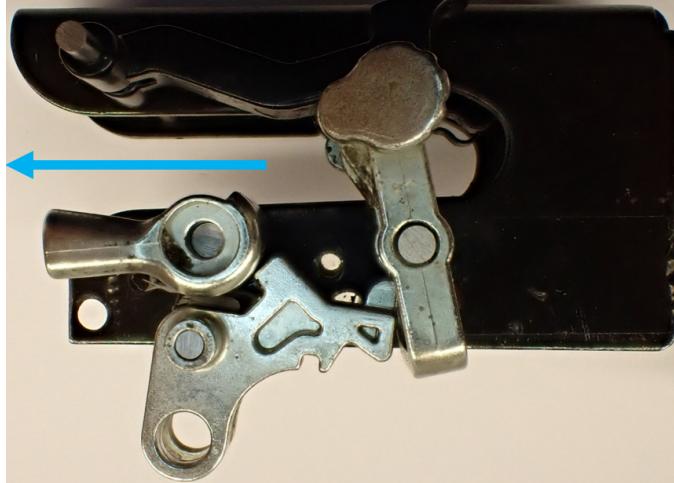
Figure 8 shows the trigger mechanism components as they are positioned at the moment of firing. The ADF lever had been moved up by the presence of the arrow. The safety was then moved forward to the FIRE position. The draw bar pulled the tumbler such that it rotated clockwise, disengaging the tumbler's sear surface from the mating surface of the clasp. The unconstrained clasp rotated ~90° counter-clockwise and released the bowstring and arrow, which rapidly moved forward (left) as represented by the blue arrow.

Incident crossbow trigger mechanism showing discharge position.

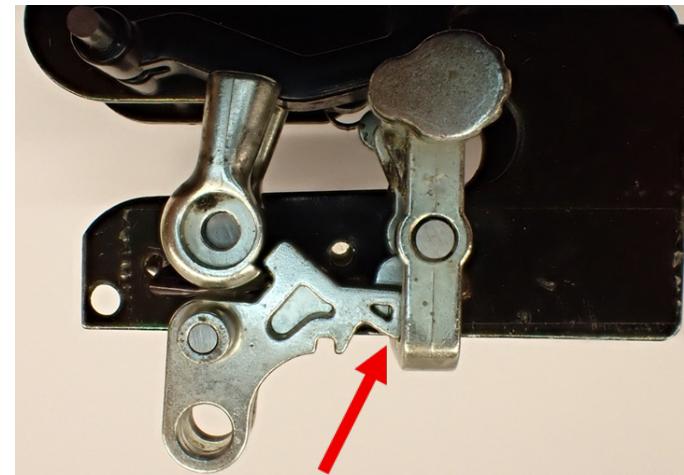
Figure 9

Analysis and physical testing of the incident mechanism revealed that the most likely situation was consistent with the testimony of the crossbow owner and other users who complained of inadvertent discharge. By pulling the rope cocking mechanism backwards incompletely, the clasp would index and accept the bowstring while not fully pushing the safety to its full SAFE position. This is illustrated in **Figure 9**. As is shown with the dismounted components, the tumbler and safety can each be in the partially engaged position if the crossbow is not vigorously cocked by the rope cocking device.

Incident crossbow trigger mechanism showing position in which the tumbler is barely constrained by the mating ledge of the safety (see red arrow).

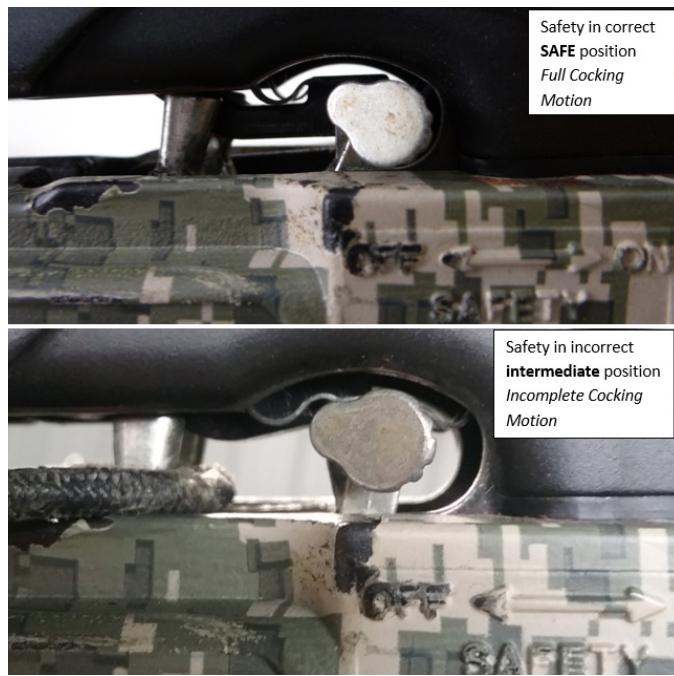
Figure 10

This is also shown with the components properly assembled in the crossbow. The top image of **Figure 10** shows the safety in the fully SAFE position without the bowstring present. Note that the ADF lever has moved downward, blocking forward motion of the safety if no arrow is loaded. The lower image of **Figure 10** shows the cocked crossbow with the bowstring and clasp in the proper position, but the ADF and the safety are not in the proper position. This miscocked condition was deliberately produced by a minimal rope cocking device pull for which the bowstring would index the clasp but not move the top of the safety lever fully rearward.

Based upon analysis and investigation of the incident crossbow, it was determined that this trigger design was sub-optimal. It was found that the ADF lever, while somewhat valuable, was not “active” in that the safety could be moved to FIRE after an arrow was loaded. Then if the arrow were removed, the safety would not automatically return to SAFE. In addition, the geometry of this mechanism was such that the bowstring could be deliberately or

Incident crossbow safety and ADF lever showing the proper position when drawn at top (bowstring not shown), and an incorrect intermediate position at bottom with the ADF not actuated and the tumbler not fully constrained, if at all.

unintentionally cocked with the clasp in the proper position without the safety being moved to the full SAFE position to engage the tumbler completely. This design is no longer in production and has been replaced by more sophisticated and ostensibly more reliable designs.

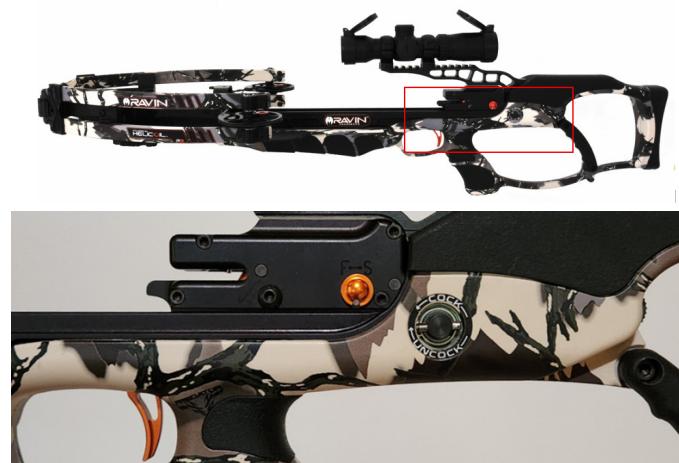
Figure 11

The second crossbow design evaluated in this study represents a significant technological advancement over the “value” crossbow model described in Case Study 1, despite their brief concurrent market presence. Introduced in 2016 by Ravin, a startup company founded to develop and market this design, this premium model features composite construction materials, relatively short power cables that do not cross under the barrel, and helical power cable journals facilitating a compact limb arrangement. Unlike many designs (e.g., Case Study 1 crossbow), this crossbow omits a foot stirrup as it incorporates an integrated crank cocking mechanism to draw the bowstring. This design also features an internal ADF trigger mechanism intended to allow the crossbow to only fire when an arrow nock is fully engaged to the center of the bowstring (Figure 11).

Photograph of the crossbow design of Case Study 2, Ravin R9 / R15 at top, along with a close-up of the trigger shoe and trigger pack at bottom.

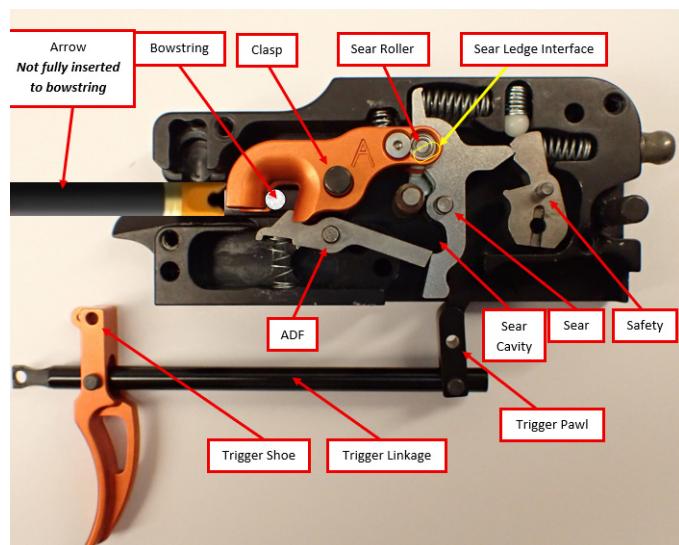
Figure 12
Photograph of the generation 1 trigger mechanism in the cocked but unloaded position.

Figure 12 illustrates the dismounted and partially disassembled “generation 1” (that is, originally marketed) trigger mechanism of the Ravin R9 and R15 crossbows, which are detailed in the associated patent¹⁶. To enhance visibility of key components, the left cover of the trigger housing has been removed. For clarity, a digital representation of an arrow stub equipped with an orange post-recall nock and a circular depiction of the bowstring cross-section, held by the clasp, have been superimposed. Red arrows, used to label component nomenclature, indicate the rotational axes of the respective parts where applicable. A yellow rectangle highlights the concealed sear ledge interface, which must disengage to enable crossbow discharge. The arrow retention actuator and its forward coil spring (located ahead of the clasp) have been omitted, as has the trigger shoe return spring, typically anchored at the forward holes of the trigger shoe and trigger linkage.

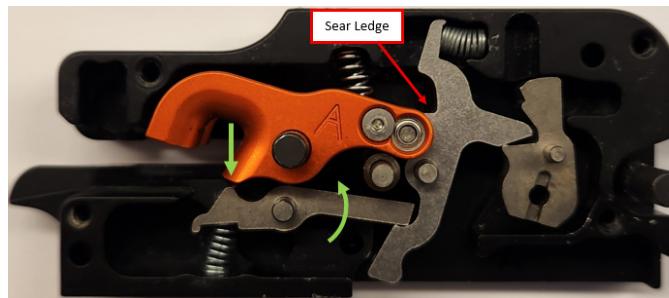
Figure 13

Photograph of the generation 1 trigger mechanism in the discharged position with the ADF lever inside of the sear cavity and the green arrows indicating the direction of ADF travel to disengage the ADF and allow sear rotation.

to the upward position, the ADF endform rests within the sear cavity, and the safety automatically returns to the SAFE position.

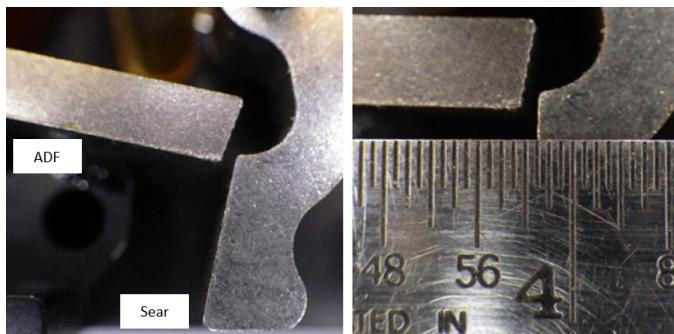
Figure 14

1. The archer cocks the crossbow using the integral crank mechanism, which automatically engages the physical blocking safety against the sear. The user interface button is below the safety rotation axle, so that the button moves backward to the SAFE position and displays a white dot, while the internal ledge, which is above the axis of rotation, moves forward and supports the sear.
2. The archer loads a factory arrow with its clip-on nock. The nock clicks and vibrates upon interaction with the bowstring, giving the user both tactile and audible feedback of success. The bottom surface of the arrow nock rotates the ADF lever from its fully engaged at-rest position, but not completely, putting it in a position that will prevent it from entering the sear cavity upon trigger pull. That is, the ADF is rotated into an intermediate position (**Figure 14**), with a prominent

Photographs of the generation 1 ADF and sear in the intermediate position with the ADF trailing edge not completely clearing the entrance to the sear cavity.

gap between the ADF endform and the sear. This gap is objectionable; it allows the sear to rotate enough to assume an unsafe and unstable position.

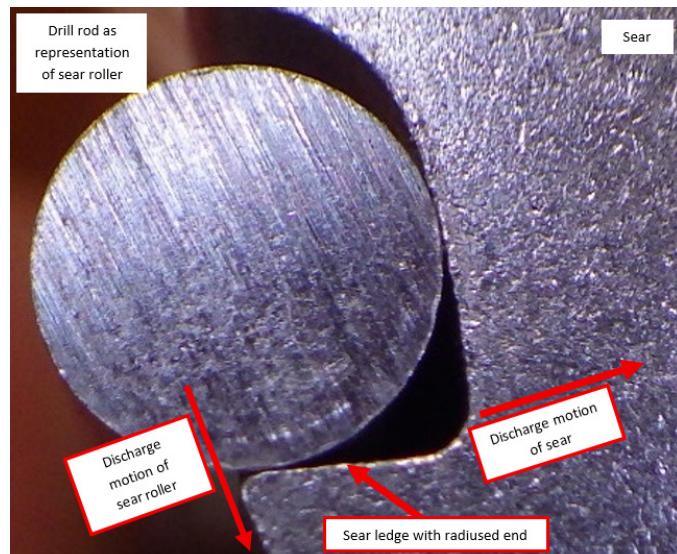
4. The archer's trigger finger pulls the trigger shoe, causing the front surface of the trigger pawl to press against the back surface of the sear and rotate it slightly, taking up the gap between the sear and the ADF lever. As the ADF lever is only partially aligned with the sear cavity's entrance, it prevents the sear from fully rotating. As a result, the sear roller shifts beyond the supporting point on the sear ledge (Figure 15), exerting considerable force and prying the sear toward the discharged position. The red arrows in Figure 15 highlight the insufficient support of the clasp's sear roller by the sear ledge, indicating a design error.

5. The actions of the sear, ADF, and clasp have placed the crossbow's trigger into a semi-stable, dangerous configuration. The sear roller teeters on the radiused end of the sear ledge, while the sear is prevented from fully disengaging due to the blocking ADF.

Drill rod in the same diameter as the sear roller resting on the sear ledge, showing that the contacting point of the cylinder is incrementally past the point of edge radius initiation with red arrows representing discharge motion direction.

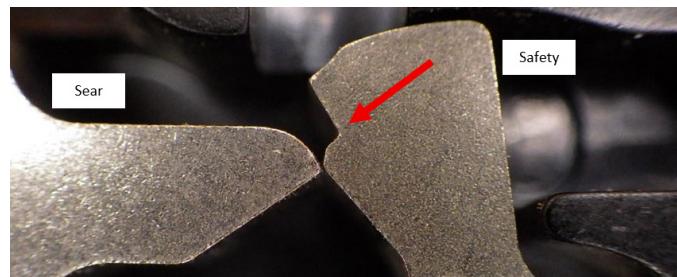
Figure 16

the safety button rearward (away from the discharge end). However, the internal safety mechanism only partially moves and becomes fixed in an unstable intermediate position — unable to fully engage beneath the sear's horn (Figure 16). The sear obstructs the safety's path, preventing proper engagement.

7. The archer, confident that the manual safety has fully engaged due to the familiar actuation resistance and audible click, observes the external safety button's window indicator displaying half of the white SAFE dot and half of the red FIRE dot. Unaware of the crossbow's internal mechanics, the novice user does not realize that the Anti-Dry Fire (ADF) mechanism, sear, clasp, and safety are all in unstable intermediate positions,

Generation 1 sear in the intermediate position at left and the safety at right in the FALSE SAFE position, with the red arrow showing both the direction of motion of the safety against the sear and the unengaged safety ledge.

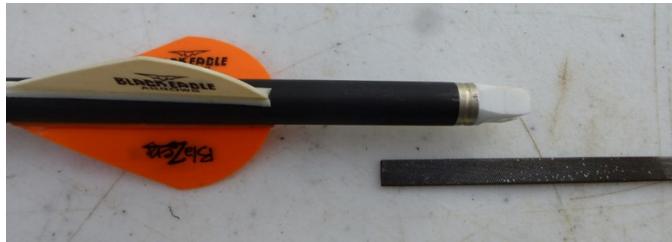
Figure 17

To validate the mechanistic feasibility of the incident sequence, crossbows involved in user injuries were individually tested using modified arrow nocks. These modifications enabled a cock/load/trigger pull sequence with the ADF lever positioned at various angles. Specifically, the bottom surfaces of polymer nocks were incrementally filed to reduce the ADF lever's rotation when an arrow was fully inserted. Minimal filing had a negligible impact on the ADF lever's rotation, whereas extensive filing prevented arrow discharge by entirely restricting the sear's rotation. The objective was to identify an "intermediate" degree of filing that replicated the conditions leading to user injuries and to document the crossbow's characteristics when this intermediate condition manifested, as shown in **Figure 17**.

As anticipated, the intermediate position was reliably replicated by iterative nock filing. When the ADF lever was rotated incompletely and into the intermediate position, the cocked and loaded crossbow would make a subtle

Jeweler's file and Ravin crossbow filed nock on the side with the index vane — the bottom surface of the arrow when inserted into the trigger pack.

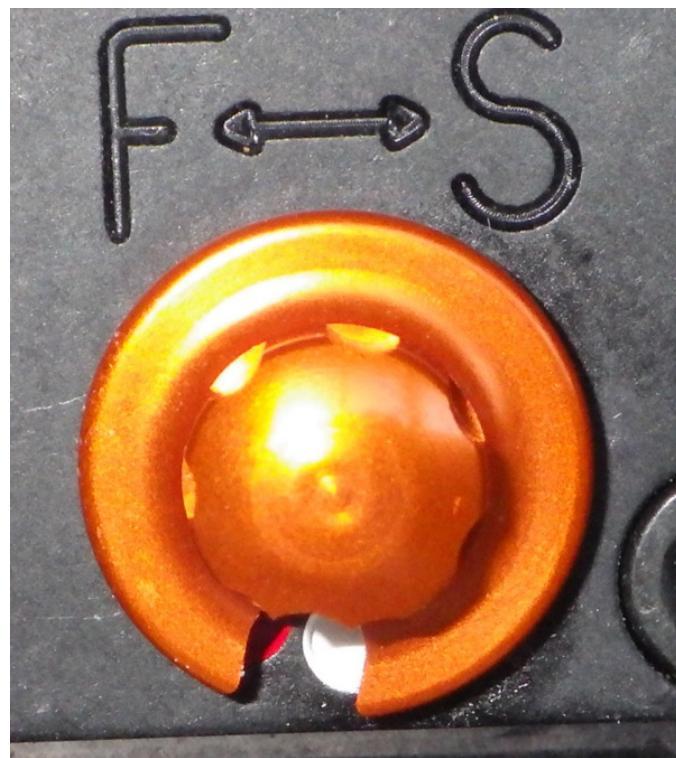
Figure 18

To document the extent of the issue, photographs were taken of multiple Ravin R9 and R15 Generation 1 trigger design crossbows with their safety mechanisms in the FALSE SAFE position, confirming a systemic design flaw rather than isolated incidents. Additional tests were conducted to evaluate crossbow performance, including:

Ravin R9 crossbow safety showing the intermediate FALSE SAFE position with half of the SAFE white dot showing and half of the red FIRE dot showing.

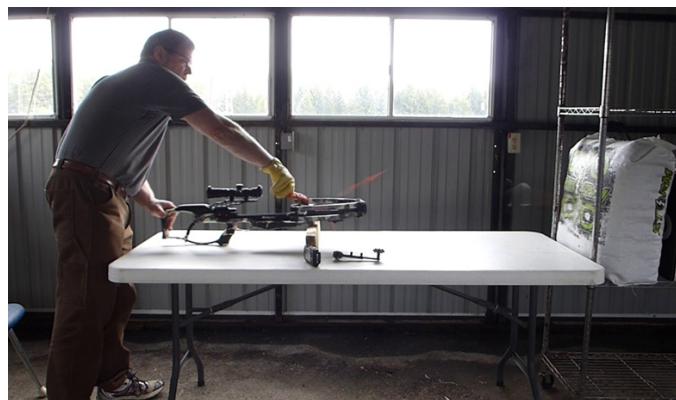
Figure 19

All crossbows tested in the intermediate position, with the safety mechanism set to the FALSE SAFE state, underwent further evaluation by re-seating the arrow shaft and nock into the trigger pack using a shaft-gripping implement. In every instance, this action resulted in immediate crossbow discharge (**Figure 19**).

Author deliberate re-seating of an arrow in an incident crossbow using an implement causing discharge without a finger on the trigger — notice the arrow vane which has dislodged as a result of the discharge.

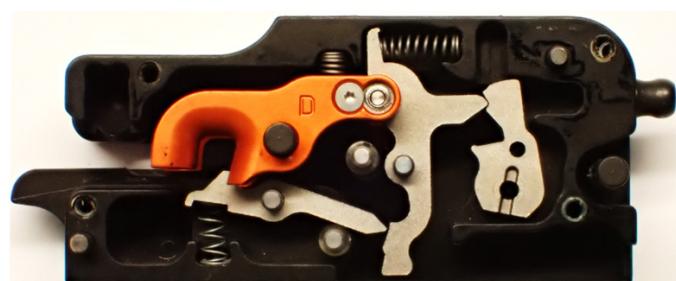
Figure 20

Photograph of the generation 2 trigger mechanism documenting geometric changes at ADF / sear interface amongst other improvements.

Laboratory testing of the incident crossbow trigger design substantiated the eyewitness accounts of the multiple injured users, confirming that their crossbows discharged unexpectedly during arrow reseating. These incidents occurred under the following conditions: (A) after a misfire; (B) following re-engagement of the safety mechanism as outlined in the user manual; (C) without subsequent trigger activation; and (D) during the manual reseating of the factory-supplied arrow. Changes were made to the ADF lever, sear, sear roller, and other components of the generation 1 trigger mechanism as a comprehensive upgrade, making the generation 2 trigger that has shown to be substantially more reliable.
