Journal of the
National
Academy OF
Forensic
Engineers[®]

Vol. 37 No. 1 December 2020

Forensic Engineering Investigation of the Catastrophic Breakdown of a Diesel Engine in an Emergency Generator Set

By Daniel P. Couture, PEng (NAFE 951M)

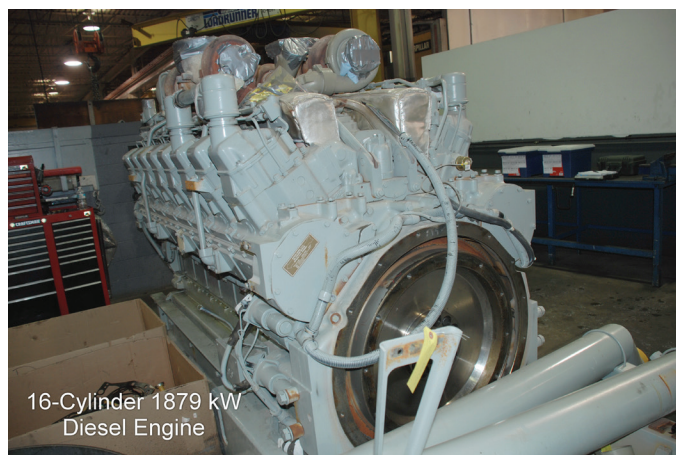
Figure 1

Diesel engine for parking garage generator set.

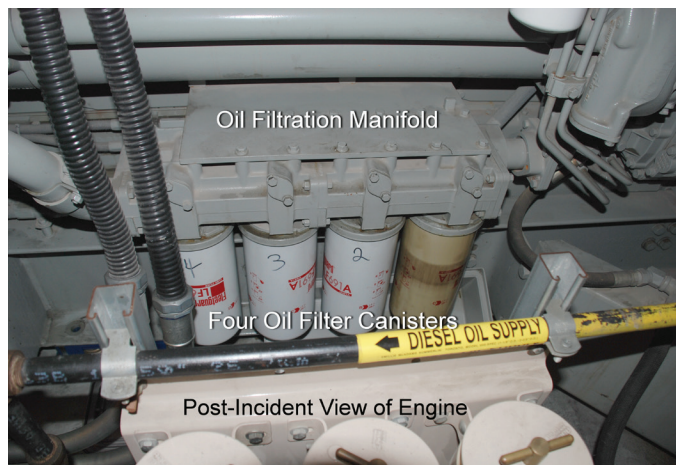
Figure 2

The check sheets from the local maintenance company for Sept. 27 and Oct. 26, 2010 were reviewed and found to be uneventful. The engine oil levels were described as “good.” The annual service procedures, including an oil change and replacement of oil filters, had been undertaken on the date of failure (**Figure 2**). Documents submitted for the maintenance history confirmed this narrative.

Post-incident view of oil filter housing.

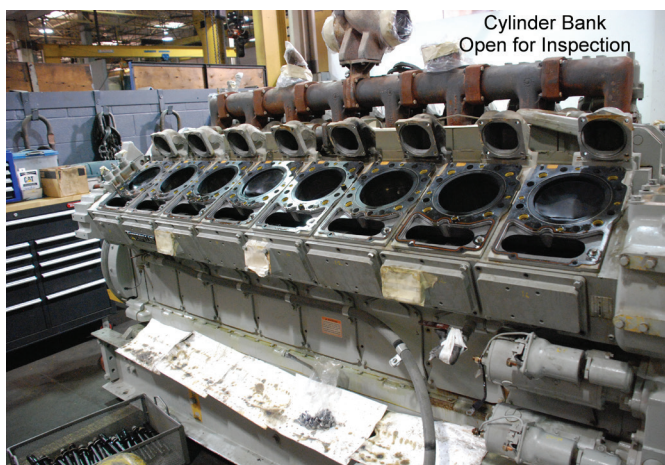
Figure 3

Company C, which had a large engine remanufacturing facility nearby, sent a crew who reported that the bolts on rods of cylinder #8 were loose, and its bearing was spun. The bearing shell had seized on to the crankshaft, and the shell had been spinning inside the big end of the connecting rod. The technicians opened the cylinder bank at this shop (**Figure 3**).

The spun bearing could have been the result of a lack of torque on the bolts, per the Company C’s technician. Since Company B stated that it did not intervene at those cylinders, a suggestion was put forth that the bolts may not have been correctly torqued during the manufacturing process. One objective of the investigation was to determine whether this could have been the root cause.

Cylinder bank open for inspection at the Company C shop.

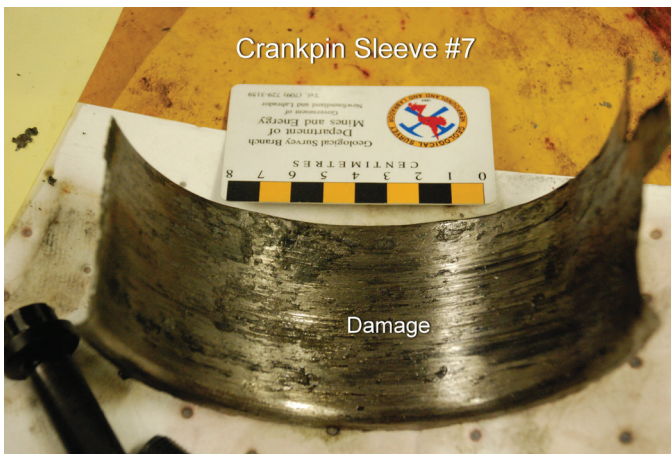
In the lower engine, each of the bearing shells for the main and rod journals had notable contamination, again from metal particles, with some concentrated damage on big end and rod cap inserts for #7 and #8 cylinders (see **Figures 4 through 8**). Light wear was reported on the shanks of some cap bolts, showing movement and contact with the rod cap had occurred, such as bolt thread impressions (**Figure 9**). The crankpin journals for cylinders #7 and #8 were examined, and these showed (**Figure 10 through 13**) symptoms of frictional overheating and premature wear.

Figure 4
Shell damage on rod cap for cylinder #7.

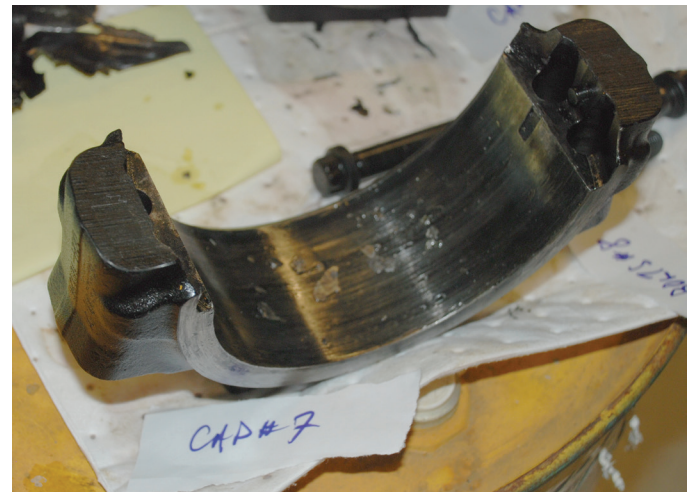
Figure 6
Shell damage on rod cap of cylinder #7.

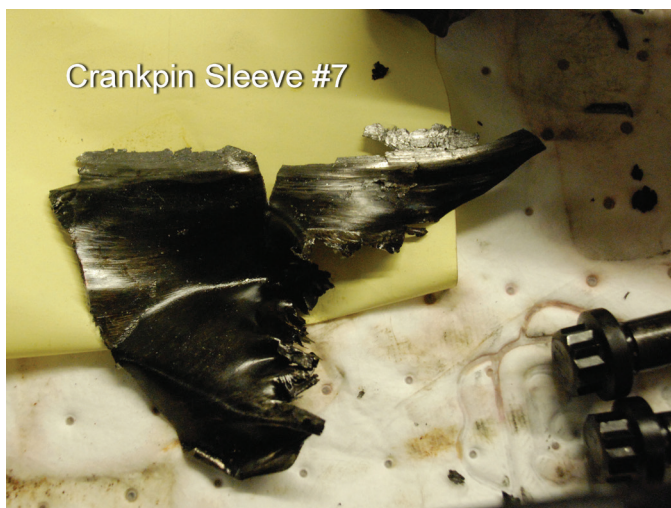
Figure 5
Destroyed big end shell for cylinder #7.

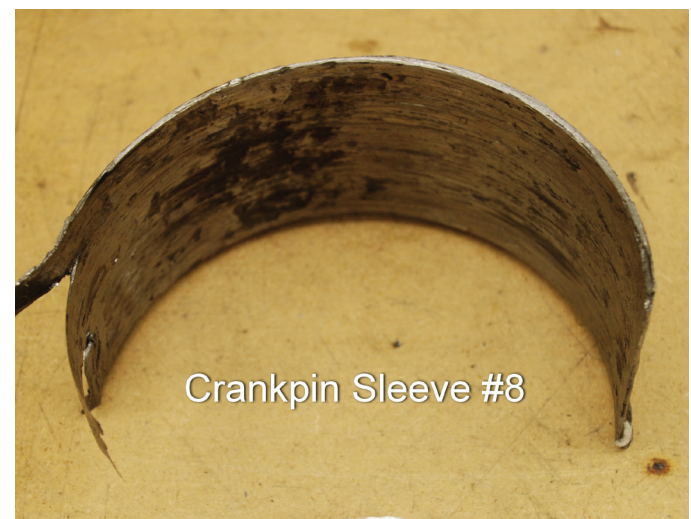
Figure 7
Shell damage on big end for cylinder #8.

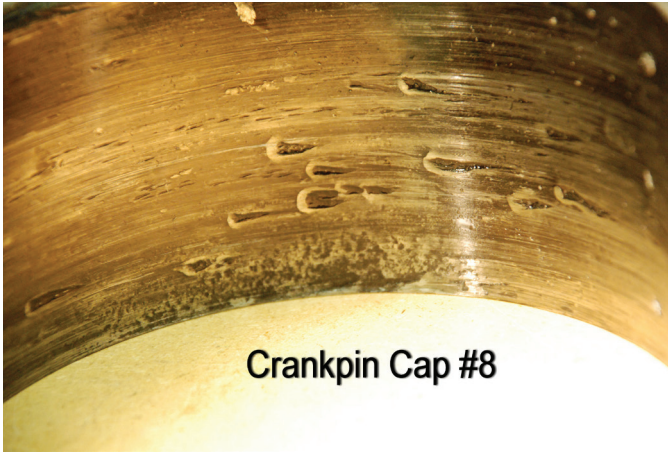
Figure 8

Shell contamination and damage on rod cap, cylinder #8.

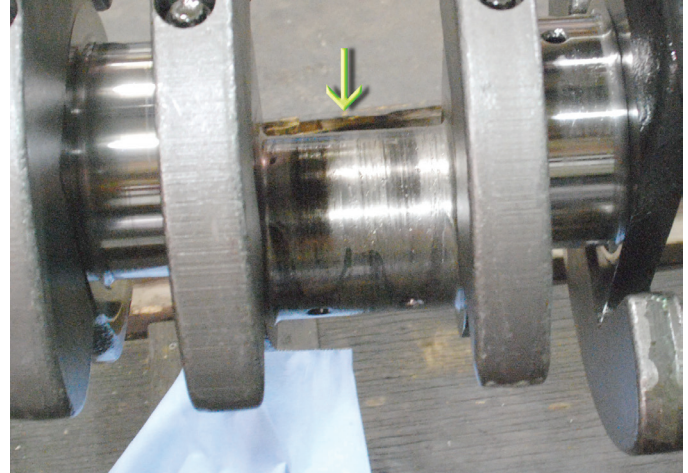
Figure 11

Damaged rod journal for cylinders #7 and #8.

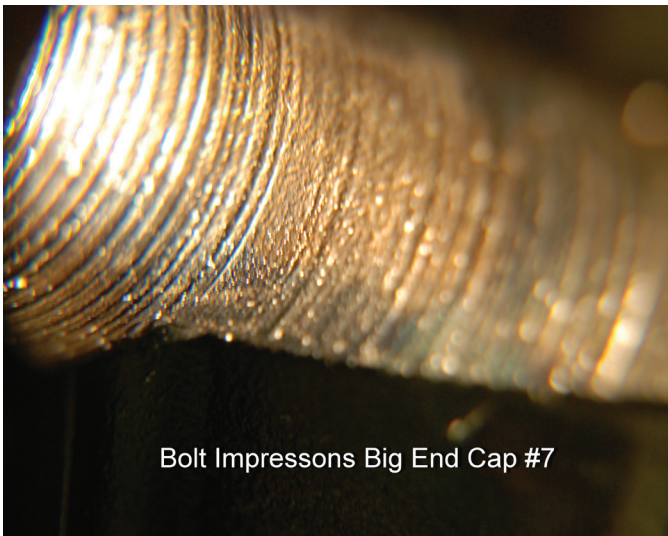
Figure 9

Bolt thread impressions on the rod cap, cylinder #7.

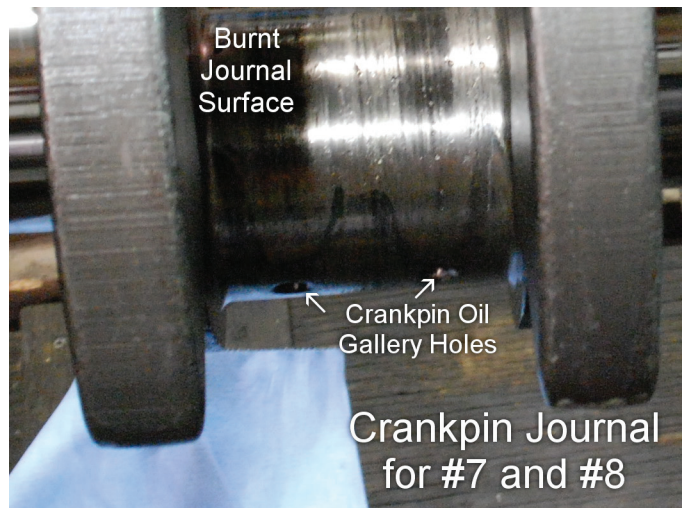
Figure 12

Zoom in on damaged rod journal, cylinders #7 and #8.

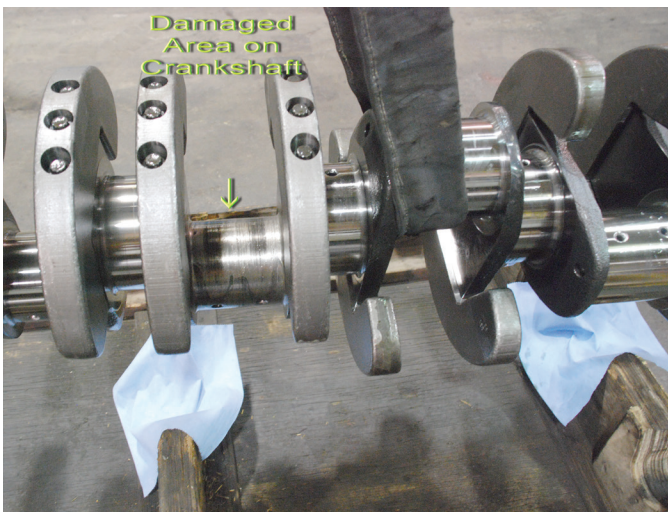
Figure 10

Damaged area on crankshaft rod journal for cylinders #7 and #8.

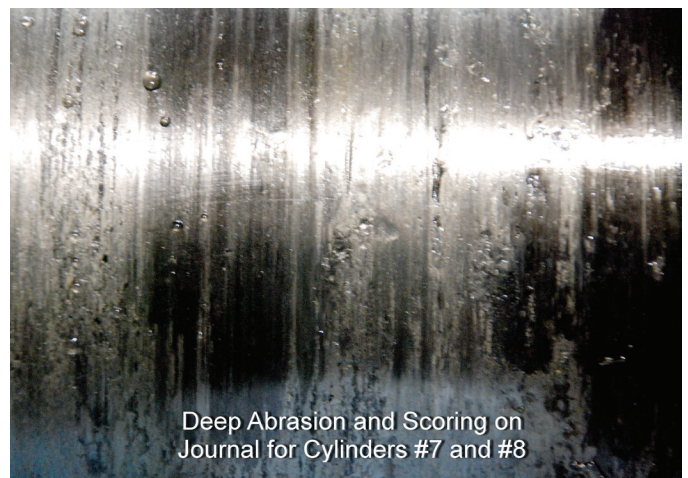
Figure 13

Deep abrasion and scoring at the rod journal for cylinders #7 and #8.

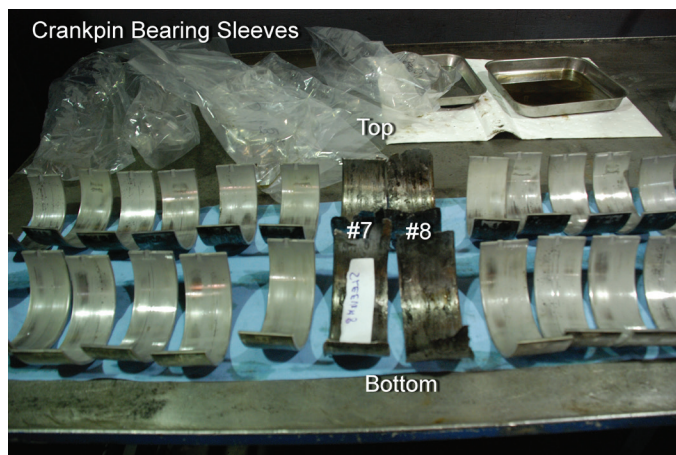
Figure 14

Figures 14 and 15 depict the crank throw shell sets, with the significant difference in appearance for cylinders #7 and #8 sets, while the heat discoloration damage can be seen in the shell on the fourth support block.

Crank throw shell sets — big end (top) and rod cap (bottom).

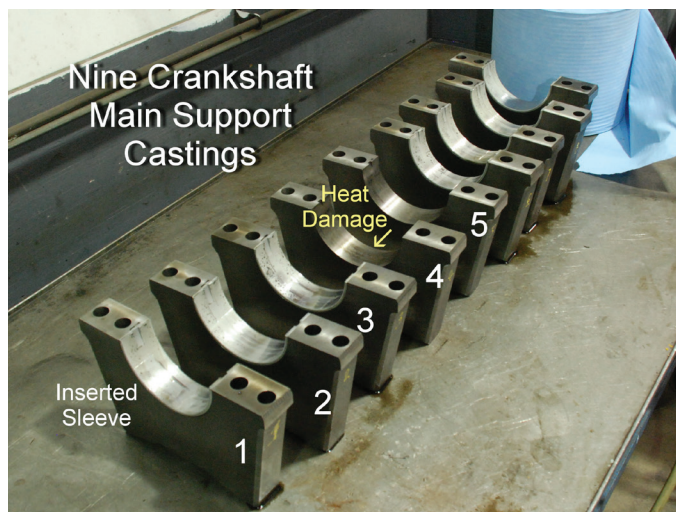
Figure 15

Crankshaft support castings with inserted shells for the main journals.

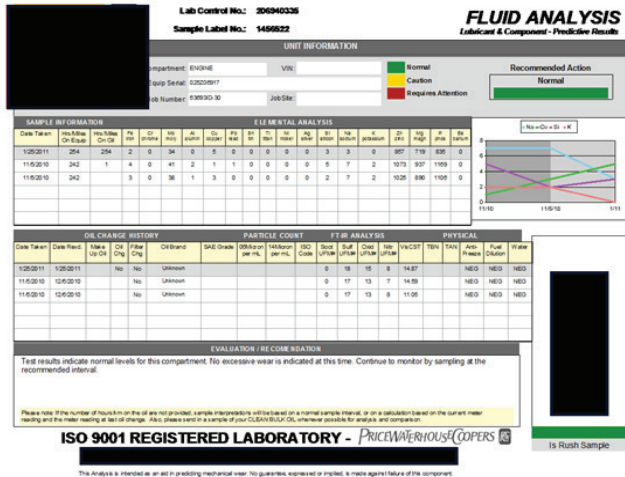
An oil analysis was completed after the incident on the new oil supplied on Nov. 10, 2011, and the findings compared to previous yearly oil test results. These were found to be in the normal range for wear elements such as copper and zinc (**Figures 17 and 18**). Given the normal range of results from the prior year, when extra elemental content would arise from premature wear, it followed that the degradation of the sleeves was a recent event, rather than one that occurred years earlier.

Figure 17
Oil analysis history for the engine.

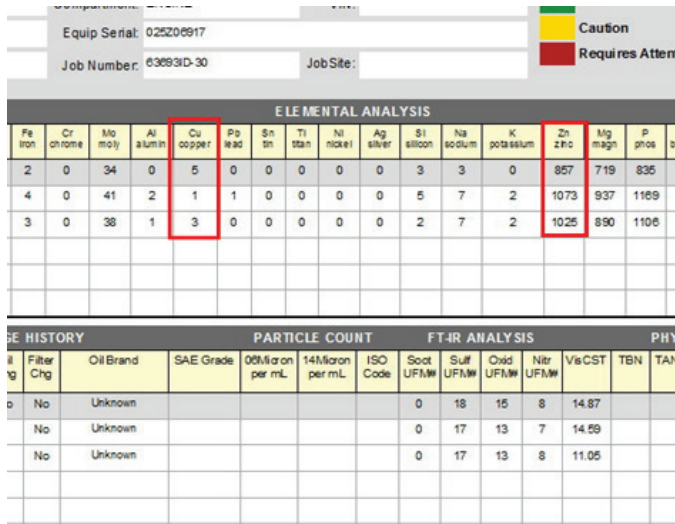
Figure 18
Zoom in on oil element analysis.

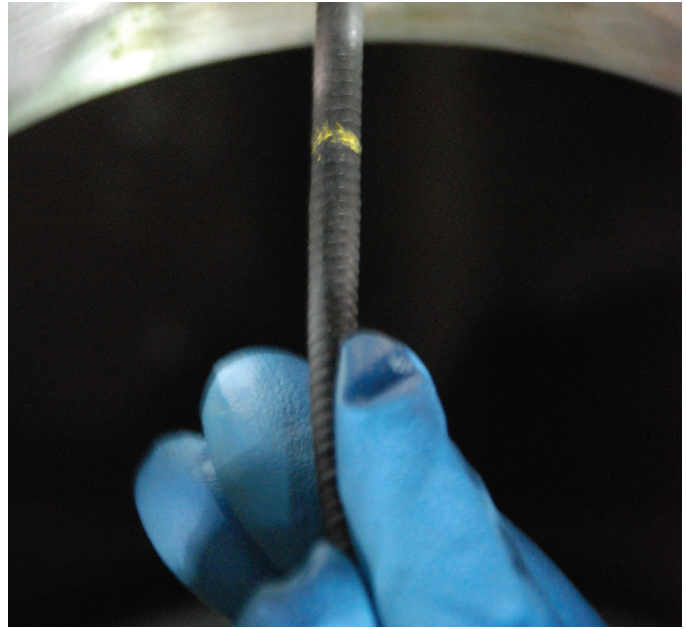
Figure 20
Recreation of the detection of obstruction within the port for main #4 and cylinders #7 and #8.

(222 mm). However, during the inspection of the lateral port leading to cylinders #7 and #8, the probe met an obstruction at 7.5 in. (190 mm) depth, as shown in **Figure 20**.

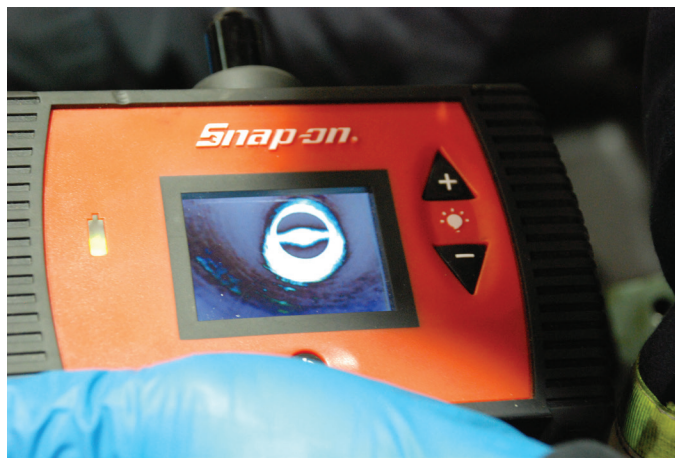
The symptoms of localized overheating and major oil supply failure to just two of the bearings on a common crank pin required that careful attention be paid to the side passages supplying oil to those areas. A boroscope with digital viewing screen was used to probe the side passages (**Figure 19**). The length for the probe to reach within to the other side of the main gallery in the block was 8.75 in.

Figure 19
Probe of side passage from main oil gallery to cylinders #5 and #6 — all clear.

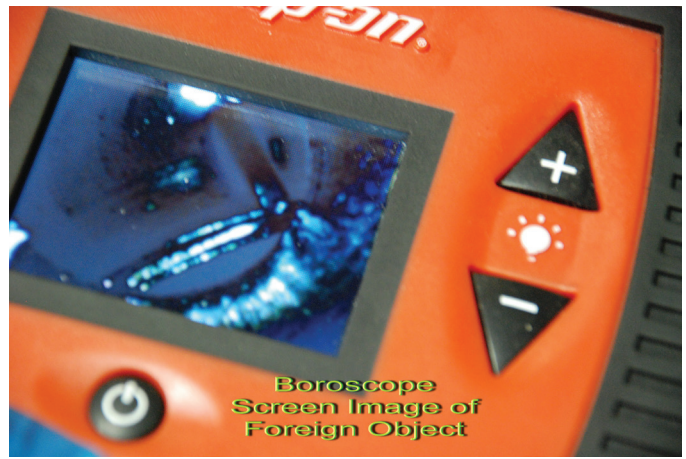
The dark foreign object was visible in the boroscope device screen (**Figure 21**). Continued inspection along the length of the main gallery within the block found this dark object at 35 in. (890 mm) from the front end of the engine (**Figure 22** and **Figure 23**). The object was carefully removed by the mechanics with a pincer attachment on a telescopic rod. The object was 3-in. OD, 1½-in. ID, black rubber polymer gasket, with the letters NX 1 visible on one side (**Figure 24**).

Figure 21
Boroscope screen image with foreign object.

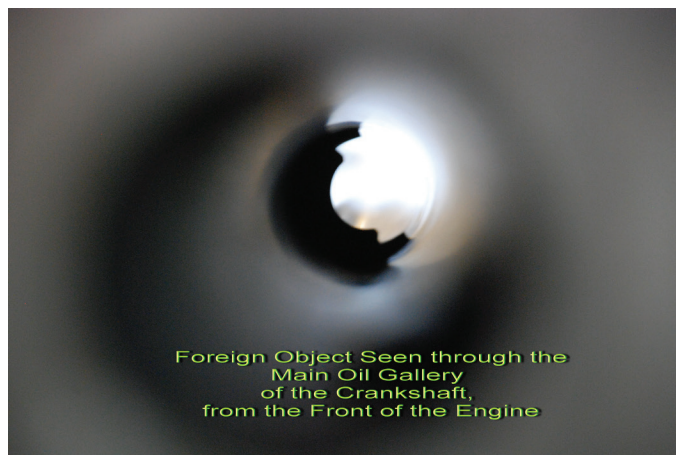
Figure 22

A longitudinal view toward the foreign object in the main oil gallery.

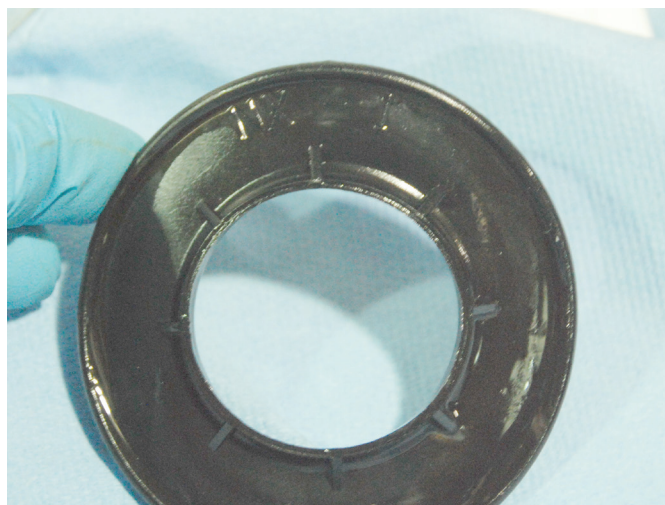
Figure 24

Foreign object extracted from the engine.

port. The lines seen in **Figure 24** were a portion of the letters identifying the gasket. The original equipment manufacturer's (Company C) canister was a different configuration with similar overall length (**Figure 26**). The Company D model had an outer and inner gasket, while the original equipment model had only the outer gasket ring, as seen in **Figure 27**.

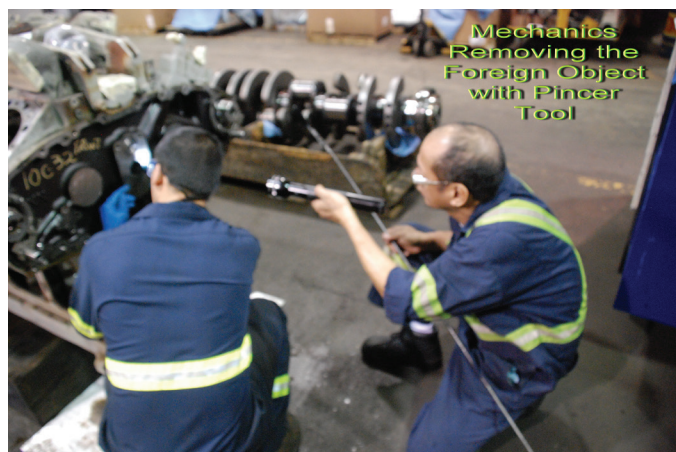
Figure 23

Removal of the object with a telescopic tool.

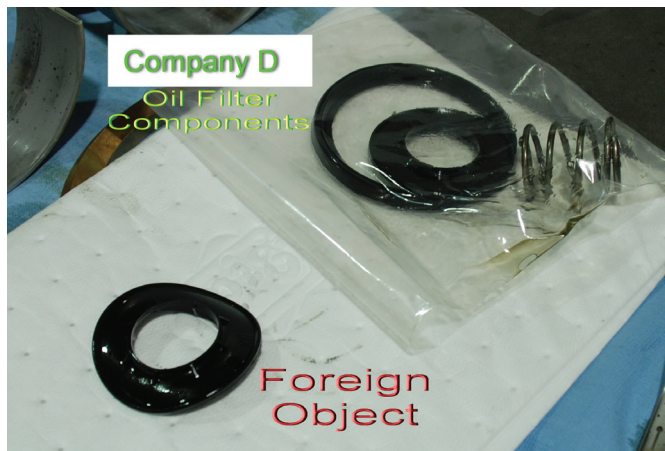
Figure 25

Comparison of Company D gaskets and the foreign object.

When compared to the components of a Company D brand oil filter taken from the site, it was immediately apparent (**Figure 25**) that the foreign object was an inner end gasket from such a filter. The found object was still flexible, soft to the touch, and did not appear to have physically degraded by heat, when compared to the one just removed from the Company D filter. It wanted to retain its curved shape, matching the diameter of the main oil gallery, suggesting that some permanent set had been acquired. The width of the ring was wide enough to fully block the oil

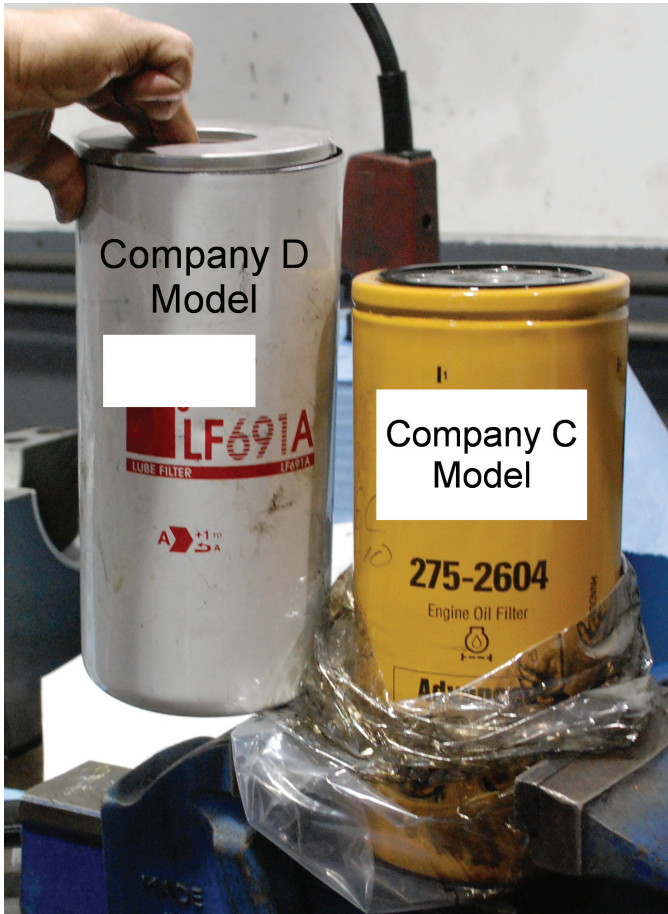
Figure 26

Company D and Company C OEM canisters were compared.

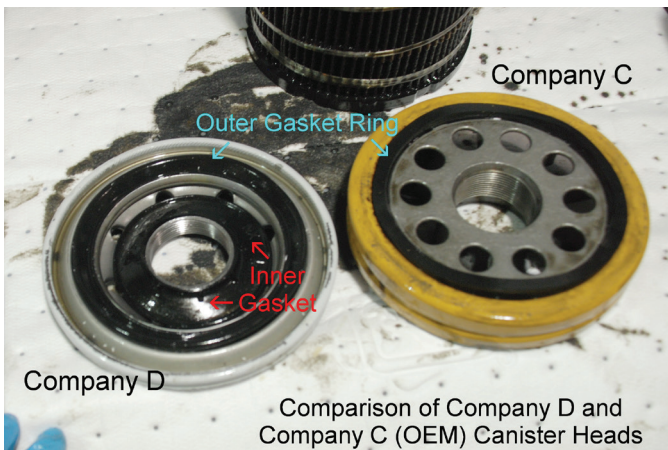
Figure 27

Comparison of different model canister heads.

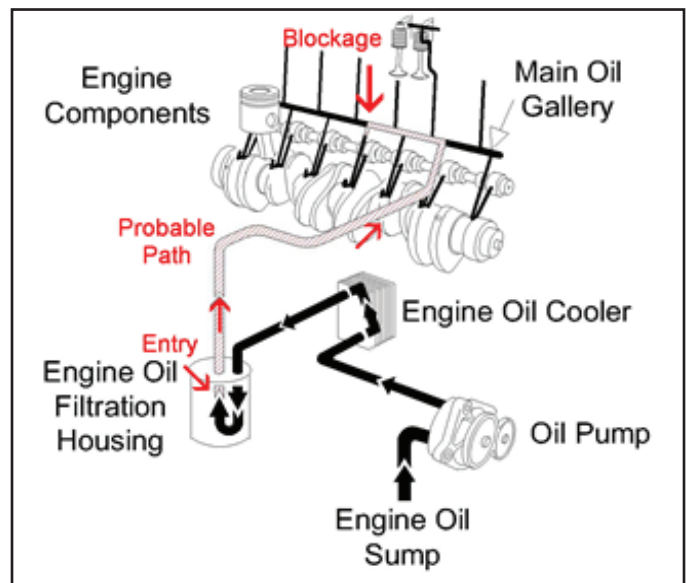
Figure 28

The theoretical gasket path based on engine schematics was reviewed to determine how the gasket had travelled almost three feet into the engine. **Figure 28** shows the probable path in red from the entry point in the engine oil filtration housing to the blockage at the port in the main oil gallery. The gasket would be pushed along the path by oil pressure in the system.

Probable path of the gasket from the oil filtration housing to the blockage location.

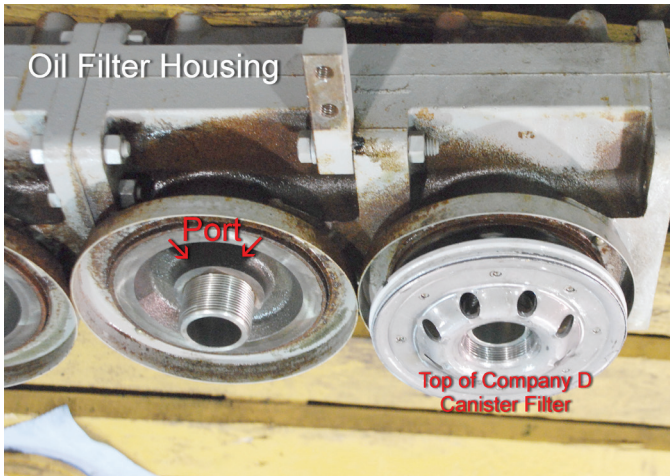
The gasket had to pass from the top of the Company D model canister, into the port in the oil filter housing, shown in **Figures 29** and **30**. Each of the four housing positions contains one port, but there were no means of determining which port the gasket had entered. In **Figure 29**, the cut-away end of the Company D model canister is shown. Note: This is put on from below, such that if a gasket “stayed behind” as seen in **Figure 30**, it might not be visible from above (**Figure 2**).

Figure 29
Underside view of housing with port, with underside tope of a Company D filter.

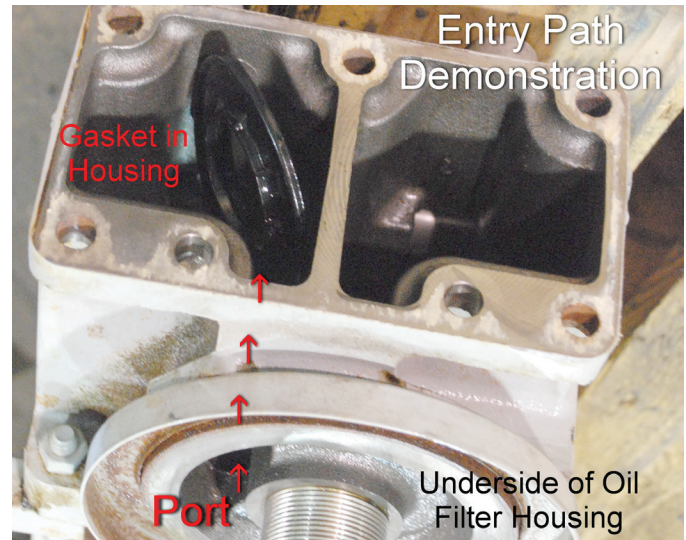
The potential path of the folded gasket was traced through the port (**Figure 31**) and up into the housing (**Figure 32**). From here, the gasket must cross into the supply pipe to the engine (**Figure 33**) and past the end of this pipe at the engine end (**Figure 34**). The gasket must pass by the adapter and then into the main oil gallery (**Figures 35** and **36**).

Figure 32
Entry path demonstration from port into housing.

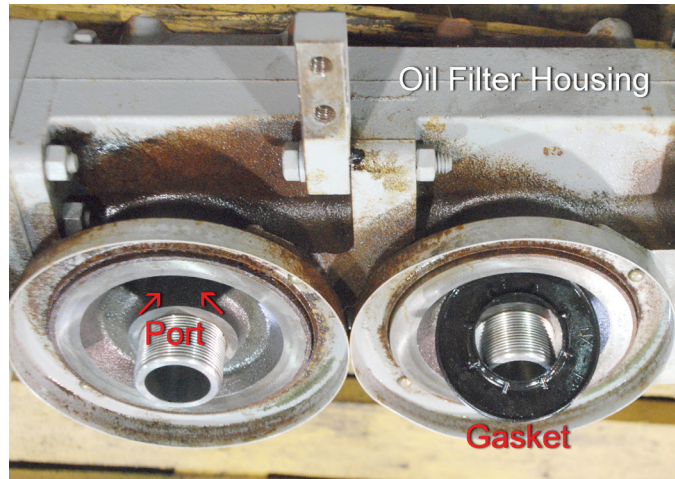
Figure 30
Underside of housing with port and gasket in loss position.

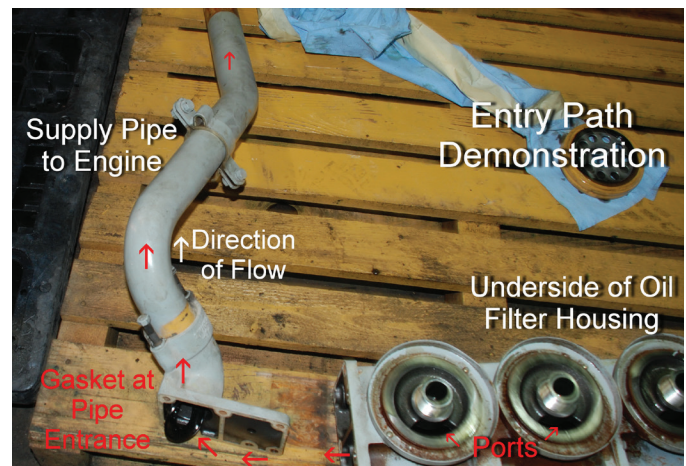
Figure 33
Entry path from housing into supply pipe.

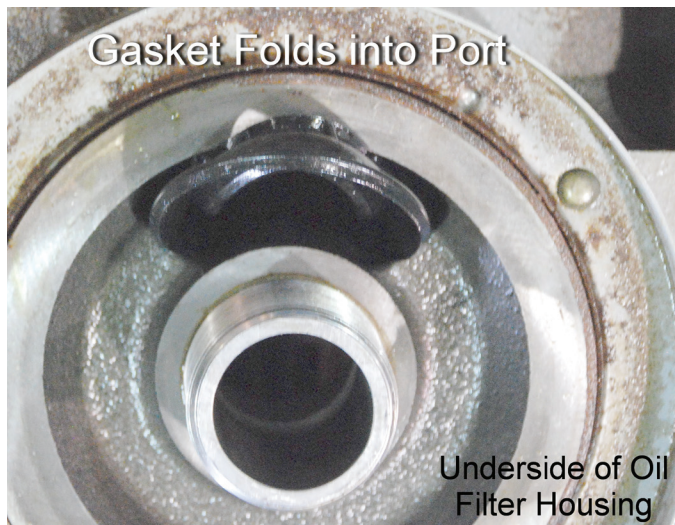
Figure 31
Gasket folded into port demonstration.

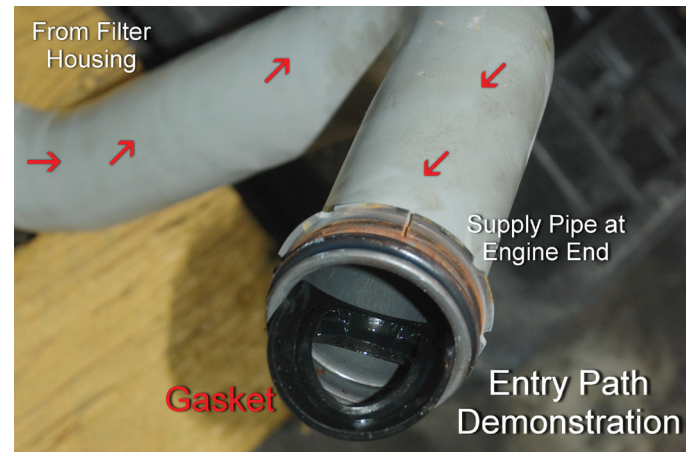
Figure 34
Continued entry path into end of supply pipe.

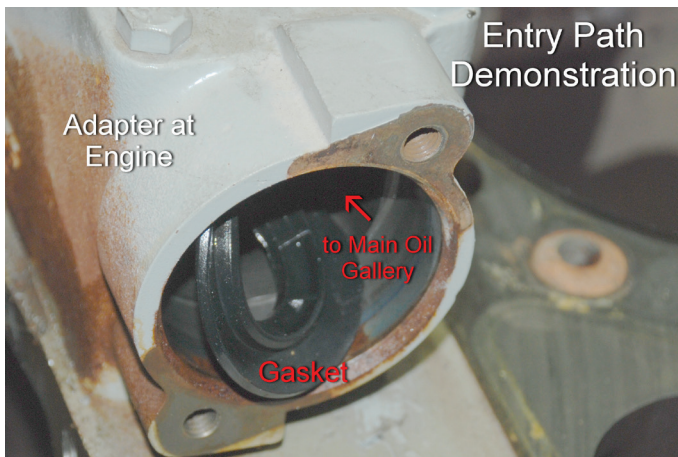
Figure 35
Entry path of gasket at the adapter on the engine.

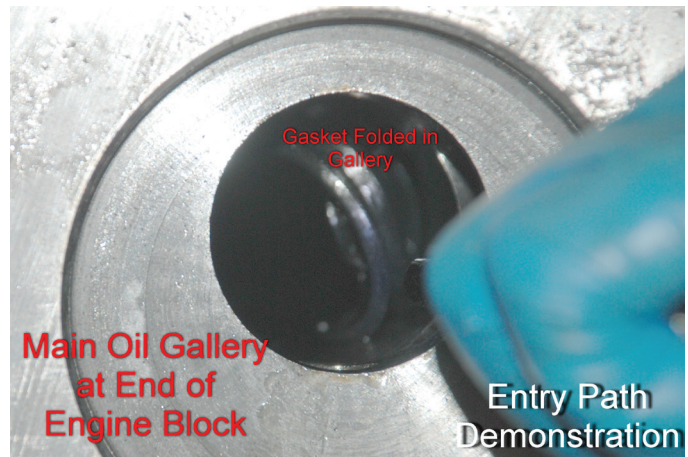
Figure 36
Entry path at the side of the engine block into the main oil gallery.
