Journal of the  
**National**  
**Academy** OF  
**Forensic**  
**Engineers**<sup>®</sup>

Vol. 37 No. 1 December 2020

<b>‡ Forensic Engineering Analysis of Projectile Thrown from Phantom Vehicle.....</b>	<b>1</b>
<i>By Richard M. Ziernicki, PhD, PE (NAFE 308F), William H. Pierce, PE (NAFE 846C), and Angelos G. Leiloglou, M Arch., (NAFE 956C)</i>	
<b>‡ Misapplication of Pressure Vessel Codes in Forensic Applications .....</b>	<b>15</b>
<i>By Bart Kemper, PE (NAFE 965S)</i>	
<b>‡ Forensic Engineering Analysis of Residential Underdrain Design Methodologies, Performance, and Failures .....</b>	<b>27</b>
<i>By Edward L. Fronapfel, PE (NAFE 675F)</i>	
<b>* Machine Safeguarding: Theory, Practice, and Case Studies .....</b>	<b>43</b>
<i>By Nicholas A. Petrucci, PE, CSP (NAFE 650M)</i>	
<b>* Forensic Engineering Analyses of Right-Turning Trucks Impacting Bicyclists .....</b>	<b>53</b>
<i>By Richard M. Ziernicki, PhD, PE (NAFE 308F), William H. Pierce, PE (NAFE 846C)</i>	
<b>† Forensic Engineering Analysis of a Failed ROPS .....</b>	<b>65</b>

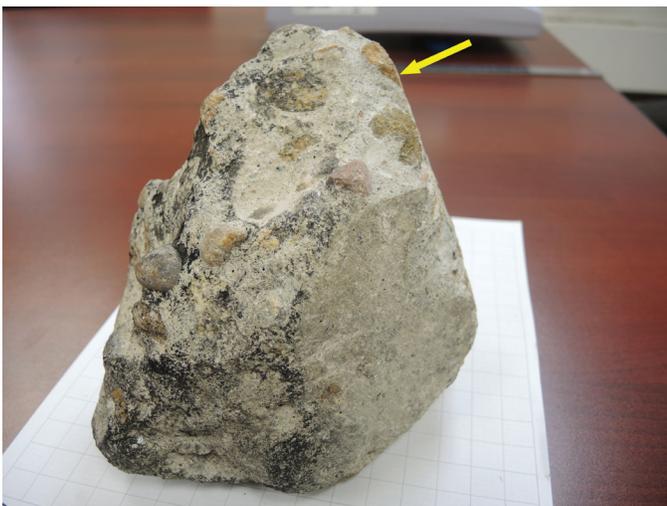
**Figure 4**

The presence of soil on only one of the concrete's faces is evidence that the face had initially been resting on soil, and a force was applied on the projectile to embed the soil onto the surface of the concrete. Black residue was also observed on two sides of the concrete. The black residue was primarily found on the two faces that formed a wedge shape opposite of the soil (**Figure 4**).

Black material observed primarily on two faces of concrete projectile opposite of soil (yellow arrow points to general side of embedded soil).

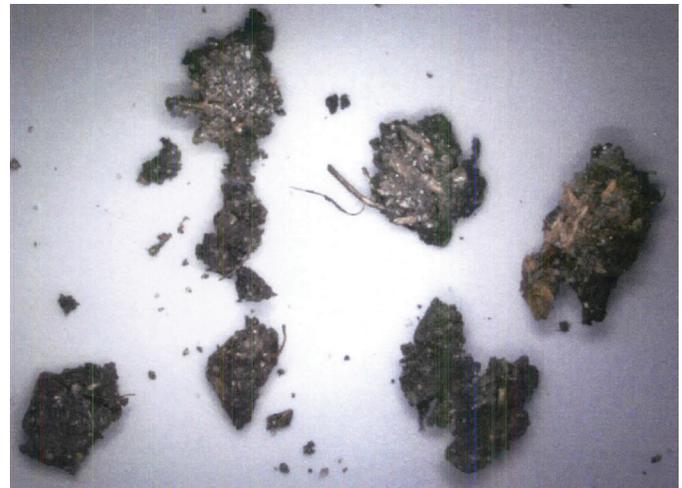
**Figure 5**

A digital microscopy image of the black material is shown in **Figure 5**. The lab analyst visually observed "black material, semi-translucent crystal, and fibers." The lab determined the black material likely contained styrene butadiene rubber, which is a typical elastomer used in the manufacture of tires<sup>2</sup>. The lab also determined that the fibrous material displayed chemical similarities with a compost sample, which was the same type of compost delivered to the park by the two dump trucks on the day of the incident. Therefore, the lab testing showed that there was material that had chemical similarities to tires, and the compost that had been delivered on the day of the incident to the park via dump trucks. A geometric analysis was performed.

Digital microscopy of the material.

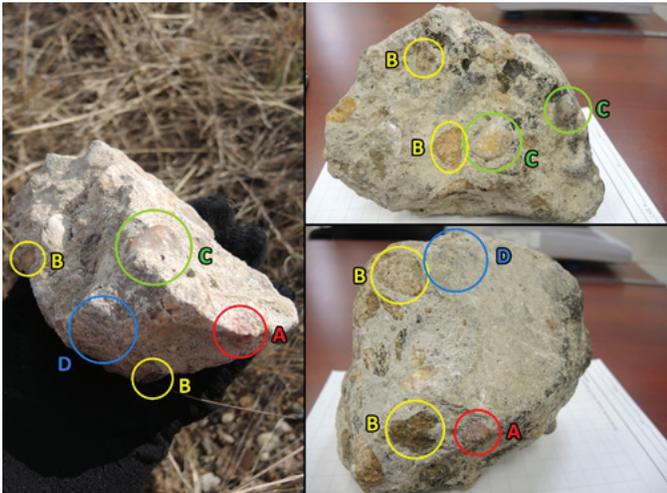
**Figure 14**

Visual similarities between sample recycled concrete found during inspection (left) and the concrete projectile (right). Colored circles identify areas of visual similarity.

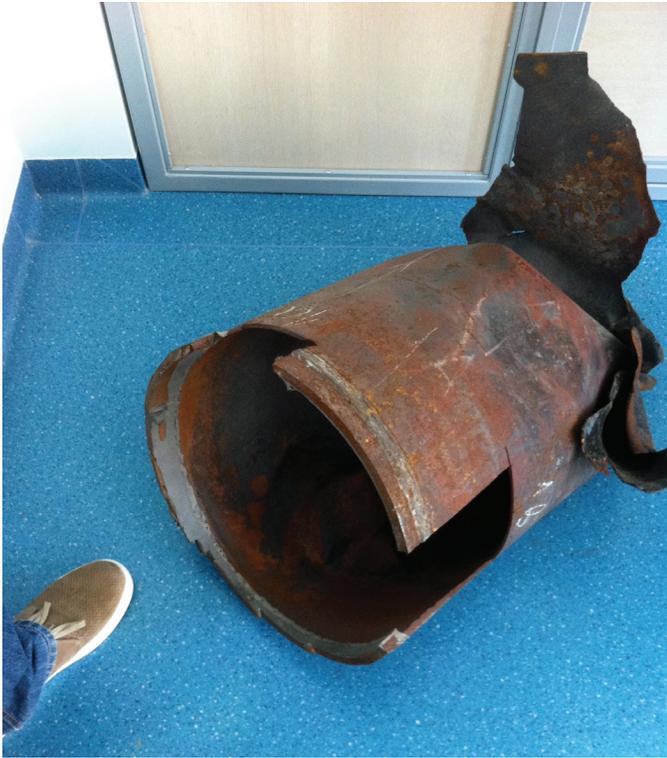
**Figure 2**

The failure in question was in a pipe with chemistry conforming to ASTM A106B carbon steel pipe (**Figure 2**). The inner diameter was 426 mm (16.8 in.) with a 10-mm (0.394-in.) thickness when new. The general thickness was 7 mm (0.276 in.) at the time of failure. Forensic measurement and analysis of the failed pipe showed the pipe wall at the point of failure was thinned to 0.15 mm (0.006 in.) before the failure and fire. This is more than a 65:1 aspect ratio — about the thickness of a sheet of paper. The equipment was designed and fabricated overseas and not to

Photo of the failed carbon steel facility piping.  
Coupons had been cut out for testing.

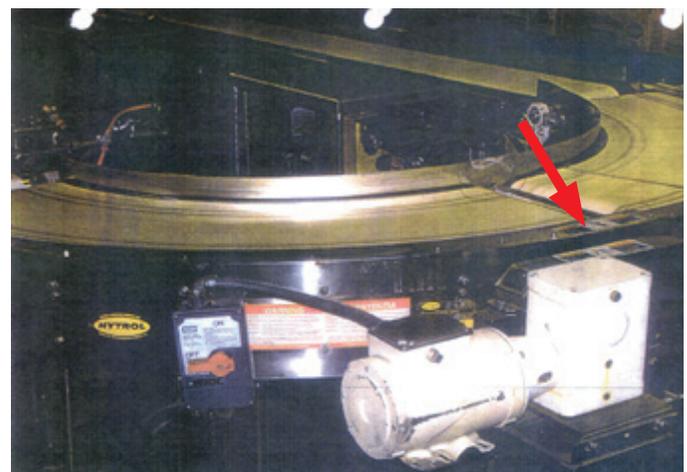
**Figure 3**  
Arrow shows where worker was injured between two 90° conveyor sections while removing cookie nuggets from the conveyor. Product flows from left to right.

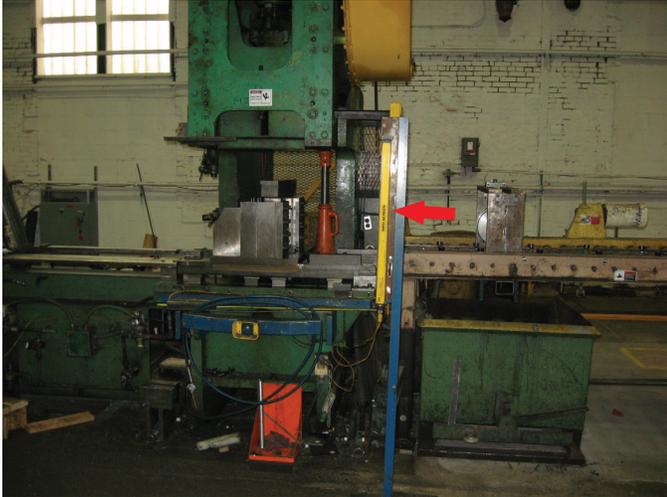
**Figure 15** shows a sheet metal power press with a presence-sensing light curtain. A stopping time of 0.360 seconds was measured from when the light curtain was tripped until the downward stroke of the press ram was stopped. This time coupled with OSHA's stipulated 63 in./second hand speed yielded a minimum safety distance of 22.68 in.<sup>4</sup>. The actual shortest distance from the light curtain to the press was approximately 25 in., which was acceptable (**Figure 16**). It should be noted that if the presence-sensing device is too far from the hazard, other safeguards may be necessary between these two items.

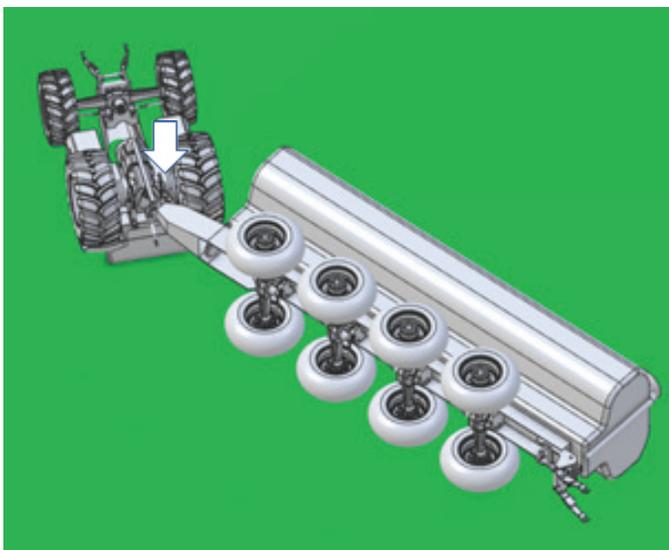
Hitch pin connection remained intact after the roll-over event.

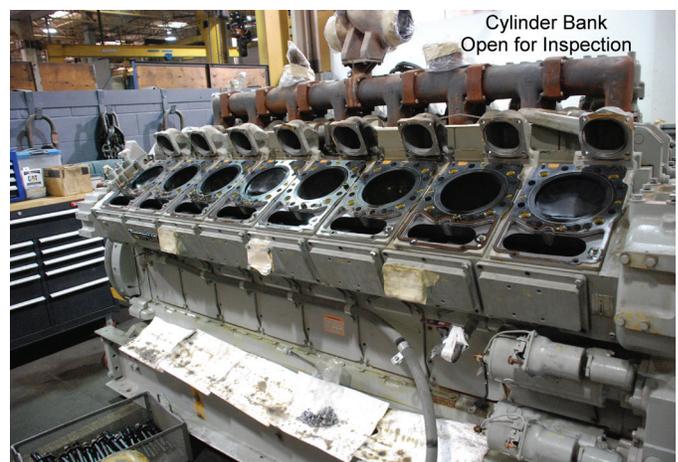
The spun bearing could have been the result of a lack of torque on the bolts, per the Company C’s technician. Since Company B stated that it did not intervene at those cylinders, a suggestion was put forth that the bolts may not have been correctly torqued during the manufacturing process. One objective of the investigation was to determine whether this could have been the root cause.

**Figure 3**  
Cylinder bank open for inspection at the Company C shop.

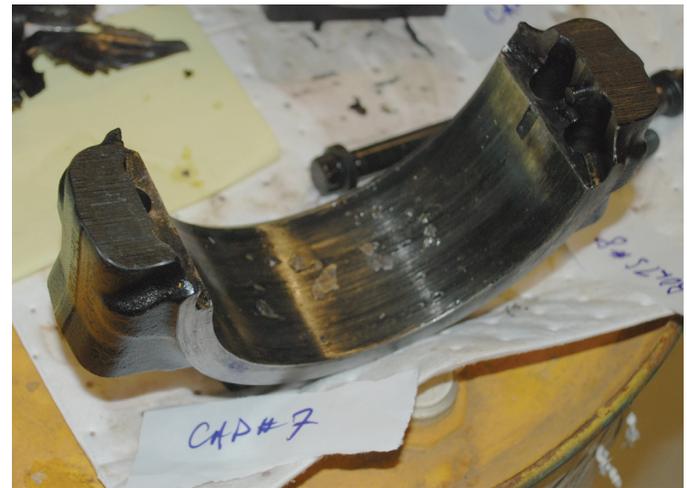
**Figure 6**  
Shell damage on rod cap of cylinder #7.

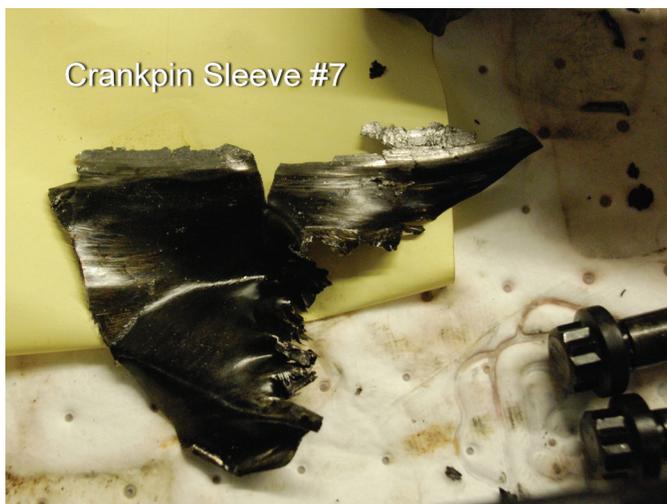
**Figure 5**  
Destroyed big end shell for cylinder #7.

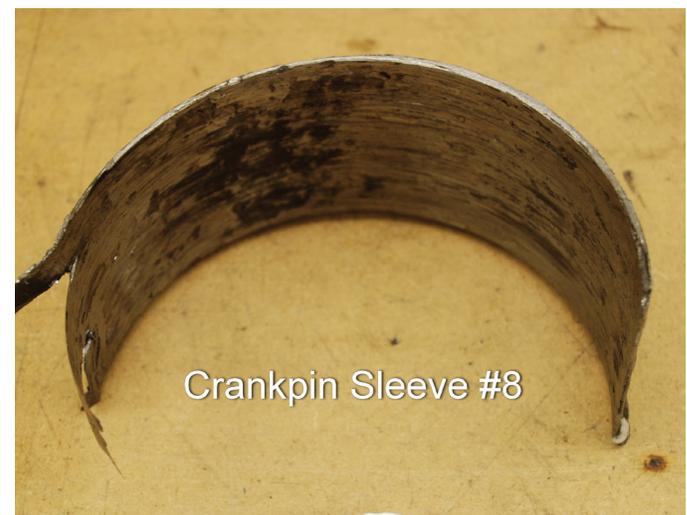
**Figure 7**  
Shell damage on big end for cylinder #8.

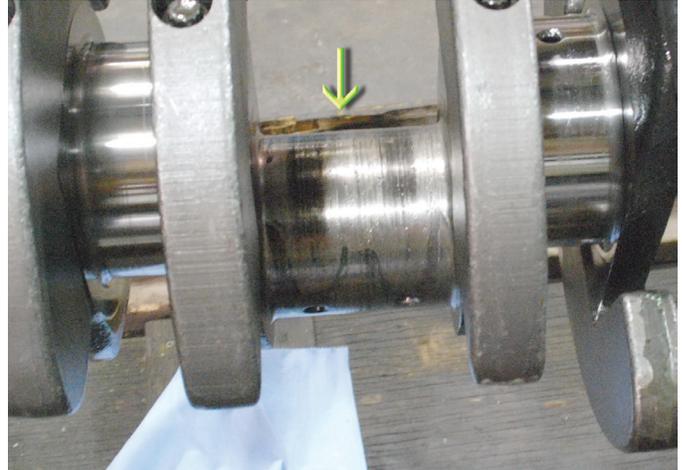
**Figure 11**

Damaged rod journal for cylinders #7 and #8.

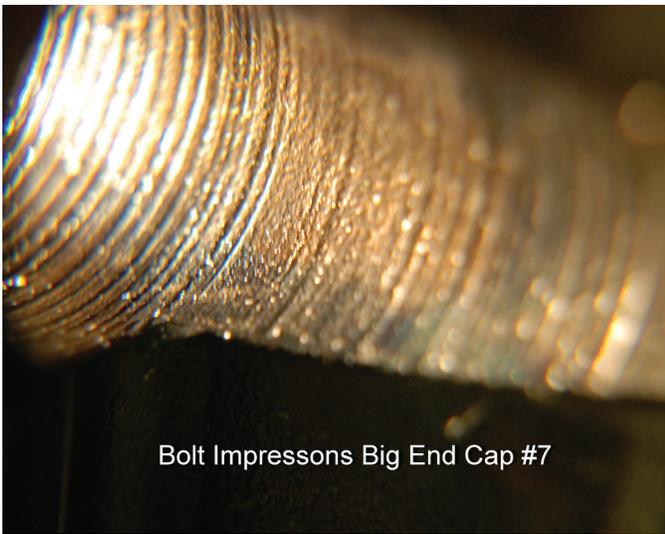
**Figure 9**

Bolt thread impressions on the rod cap, cylinder #7.

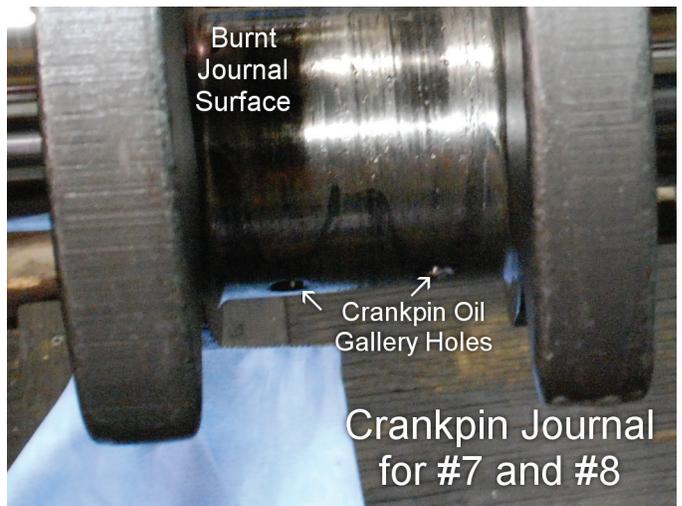
**Figure 12**

Zoom in on damaged rod journal, cylinders #7 and #8.

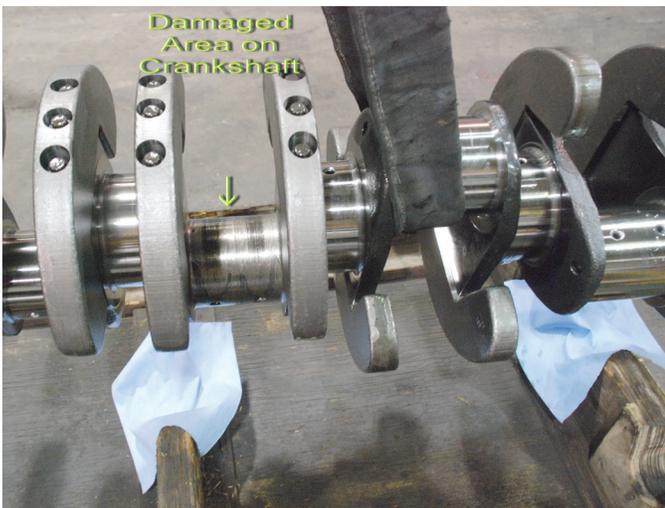
**Figure 10**

Damaged area on crankshaft rod journal for cylinders #7 and #8.

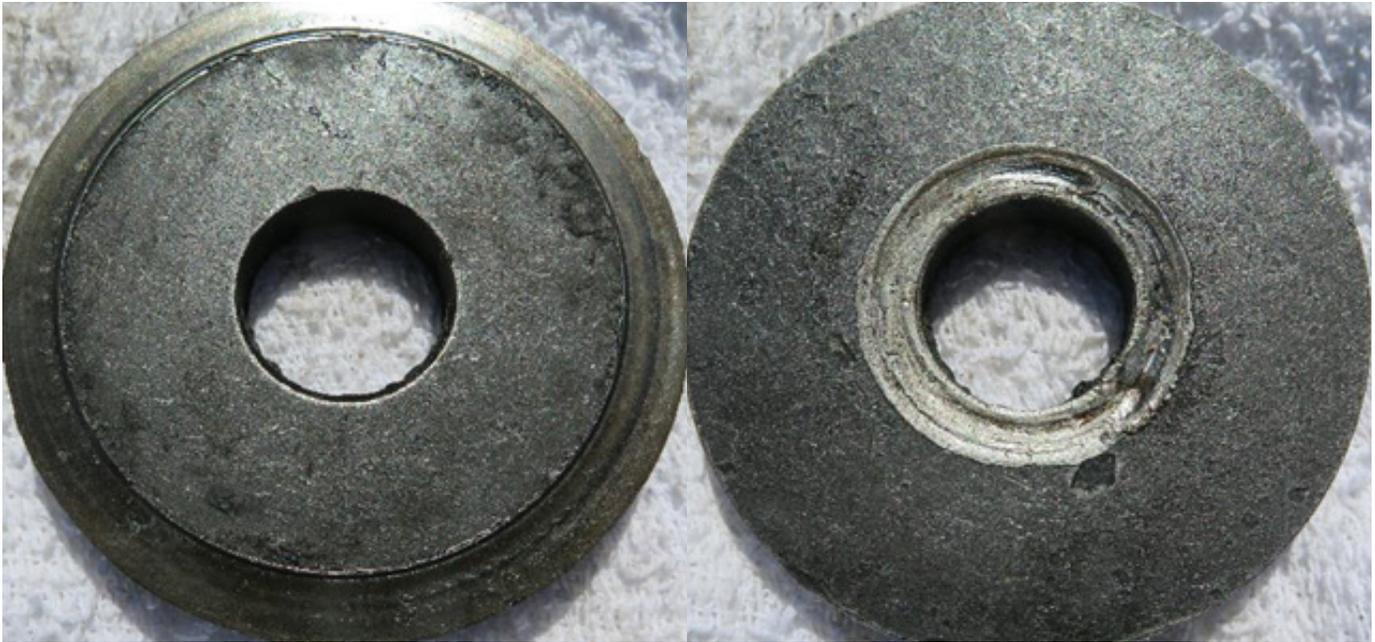
The washer in **Figure 18** was damaged with material displaced/removed on both sides from the contact with the inner bearing and the nut. The washer depicted in **Figure 18** shows damage from the rotation and impact damage of the washer relative to the bearing on the left and the nut on the right. The damage displaced some of the material of the washer, which is a softer

**Figure 18**  
Washer bearing side (left), nut side (right).

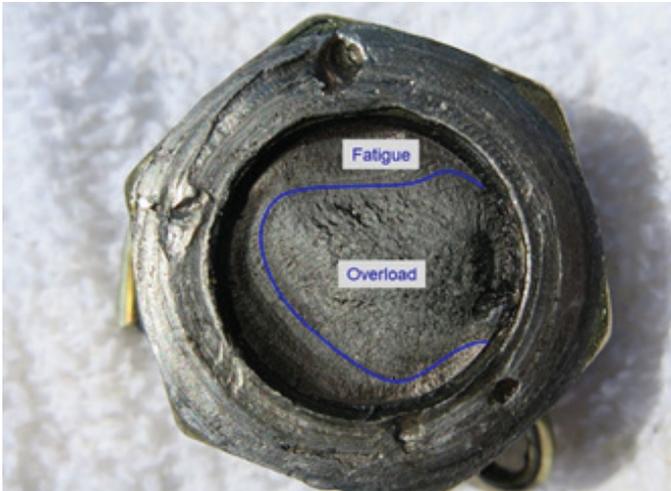
**Figure 25**  
Fracture surface on castle nut.

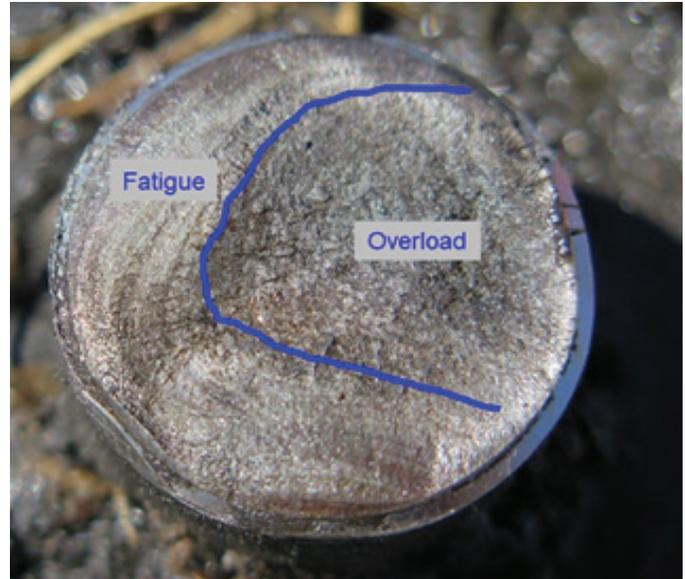
The pattern on the nut end and the mating spindle (shown in **Figure 27** is consistent with unidirectional bending<sup>22</sup> where the force is applied from one direction as seen with the fatigue area making a horse-shoe shape

**Figure 27**  
The fatigue horse-shoe pattern shown on spindle.

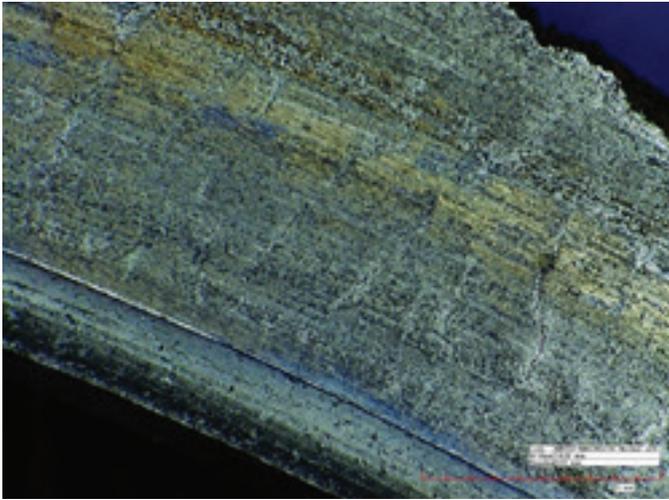
**Figure 2b**

Close-up photomicrograph in location B shows heat tinting and fissure cracks.

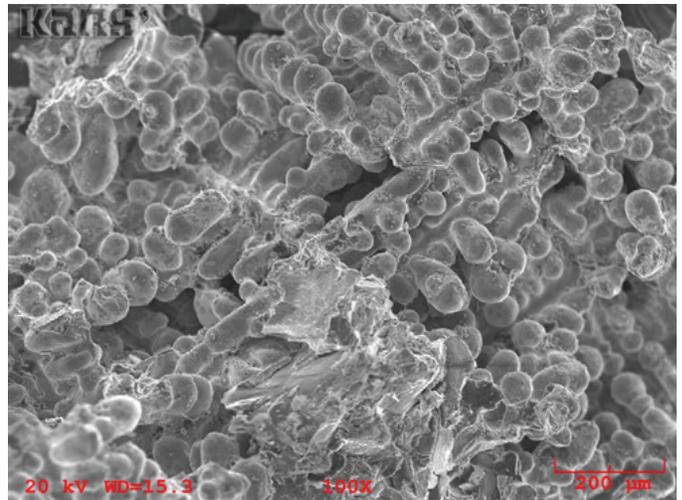
**Figure 3b**

High magnification SEM image in dull fracture surface area shows dendrites and solidified droplets that were not fractured.

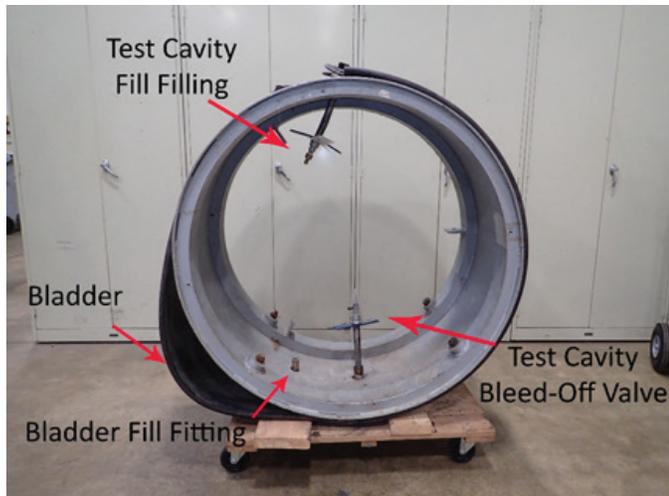
**Figure 1**

Damaged pipe joint tester (post-incident).

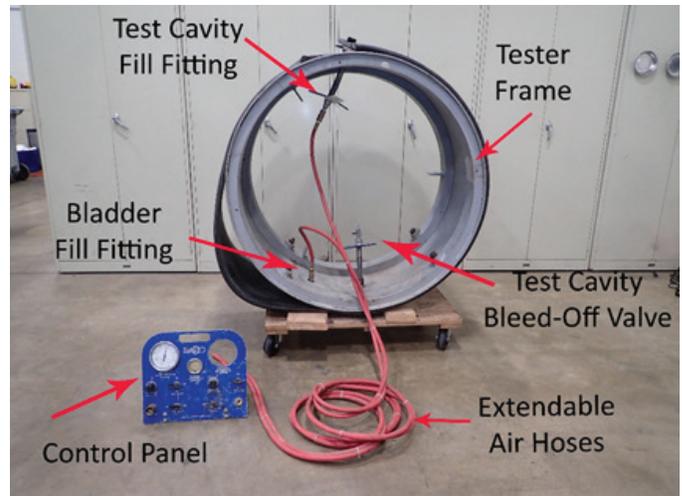
**Figure 5**  
Control panel attached to tester (post-incident damaged condition).

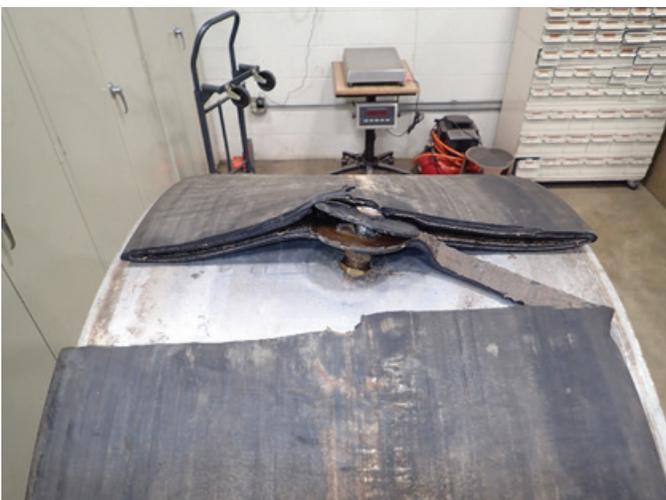
**Figure 15**  
Ruptured bladder showing test cavity supply tube connection.

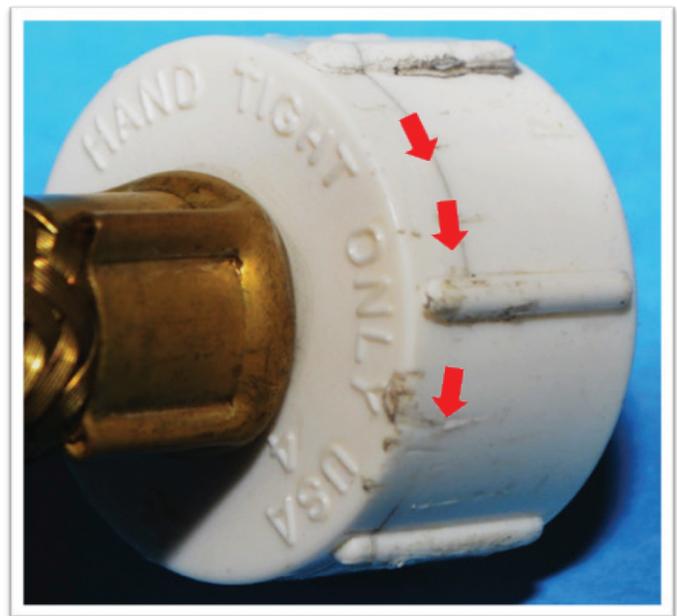
**Figure 3**  
Failed ballcock nut. Warning: “Hand Tight Only.”
