Journal of the
National
Academy OF
Forensic
Engineers[®]

Vol. 38 No. 2 December 2021

Forensic Engineering Investigation and Analysis of Crack Formation in Acetal Resin Nuts Used for Water Supply Lines

Non-destructive and destructive techniques were used to document and model crack formation in acetal resin nuts used for household toilet water supply lines. The morphologies of creep rupture and overload failure were documented using optical microscopy and scanning electron microscopy (SEM). The forensic investigation stemmed from litigation between a homeowner, plumbing contractor, and parts supplier related to a failure at a single residence. Fortuitously, 447 fittings in service for approximately two years under similar conditions were available for examination. In many properly installed fittings, cracks had initiated at the notch created by the sharp thread root radius, as predicted by engineering mechanics and finite element analysis. This study found that the cracks had propagated via plastic creep.

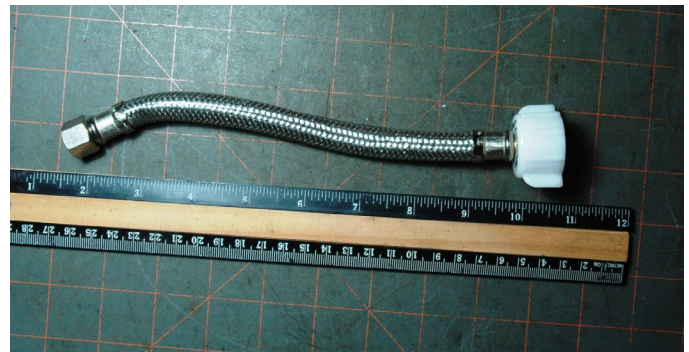
Figure 1

A plumbing contractor was sued by a homeowner related to the failure of an acetal resin nut that was part of a water supply line to the toilet tank (**Figure 1**). The plumbing contractor subsequently filed a third-party lawsuit against the supplier of the water line, alleging negligent design and manufacture of the acetal resin nut.

As-received photo of toilet supply line.

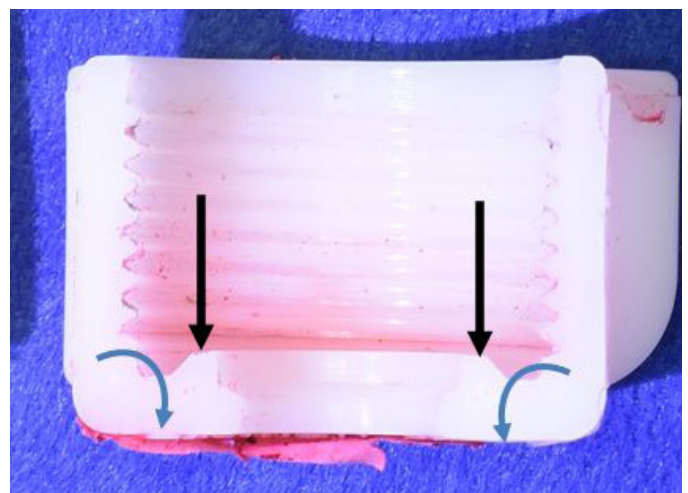
Figure 4

In use, the toilet connector threads onto a male pipe at the bottom of the toilet tank, compressing a rubber gasket between the interior surface of the connector and the end of the male pipe to prevent water leakage (**Figures 2 and 3**). The contact between the end of the male pipe and the connector creates an outward-directed longitudinal force on the interior surface of the connector. This force creates a shear stress and bending moment within the wall of the connector, with the highest stress located at the interior surface at the bottom of the wall (as shown in **Figure 4**). In addition, the threaded wall of the cap is subjected to a

Cross-section of nut with crack, showing force and bending moment at end-cap.

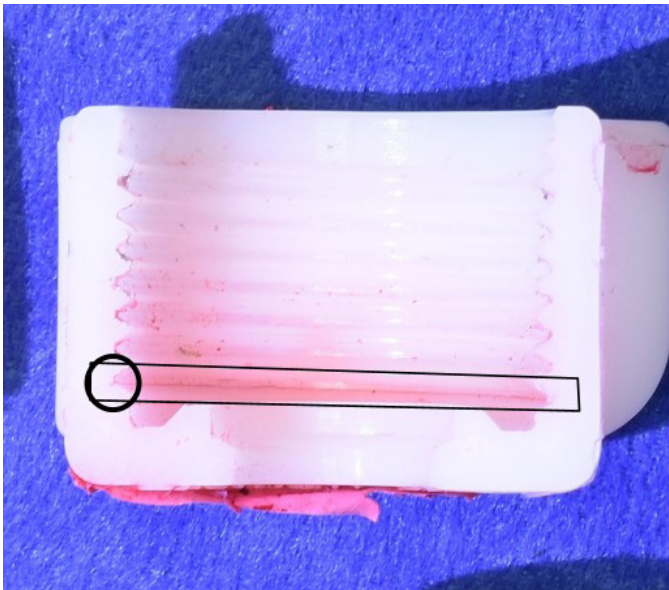
Figure 5

The interior thread extends to the base of the cap. The sharp-edged roots of threads are known as stress risers, which lead to local stress concentrations many times greater than the stress that would be present without the stress riser⁵. **Figures 5** and **6** show a cross-section of a nut examined during this investigation that revealed the presence of a crack that formed at the root of the base thread, as predicted by static analysis of the applied forces and illustrated in the output of FEA performed during this investigation (shown in **Figure 7**).

Cross-section of nut, showing crack at root of base thread.

During the first phase of the investigation, 43 fittings were cut in cross-section. Incipient cracks were present at the root of the base thread in 11 of these, as seen in the sample shown in **Figures 5** and **6**. The onset of cracks in 25 percent of the samples with no evidence of tool marks, along with the three prior known failures of the same parts associated with this installation, provided strong evidence of a design or manufacturing defect specific to this lot of fittings. At this point in the study, deposition testimony was provided by experts for the various parties, and the suits were settled.

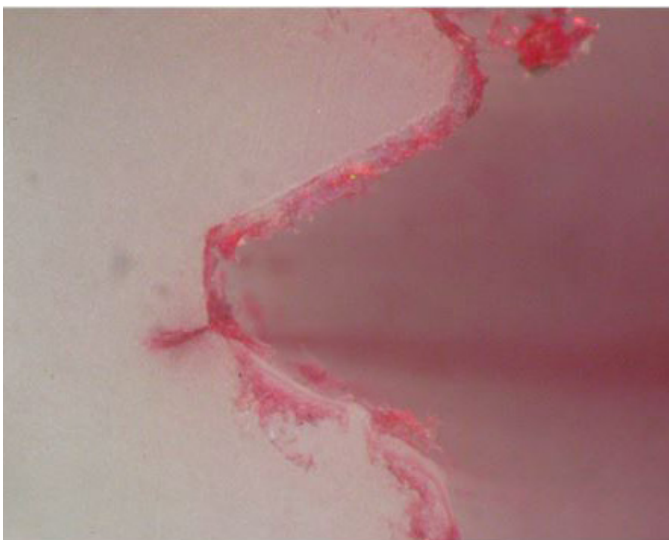
Figure 6

Close-up of crack in cross-section.

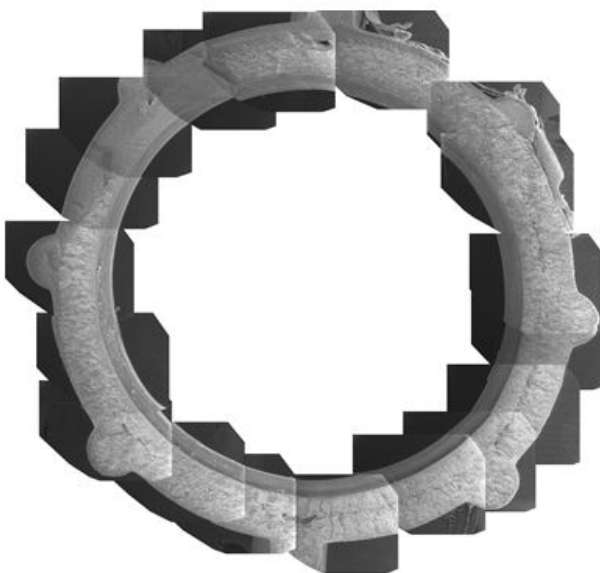
Figure 9

Composite photograph of cross-section of subject nut; interior thread ends at a notch in the upper left of image.

The subject nut was examined by experts retained by the parties involved. The joint examination included visual examination under optical microscope and SEM. **Figure 9** is a composite photograph of the fracture surface of the subject nut. Failure initiated at the notched end of the interior thread at the base of the fitting, consistent with the location of the highest stress as shown by FEA.

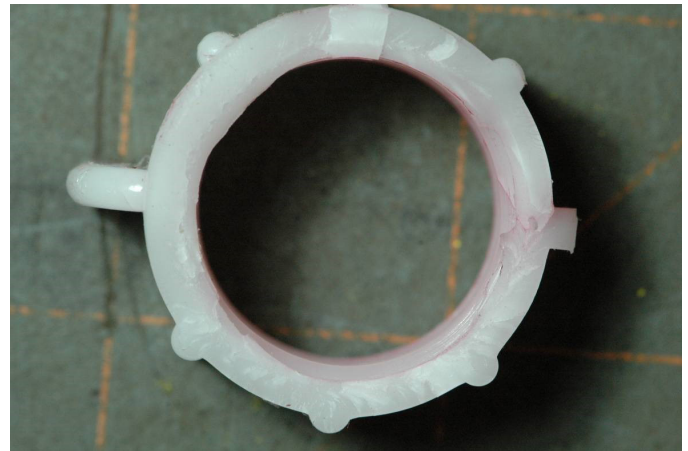
The thread base of an additional 100 supply line nuts was then examined microscopically to determine if any cracks had started over the two-year in-service period. These nuts had no signs of tool marks. As shown in **Figures 13 and 14**, Sample #17 had red dye penetrant on the inside of the fracture surface, indicating the presence of a crack. Of the 100 parts examined in this phase, 10 were found with cracks at the base of the last thread, corresponding to a crack formation rate of 10 percent.

Figure 13
Fracture surface of Sample #17.

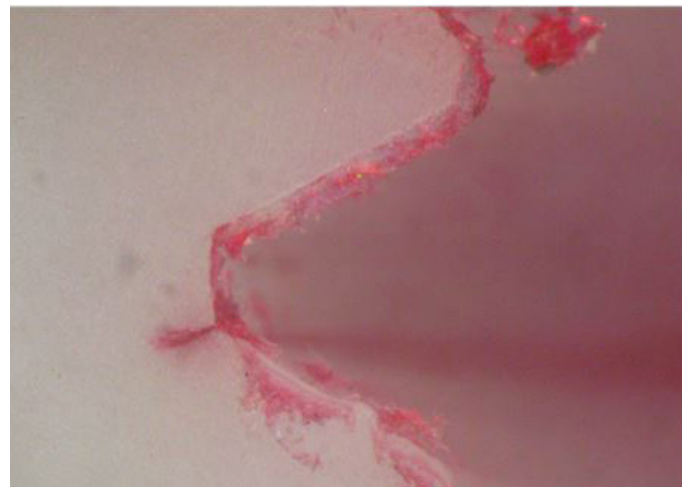
Figure 14
Red dye penetrant in crack on the fracture surface of Sample #17.

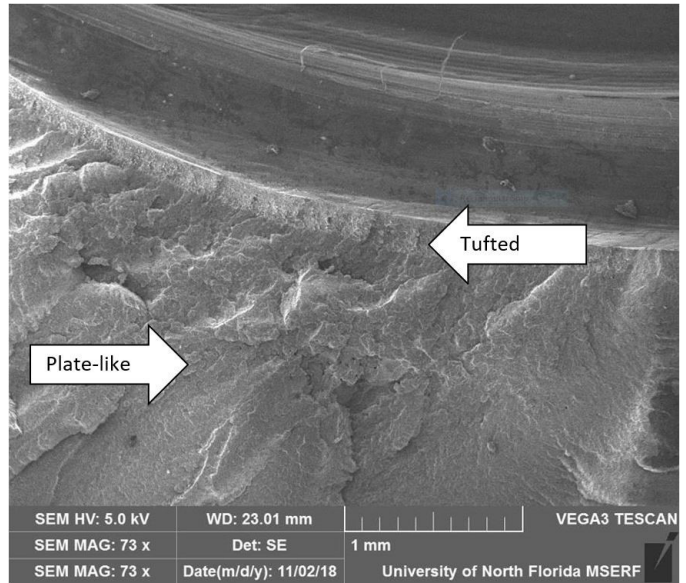
Figure 17

The SEM images after gold coating clearly show two different types of fracture morphologies present in the surface of the same sample. One has plate-like fracture zones corresponding to a fast overload fracture achieved with the torque wrench, while the other (crack that visually showed as red in color) has a tufted appearance associated with sustained loading over time, resulting in creep rupture morphology. See **Figures 16** through **20**. Under sustained

Medium magnification, Sample #17, gold coated showing fracture morphologies.

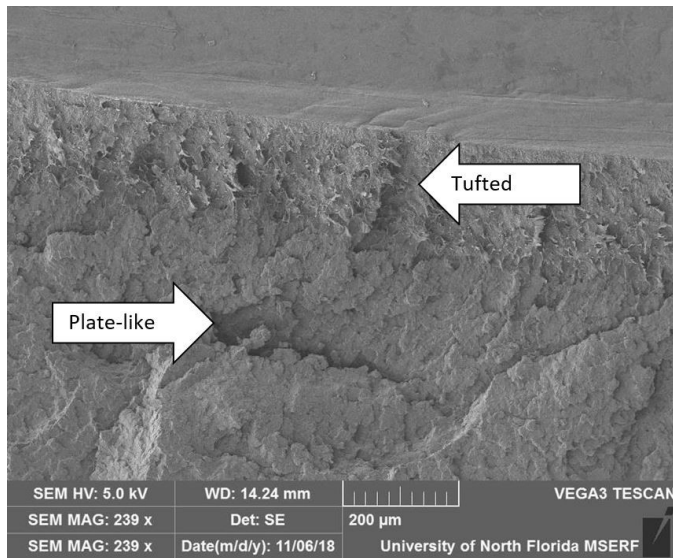
Figure 19
Higher magnification, Sample #17, gold coated showing fracture morphologies.

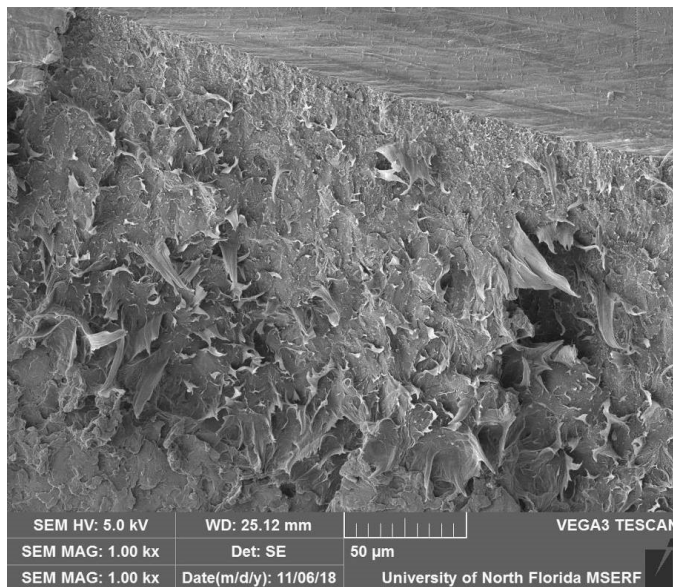
loading, this material undergoes slow, stable crack extension, resulting in the development of a tufted fracture surface appearance. These tufts represent fibril extension and subsequent rupture in various polymers⁹.

Figure 20
Even higher magnification, Sample #17, gold coated showing tufted appearance of fracture surface.

The SEM study revealed the presence of a tufted surface morphology, which is associated with slow stable crack extension due to sustained loading over time defined as plastic creep^{8,9}.

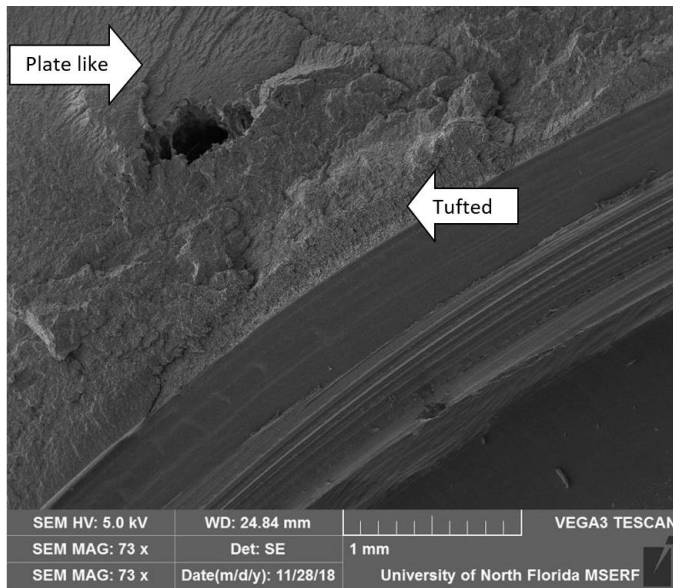
Figure 23
Sample #56 with two fracture morphologies.

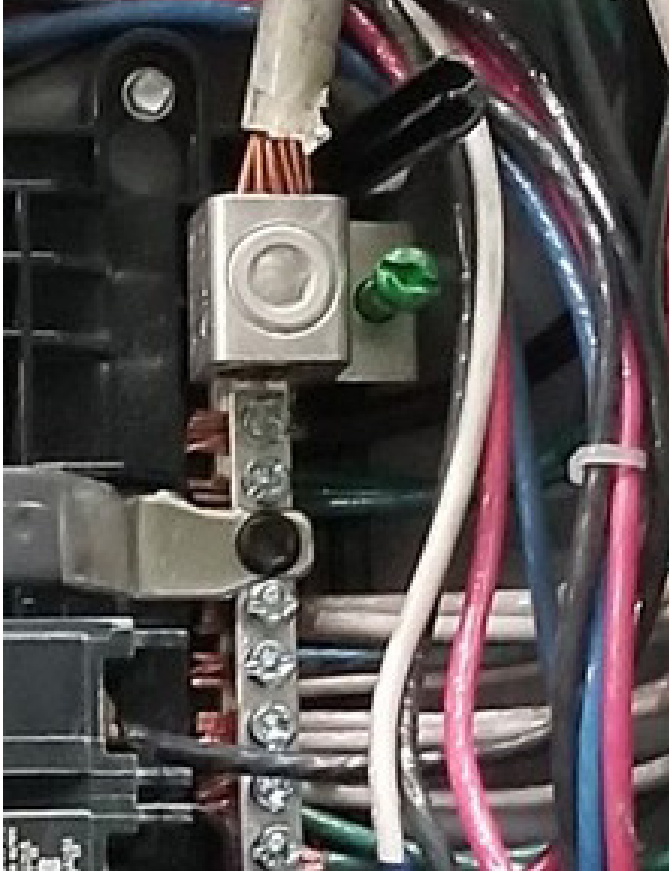
Figure 10
Close-up within Panel 3, showing improper bonding of neutral to ground.

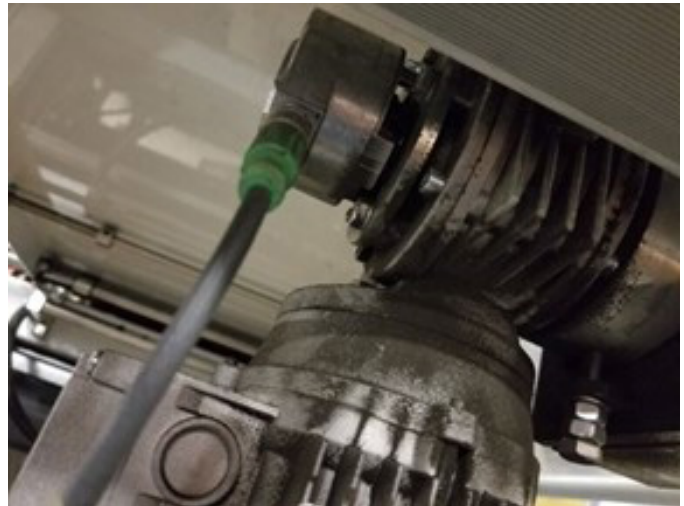
Figure 12
One of the position sensors that regularly failed shows intact cabling and shielding.

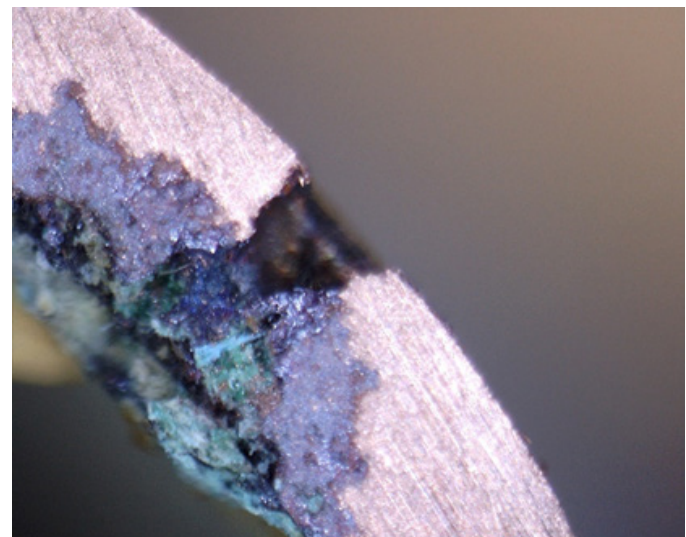
Type II and Type III pitting (**Figure 3**) are now recognized as similar processes with a high probability that both originate or are associated with periods of stagnation during construction or use, although other processes are suggested in the literature^{14,15}. Installation standards now recognize this problem and recommend procedures to avoid it.

Figure 3
Polished section through a Type II pit from a system that was subject to stagnation.

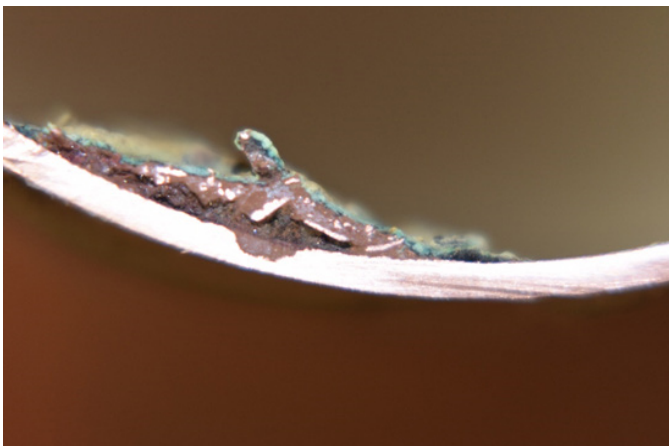
Figure 4

Pit caused by an accumulation of debris at the bottom of the pipe.

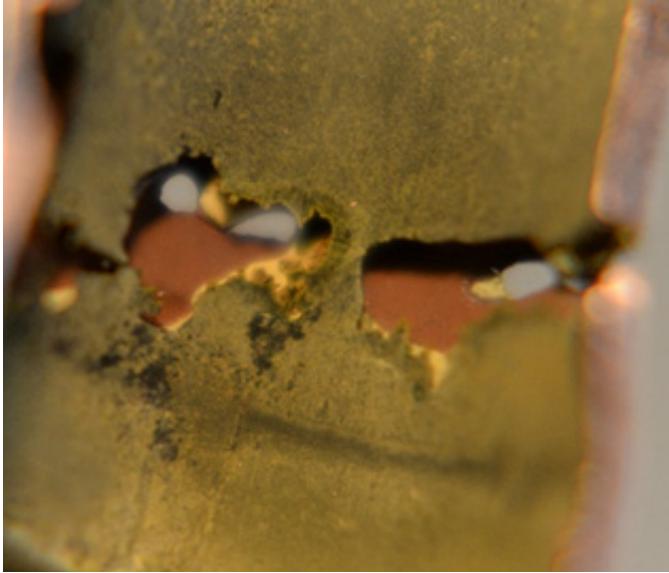
Figure 7
Erosion penetrations at poorly formed joints.

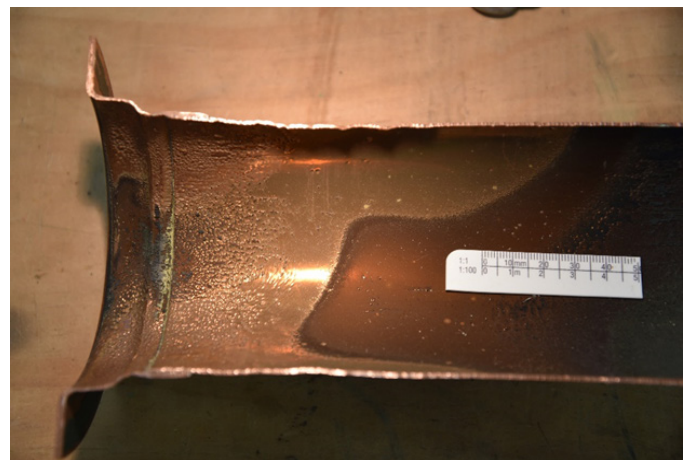
Figure 8
Copper pipe removed from service showing erosion and surface polishing where a butterfly valve was used to throttle flow rates. Flow left to right.

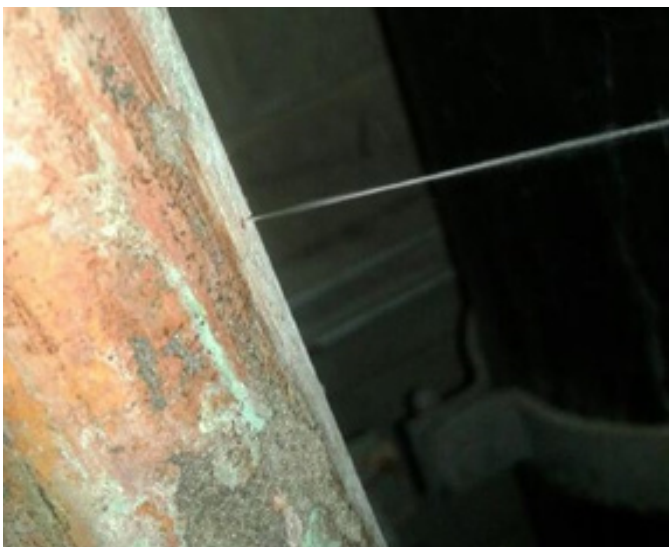
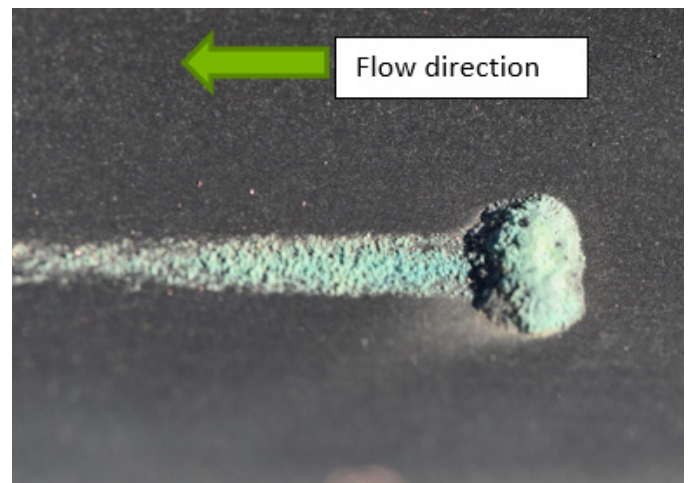
Figure 10

Typical active pin-hole leak and internal corrosion tubercle.

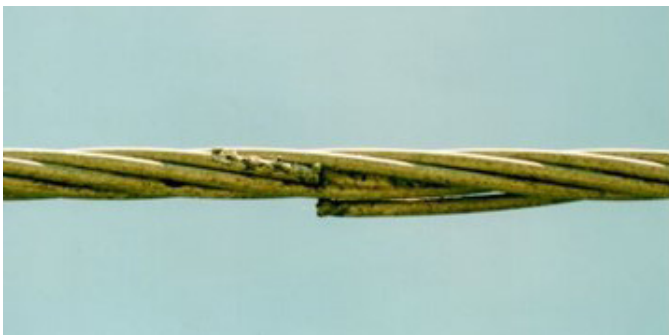
Figure 6
Neutral conductor defect.

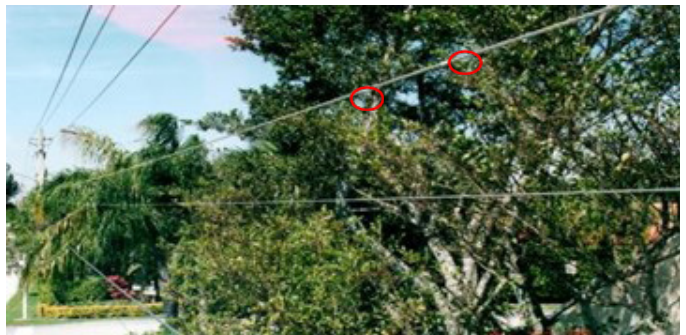
Figure 7
Two pieces of tape on 3/0 neutral conductor.
