Journal of the  
**National**  
**Academy** OF  
**Forensic**  
**Engineers**<sup>®</sup>

Vol. 39 No. 1 June 2022

‡ FE Analysis and Visual Presentation Methodology of Mechanical Systems .....	1
<i>By David A. Danaher, PE, DFE (NAFE 703F) and Sean M. McDonough, PE (NAFE 1146M)</i>	
‡ Forensic Engineering Research and Testing of Building Copper Tube Water Piping System Freeze Failures.....	13
<i>By Joseph G. Leane, PE, DFE (NAFE 524F)</i>	
+ FE Use of Arc Mapping/Arc Fault Circuit Analysis in a Residential Kitchen Fire Investigation .....	29
<i>By Jason McPherson, PE (NAFE 852M)</i>	
§ Forensic Engineering Investigation of a High-Voltage Transmission Line Anchor Shackle Failure .....	35
<i>By Daniel P. Couture, PEng, DFE (NAFE 951S)</i>	
+ Resolving Schedule Delay Claims with Forensic Analysis .....	47
<i>By Michael D. Stall, PE, DFE (NAFE 955M)</i>

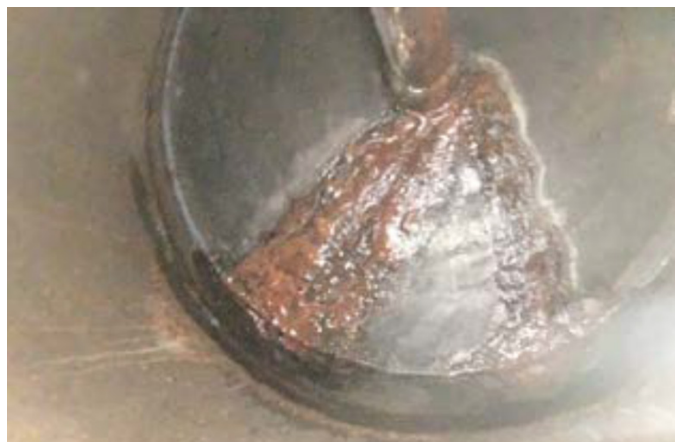
**Figure 8**  
Picture taken by the plant engineer showing the leak from the bottom cap of the SCR.

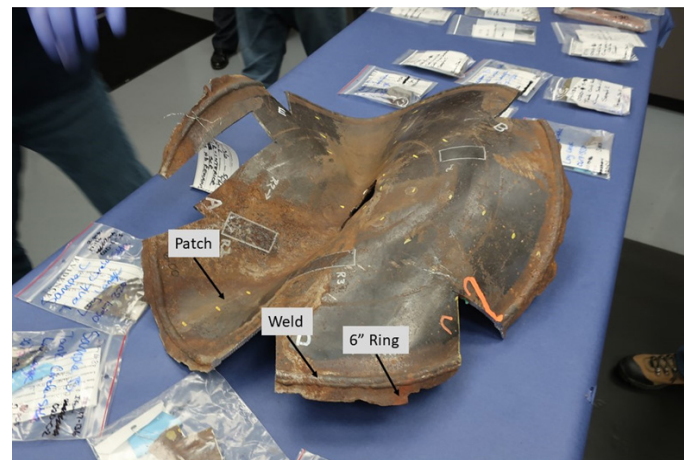
**Figure 9**  
Repaired bottom cap with the 24-inch patch after the failure (photograph taken by Kineticcorp).

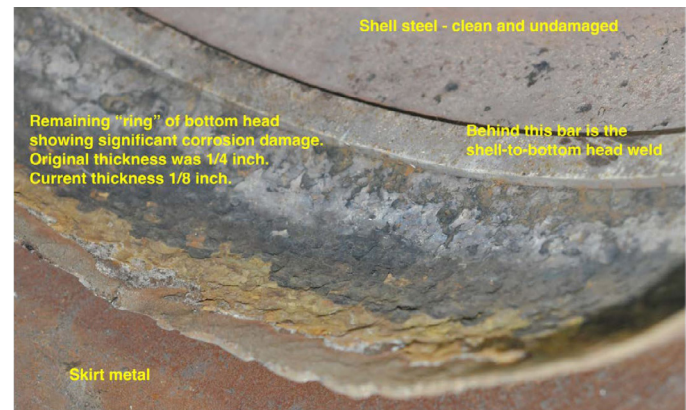
The thickness of the 6-inch ring at the time the SCR

**Figure 10**  
An image from the CSB report showing the corrosion of the 6-inch ring.

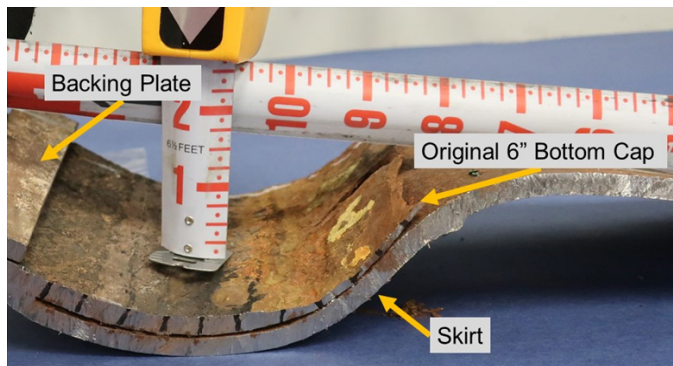
The repair to the head of the pressure vessel changed the shape. The original certified shape was a 2:1 ellipsoidal. After the repair, the shape of the head became torispherical. A torispherical surface is obtained from the intersection of a spherical cap with a torus tangent. The radius of the sphere is called the crown radius, and the radius of the torus is called the knuckle radius. The torispherical shape of the head of the pressure vessel increased the stress and reduced the safe operating pressure. **Equation 1** below is the calculation for the max allowable internal pressure of a 2:1 ellipsoidal head<sup>6</sup>, and **Equation 2** is the calculation for the max allowable internal pressure in a torispherical head<sup>6</sup>.

**Figure 11**  
Cross-section of the skirt, the original 6-inch bottom cap, and the backing plate (image taken by Kineticcorp).

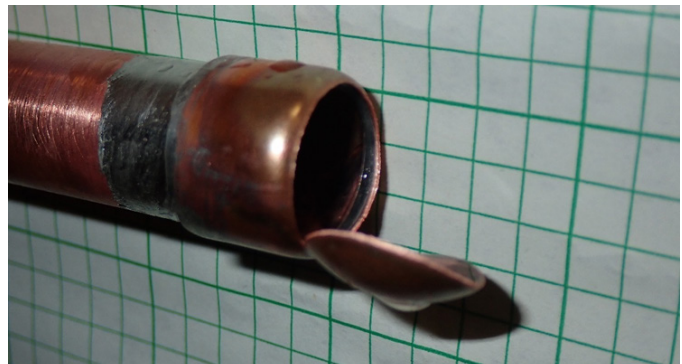
**Figure 9**  
Photo of a “fish-mouth” rupture of copper cap.

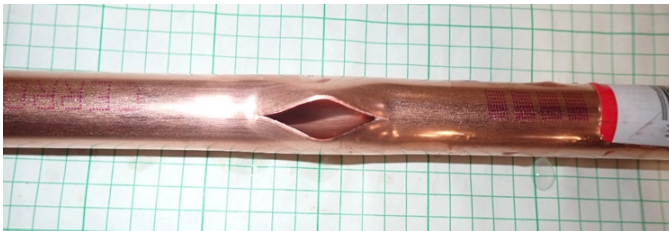
**Figure 10**

Photo of a longitudinal rupture in Type M copper tube.

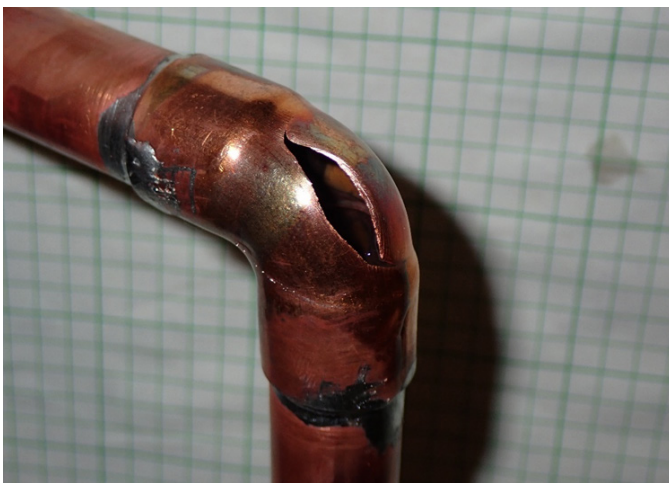
**Figure 11**

Photo of a longitudinal rupture in copper elbow fitting.

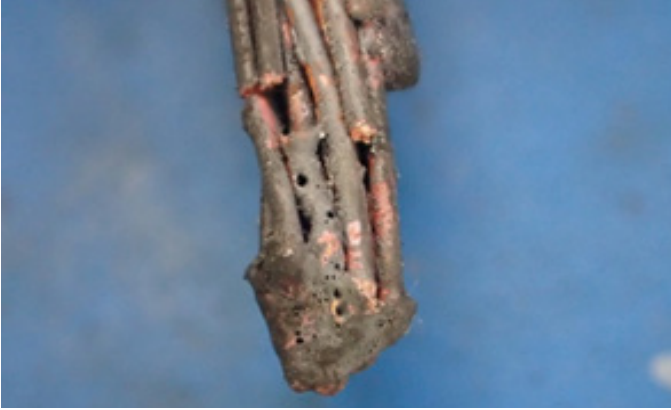
**Figure 7**  
Arc site found on range hood wiring.

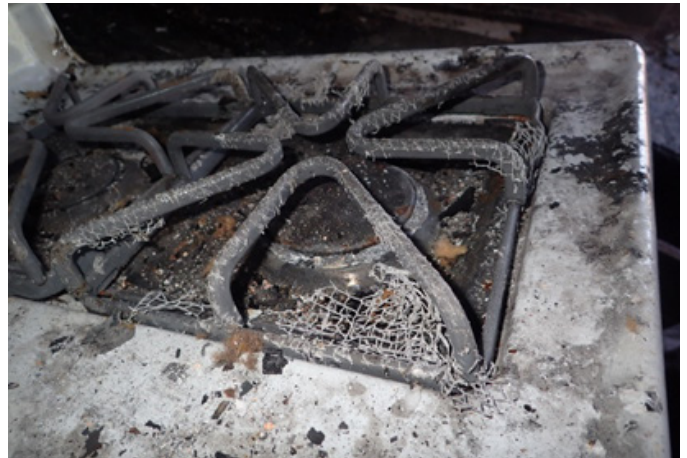
**Figure 9**  
Mesh found on right-front burner.

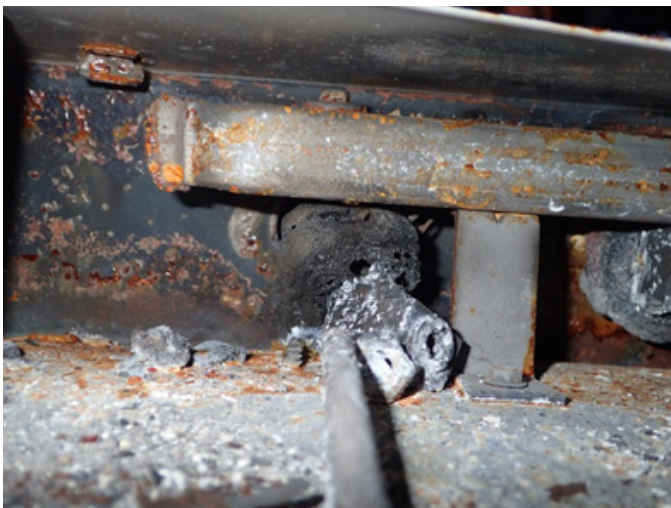
**Figure 11**

As-found position of the right-front burner control valve.

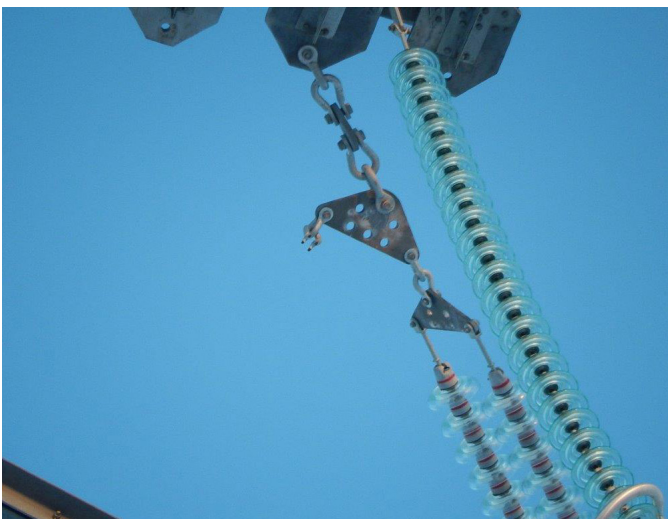
**Figure 3**  
Fractured shackle on the tower.

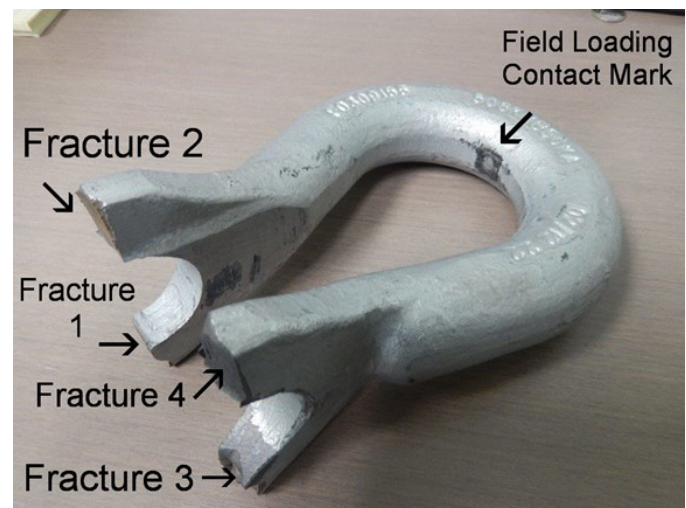
The single Number 9 anchor shackle that fractured on the transmission line is shown in **Figures 5** and **6**. Four fracture surfaces of the field failure shackle were examined with metallographic techniques on behalf of the utility and Company A by the laboratory of Company B in Europe. These fractures are displayed in **Figures 7, 8, 9, and 10**. Each fracture was individually characterized by high-power microscopy. Fracture origins were found along the inboard edge of the eye at forging laps on two of the four fracture surfaces, while the other fractures appeared to be consequential to the two primary fractures. Thirty-one shackles from Batch 2525 were examined and tested.

**Figure 5**  
Fractured anchor shackle.

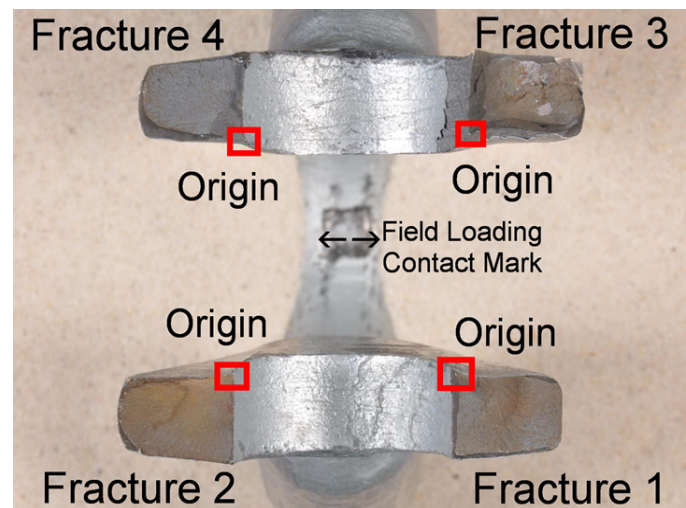
**Figure 6**  
End view of fractures on anchor shackle.

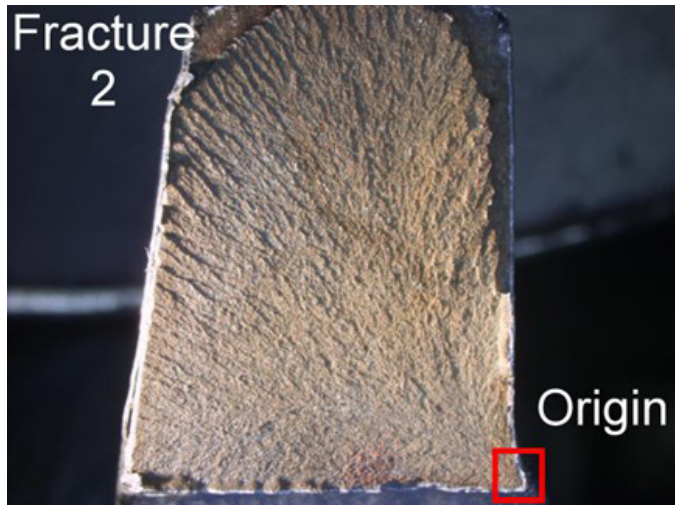
**Figure 7**  
Shackle fracture 2 at the inner eye, origin at lower right.

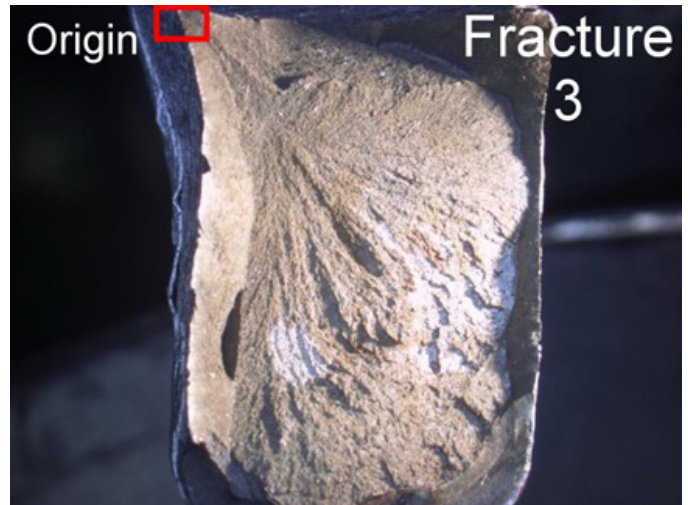
**Figure 10**  
Shackle fracture 3, origin at the inner eye on the upper left.

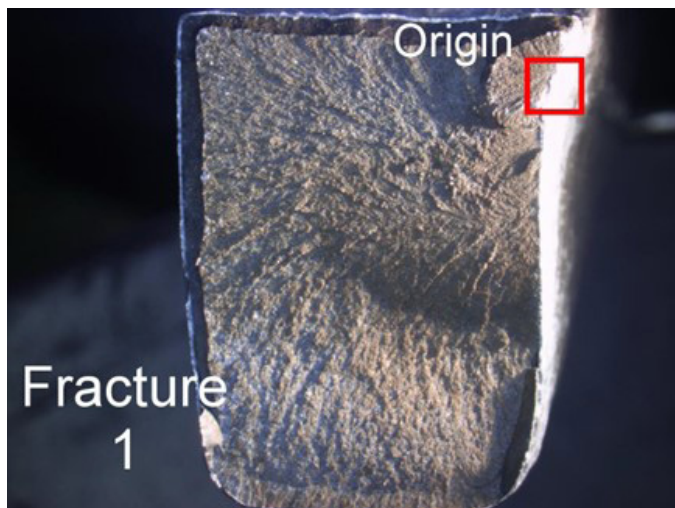
**Figure 8**  
Shackle fracture 1 at the inner eye, origin at upper right.

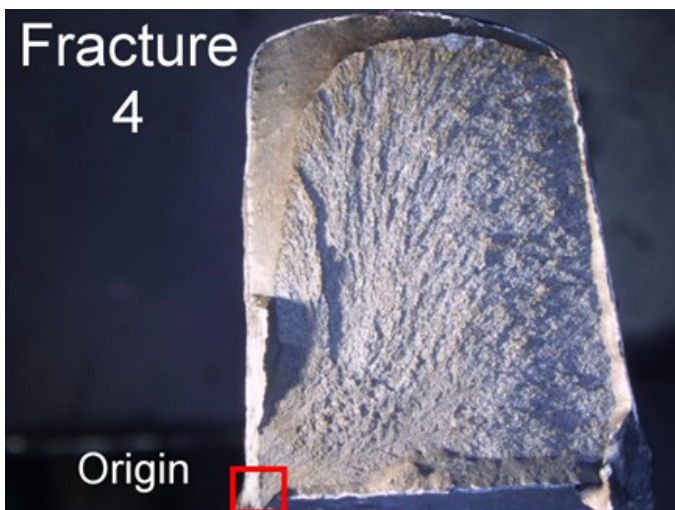
**Figure 9**  
Shackle fracture 4, origin at the inner eye on the lower left.

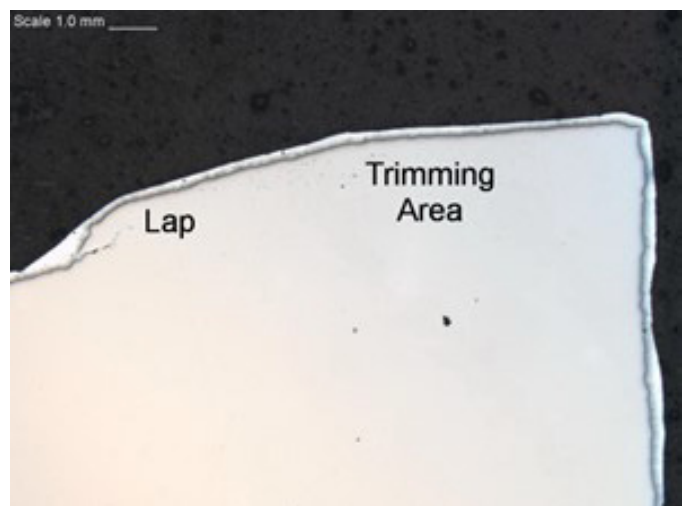
**Figure 11**  
The trimming area with underlying lap.

The essence of the Company B working hypothesis was that these forging laps, coincidental with a trimming line (Figures 11 and 12), had created the critical crack size necessary for the crack to propagate through the arm under cold weather service conditions at Fracture 1 area shown in Figure 8. The forensic engineers concurred with the first part of the hypothesis, but disagreed that the service conditions were necessarily contributory, based on prior fracture mechanics and failure analysis experience. The low alloy 41Cr4 (5140) steel has a ductile/brittle transition temperature near -100°C (-148°F), and tempered martensite does not undergo this transition. The cold weather effect hypothesis was tested with a factorially designed series of experiments developed by the forensic engineers to quantify the effect of service temperature.

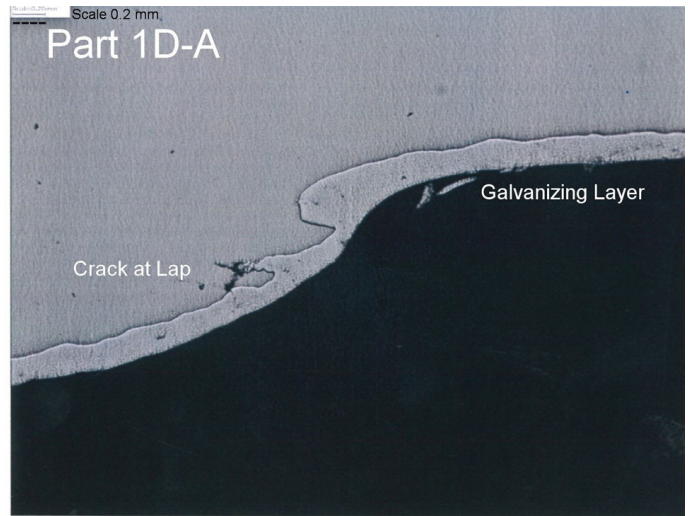
**Figure 25**  
Polished cross-section showing crack at lap in Part 1D-A.

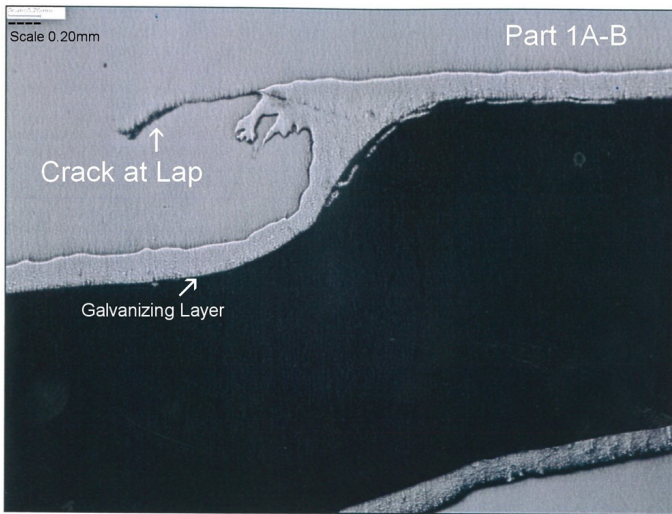
**Figure 23**  
Polished cross-section showing crack at lap in Part 1A-B.

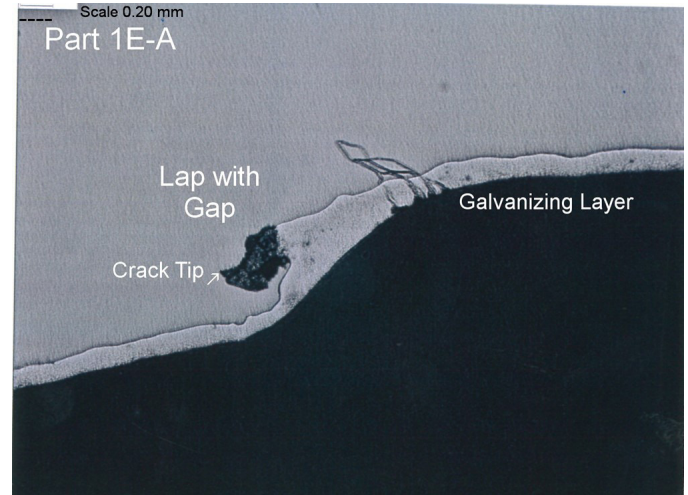
**Figure 26**  
Polished cross-section showing crack tip by gap at lap in Part 1E-A.

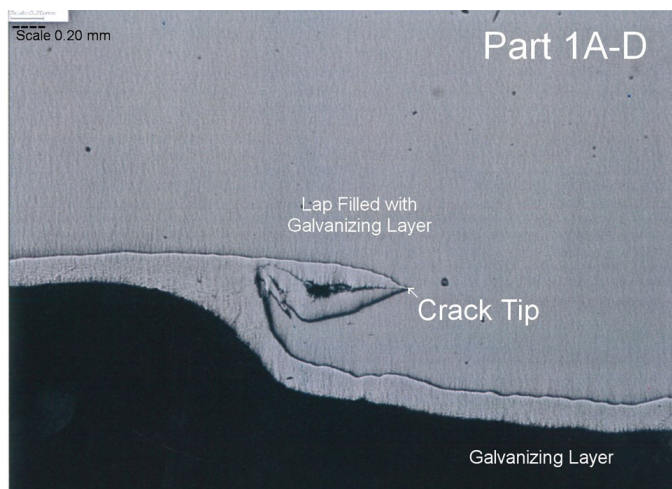
**Figure 24**  
Polished cross-section showing crack tip in Part 1A-D.

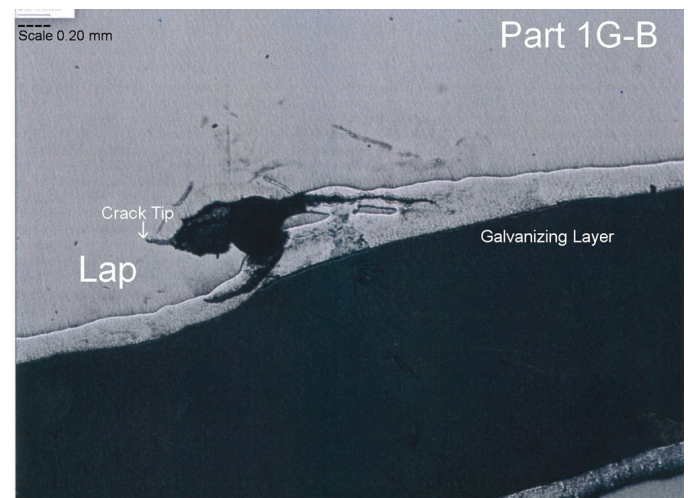
**Figure 27**  
Polished cross-section showing crack tip at lap in Part 1G-B.

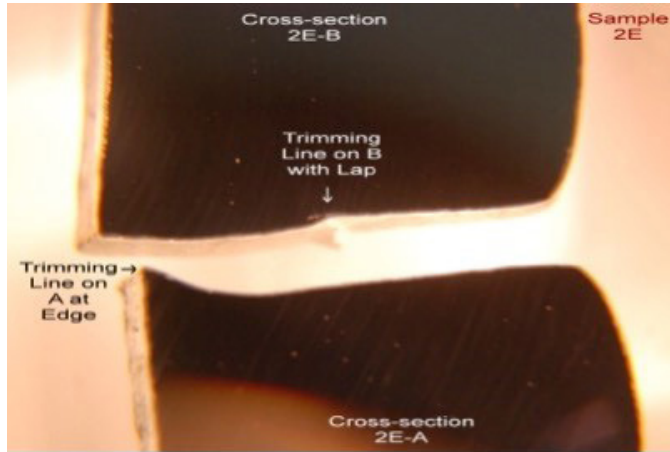
**Figure 28**

Mounted and polished cross-section of 2E-B with laps.

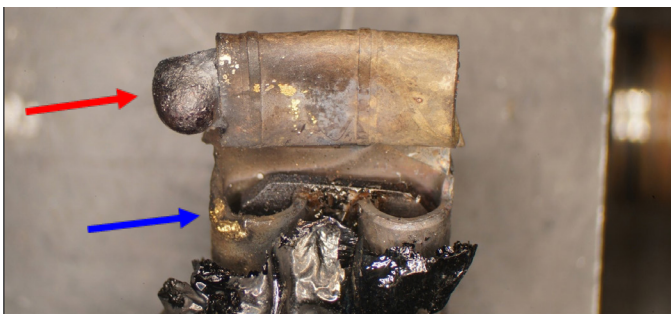
**Figure 14** shows the subject crimp from the other side. It is clear there is a melted mass where the stranded wire once exited the crimp barrel, as indicated by the red arrow. The blue arrow points to localized melting of the female brass terminal body. In all the experiments performed by this author, where OPCs were produced in the lab under various conditions, essentially no evidence of melting was observed on the metallic conductors in the connection

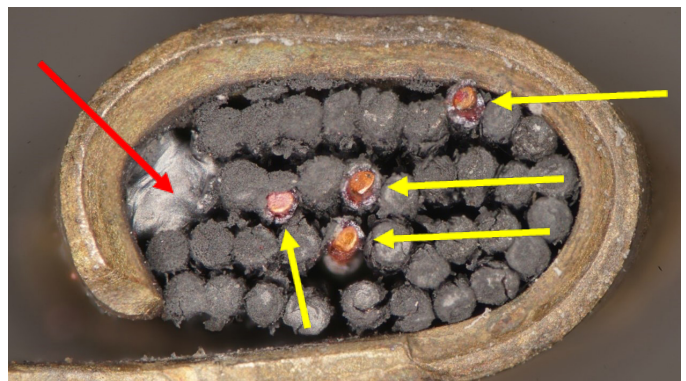
**Figure 15** shows the subject crimp at the end opposite the melted-open region. The subject crimp was improperly made because it failed to properly compress the copper strands, which can easily be seen by the large gaps between the strands. The copper strands themselves have undergone a significant amount of secondary high-temperature oxidation from the OPC. The red arrow points to a formerly liquid oxide mass, which, at some point, was undoubtedly part of the molten worm. The rippled appearance, shiny gray exterior, and engulfed strands are a dead giveaway. Surface analysis of this worm region also shows micro-sized oxide spatter droplets. The blue

arrows point to the layer of high-temperature oxidation scale surrounding the copper strands.
