Journal of the
National
Academy OF
Forensic
Engineers[®]

* Forensic Engineering Experience with Electrically Ignited Fires	1
<i>By Roger L. Boyell, P.E. (NAFE 696F)</i>	
* Forensic Engineering Analysis of an Emergency Bridge Replacement Project	9
<i>By Paul G. Swanson, P.E. (NAFE 653S)</i>

* Generalized Deformation and Total Velocity Change Analysis with Missing Vehicle Stiffness Coefficients; G-DaTAAV™	15
<i>By Jerry S. Ogden, P.E. (NAFE 561F)</i>

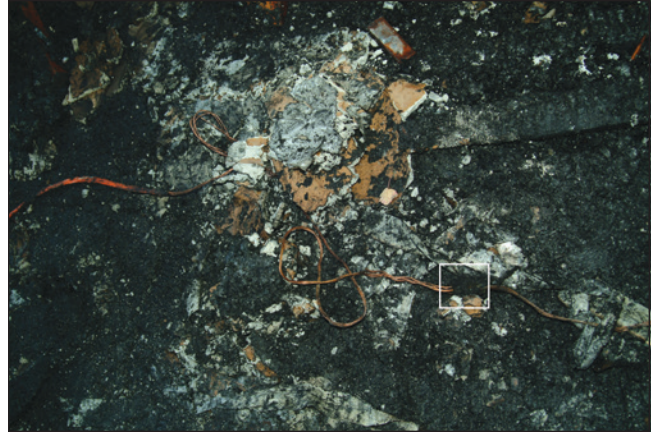
The orange jacket of the extension cord had been burned away near a plug-and-socket junction with a black power cord (lower right of **Figure 10**). The junction was encrusted with debris (right side of **Figure**

Figure 10
Plug-and-socket junction (at lower right of center).

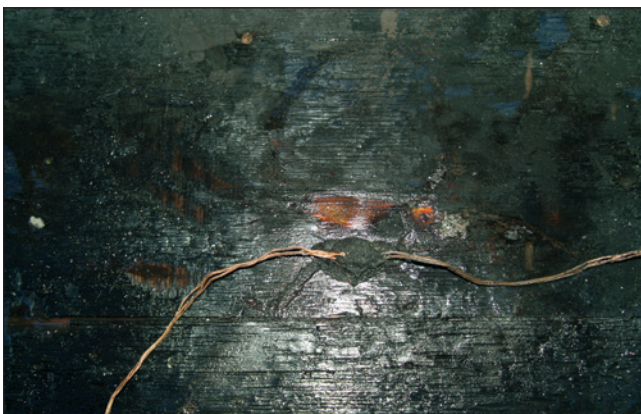
Although a winter snowstorm impeded the fire examination, the plug-and-socket junction was retained for further examination (**Figure 13**). An investigator

Figure 13
Extension cord (on the left), work light cord (on the right).

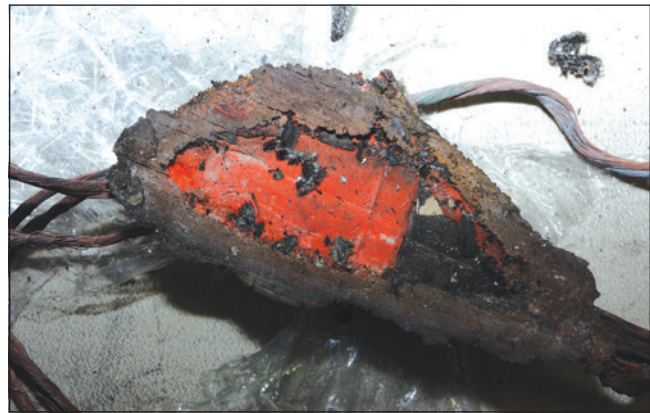
Eventually, the physical evidence was to be made available for examination. When the big day came, the extension cord and work light were unwrapped (Figure 14), and the first peek at the allegedly burned electrical junction (Figure 15) showed it to be intact and unburned. The debris that encrusted the junction seemingly protected it from damage during the fire. Engineers retained by the accused contractor opined that this physical evidence indicated the contractor's electrical equipment was not responsible for the fire.

Figure 15
Plug (black) and socket (orange) showing minimal damage.

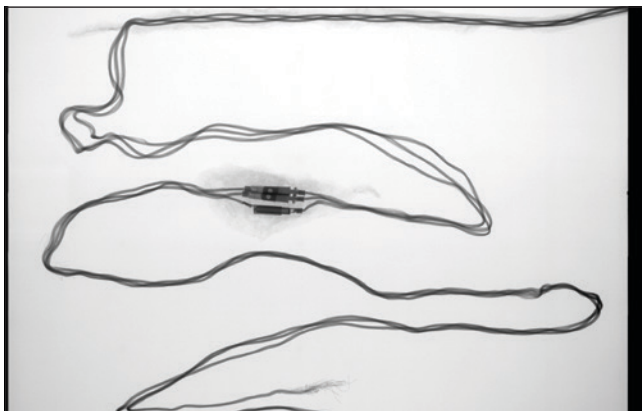
Not being deterred, the property owner's expert insisted that X-rays would show there was arcing or some other electrical damage at the junction. As a result, more time and money were spent obtaining high-resolution X-rays. Nevertheless, inspection of the resulting radiographs of the evidence (Figure 16 and Figure 17) showed that the electrical connections between the plug and the socket were perfectly normal

Figure 16
X-rays of power cords forming the junction.

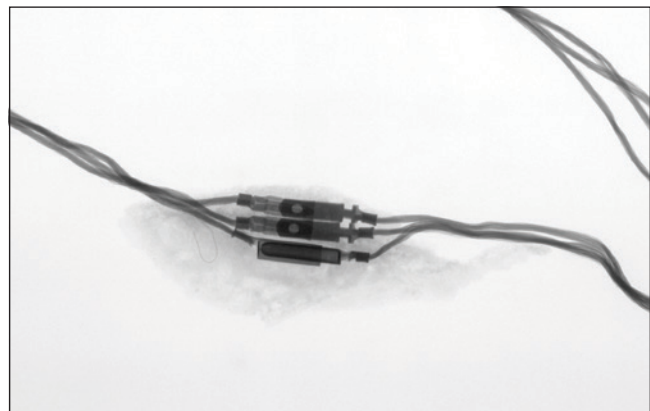
Figure 17
Enlargement showing no electrical defect.

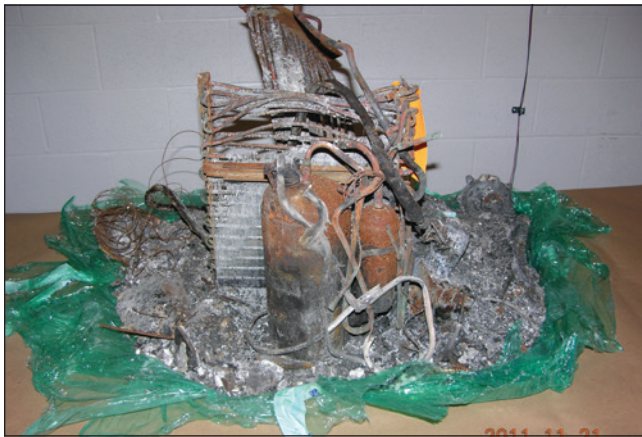
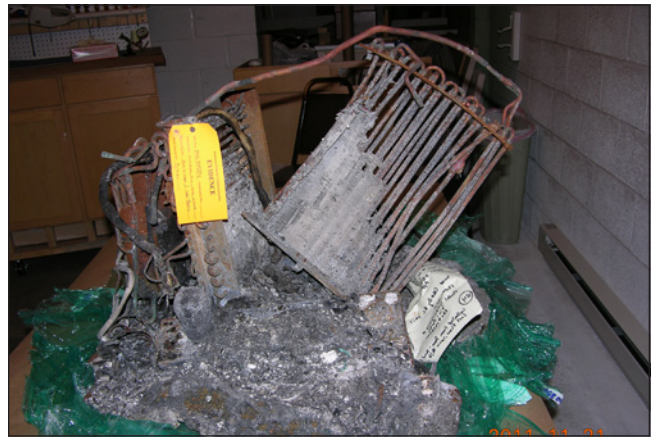
Fire investigators preserved the remains of the unit as evidence and presented them for examination (**Figure 20** and **Figure 21**). The allegation was that some electrical defect or malfunction caused

Front view of remains of room air conditioner.

Side view of remains of room air conditioner.

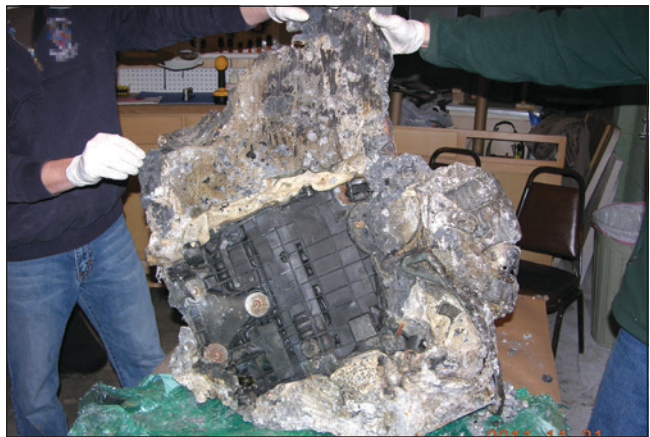
The exemplar exhibits electrical wiring, a compressor motor, and fan motors (**Figure 24**), all of which can be compared with the evidence unit to locate the presumed defect or malfunction. Upon investigation, such comparison revealed that the bottom of the evidence unit was surprisingly intact (**Figure 25**), considering that the fire was said to have begun there.

Figure 25
Underside of evidence unit showing little damage.

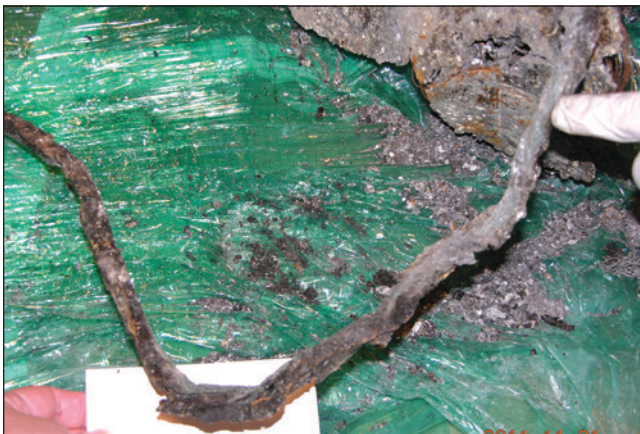
Figure 26
Power cord insulation burned away.

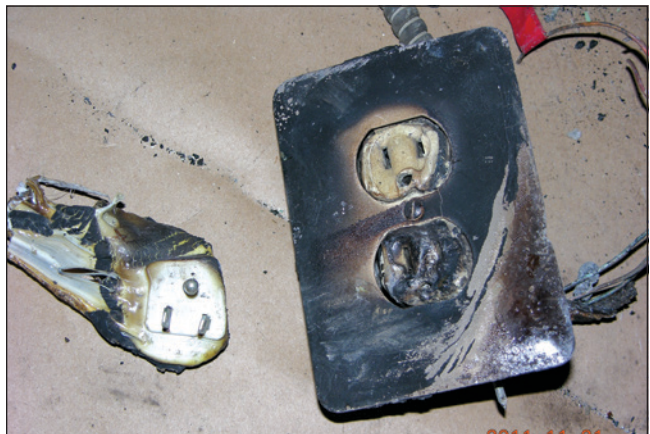
Figure 27
Plug and receptacle burned from outside in.

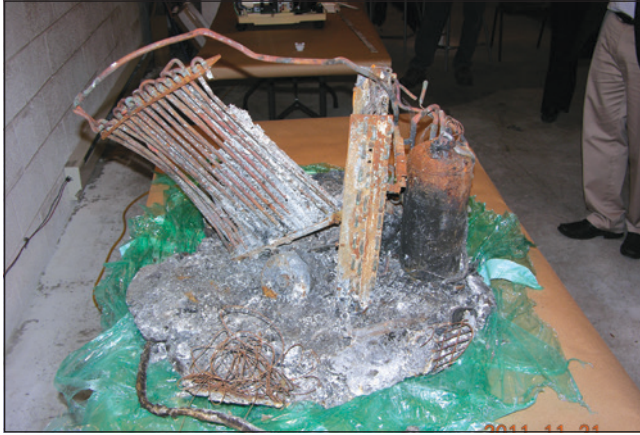
Figure 28

the air conditioner ignited first and spread to the rest of the room. It was curious, however, that the retained evidence was so thoroughly destroyed (**Figure 28**). It appeared as if a blowtorch had been applied to the unit rather than it being consumed in a plastic or wood fire. There was no damage pattern typifying a localized electrical event. Perhaps the air conditioner was merely a victim of the fire that had started elsewhere.

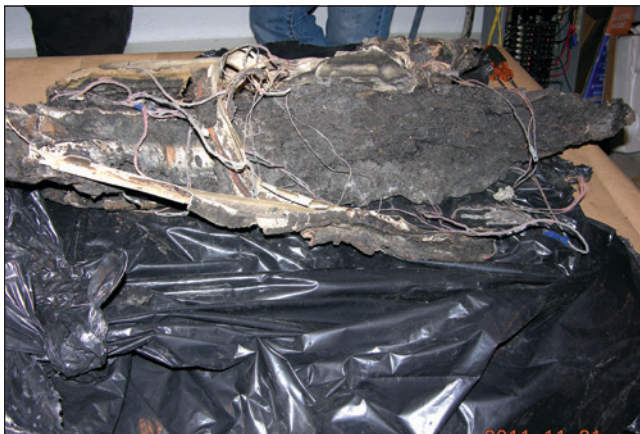
Figure 30

Inadequately preserved debris from front window.

This alternative hypothesis of the air conditioner being the victim could not be disproved, because investigators on the scene had not considered the origin to be on the porch. Little material was retained from outside the window of the room, and that material was not well preserved for examination (Figure 30).

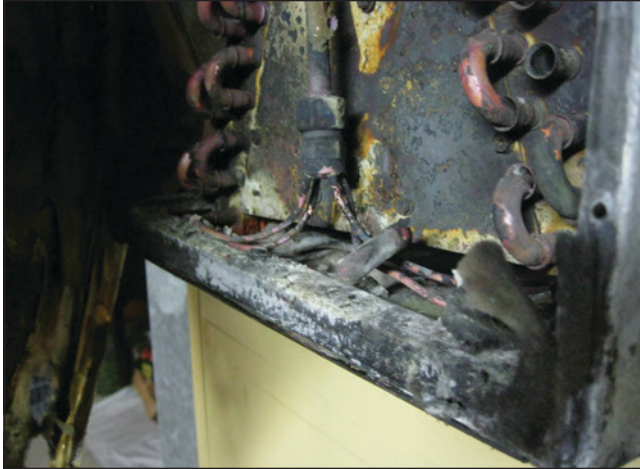
Figure 6
Heat-damaged evaporator coil and condensate pan.

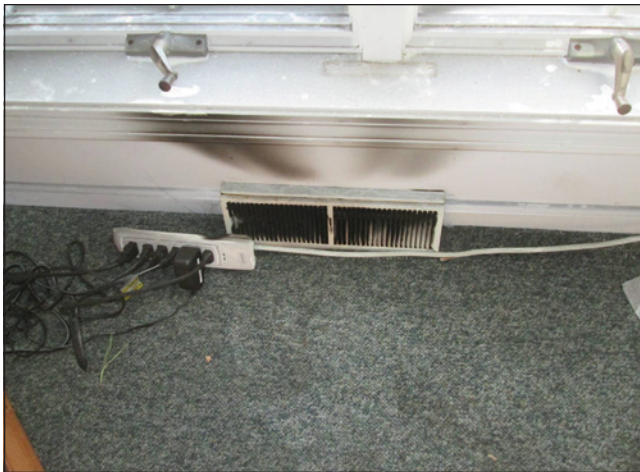
Figure 7
Soot damage.

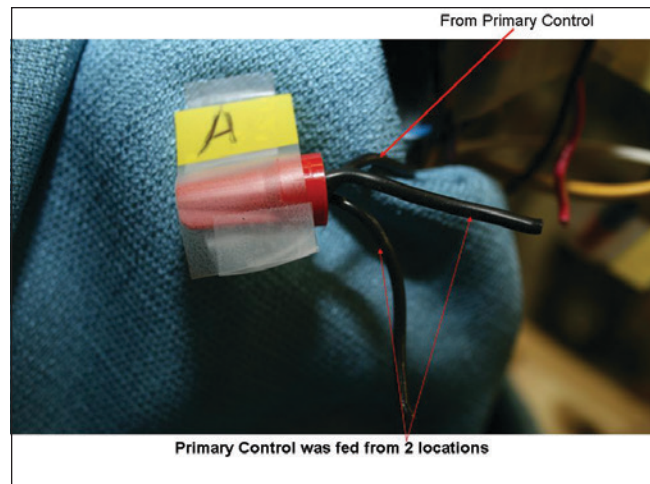
Figure 16

With this wiring configuration, the furnace burner could be energized upon a call for heat from the thermostat, regardless of the temperature being generated by the burner without the safety feature of the high limit controller. The extra power supply wire is shown in **Figure 16**.

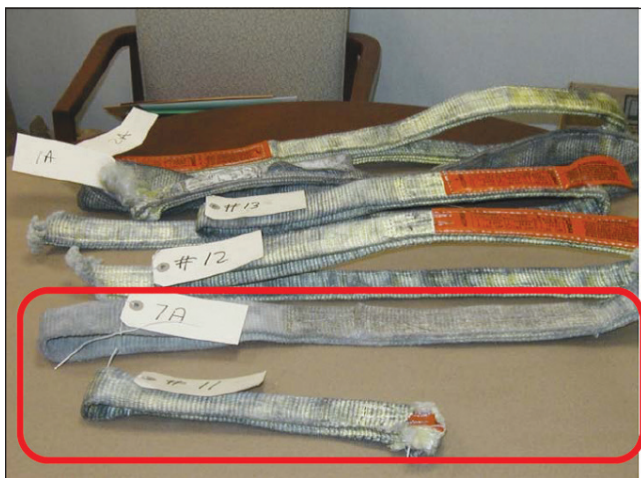
Figure 12

The highlighted faded sections should be regarded as UV-degraded based on the report’s criteria. Color fading was used to evaluate the Ex_Lift.

The retrieved section of the All_Lift slings showing the faded characteristics versus bleaching of the sling.

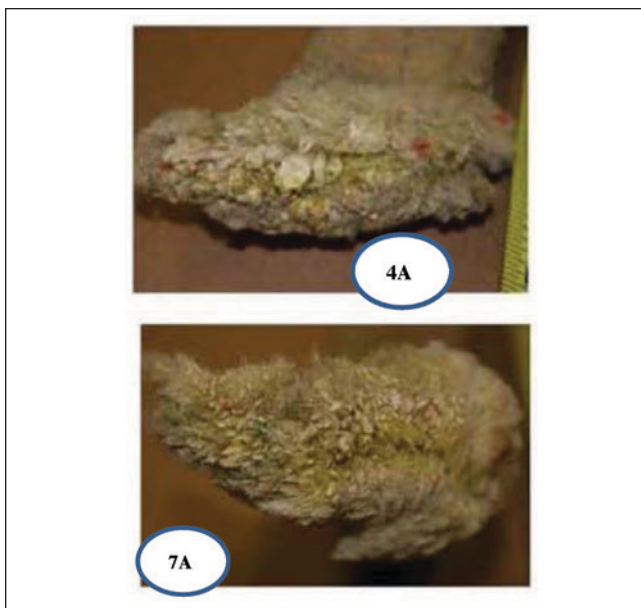
Figure 27 shows the sheared failure surfaces of All_Lift sling sections 4A and 7A. The failure process is similar to that of **Figure 26**, sling section 2A.

Figure 27
Sheared surfaces of All_Lift sling pieces 4A and 7A.

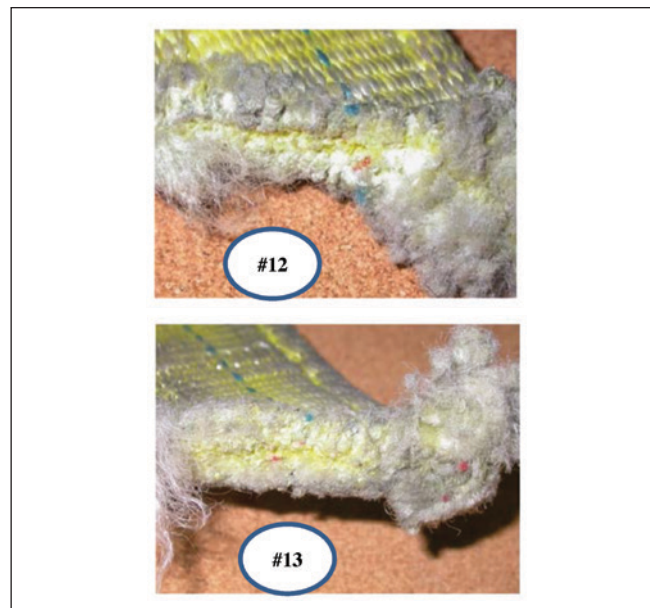
Figure 28 below shows section #12 and #13. The melted fibers are visible and stands in contrast to the frayed fibers located toward the edge of the sling sections.

Figure 28
Two All_Lift sling sections #12 and #13. High-speed shear failure process is predominant in both sections.

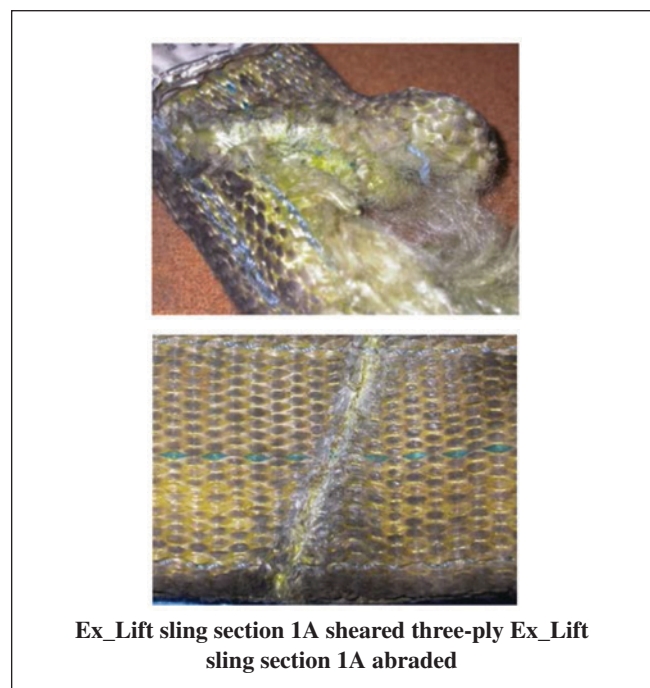
Finally, **Figure 29** shows two failed sections of the Ex_Lift sling. The top section is the three-ply shear failure surface, and the bottom section is the high-speed abrasion resulting from contact between the sling

Figure 29
Above is the Ex_Lift sling section 1A, a three-ply adiabatic shear failure with melted fibers. Below is the Ex_Lift sling section 1A with adiabatic abrasion damage.

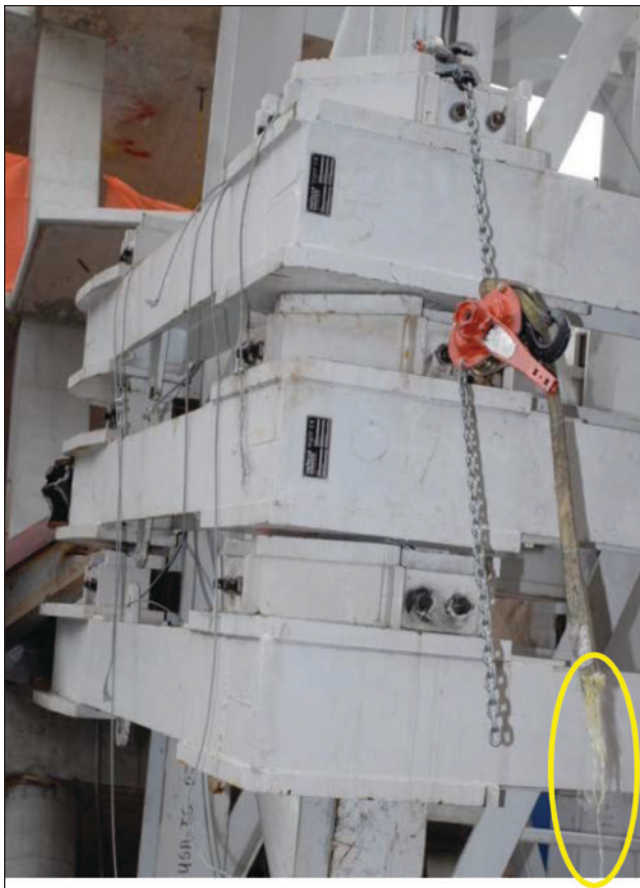
Several incident site photographs were reviewed to determine where sling sections were located just prior to the incident. **Figure 30** shows the SW (southwest) corner of the collapsed crane tower. Suspended from the crane tower section is the Ex_Lift sling 1A attached to the lever hoist.

Figure 30
SW corner with Ex_Lift sling 1A. Visibly extended fibers are evidence of slow-speed failure.

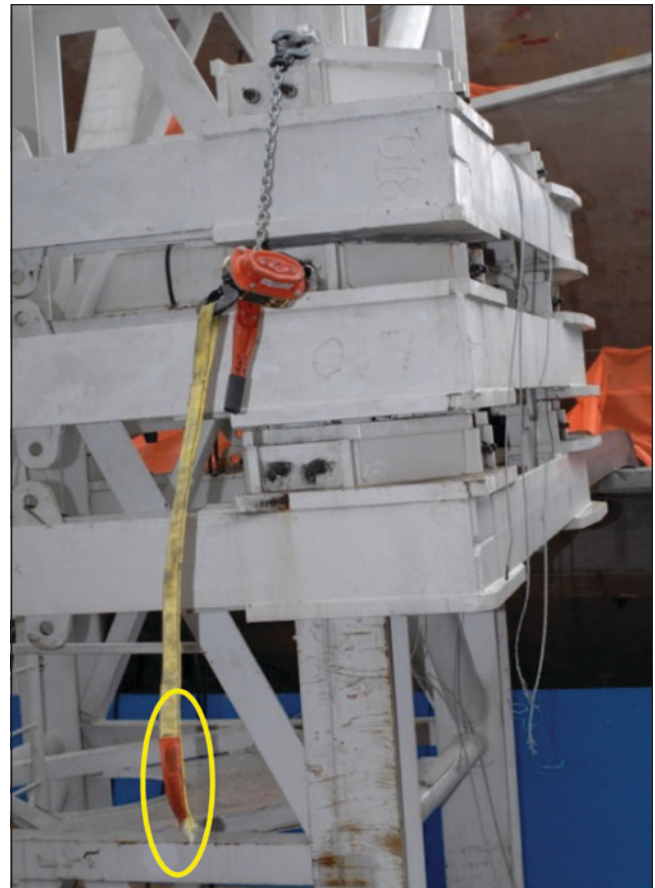
In **Figure 31**, All_Lift sling section 2A is suspended from the collapsed tower. This section combines with All_Lift section 11 to form a complete sling. Note: This sling was the only All_Lift to have been damaged at the red identification tag. In **Figure 32**, sling #12 and #13 identification tags are intact and undamaged.

Figure 31
SE corner with All_Lift sling 2A. Extended fibers are evidence of some slow-speed failure as well.

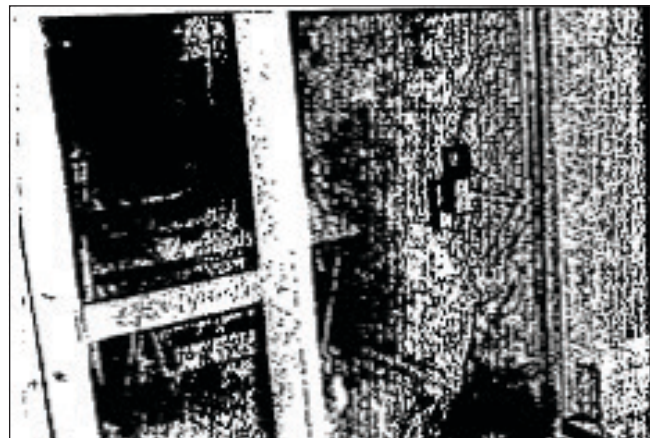
Figure 5

The poor photographic reproduction shows the glass panel as viewed from the outer lobby entrance. The shards of glass still remaining in the frame can be barely observed.
