Journal of the
National
Academy OF
Forensic
Engineers[®]

Vol. 39 No. 2 December 2022

FE Investigation into Manufacturing- and Design-Related Issues Contributing to the Failure of a Climbing Treestand

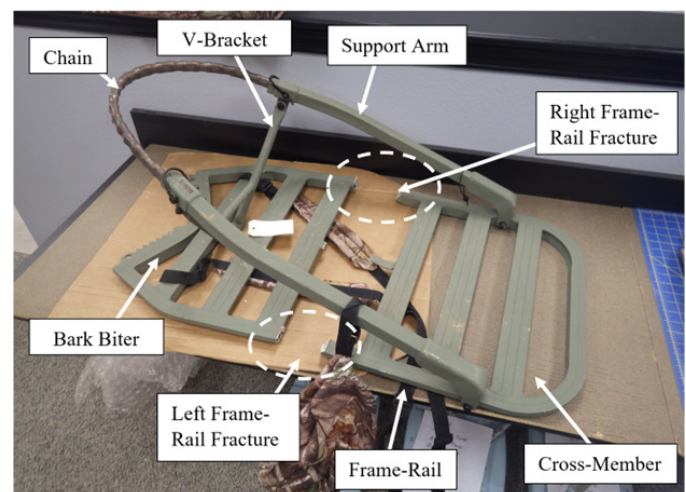
Figure 2

Photograph showing overall foot section of treestand with circles indicating failure locations.

The frame rail for the foot section of the treestand fractured at both the right and left sides of the frame rail (approximately halfway between the contact point with the tree and support arm). The bolt, which is used to connect the “V-bracket” to the support arms, was also fractured with its tab plastically deformed.

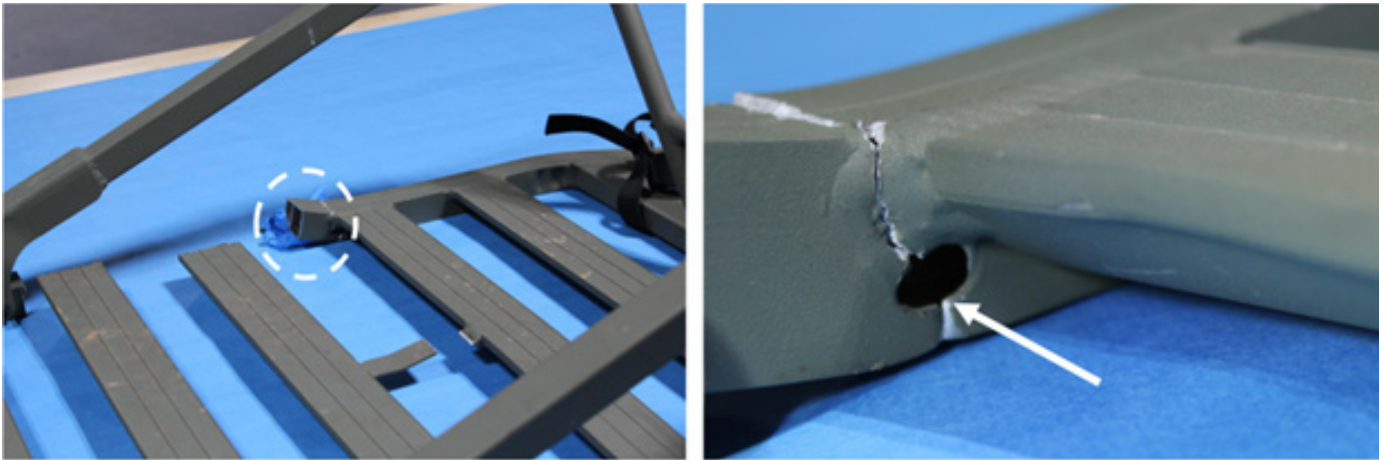
Figure 3

Closer examination of these three failure locations on the foot section revealed the presence of a $\sim\frac{1}{4}$ -inch hole near a fillet welded cross-member connection to the frame rail (**Figure 3**). This hole, which appears to have been caused by improper welding during manufacturing, was located approximately 0.18 inches from the bottom of the frame rail adjacent to a weldment connecting the cross-member to the frame-rail.

Photograph of the left frame-rail fracture in the treestand’s foot section (left) and close-up of the hole (right), showing failure origin and direction of failure.

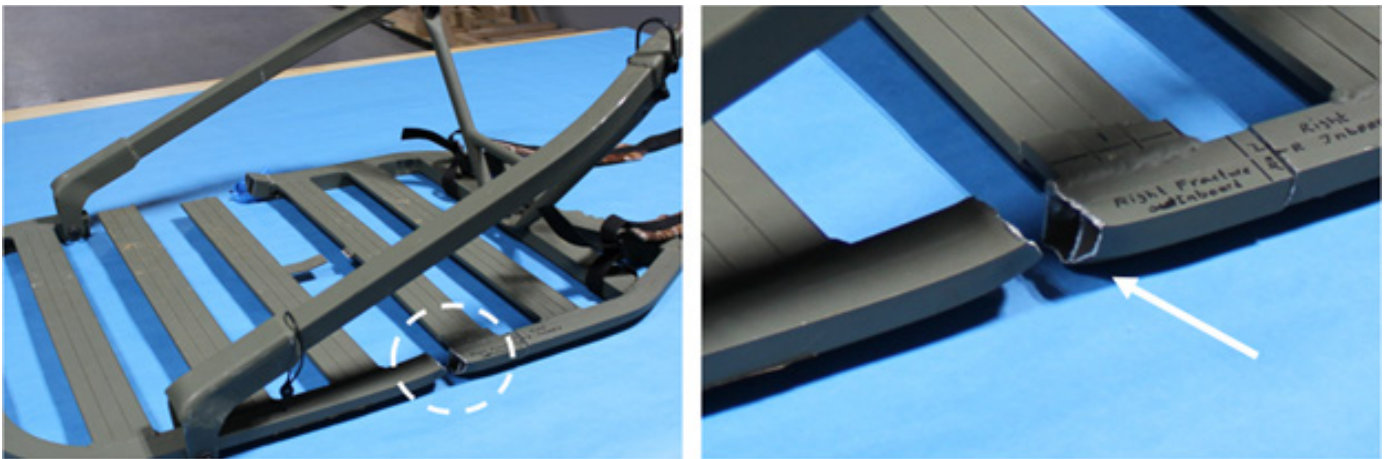
Figure 4

hole is) would be subjected to tensile bending stresses during normal usage of the device when the user is standing at the center of the platform. The presence of a $\sim\frac{1}{4}$ -inch hole in the portion of the frame railing subjected to tensile bending stresses resulted in increased stresses (due to stress concentration effect of a hole) that exceeded the material’s strength, causing the failure observed in **Figure 4** and **Figure 5**.

Photograph of the right frame-rail fracture in the treestand’s foot section (left) and close-up of the fracture (right).

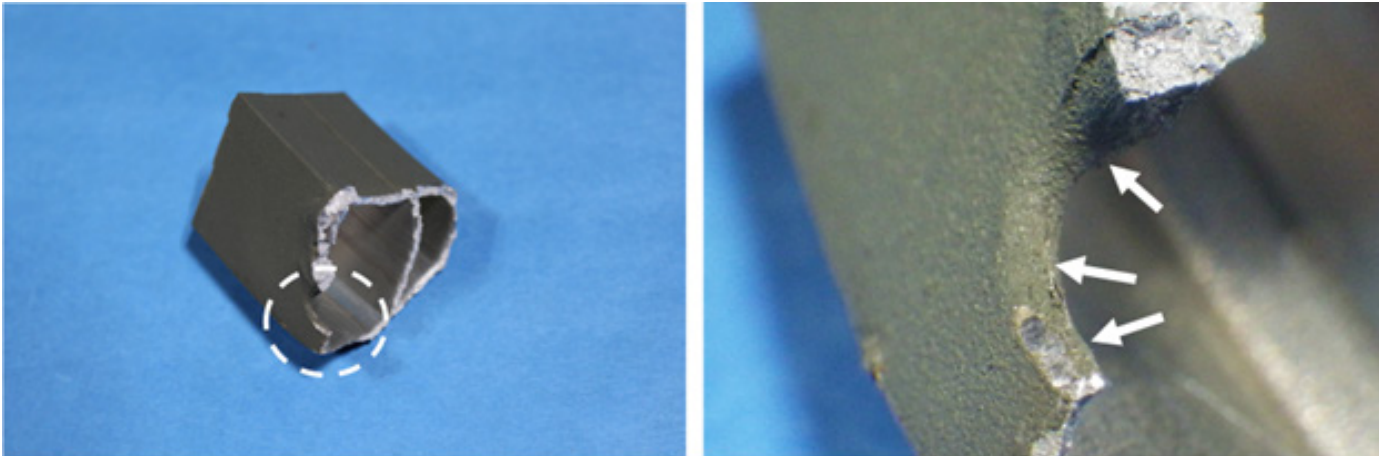
Figure 6

Overall (left) and close-up (right) of the failure area, showing the presence of protective coating around the periphery of the hole, indicative of hole being present prior to the application of coating.

To assess the stress-concentration effect of the discovered ¼-inch diameter hole (**Figure 6**) on magnifying the tensile stresses present in the side rail under the weight of the user (~200 lb), a finite element analysis (FEA) model of the treestand was created. A mesh sensitivity analysis was performed to arrive at the optimum mesh size for this analysis. The boundary conditions for the FEA model consisted of geometrical constraints where the foot platform is attached to the tree and supported by the support arms, as indicated by the white squares (**Figure 7**). The total weight of the user (200 lb) was equally distributed on the cross-members where the user would have been standing, as shown in **Figure 7**. The FEA model was run in a com-

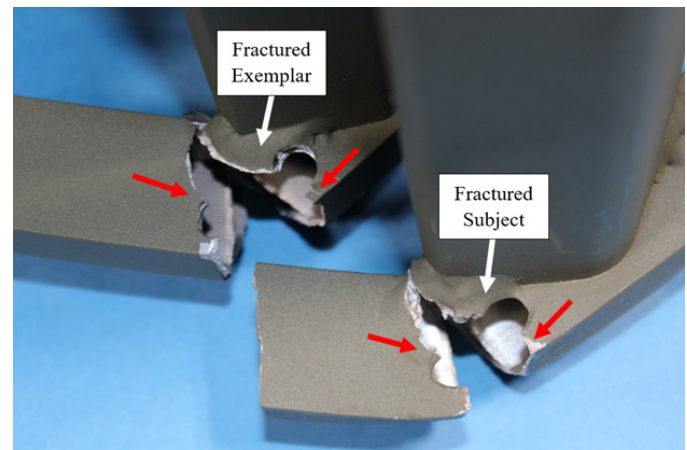
Figure 10

Near identical failure features between exemplar and subject treestands as evidence of the validity of experimental setup and procedures.

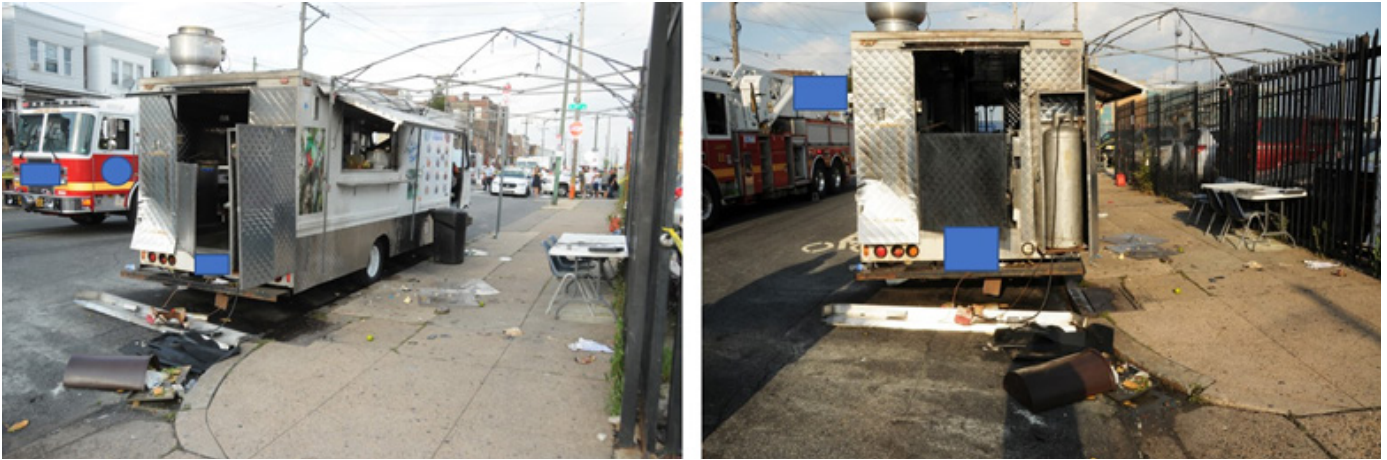
Figure 10
Images of the rear of the food truck post-incident. The left cabinet and cylinder were missing.

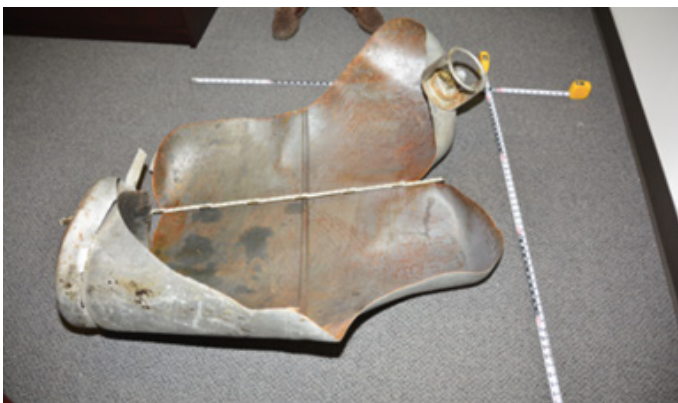
Figure 15
Left cylinder. The cylinder was ruptured, and the cylinder valve had no relief valve or fixed maximum liquid level gauge.

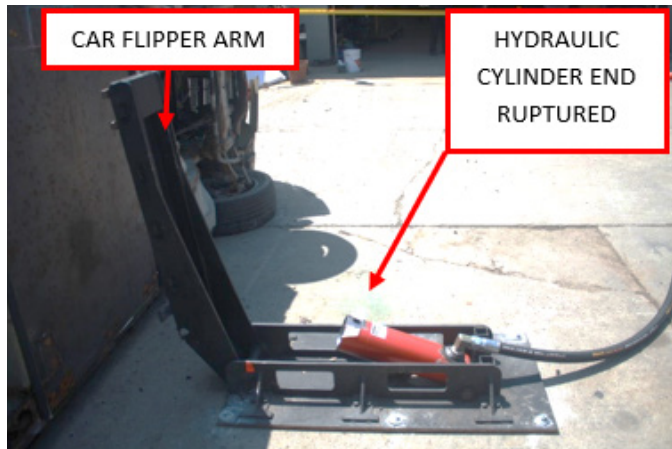
Figure 2 is a photograph of the car flipper after failure showing the location of the ruptured end cap, and **Figure 3** provides a closer view of the rupture. **Figure 4** and

Figure 2
Close of car flipper after failure.

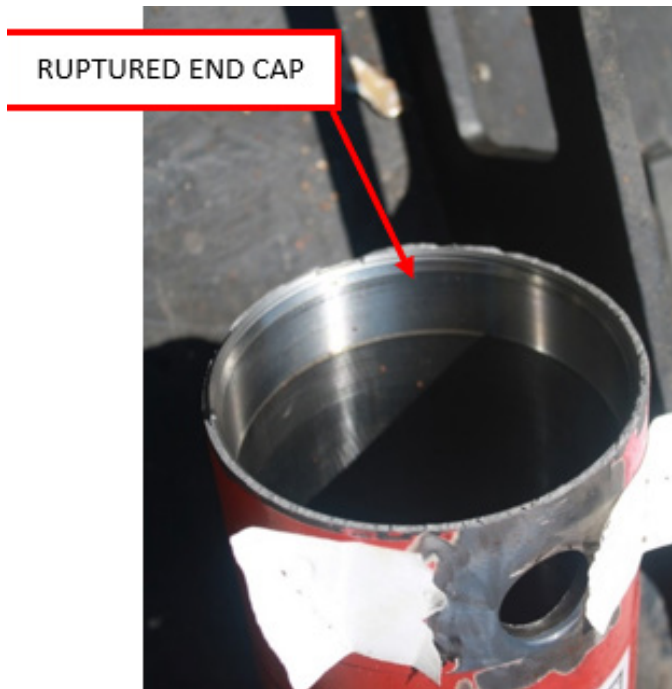
Figure 3
Cylinder end where cap was severed.

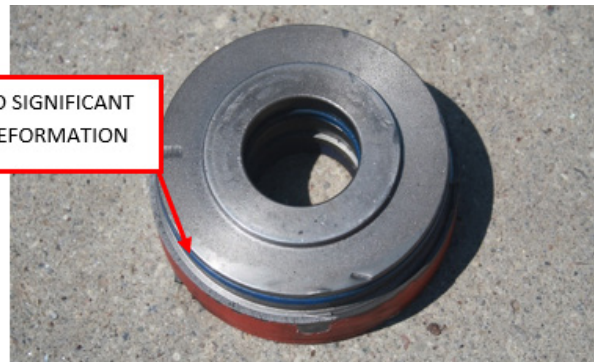
The design of the cylinder did not have a damping mechanism to attenuate the impact of the piston head and piston rod. The kinetic energy of the piston head and piston rod was absorbed by impact with the cylinder end cap. The hypothesis tested in this investigation was whether the piston and rod were moving with sufficient velocity such that their kinetic energy was adequate to result in a rupture of the cylinder as shown in **Figure 6**. The piston rod also

Figure 4
Inside of piston head after incident.

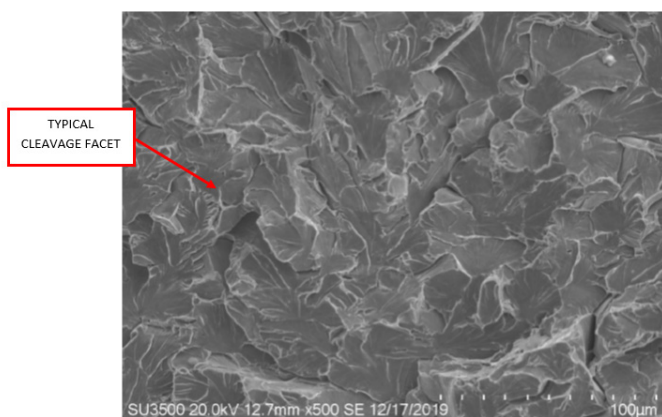
Figure 19

Cleavage facets on majority of fracture surface.

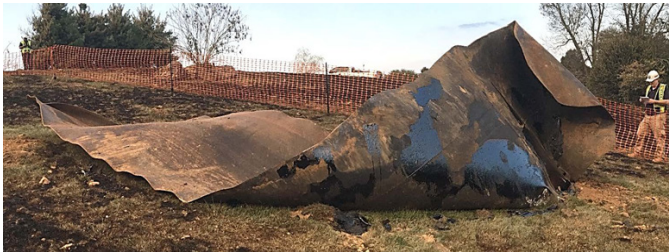
Examination of a segment of the ejected pipe section (**Figure 5**) revealed the presence of chevron marks that were utilized to identify the failure origin (**Figure 6** and **Figure 7**). The failure origin was located 90 inches from a girth weld at approximately the 4 o’clock position of the pipe (seam weld at 12 o’clock). Corrosion pitting was also

Figure 5
The 33-foot-long segment of pipe that was ejected as a result of the explosion⁴.

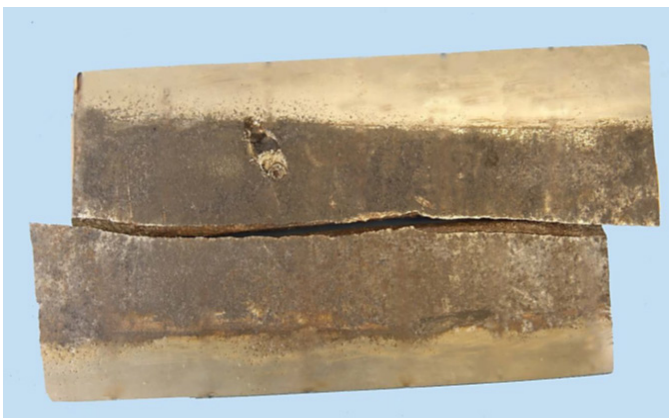
Figure 6
Sectioned segments of the pipeline at the failure origin⁴.

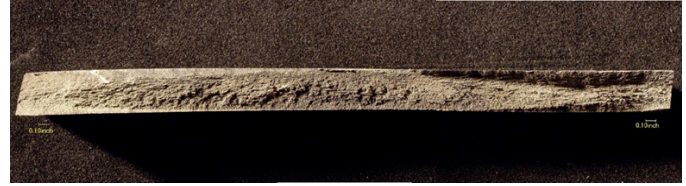
Figure 7
The fracture surface of the pipeline at the failure origin⁴.
observed near the failure origin and throughout the surrounding area.

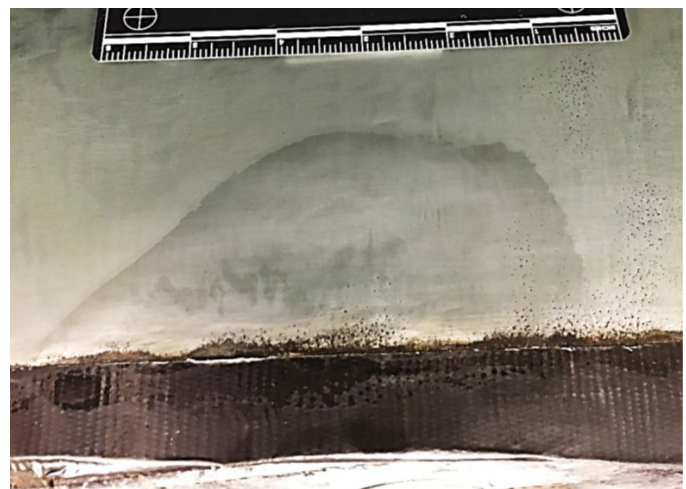
Figure 9
Close-up of the polished and etched surface near the failure origin. Note the presence of the darker region where high hardness values were measured, as shown in **Figure 10**⁴.
