Journal of the
National
Academy OF
Forensic
Engineers[®]

Vol. 40 No. 1 June 2023

Forensic Analysis of a CNC Lathe Window Guard Failure

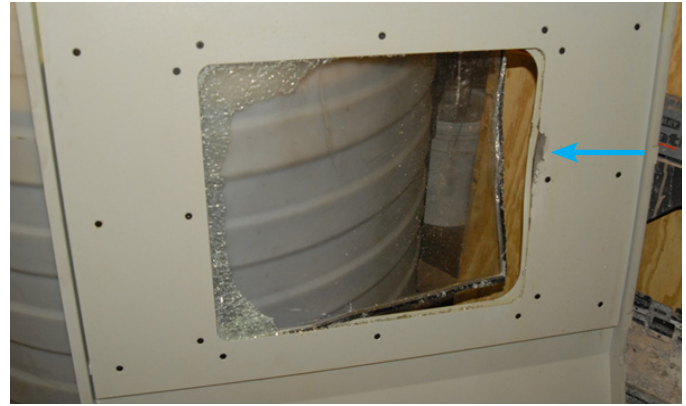
Figure 2

Interior side photograph of the detached door guard showing the interior-side tempered glass fragments of the shattered inner window pane and the witness mark damage against the steel frame.

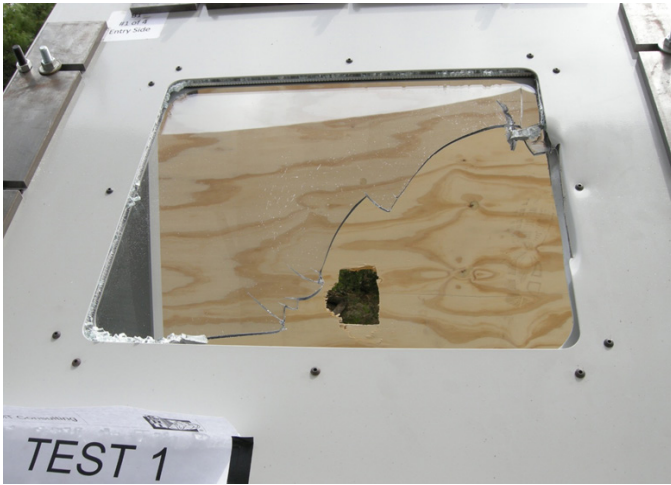
Figure 6

Test 1 — photograph of the door from the inclined impact side, post-test, showing impact damage similar to that shown in **Figure 2**.

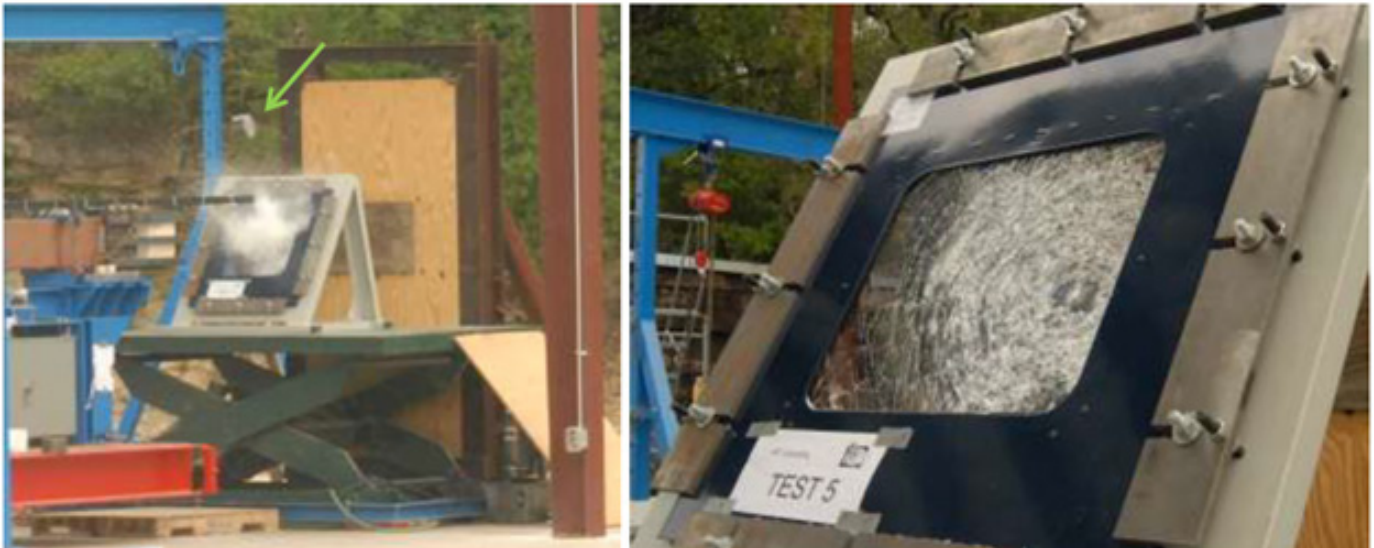
Figure 11

Test 5 – European market CNC lathe window using 12-mm polycarbonate pane.

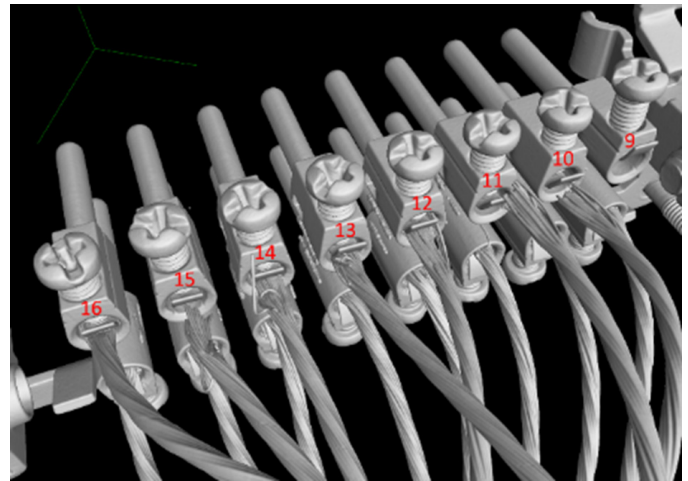
Figure 6

Top view of 3D CT scan of the subject platform control console cable connector. Numbers in red have been added to identify individual pins. Pins 1 through 8 (not numbered, located below pins 9 through 16 in this view) appeared fully secured within the screw terminals. Pins 10 to 15 were loose and withdrawn from the screw terminals. Pin 9 was left empty and had no corresponding wire.

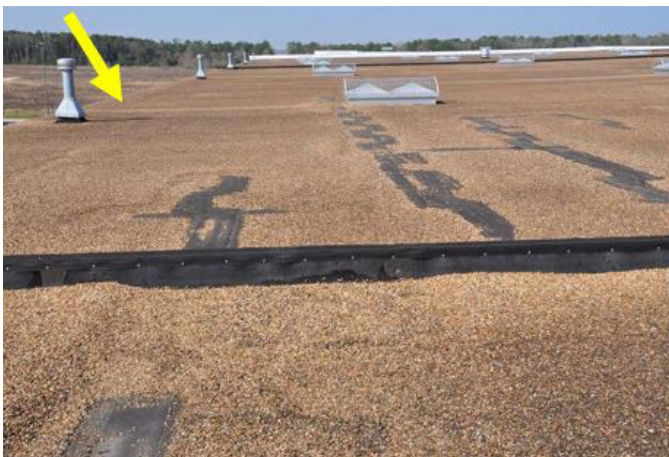
Figure 2
Fractures in the roofing membrane running parallel to the south side of the warehouse. The arrow points to the south edge of the roof.
