Journal of the
National

DOI: 10.51501/jotnafe.v40i2

| φ Factors to Consider in Developing Conceptual Scopes of Repair for Common Low-Slope Roofing Assemblies | 11 |
| υ Investigation and Root Cause Analysis of Transformer Metering Destruction by Arc Flash | 33 |

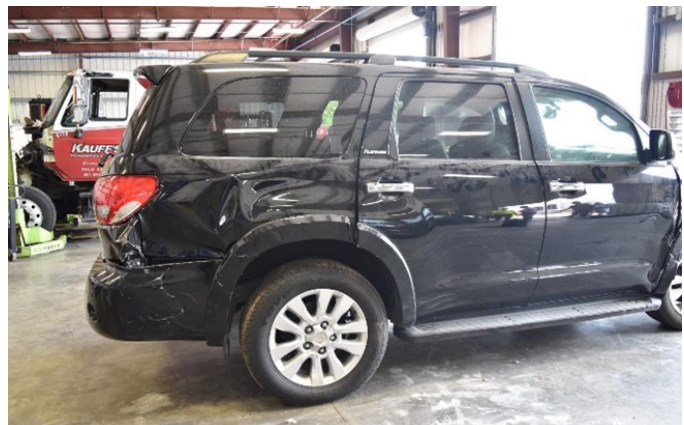
Figure 3

Damage to right side front of Vehicle A was consistent with the EDR data.

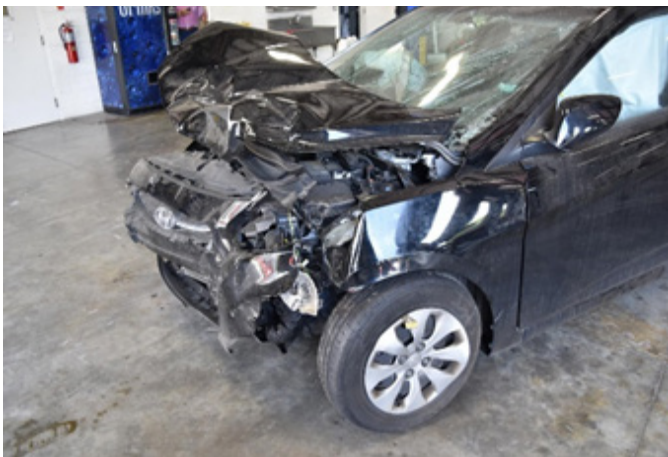
Figure 5

Damage to left front of Vehicle B was consistent with the EDR data.

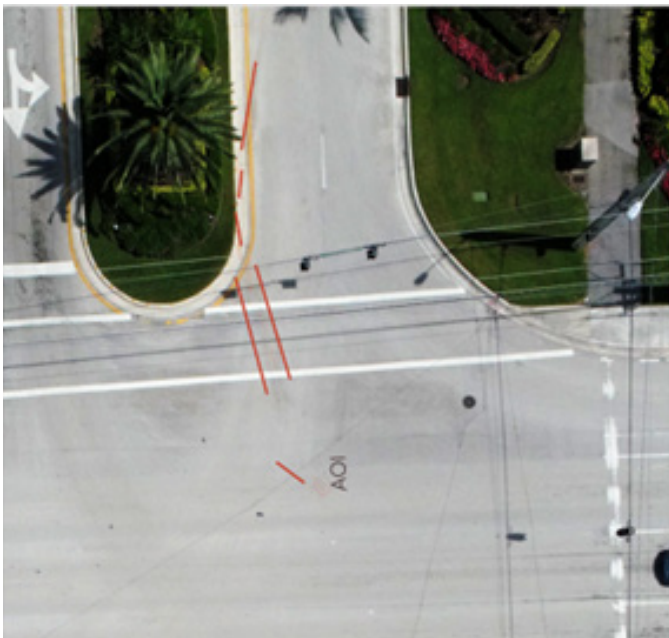
Figure 7

UAV aerial image of the intersection showing physical evidence.

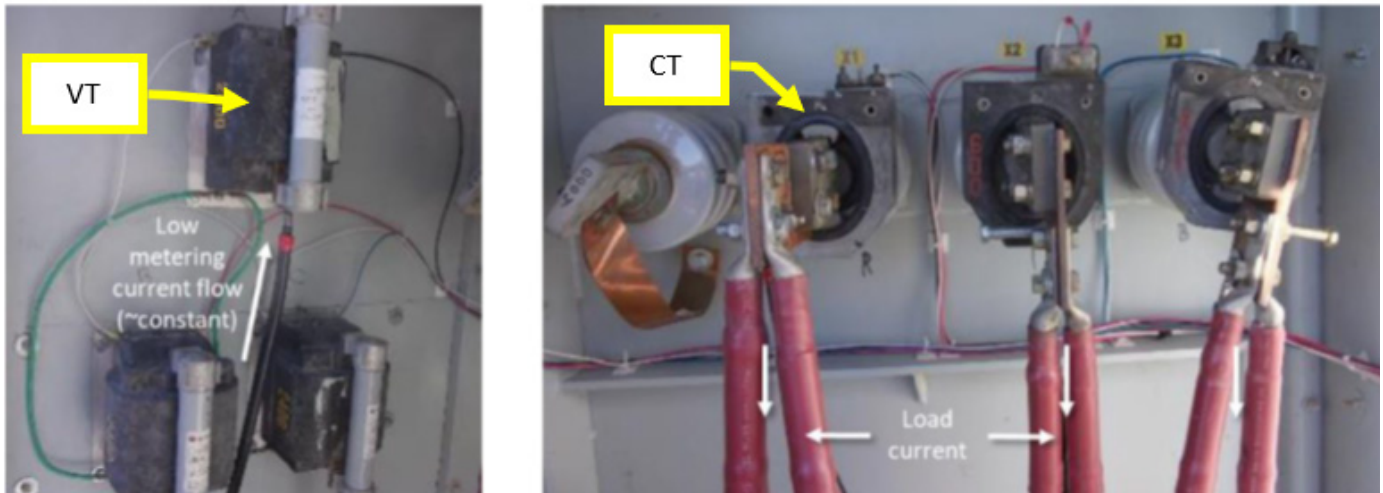
Figure 1
Newly installed VTs and CTs inside secondary compartment.

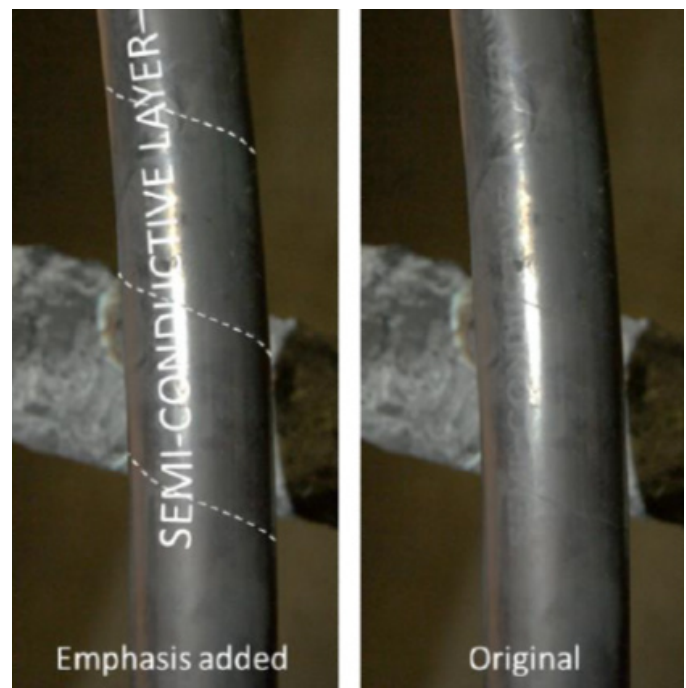
Figure 7
Faulty VT cable as installed.

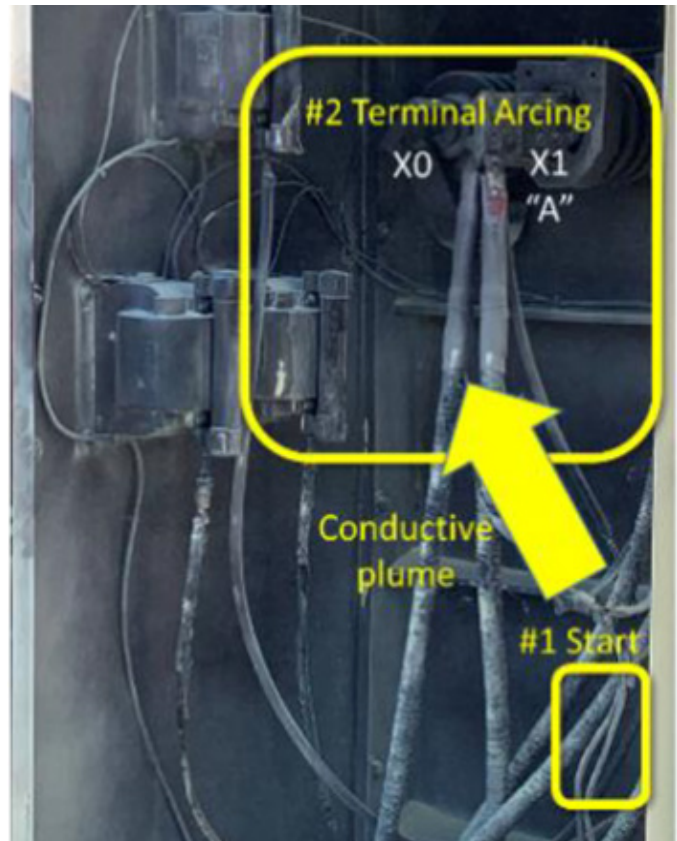
Figure 8
Arc flash propagation most-likely sequence.

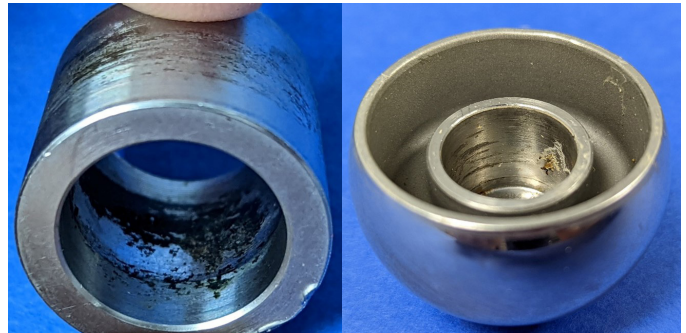
Figure 9

Images of the taper sleeve (left) and femoral head (right) from one of the retrieved devices, displaying black corrosion features and imprinted lines.

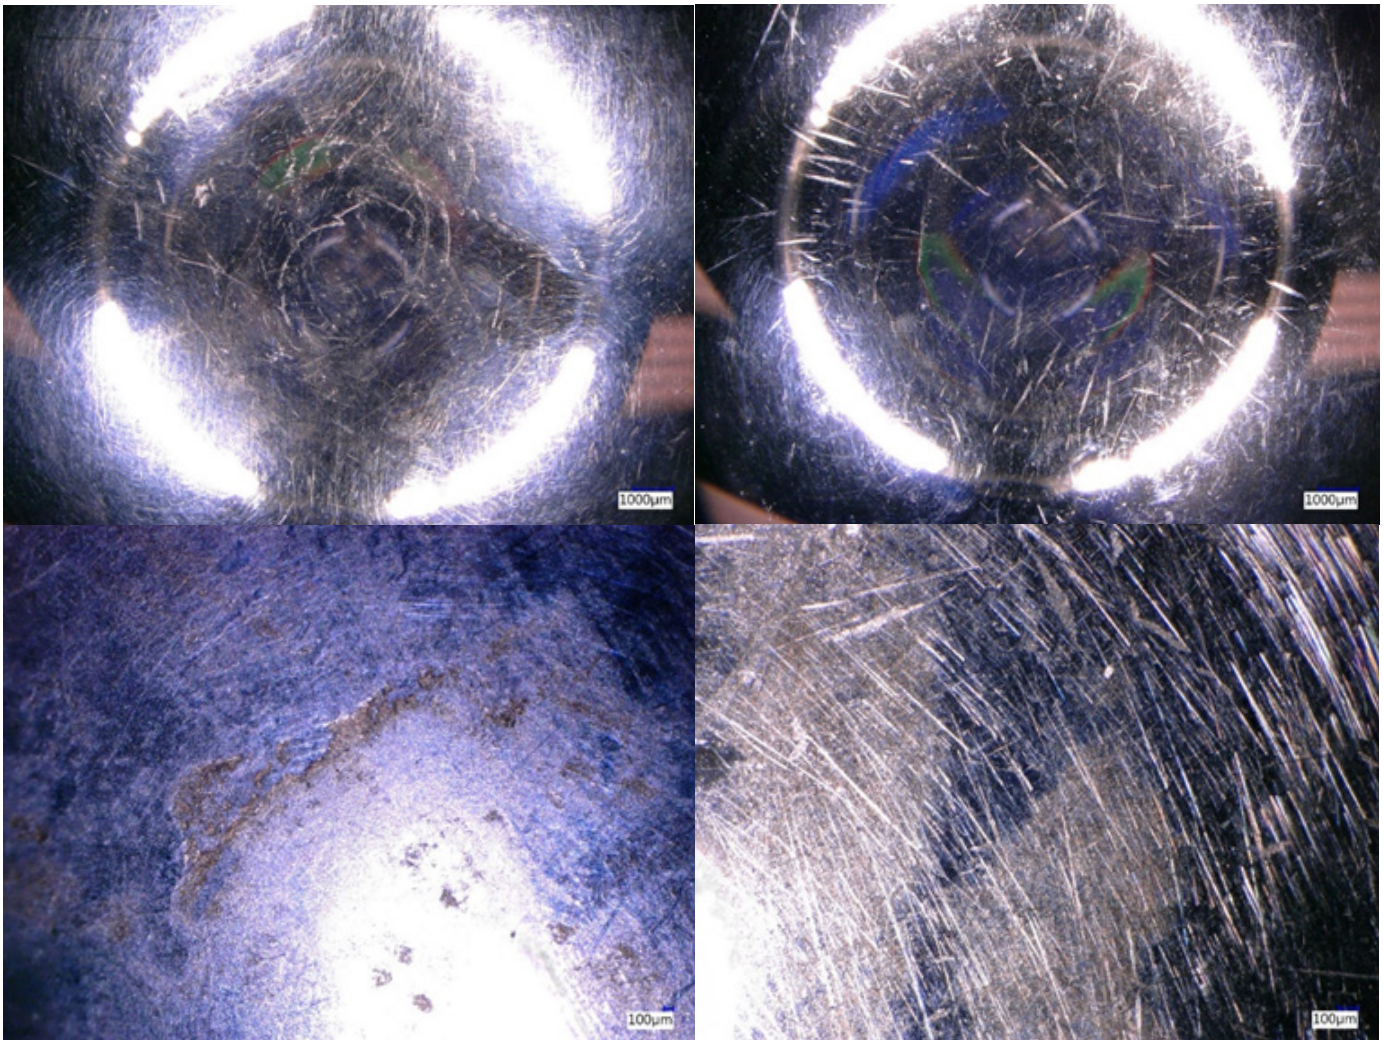
Figure 11

Image of the top of two femoral heads, showing a large number of surface scratches indicative of abrasive wear as well as corrosion.

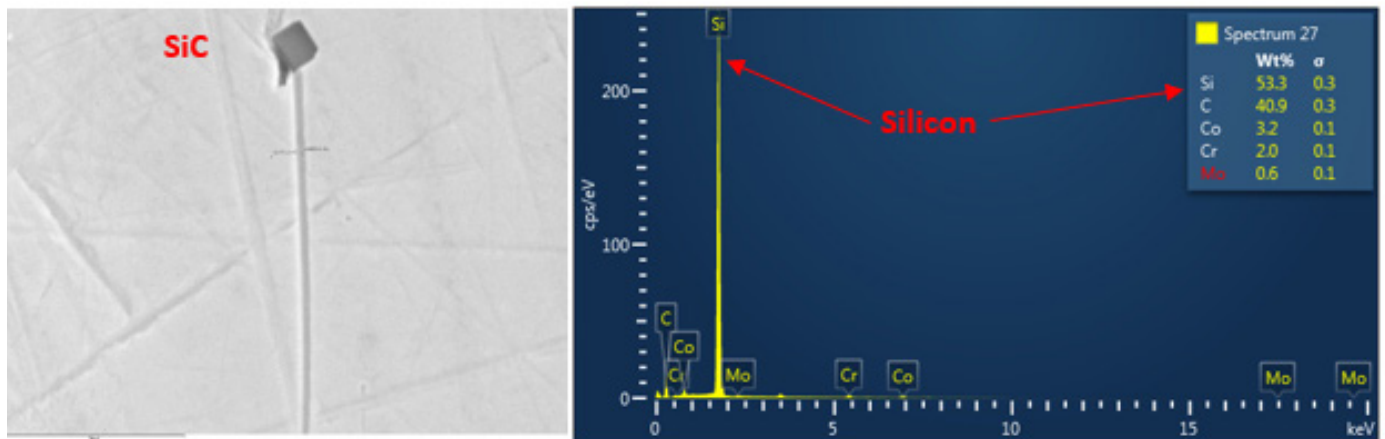
Figure 20

SEM image (left) and EDS results (right) showing a high concentration of silicon and carbon. The silicon-based imperfection was also noted to be embedded at the end of a deep surface scratch, most likely caused by said particle.

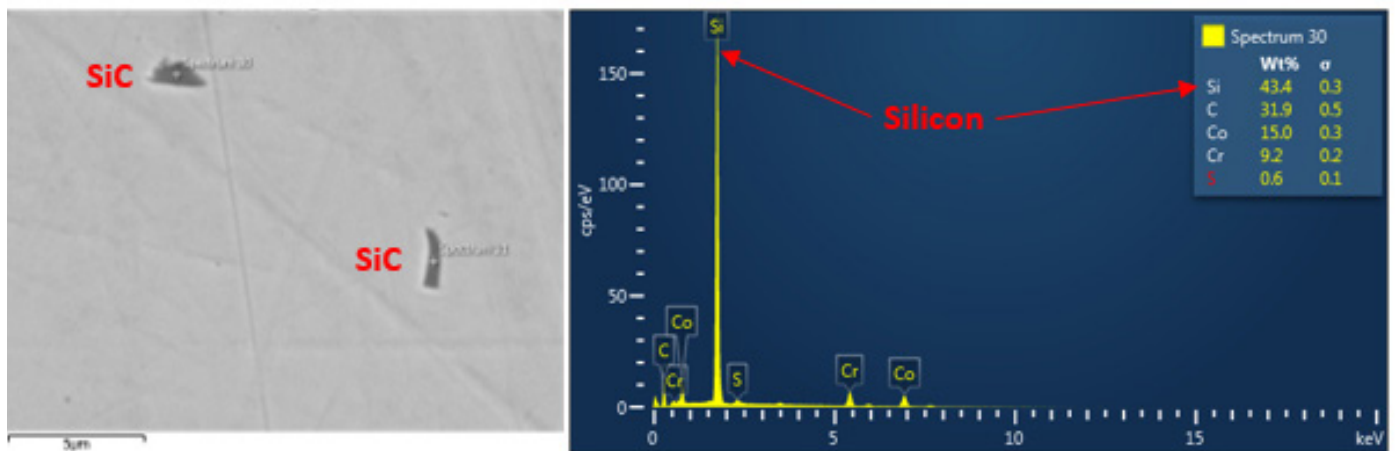
Figure 21

SEM image (left) and EDS results (right) showing embedded particles containing a high concentration of silicon and carbon.

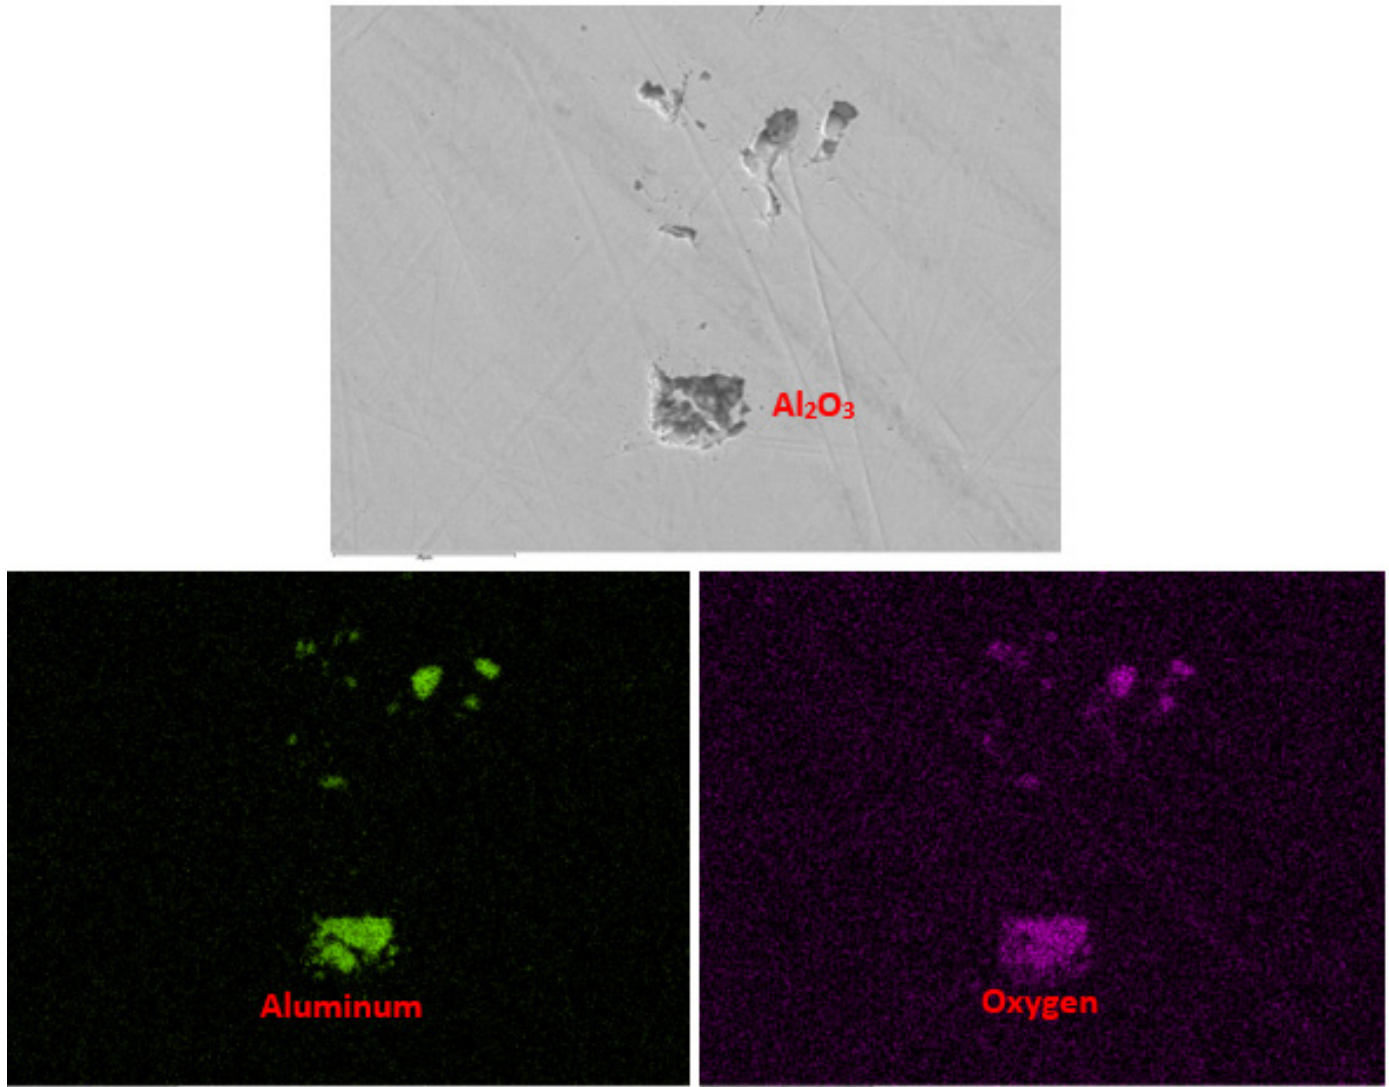
Figure 22

SEM image (top) and its associated EDS maps showing the presence of aluminum (bottom left) and oxygen (bottom right) concentrated in cracks and furrows on the hip, identifying the embedded surface particle as aluminum-oxide, which is routinely used in polishing compounds.

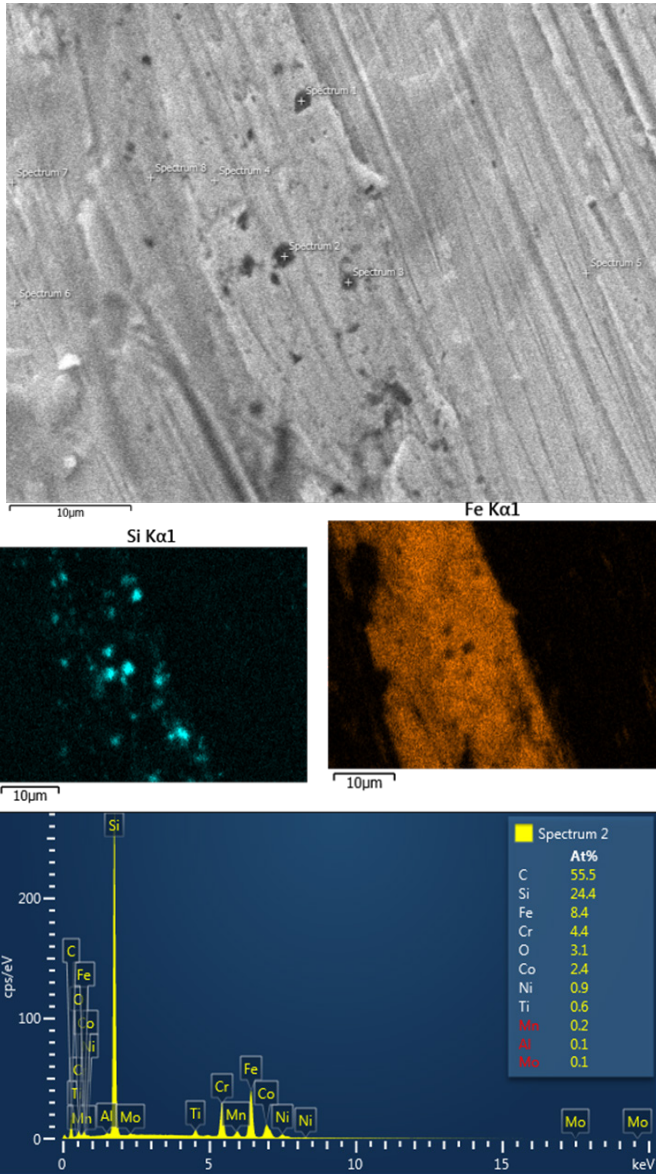
Figure 31
SEM and EDS of a metal liner, showing embedded SiC particle and biological products.

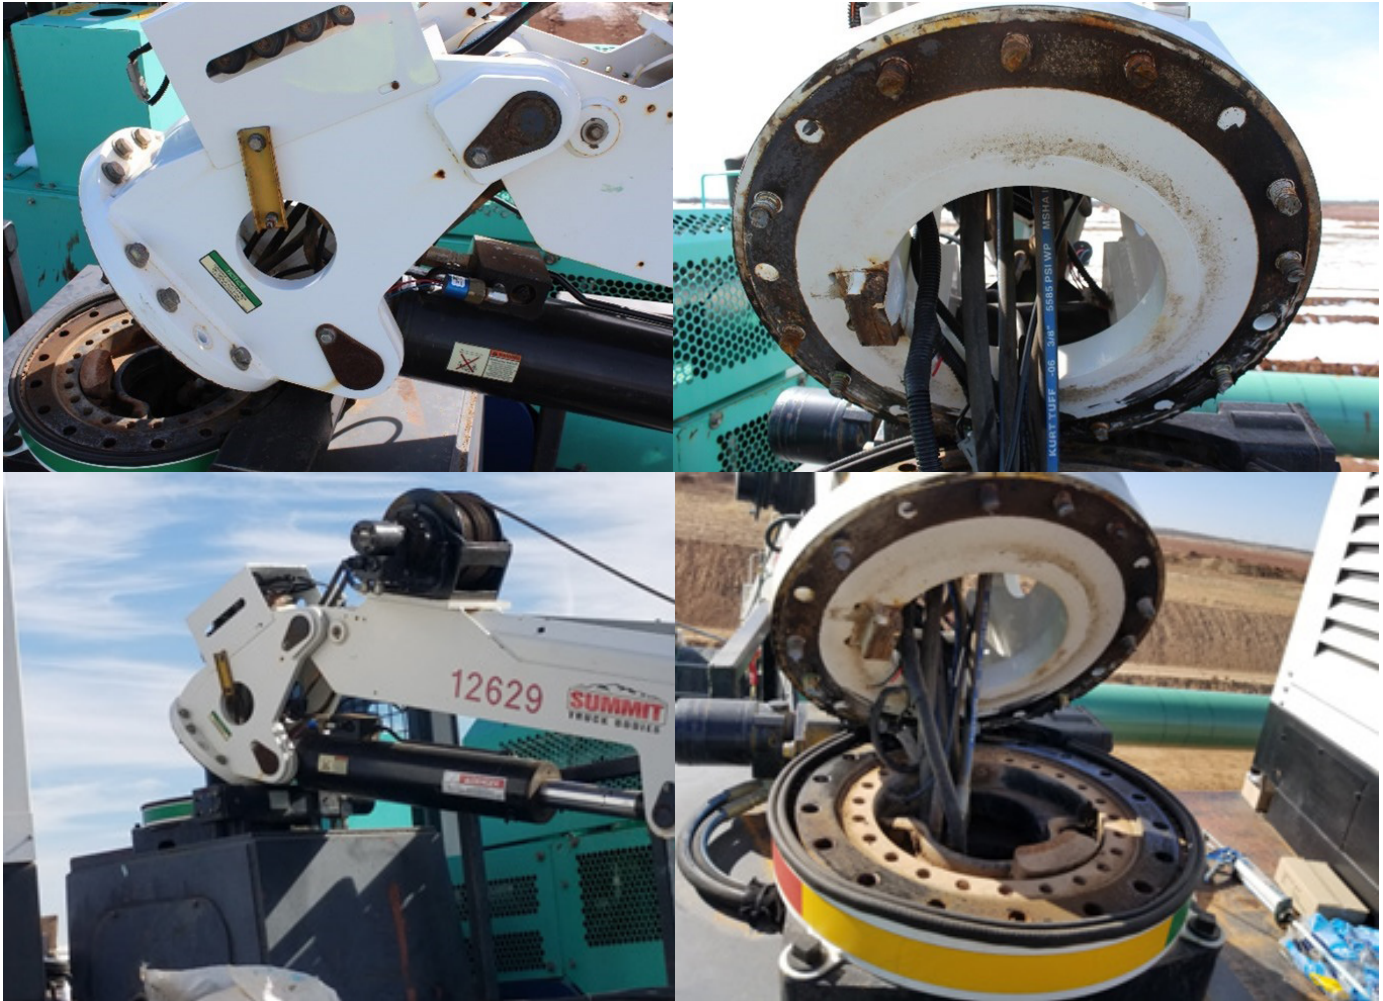
Figure 3

Overall and close-up views of the bolt circle where the failed bolts were attached.

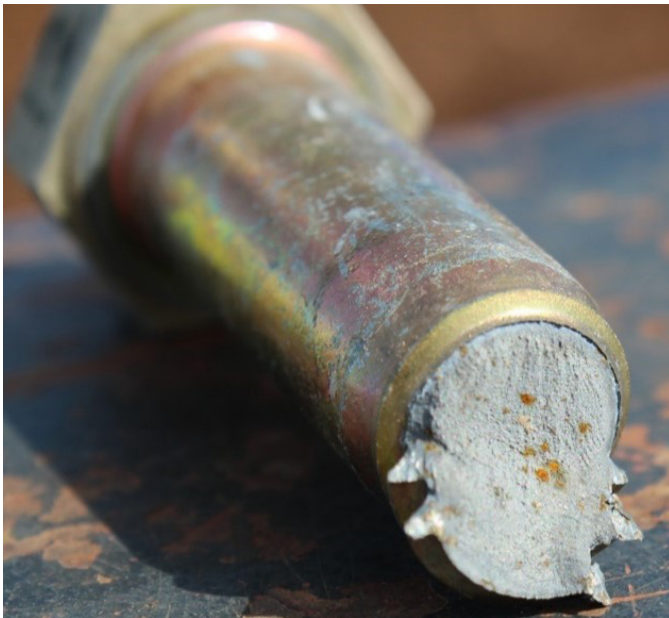
Figure 6

One of the failed bolts, showing a metallic yellow coating characteristic of yellow zinc.

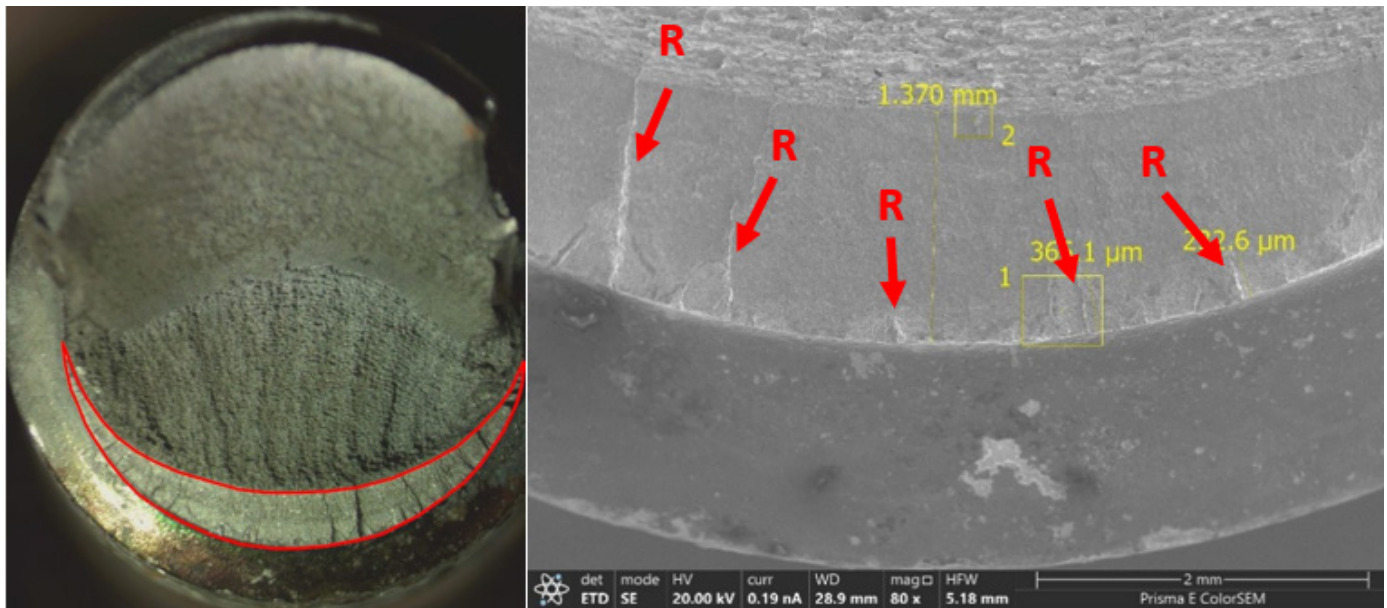
Figure 12

Fracture surface of Bolt #1, displaying crack arrest marks reaching up to the middle of the cross section. A smooth, outer zone with beach marks can be seen, signifying fatigue (left image). The fatigue region of this bolt also displays a number of ratchet marks, highlighted by the red arrows (right image).

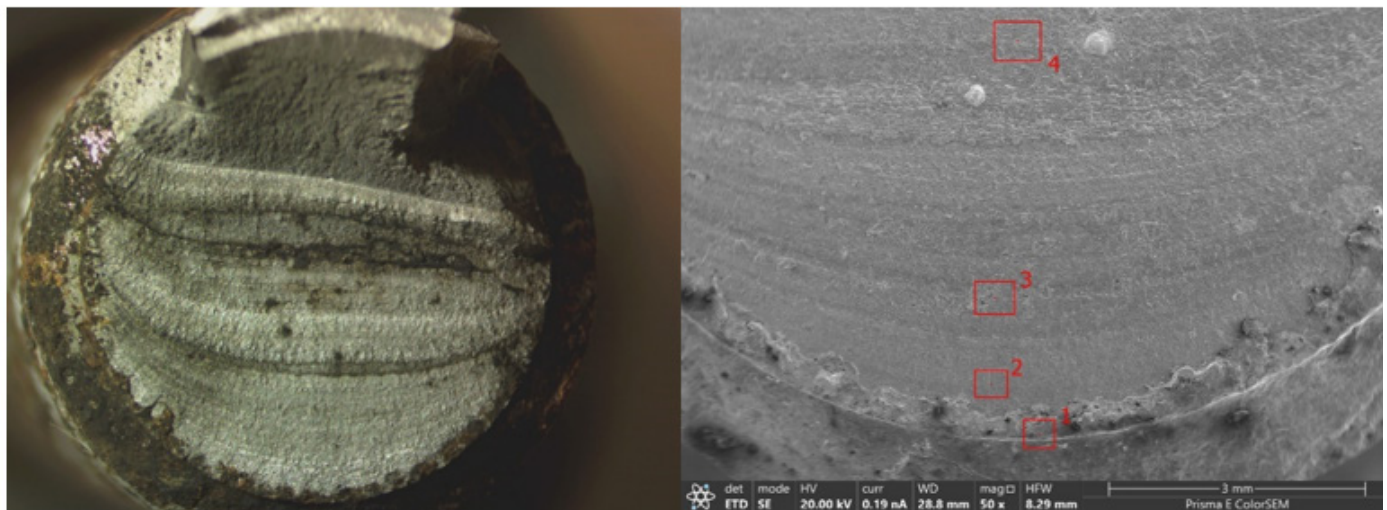
Figure 13

Fracture surface of Bolt #10, displaying a significantly large region of beach marks that extend through a majority of the bolt cross section.

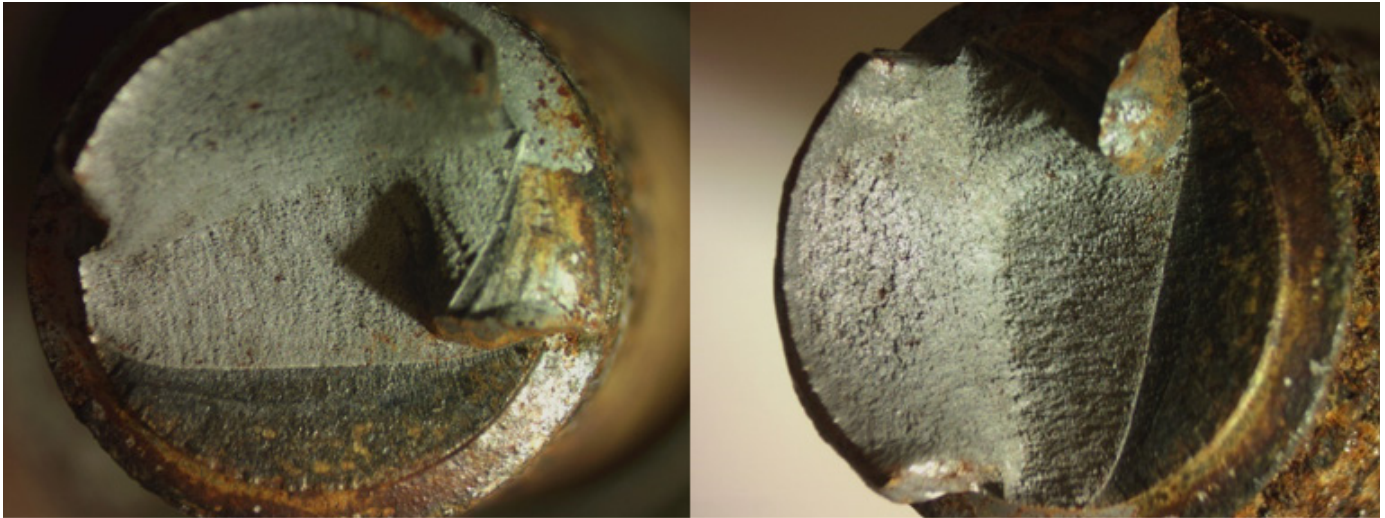
Figure 14

Fracture surface of Bolt #5, displaying a corroded beach marks region, indicative of the exposure of these bolts to a highly corrosive environment after the initial propagation of this fatigue region.

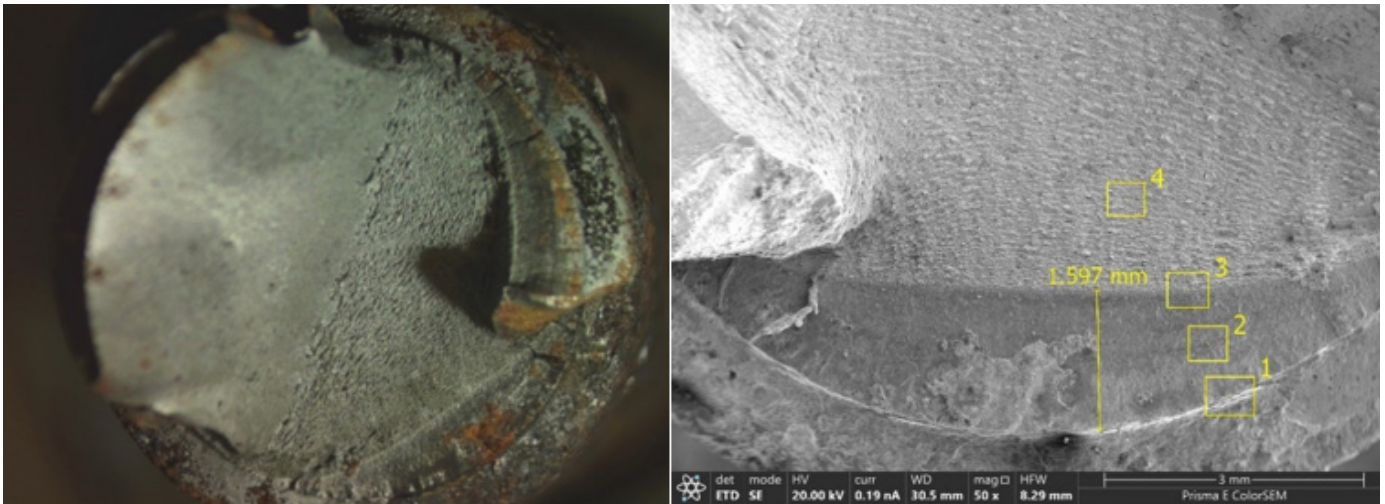
Figure 15

Fracture surface of Bolt #7, displaying a small finely fatigued region covered in corrosion products.

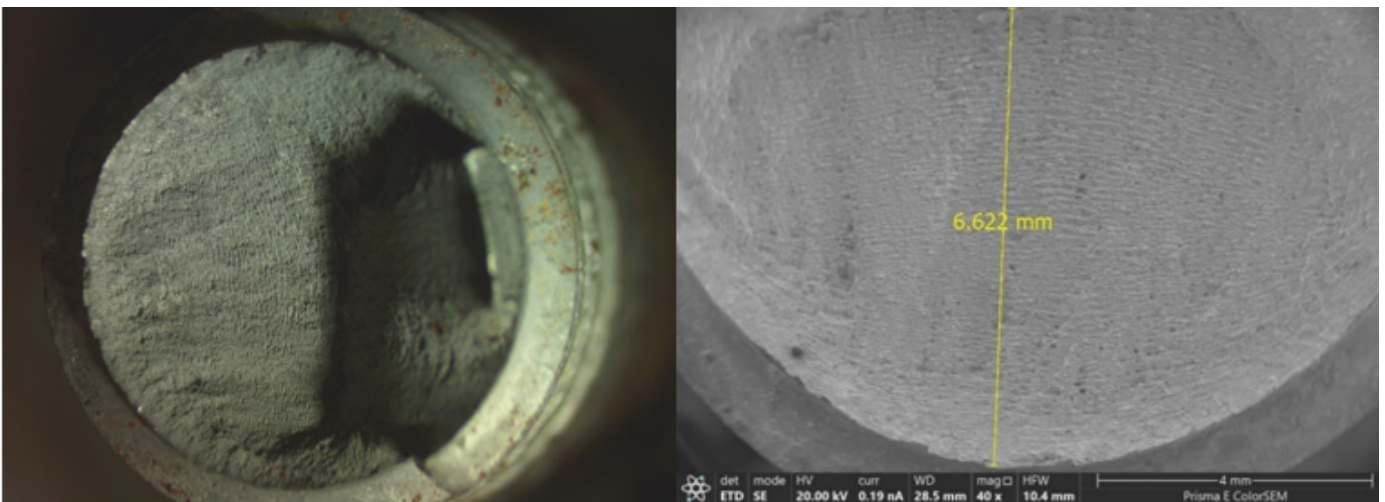
Figure 16

Parallel crack arrest marks observable on Bolt #3, covering more than half of the bolt's surface.

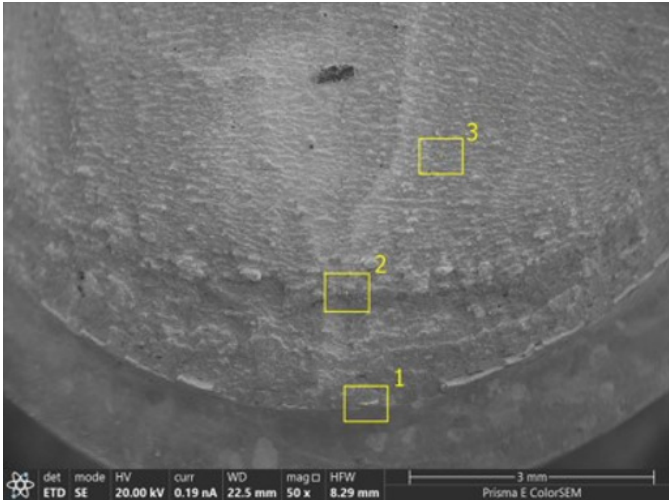
Figure 17

Fracture surface of Bolt #14, showing a region of crack arrest marks.
